Merchants Building

Building Façade Report –
Detroit Ordinance 15-88

Issued | March 23, 2023

Job number 23022

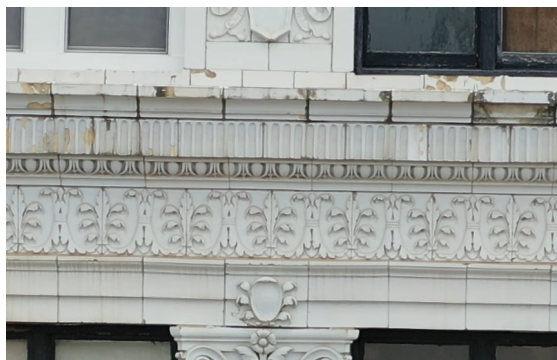
Overall, the terra-cotta façade is in moderate condition, in several areas below water tables and coping stones, the glazed terra-cotta is showing signs of severe surface delamination and spalling.

Delamination occurs overtime as water infiltrating the wall and coping gets trapped behind the glazed surface expands and contracts during freeze/thaw cycles. This condition occurs the full length of upper (P-1) and lower water tables (P-2).

P-1 Spalling of terra-cotta below water table

- **Immediate action: Remove all loose and spalling surfaces at water table to reduce fall hazard.**
- During building rehabilitation construction, address corner terra-cotta water-table pieces to repair joints and prevent water infiltration.
- Determine extent of steel corrosion behind broken terra-cotta pieces and clean exposed steel to base metal
- After coping stones and flashing issue (Section 7.5.2) has been addressed then repair/replace delaminated and damaged terra-cotta.

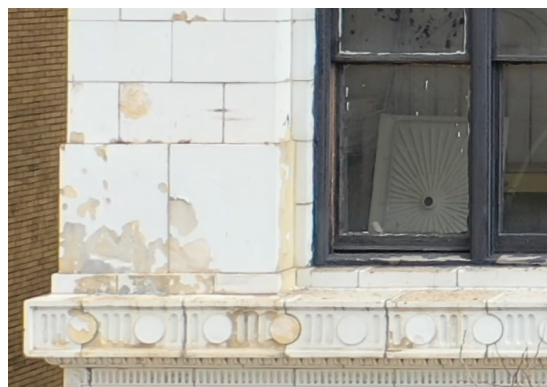
P-2 Delamination of terra-cotta around lower water tables

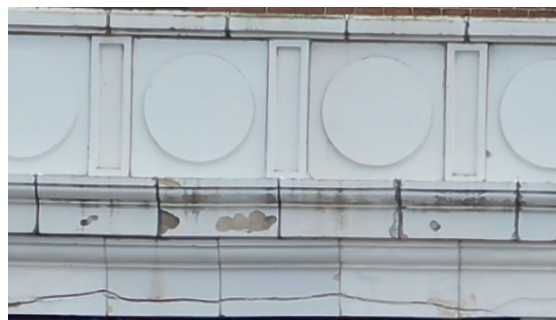
Vertical cracks at corners and horizontal crack below upper water table (P-3) are likely caused by water infiltration along upper water tables and corroding embed steel behind terra-cotta façade (P-4).

P-3 Spalling and cracking terra-cotta at upper water table

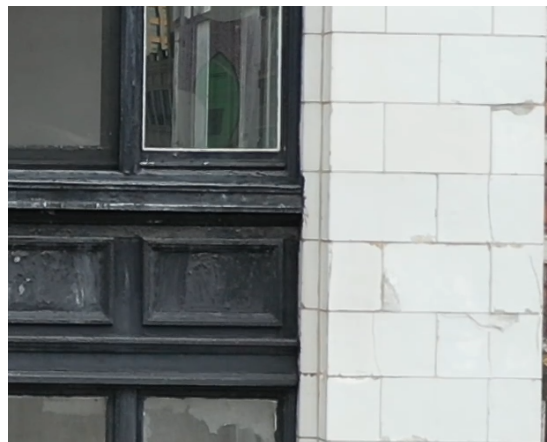
P-4 Cracks in corner terra-cotta due to corroded embedded steel

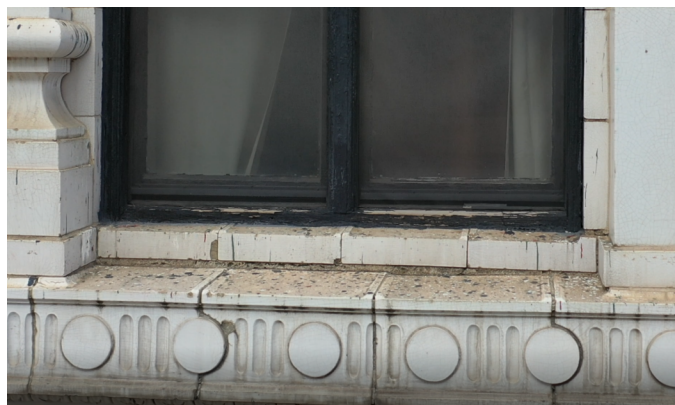
Lower water tables are in good condition and no delamination of terra-cotta is observed (P-5).

P-5 Lower water table in good condition along Broadway Street

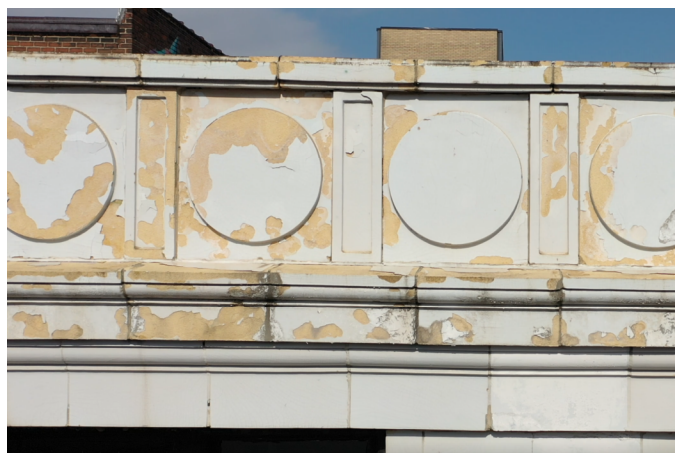
Similar to section 7.1.1, the terra-cotta façade is in moderate condition. In several areas below upper water tables and coping stones (P-6), the glazed terra-cotta is showing signs of severe delamination. Water infiltrating the wall and coping stones gets trapped behind the glazed surface expands and contracts during freeze/thaw cycles. This condition occurs the full length of upper water tables.

P-6 Spalling terra-cotta at parapet and upper water table

- **Immediate action: Remove all loose and spalling surfaces at water table to reduce fall hazard.**
- After coping stones and flashing issue (section 7.5.2) has been addressed then repair/replace delaminated and damaged terra-cotta.

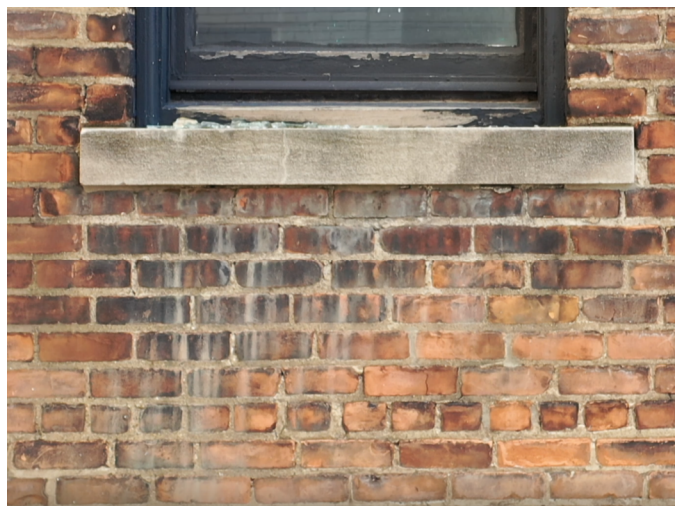
Deterioration is caused by exposure freeze-thaw cycles as observed by the efflorescence below window sills (P-7). Displaced coping stones at the roof and failed mortar joints between brick and concrete frame results in further water infiltration and deterioration.

P-7 Efflorescence at brick below window sill

- During building rehabilitation construction, the open mortar joint should be tucked and re-pointed to prevent more serious structural issues.
- During building rehabilitation construction, the corroding steel lintel should be repaired to prevent further damage.

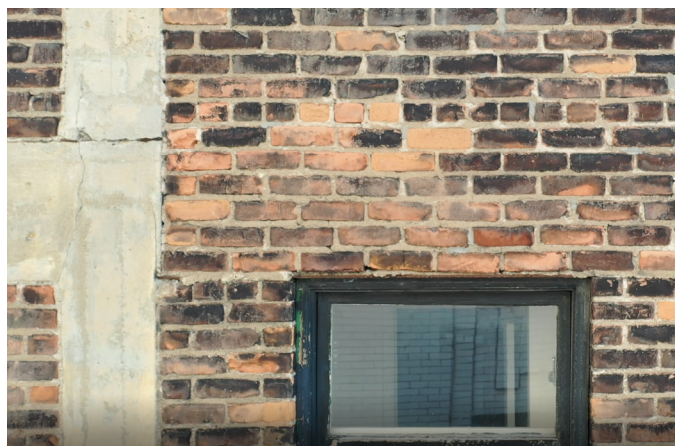
Corroding steel lintel above window opening causing displaced brick and allowing further water infiltration (P-8). Flashing above steel lintels is likely not present or is beyond serviceable life. Corroding steel expands and the resulting rust pack imposes jacking forces on the adjacent masonry. This rust jacking results in warping and deflection of steel and cracking and deterioration of brick.

P-8 Rust jacking of brick above corroded steel lintels

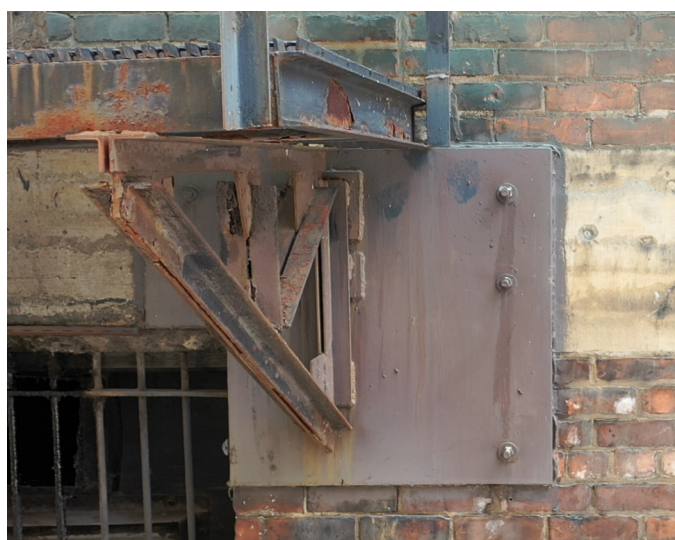
Fire escape shows signs of corrosion but does not pose a fall hazard (P-9). Brick at fire escape support brackets is displacing and cracking. It is assumed that the fire escape is not currently used as an emergency exit. Remove and reconstruct to match existing geometry if the fire escape is required as second means of egress for proposed use.

P-9 Corrosion at fire escape steel

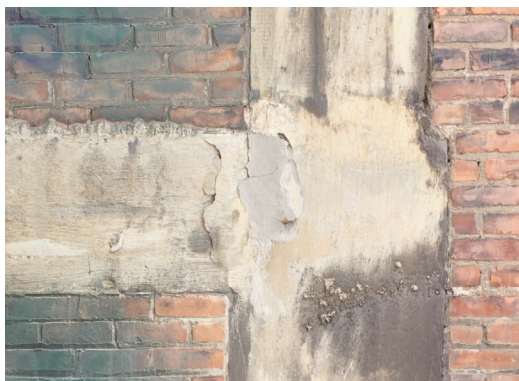
The exposed concrete frame is constructed with concrete that does not contain entrained air and is susceptible to damage/deterioration due to freeze/thaw cycling. Previous repairs have been made to reduce exposure to reinforcement but were not constructed properly and have started spalling (P-10).

P-10 Spalling of exposed concrete frame

- **Immediate action: Remove all loose and spalling concrete to reduce fall hazard.**
- Shotblast or mechanically clean exposed steel reinforcing bars to base metal.
- Hammer sound and chip away deteriorated and damaged concrete around exposed rebar.

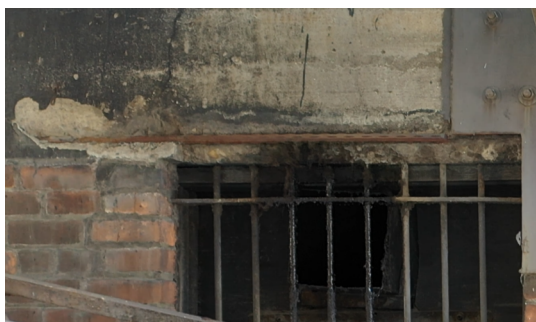
When constructed, the proper concrete cover over embedded reinforcing bars and exterior surfaces was not provided. The embedded steel reinforcing located too close to the exterior surface corrodes. Corroding steel expands and the resulting jacking forces cracks and spalls the thin concrete cover (P-11).

P-11 Reinforcement visible above window at spalled concrete

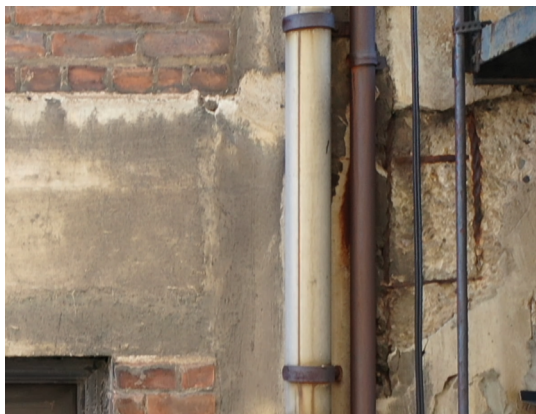
Spalling concrete at building joint is severe due to improper sealant between the two buildings (P-12). Further deterioration is observed due to proximity to plumbing lines adjacent to building façade.

P-12 Spalled concrete at building joint between columns

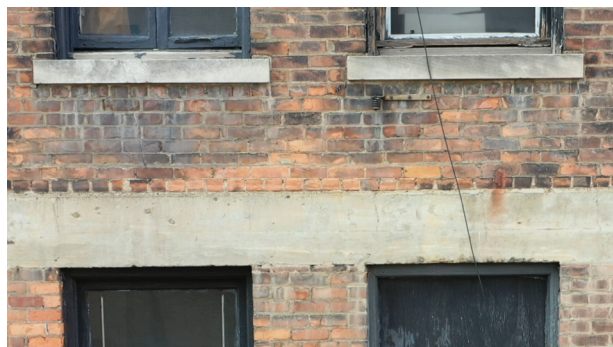
Deterioration is caused by exposure freeze-thaw cycles similar to section 7.3.1 (P-13). Displaced coping stones at the roof and failed mortar joints between brick and concrete frame results in further water infiltration and deterioration (P-14).

P-13 Brick and mortar deterioration around concrete frame

- **Immediate action: Remove all loose and spalling brick below parapet to reduce fall hazard.**
- Coping stones need to be addressed to prevent water infiltrating the brick and stop delamination and spalling.
- During building rehabilitation construction, the open mortar joint should be tucked and re-pointed to prevent more serious structural issues.
- Loose and spalled brick to be removed to prevent fall hazard.

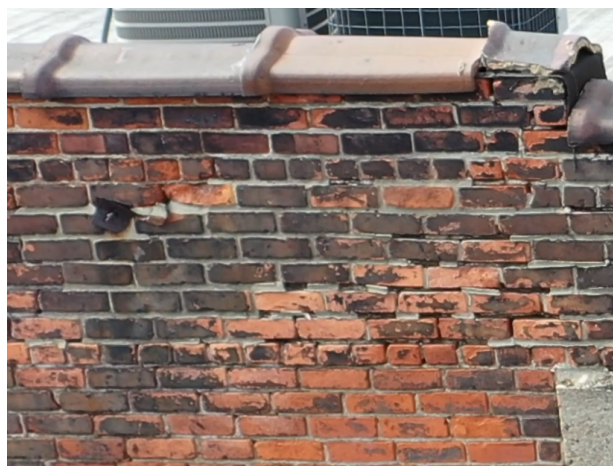
P-14 Brick and mortar deterioration below coping stones

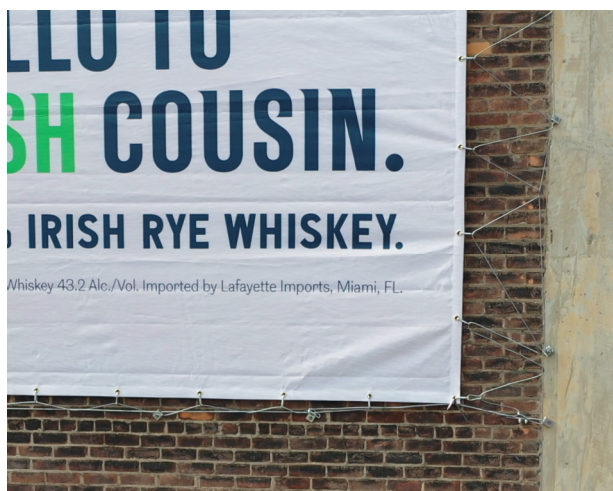
The brick façade toward Broadway Street is partially covered with advertisement and not visible during inspection (P-15).

P-15 Advertisement covering brick wall

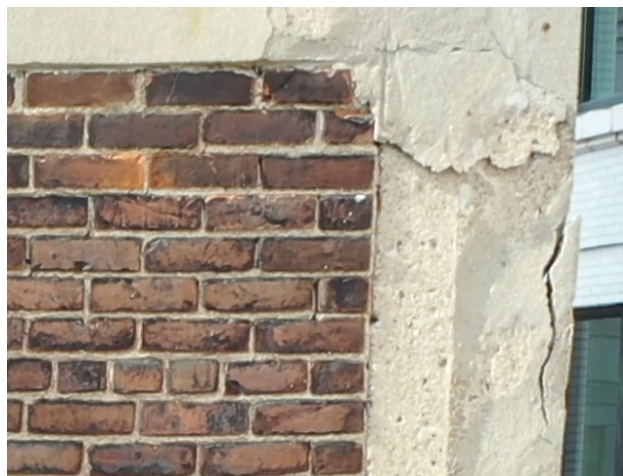
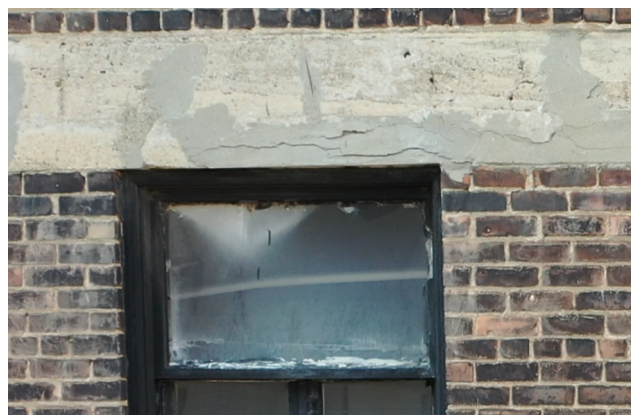
The exposed concrete frame is constructed with concrete that does not contain entrained air and is susceptible to damage/deterioration due to freeze/thaw cycling. Previous repairs have been made to reduce exposure to reinforcement but were not constructed properly and have started spalling (P-16 and P17).

When constructed, the proper concrete cover over embedded reinforcing bars and exterior surfaces was not provided. The embedded steel reinforcing located too close to the exterior surface corrodes. Corroding steel expands and the resulting jacking forces cracks and spalls the thin concrete cover.

P-16 Spalling along patched concrete column

P-17 Spalling along patched concrete column

- **Immediate action: Remove all loose and spalling concrete to reduce fall hazard.**
- Shotblast or mechanically clean exposed steel reinforcing bars to base metal.
- Hammer sound and chip away deteriorated and damaged concrete around exposed rebar.

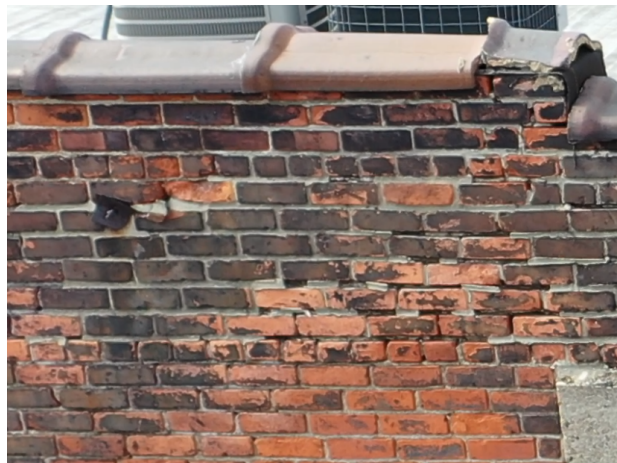
Ornamental coping stones at the parking and rear alley facades are in poor condition with several observed broken coping stones and the majority of stones displaced. Deterioration of brick below alley coping stones is minor due to flashing on the underside of the stones (P-18).

P-18 Broken and displaced coping stones at parapet

To reduce further deterioration, continue flashing beyond edge of parapet and reset/replace coping stones to redirect water as well as repair and maintain all exposed head joints.

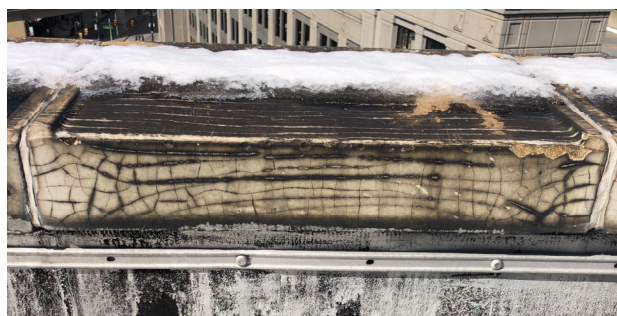
Rubber flashing on top of terra-cotta coping stones joints and mortar joints is beyond their serviceable life allowing water infiltration between coping stones (P- 19) and into parapet below causing delamination/spalling of terra-cotta faces.

P-19 Delaminating coping stones and deteriorated joints

- Option 1: Through wall flashing is recommended under the coping and top horizontal and vertical joints sealed to prevent water infiltration.
- Option 2: Add metal flashing over the top of the coping to cover all joints.
- Option 3: Seal horizontal and vertical joints with impermeable sealant to prevent water infiltration.

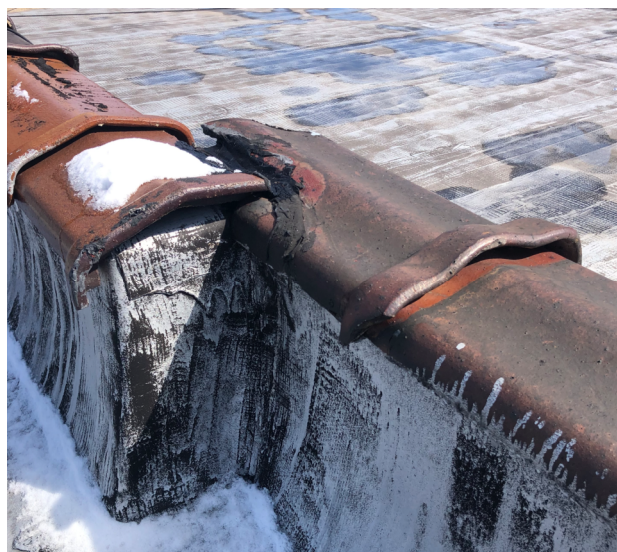
Coping stones at building joint parapet are displaced, however roof flashing is continuous underside of stones (P-20). Reset coping stones as part of ongoing maintenance.

P-20 Displaced coping stones overtop flashing at building joint parapet

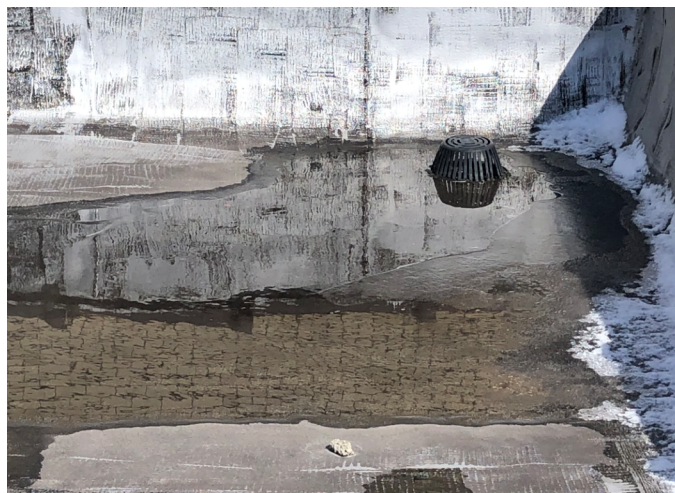
Overall, the roof is in fair condition. The roof membrane appears in good condition with few areas at the roof showing water ponding (P-21) to be addressed.

P-21 Poor drainage and ponding at roof

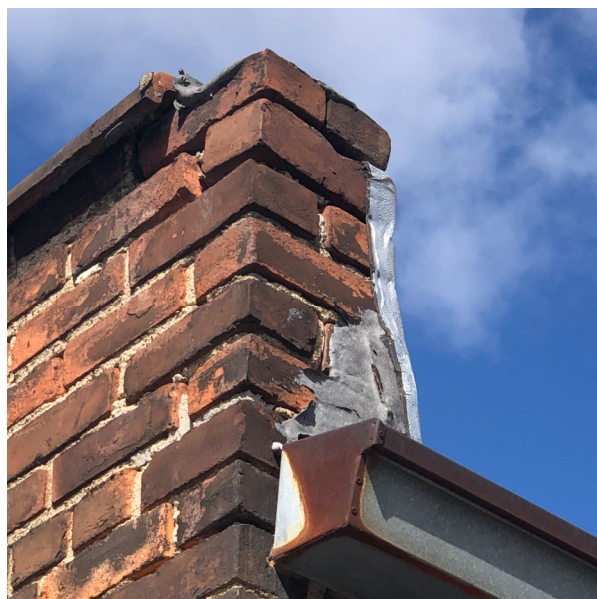
Coping stones and mortar joints are allowing water infiltration and into brick wall below (P-22) causing mortar and brick deterioration.

P-22 Broken coping stones and deteriorated mortar joints at elevator shaft

- During building rehabilitation construction, remove coping stones, install flashing overtop parapet and reinstall ornamental coping stones.
- During building rehabilitation construction, Remove and replace gutters and flashing at elevator shafts.
- After coping stones, flashing, and gutters have been addressed, tuck and repoint mortar joints to prevent serious structural issues.

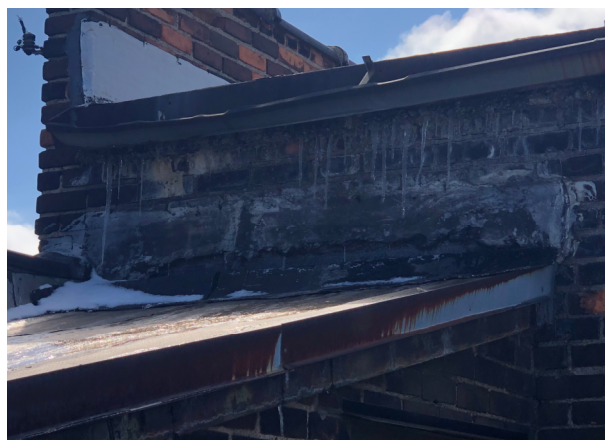
Efflorescence and substantial brick deterioration observed below elevator roof gutters. The gutters and flashing below are beyond serviceable use and are allowing water infiltration into the building (P-23).

P-23 Broken gutters and deteriorated flashing below elevator roof
