City of Detroit
Planning & Development Department
2 Woodward Avenue, Room 808
Detroit, Michigan 48226

The following sheets describe the restoration projects at my home at 2405 Burns Street in Indian Village. This is in response to a letter sent on March 24, 2023 describing "Replaced Windows" and "Installed Fence" sent by Daniel Rieden. The fence work is described within, and has been partially completed. There have not been any windows replaced since my ownership in 2019. I have, however, been restoring original windows, which is described within. There are also several restorations described which have also been completed

FENCES

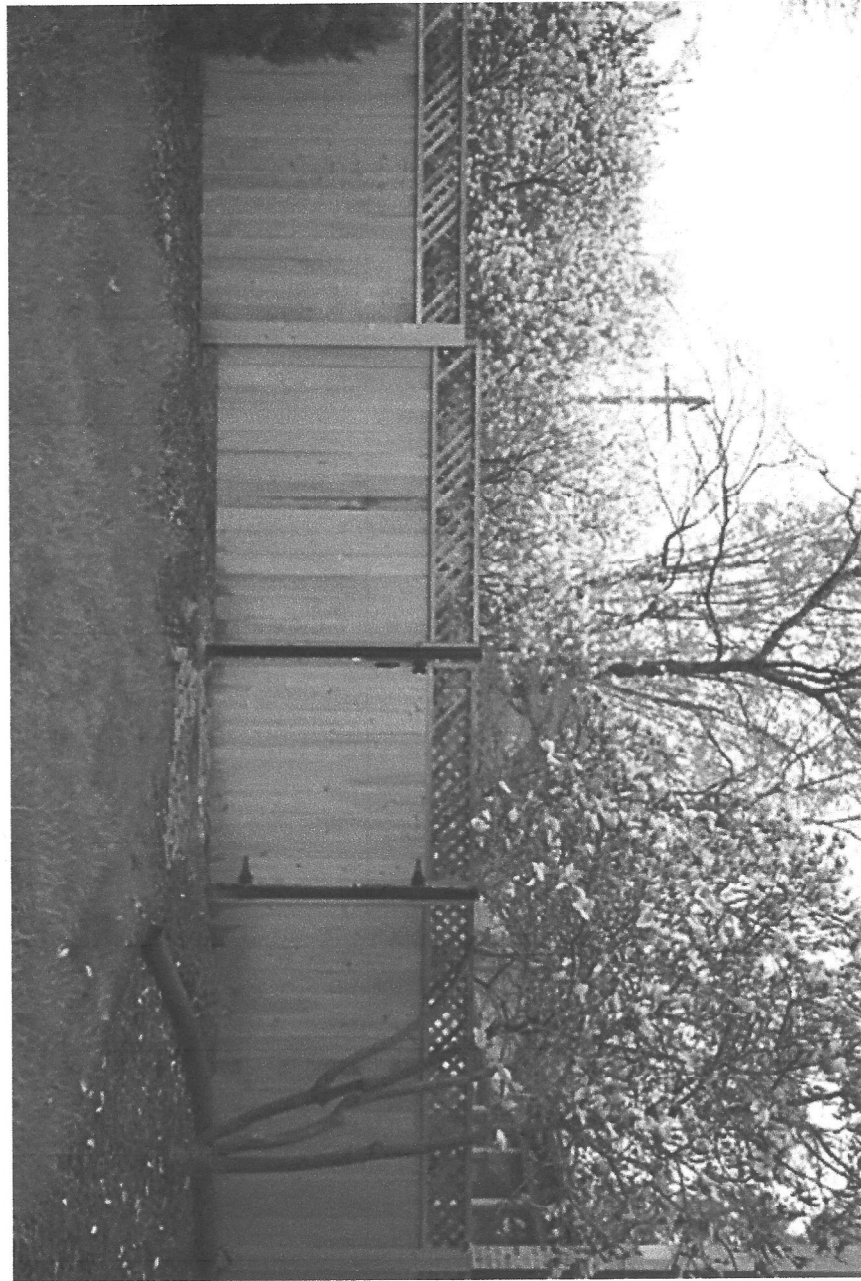
The first 4 pictures (captioned Picture 1 through Picture 4) are of the backyard privacy fence. It has been completely removed and replaced exactly as it was with new cedar construction. The previous fence was falling down and rotting in many areas. The contractor was Kimberly Fence in Warren. They did exemplarily work and I would recommend even though they were not the lowest bid. This work was completed in January.

Picture 1: Backyard fence
facing Burns on Vernor
side of house.

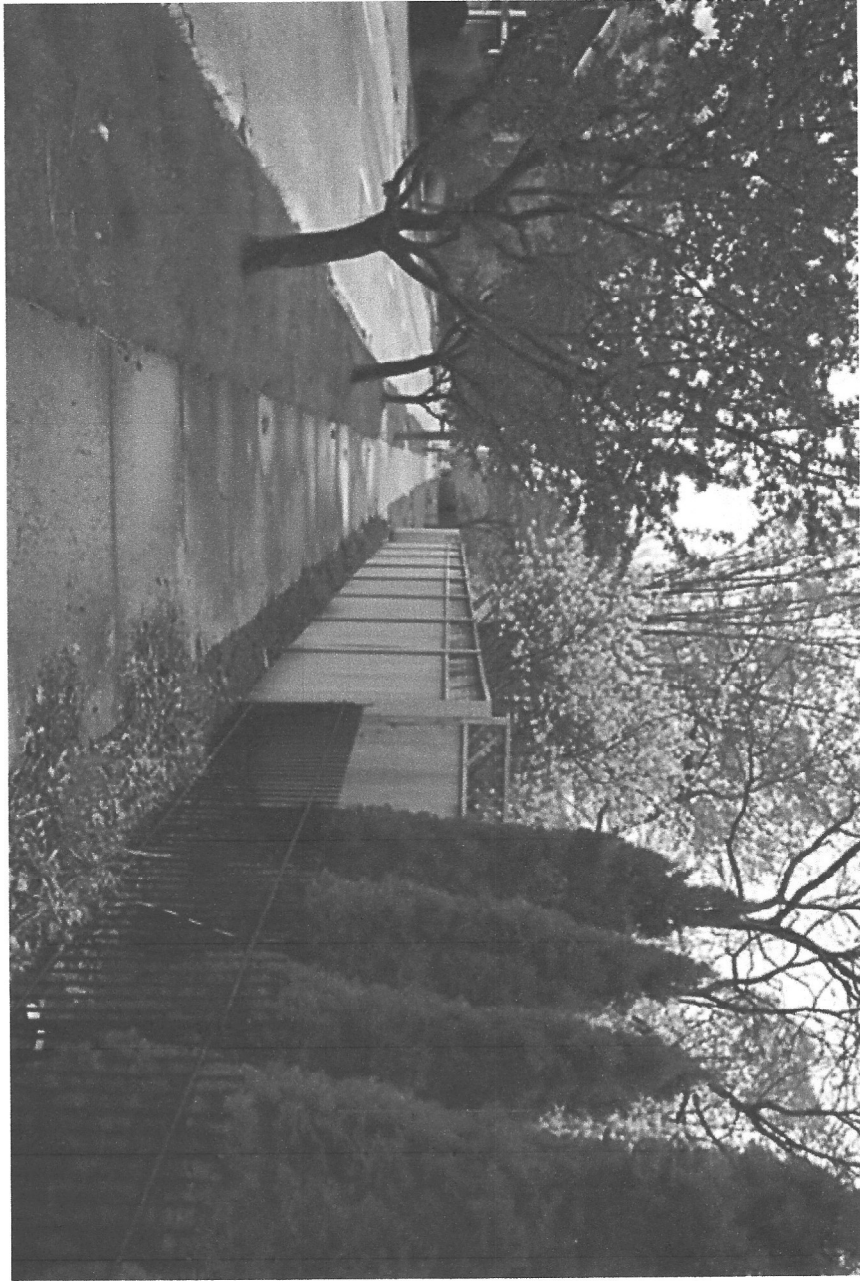
Picture 2: Vernon side
of fence

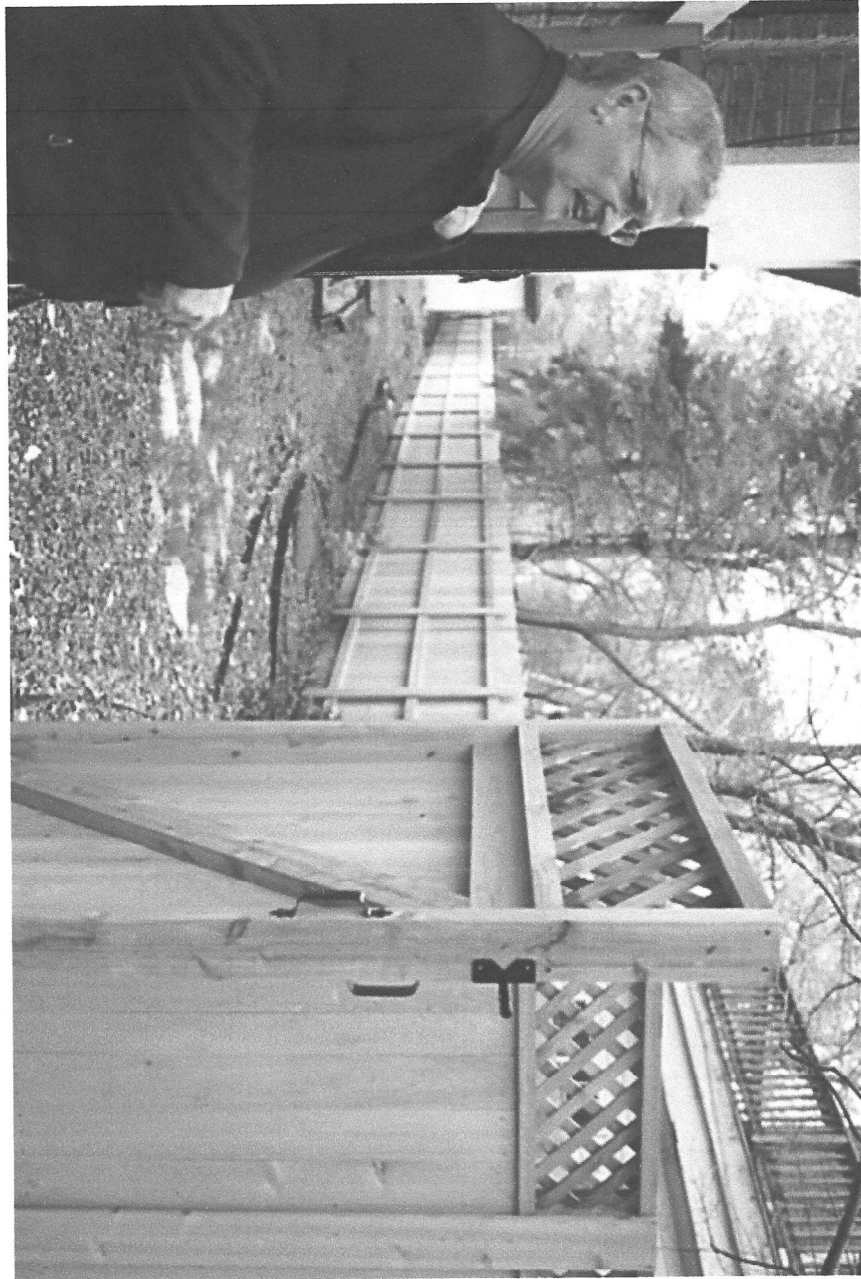
Picture 3 : Fence between
my yard and neighbors

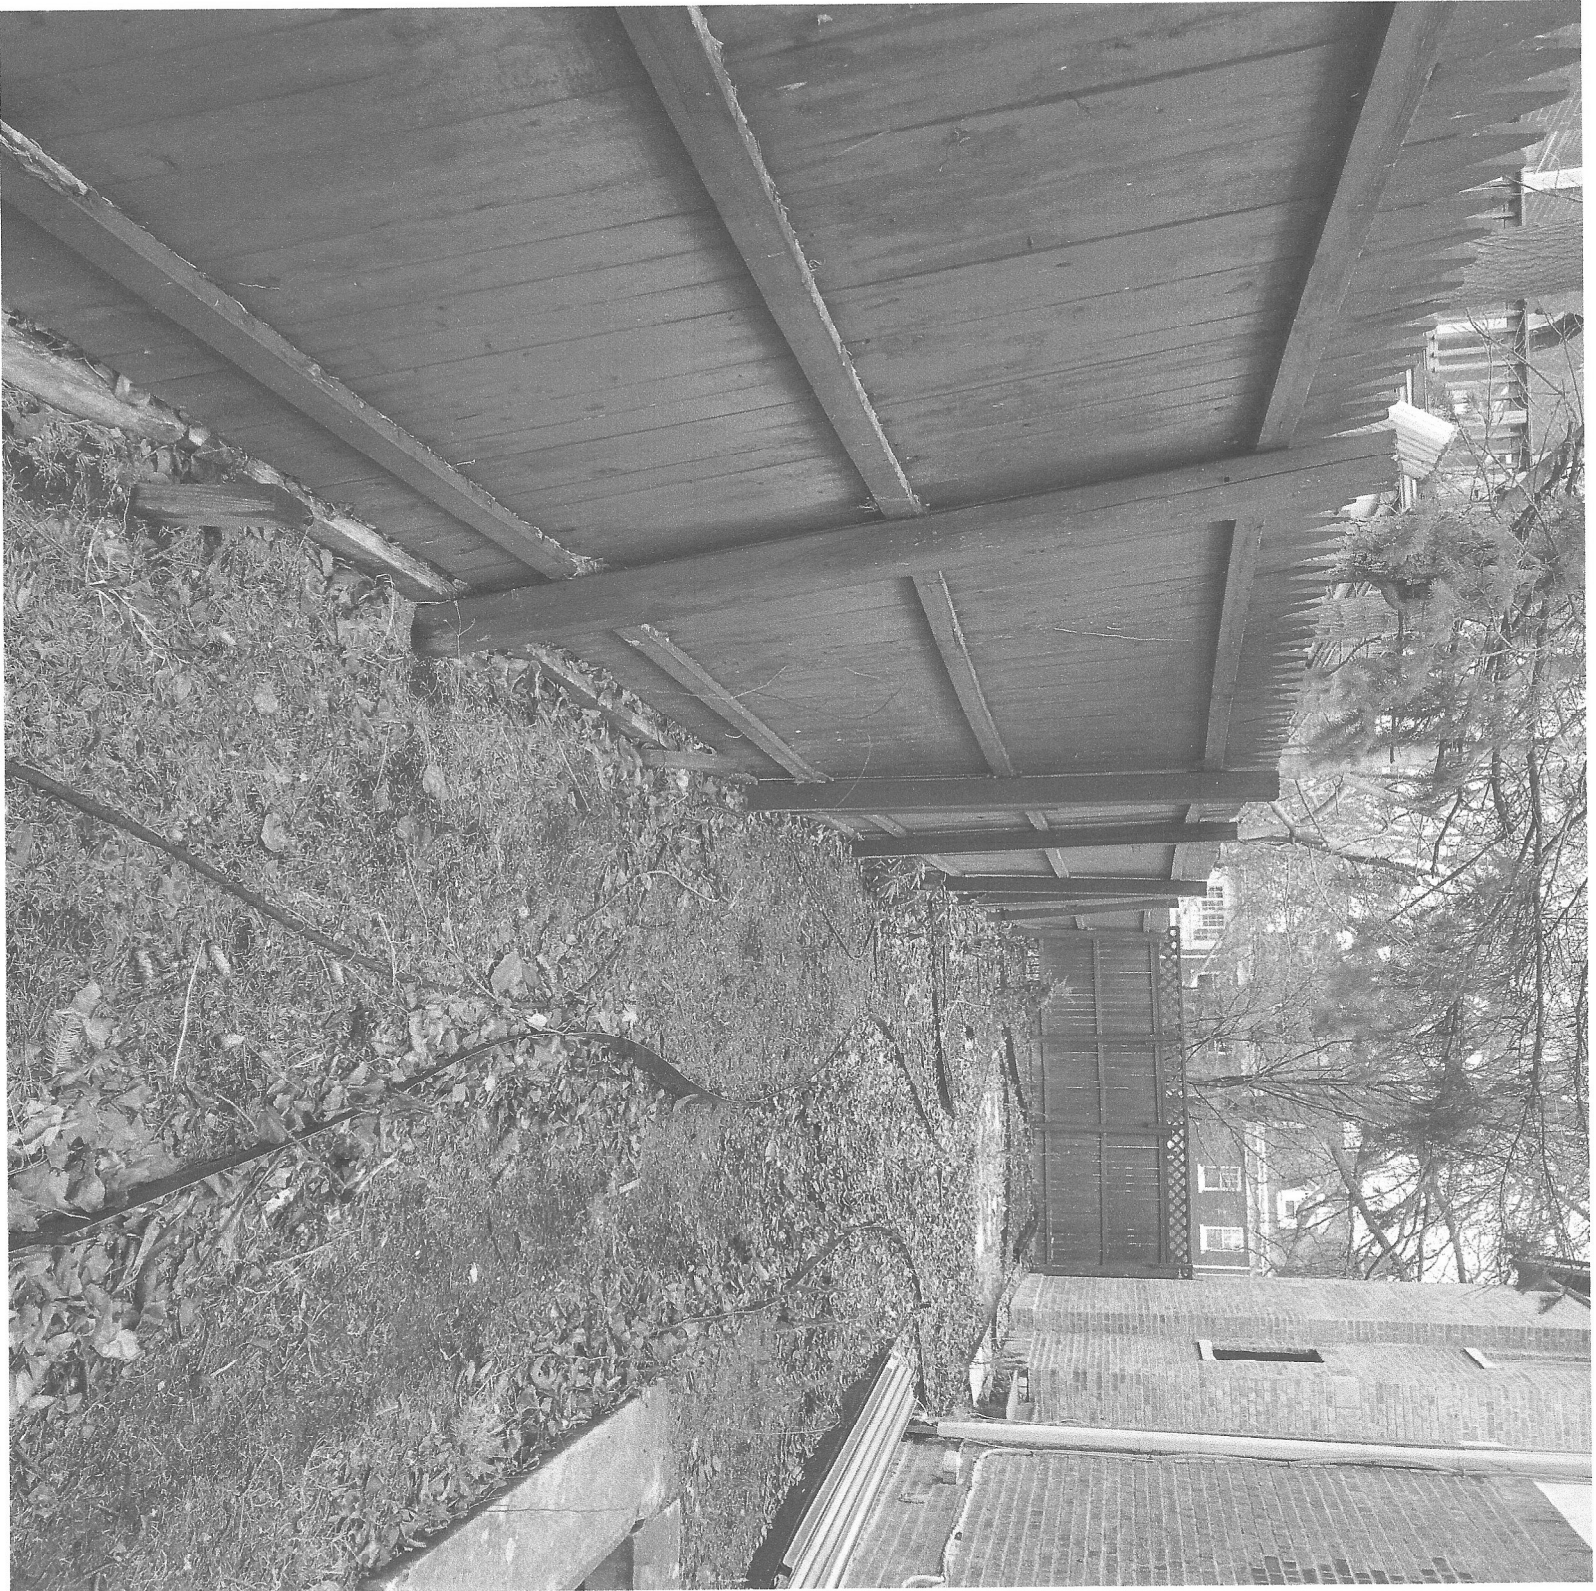
Picture 4: Same Section as
Picture 3 of old fence

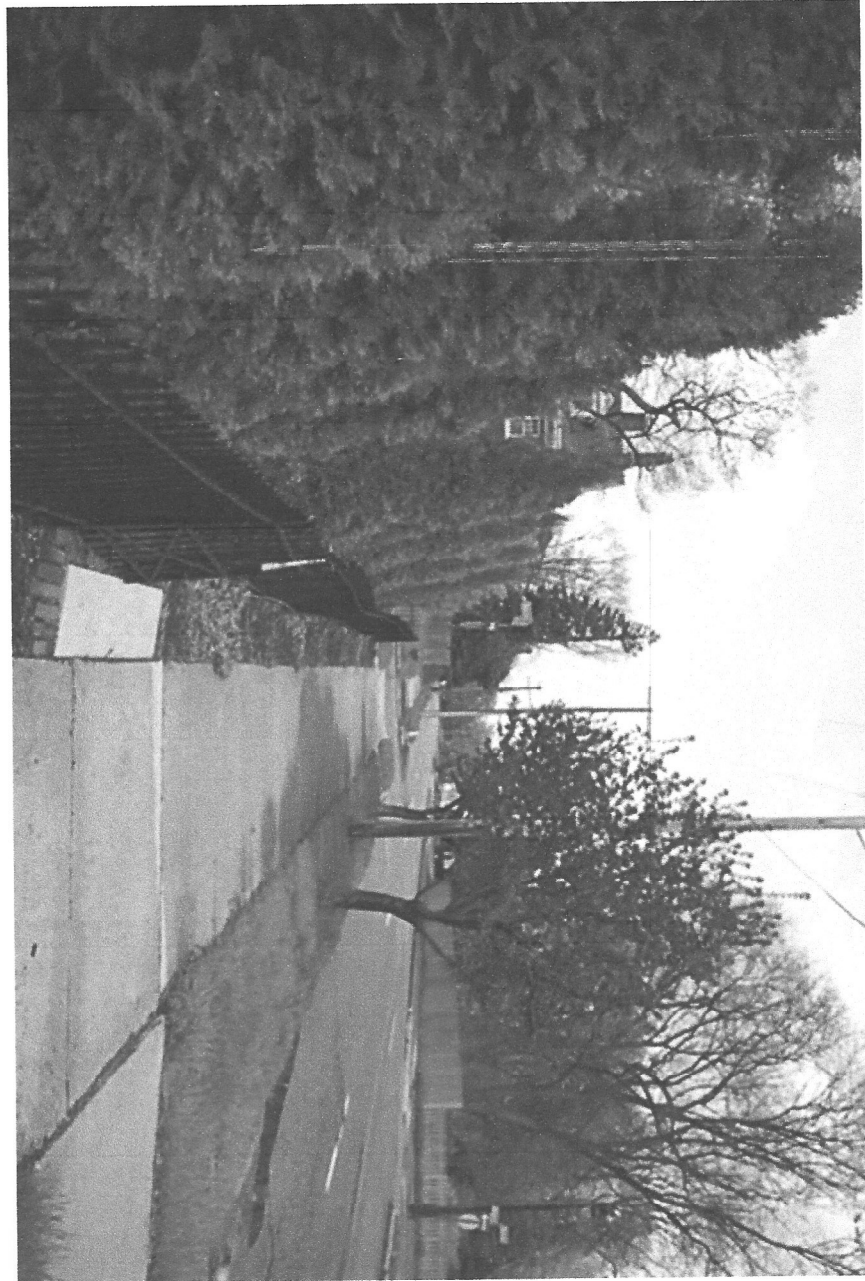
Pictures 5 through 8 are of the current iron fence on the front of the house. This is to be replaced as in Picture 7 and 8 which is an identical construction as originally put it. This work has not been started to date

Picture 5 Vernor Side
Iron fence

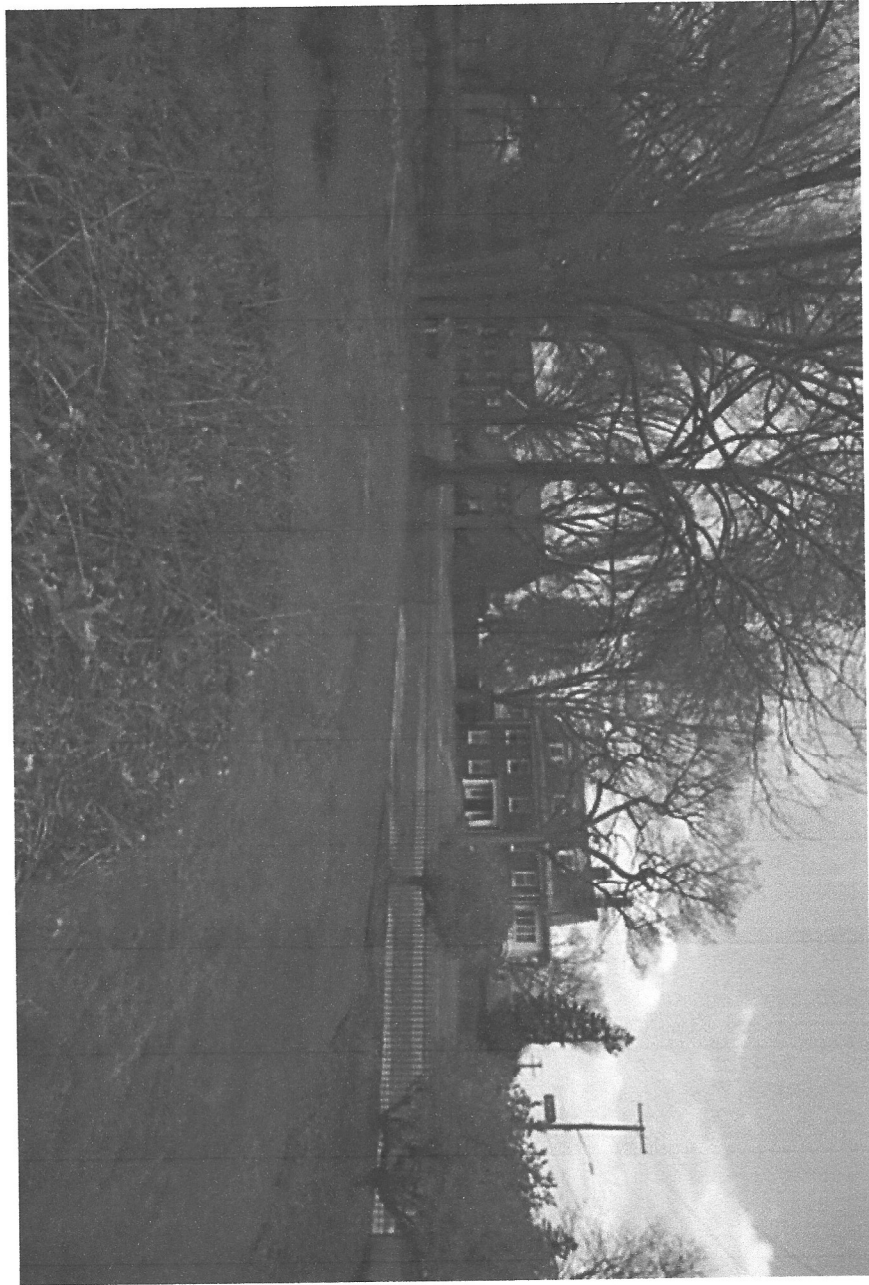
Picture 6. Vernon Side
Iron fence

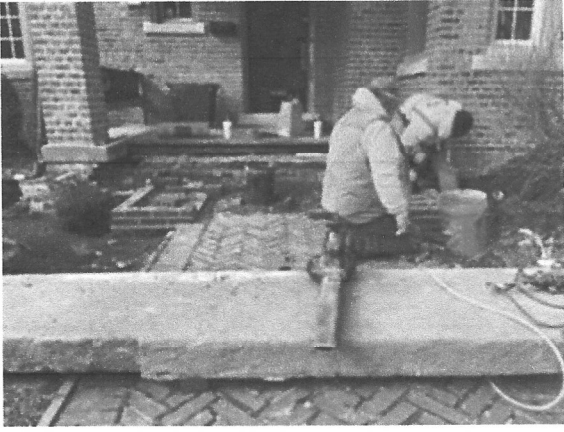
Picture 9

The front steps were falling backwards causing water to flow towards the house. This was due to the foundations had deteriorated. I hired a restoration concrete and brick contractor (Grunwell-Cashero) to do this work. The limestone steps were temporarily removed and the foundations were rebuilt. The limestone steps were placed back on the new foundations. This portion is complete. (Pictures 9 through 12)

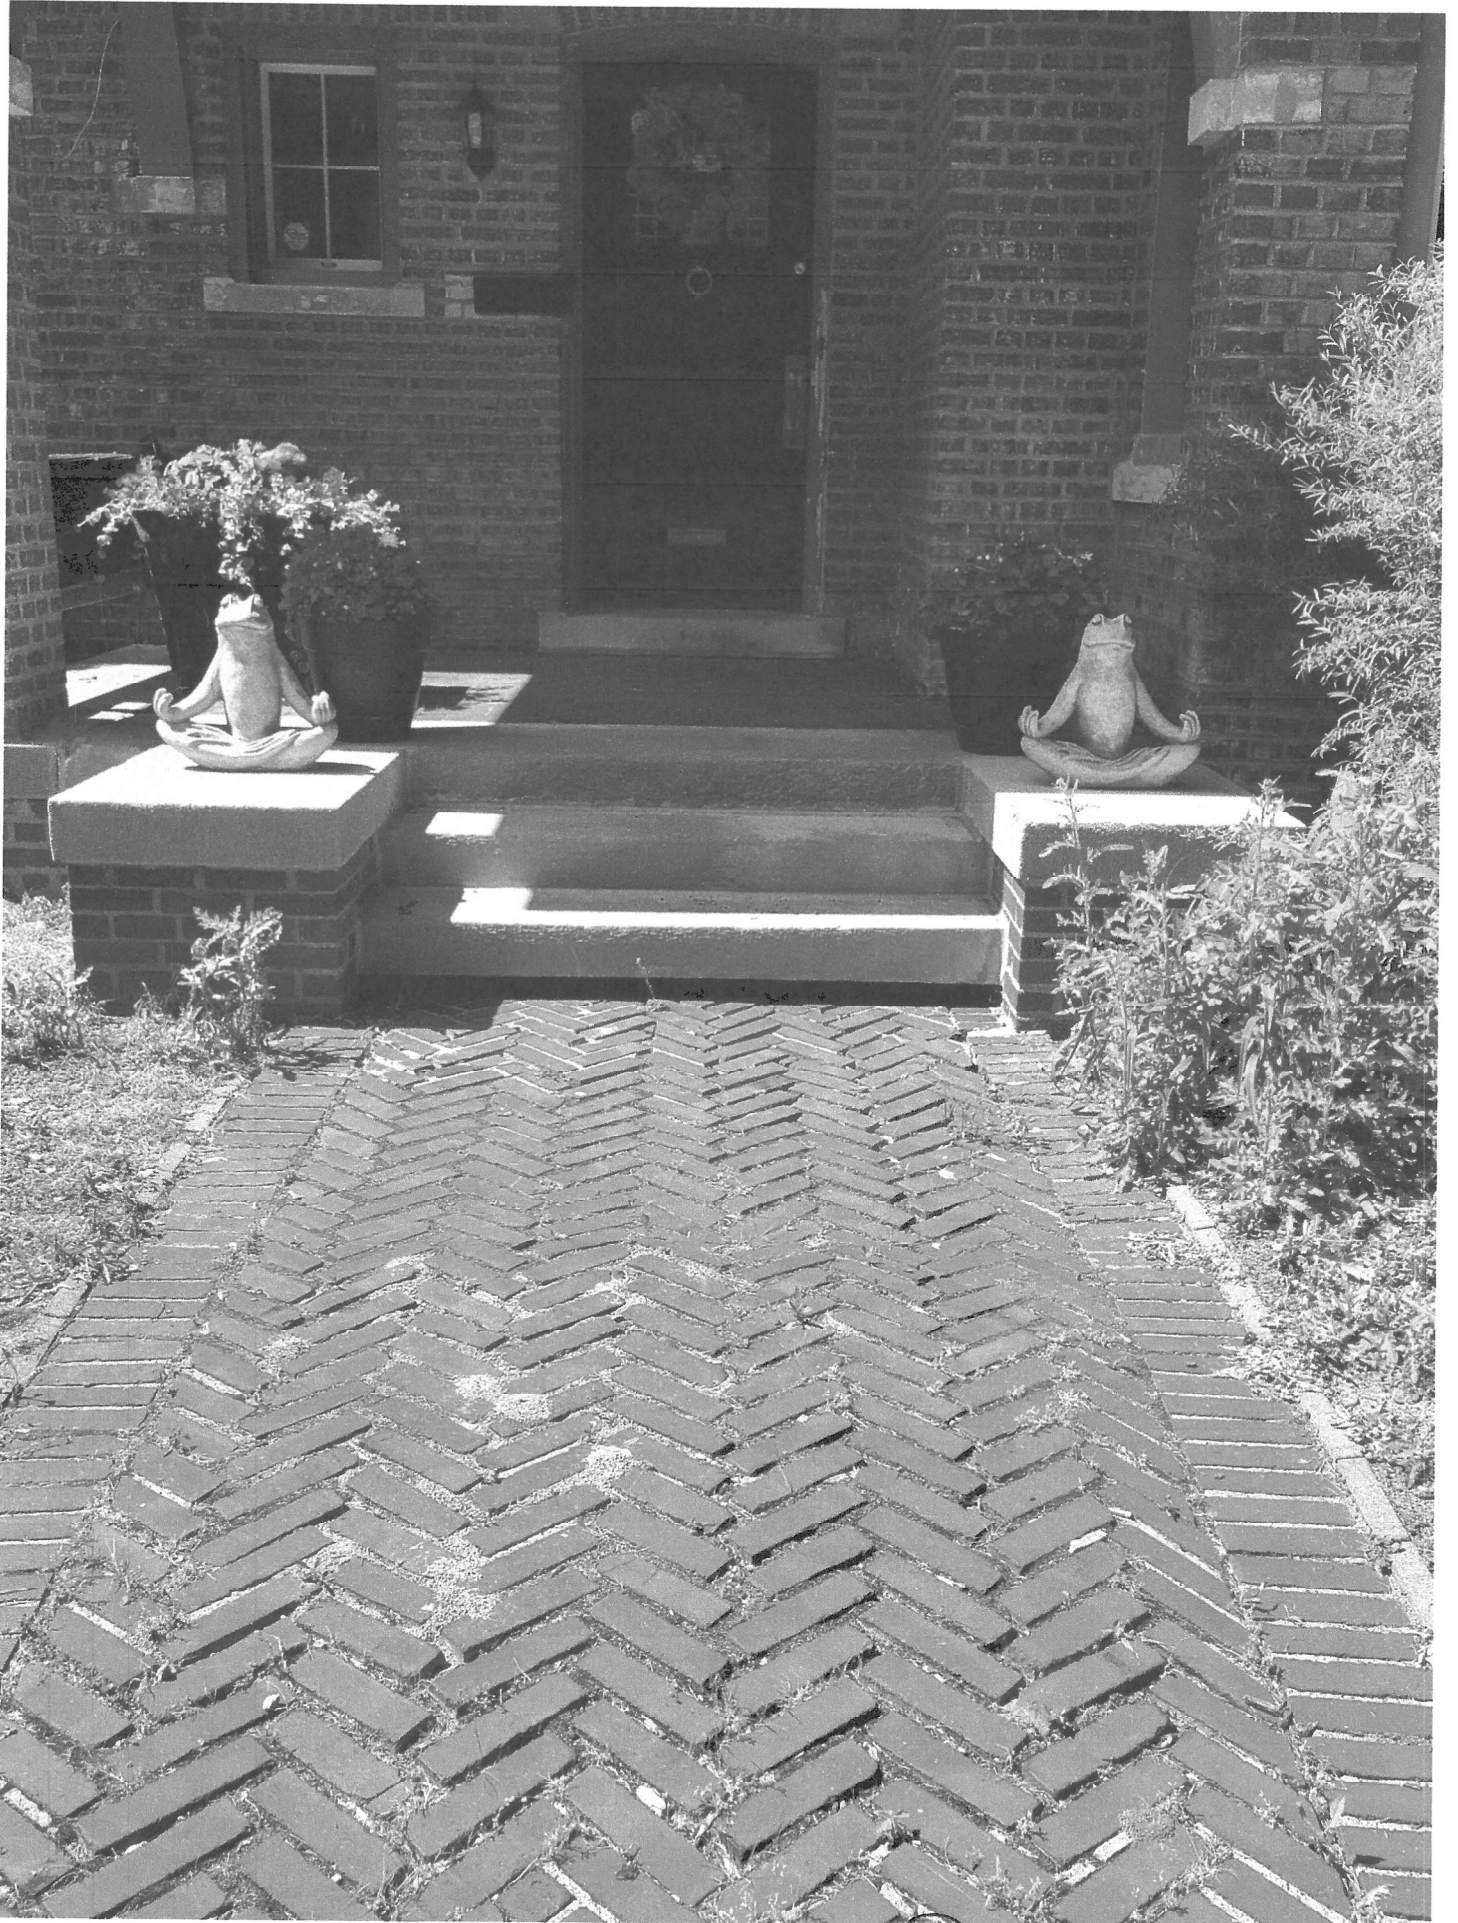
Picture 13

What remains of this project is to rebuild the walkway from the sidewalk on the Vernor side to the steps. As you can see in Picture 13, the brick sidewalk is approximately 3 inches too low to the porch step. Also, years of settling and other things has left the bricks uneven and thus a trip hazard. Plans are for a contractor to dig up and reinstall this feature evenly and at the level to meet the lower step. (Picture 13).

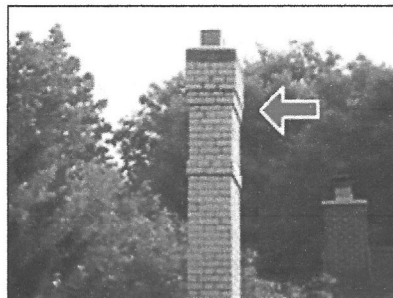
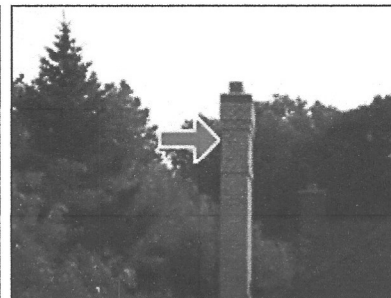
(2) The chimney at the rear left of the house has a slight lean to it, but it could have been this condition for an extended period of time. We did not see any issues at the time of inspection and recommend to monitor the area as needed.

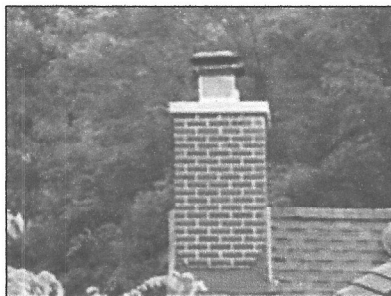
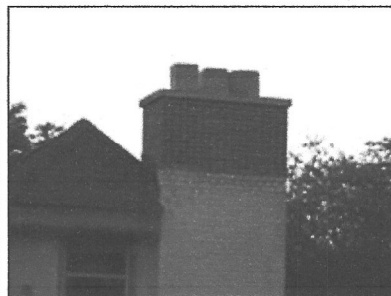
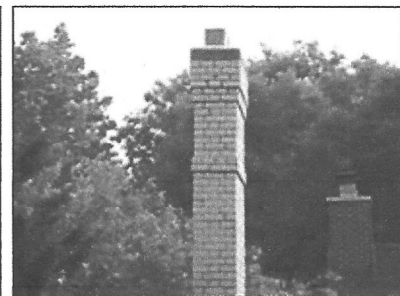
(3) Due to the height of the chimney, slope of the property or steep roof, we could not observe the condition of the masonry or metal chimney cap. The cap performs the important function of keeping water out of the masonry or wood chimney structure, and must be kept maintained. - SUGGESTION: If there is any concern about the condition of the cap, the client is advised to have the condition evaluated by a qualified chimney sweep contractor.

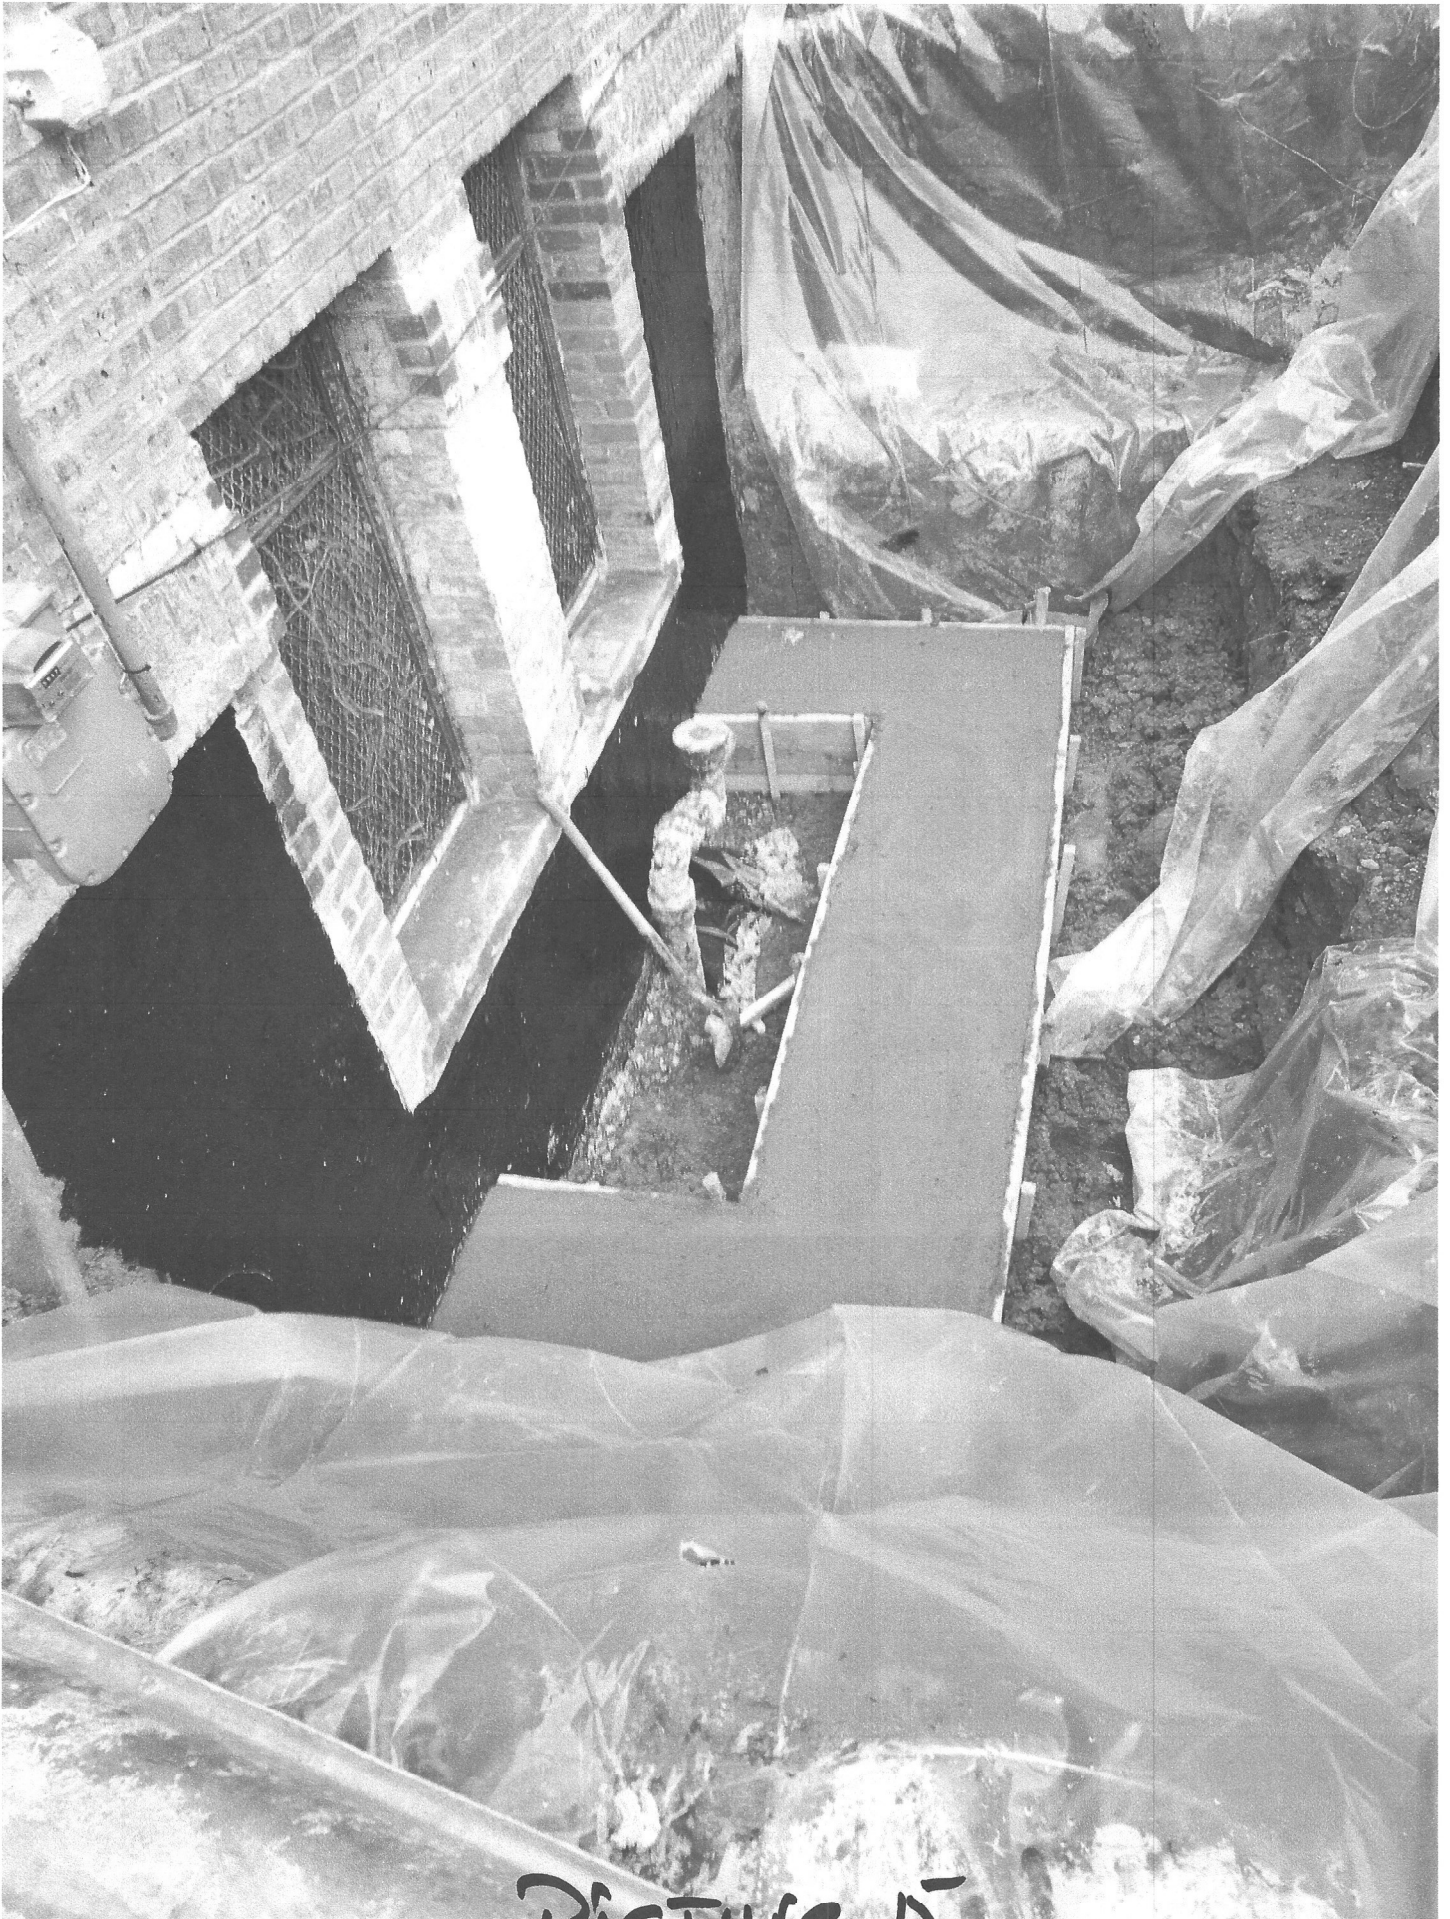
Picture 15

A basement window well on the Burns elevation was dug out and restored to original function. The walls had crumbled and fallen, the windows had been caged over and boarded up, and bricks had been layed in to cover the openings. The original windows were remarkably still in tact including the glass. All of the brickwork was repaired in both the house walls and the window pit surrounding the windows (Picture 15). Both windows were removed and completely restored. They now function normally (picture 16).

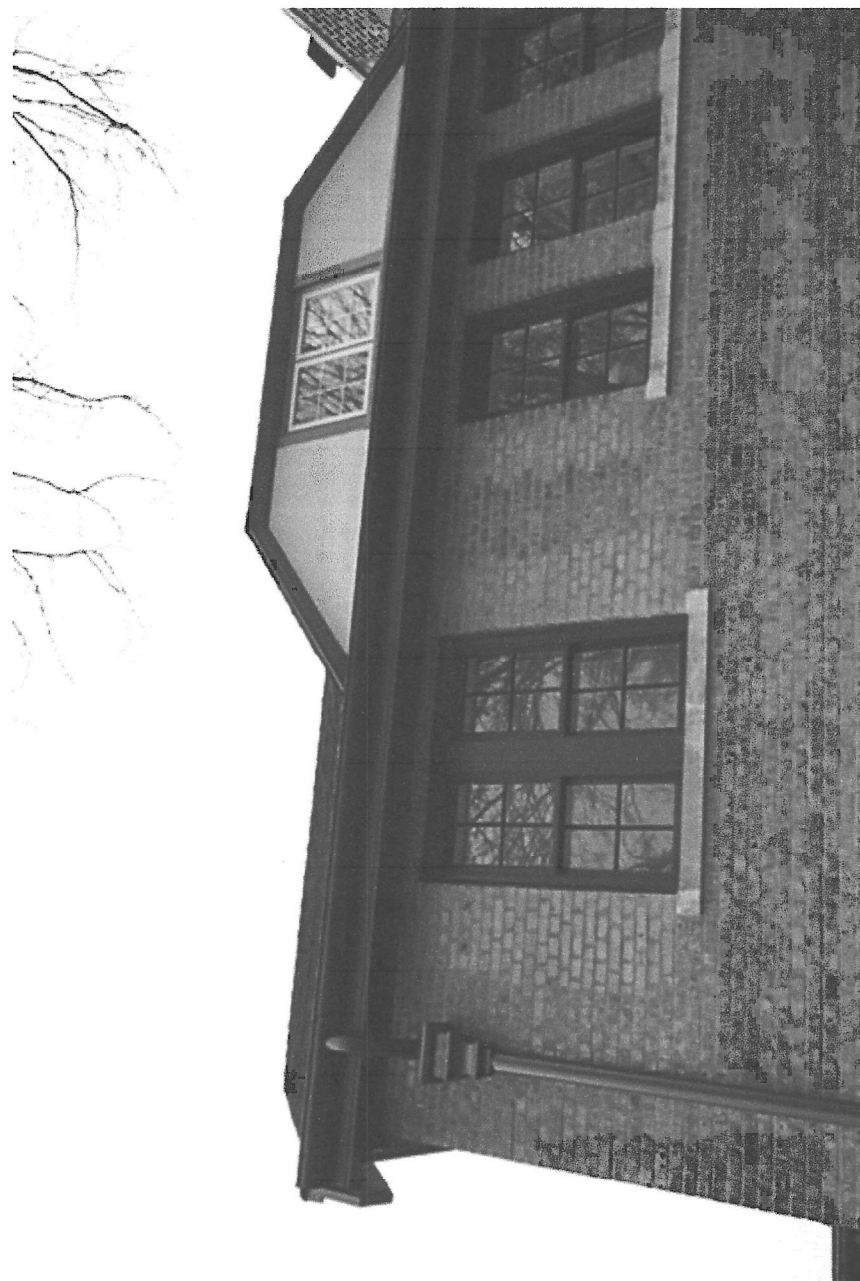
Picture 17

The remaining windows on the Vernor and Burns elevations are being removed for restoration and reinstalled (Picture 17). I am using a certified window restoration contractor. Some of the windows are complete at this time. The remaining windows on these two elevations will be done this year.
