Job Name: 1315 Broadway
Job Location: Detroit, MI

Historic Window Site Review:

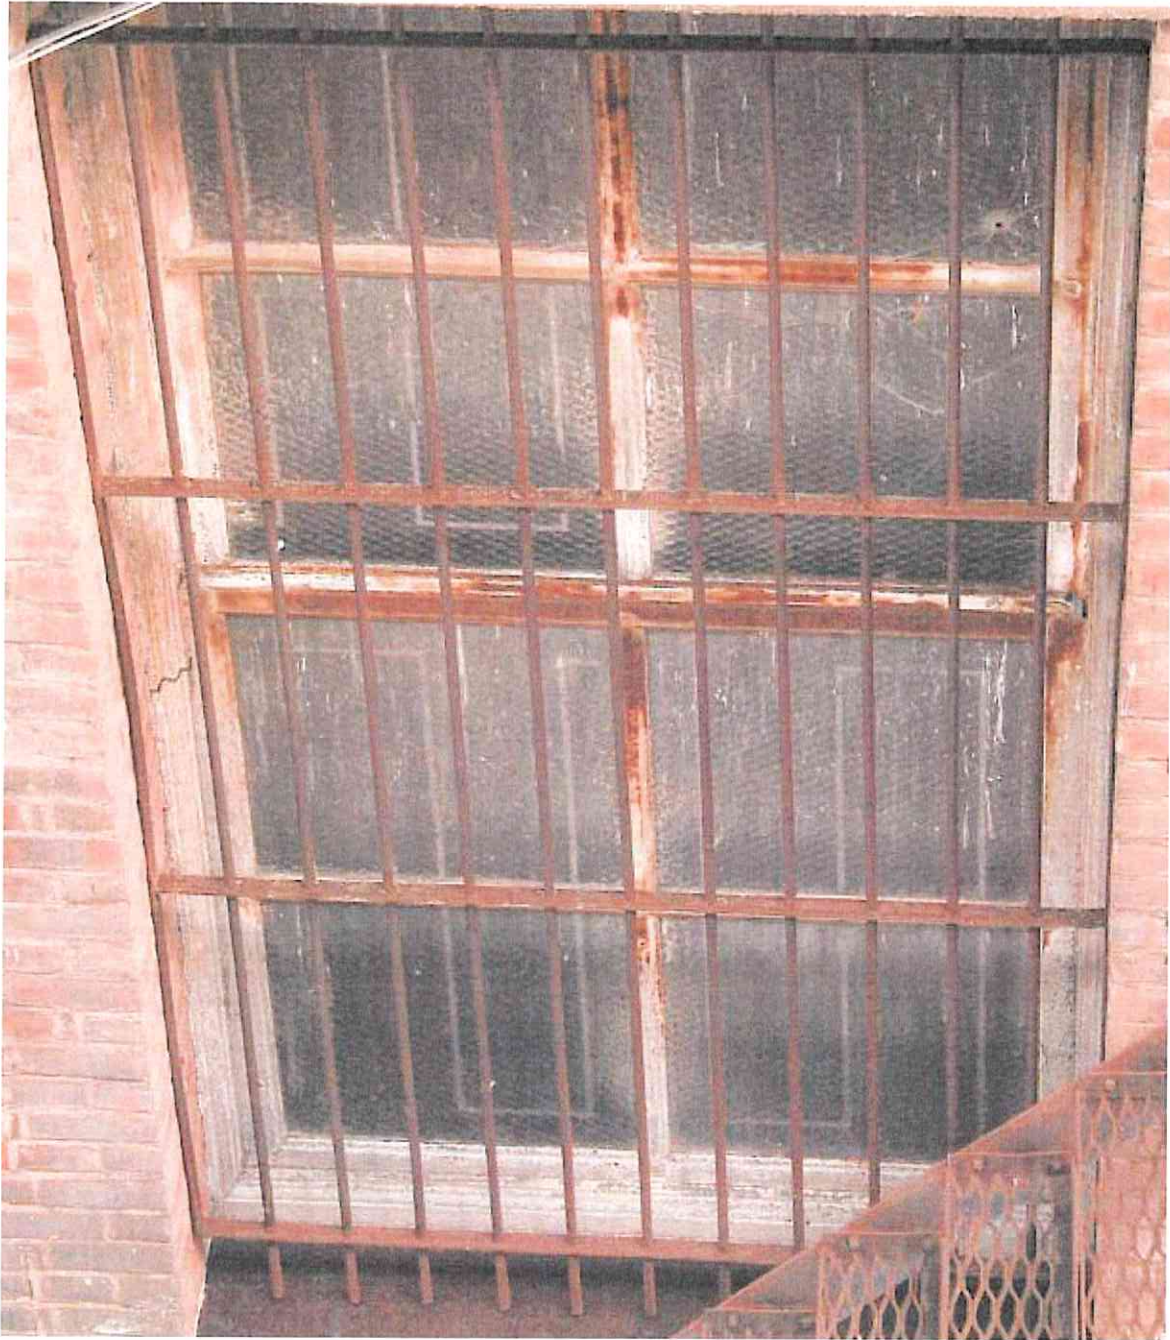
Exterior View of typical steel window

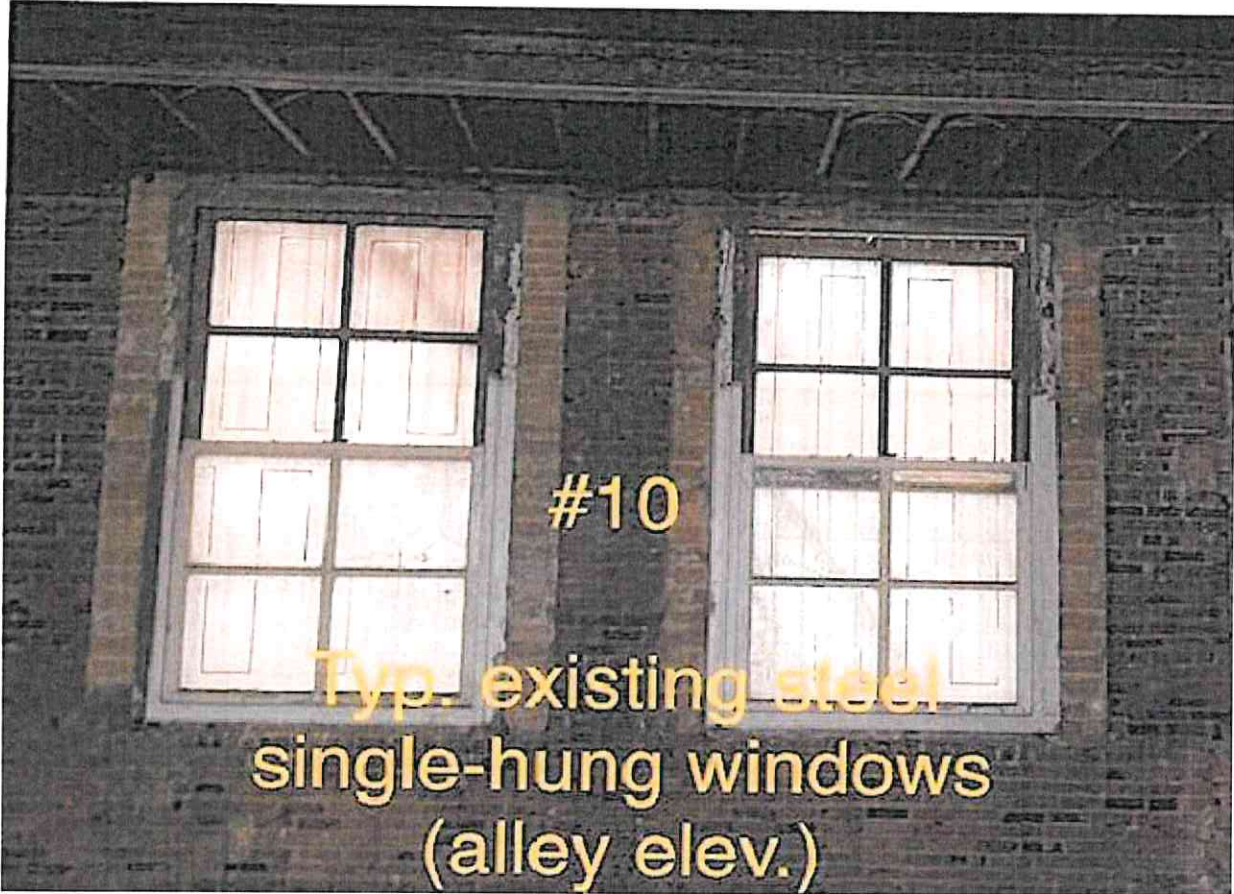
Interior elevations of existing steel windows

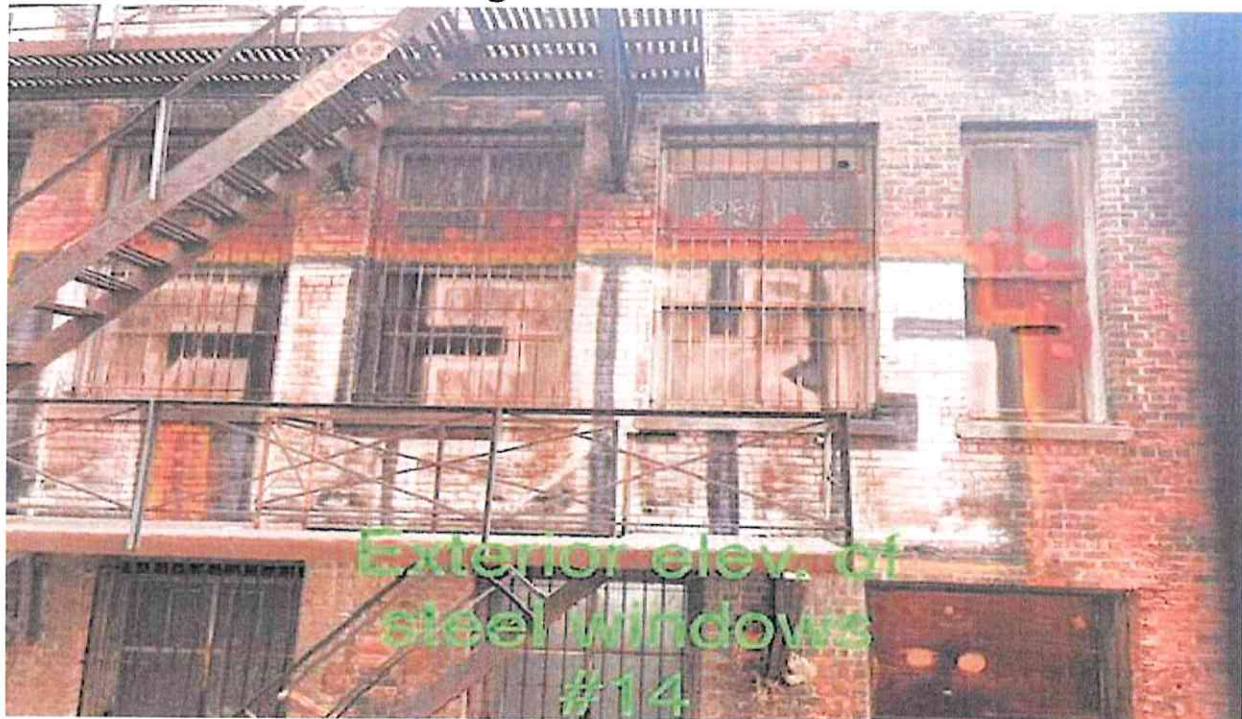
Exterior of typical steel windows exposed to elements and vandalism

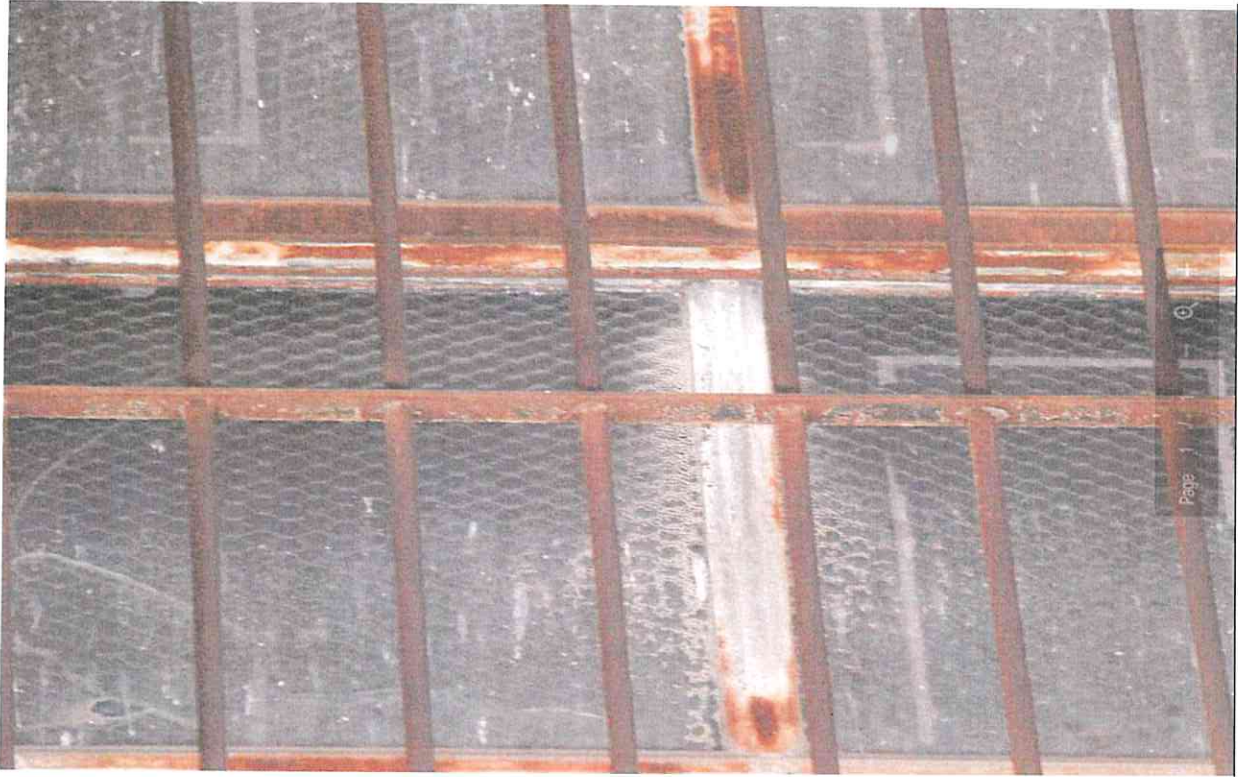
The overall condition of the windows is "Poor" condition. The windows have not been maintained for decades in terms of painting/refinishing, re-glazing, and perimeter caulking. The exterior frame of the windows have all been compromised by weather, and as a result are heavily rusting. Vandalism has left a large portion of the windows covered in paint. Although not visible from the exterior or interior, the rust from being exposed to the elements and not maintained has likely spread to the interior areas of the tubular style frames.

Exterior view of typical rust and corrosion on meeting rails and muntins

We recommend that the windows be replaced with a aluminum thermally broken single hung and fixed window system using an exterior custom panning/sill assembly and interior snap trim. This should include 3 - part simulated divided lite muntin. All windows should include low-e/argon insulated glass, standard hardware, and an AAMA 2604 or 2605 painted finish. See the attached drawings showing existing and proposed details. These proposed details are based on the Quaker H650 Historic Single Hung Series window.
