1490 Iroquois
Detroit, MI 48214
Homeowner: Tammie Soto & Mike Wong

Carriage house roof:

Carriage house railing:

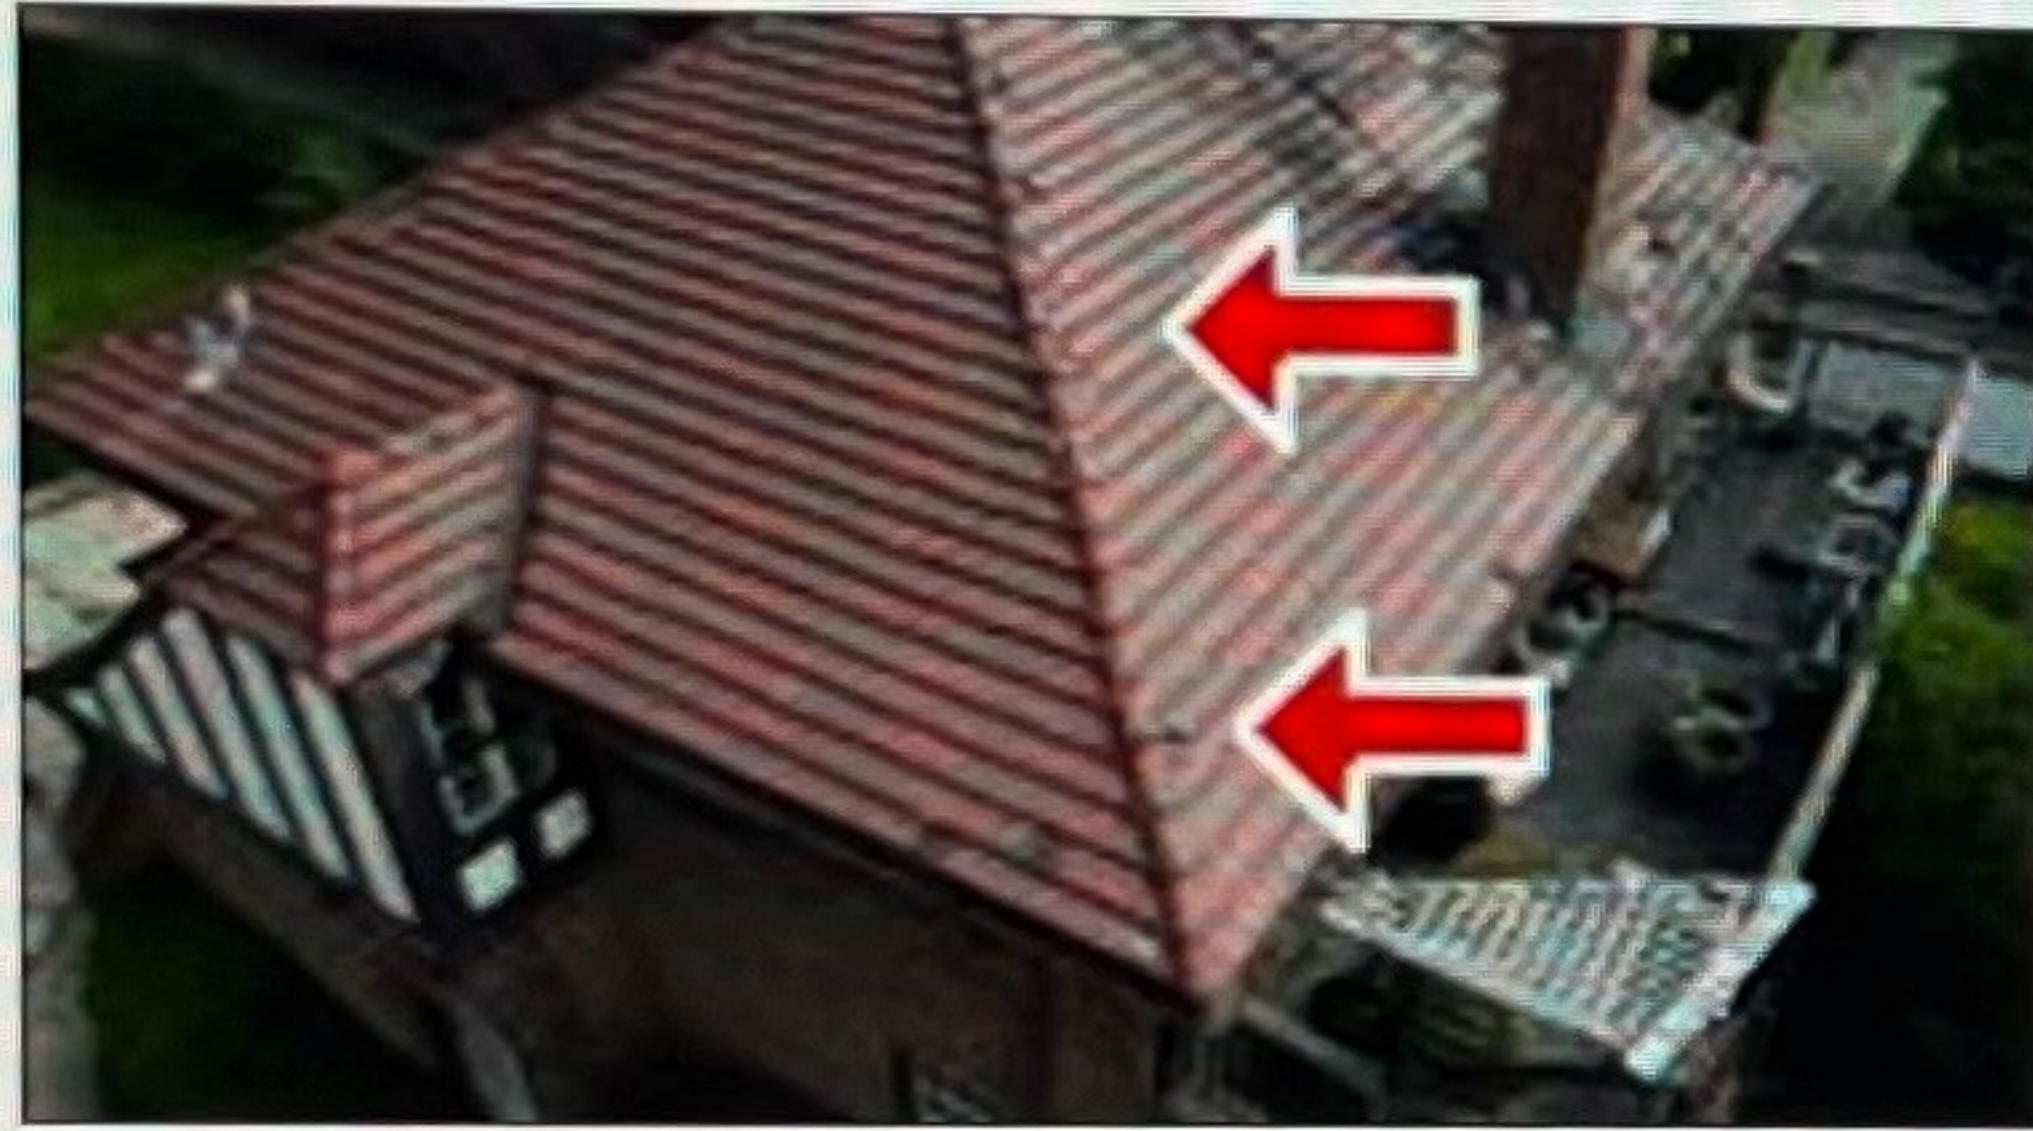
4.3 Picture 2

(2) The carriage house roof covering is at the end of its useful life and should be replaced at this time. Cost estimates should be obtained.

There is evidence of past leaks in the carriage house. In our opinion, leaks could still exist in one or more areas. - SUGGESTION: A qualified roofing contractor should evaluate the roof and make repairs or modifications as necessary.

Damaged/missing/loose tiles should be replaced to reduce risk of leaks.

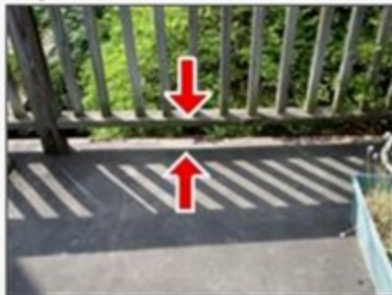
2.8 Picture 1

On the West side of the carriage house is a railing that sits on top of the flat roof. As it stands now, the railing is unsafe as it is poorly constructed. It is extremely wobbly and the wood shows signs of deterioration. We are proposing to replace the existing railing with the following materials to recreate the existing railing:

🔍 **2.8 (1)** The railing at the carriage house balcony has spaces between the balusters that are wider than current standards permit. Large openings can allow a child or pet to fall through or get a head stuck. For safety, railing balusters should be spaced close enough to prevent the passage of a 4-inch sphere through any part of the railing. Consider modifications to reduce the width of the openings to meet current standards. A qualified carpenter can perform the work.

- 4x4 lumber for the posts in the exact same location.
- 2x4 lumber that will be attached to the house as it does now
- 2x2 square spindles spaced less than 4 inches apart. These spindles will fit into the top and bottom rails
- 2x4 top and bottom rail
- Deck railing will be stained after a year's time using semi-transparent stain in a medium brown color

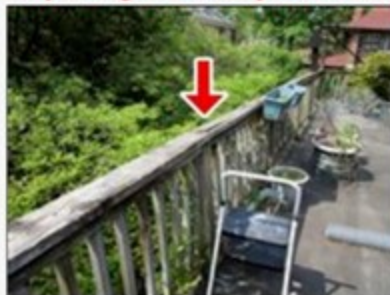
2.8 Picture 2

🔧 **(2)** The carriage house balcony railing has loose joints and connections. Secure as necessary for safety.

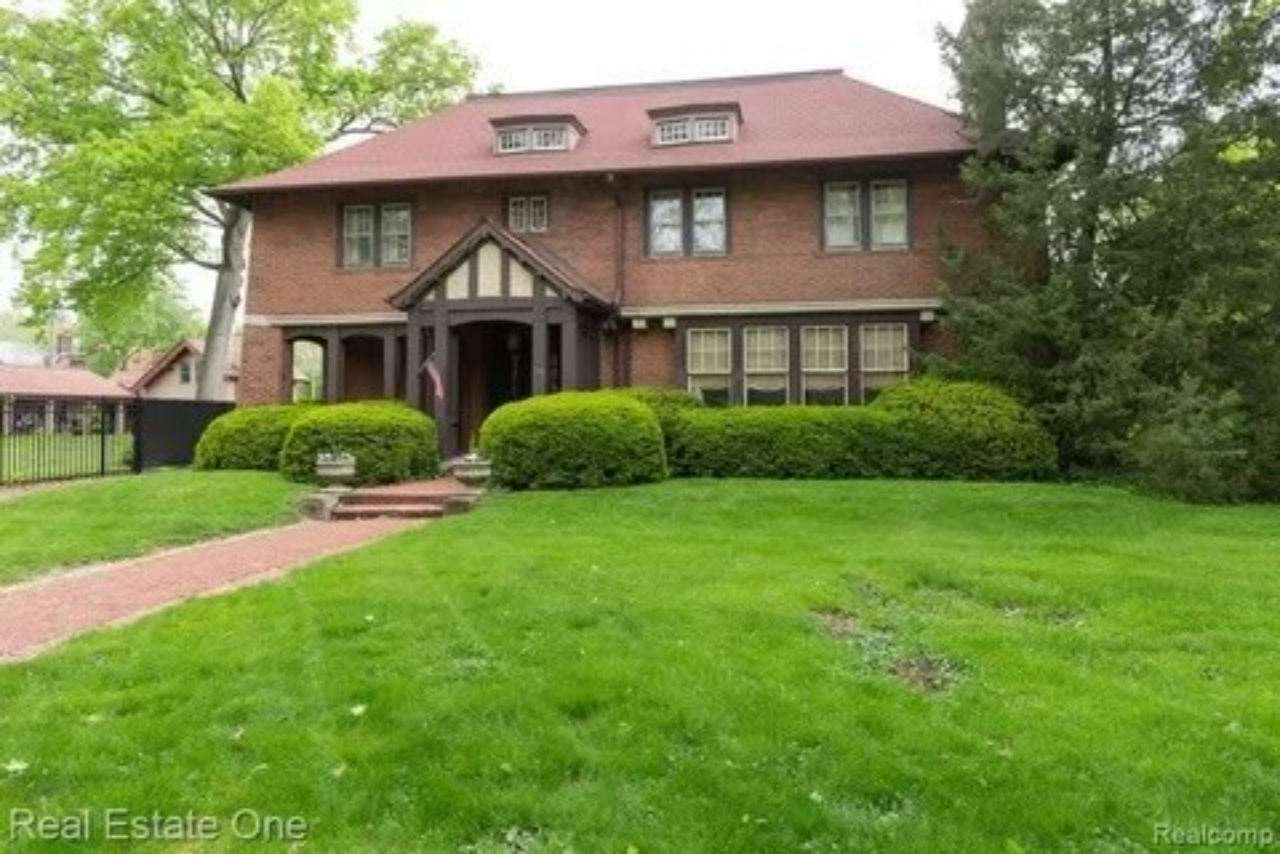
There was a large Juniper tree that was removed from the front yard. Attached is a photo of the tree as well as a letter from the arborist.

My Client, Tammy Soto, who lives at 1490 Iroquois in Indian Village, recently had a juniper tree removed from the front of her house. This tree was planted, extremely close to the structure of the building. It is my opinion that it was planted 40 years ago as part of a new landscape plan but the full grown size of the species was not taken into account when the landscaper placed it one foot from the house. In addition, a foliar fungal disease was causing a large number of leaves to fall which made the tree look sparse. In conclusion, I recommended removing this tree in order to replace it with a tree that will be planted farther away from the house. Please note that this client is interested in preserving many of the original features of the yard including a 100+ year old lilac. I have consulted with the homeowners and have suggested historically appropriate replacements. Please do not hesitate to reach out to me if necessary. My cell phone number is 734-417-7910 and my email is emibrent@umich.edu.
