**Re: The City of Detroit v Urban Renewal Initiative Foundation  
Case No. 2023-004376-CH**

# EXHIBIT C

RE: Water Department Building on East Jefferson  
Grosse Pointe Park DPW  
1005 Wayburn Street  
Grosse Pointe Park MI 48230

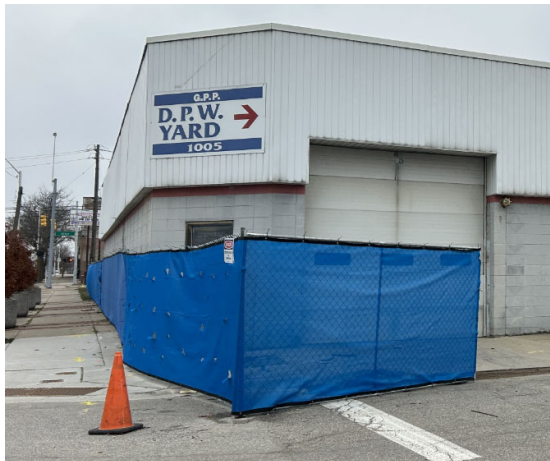
Exterior viewed from Wayburn entrance

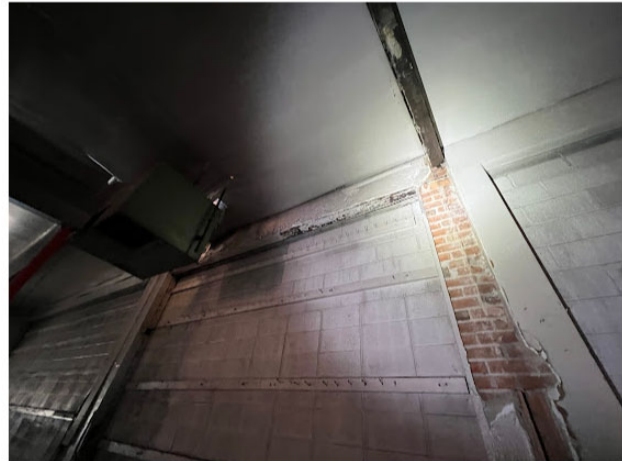
Interior - precast concrete panel with block above

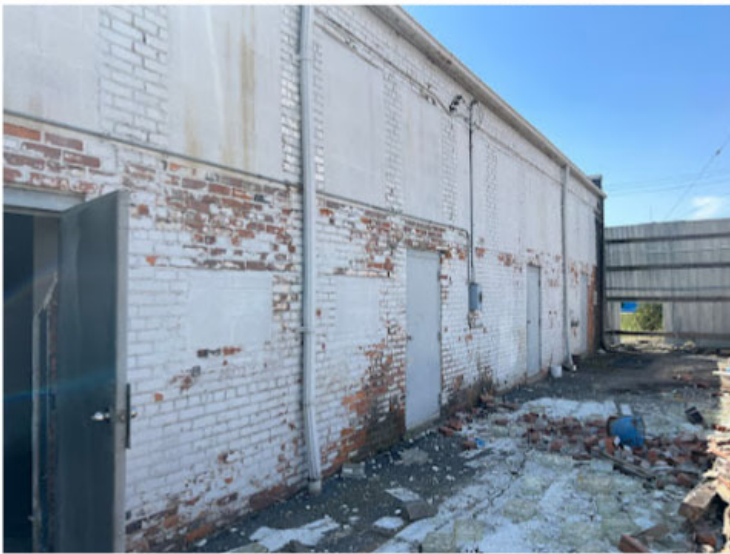
The other two sides of the building exhibit the original brick exterior, which has been painted. The upper walls at the side opposite East Jefferson originally had windows to admit natural light, and have all been infilled.

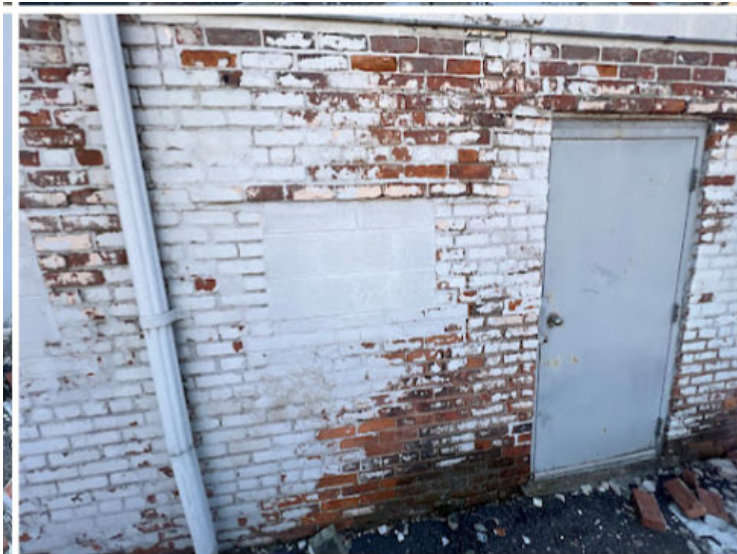
The lower half of the wall exhibits significantly more weathering and distress than the upper half.

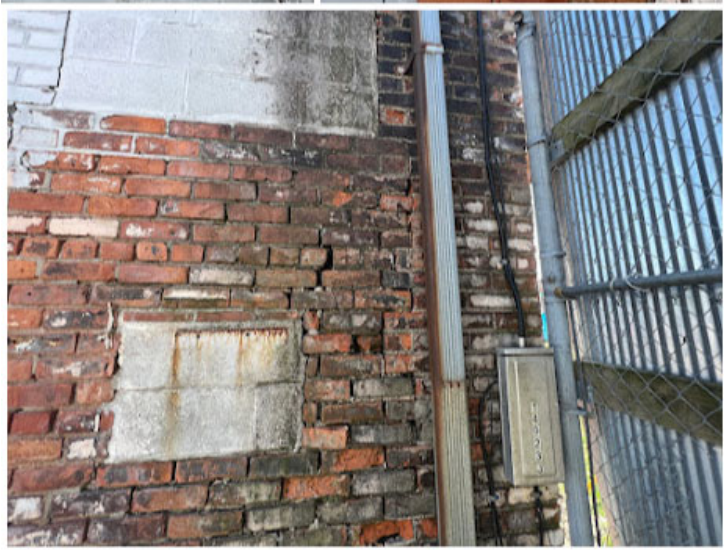
The northwest corner of the building is in an advanced state of deterioration, with the west wall facing Alter pulling away from the rest of the building by 1 1/2 inch at the top corner of wall.

An immediate danger and safety hazard exists at the wall facing Alter Street. Further shifting of the wall outward will cause additional roof joists to separate from the wall, eventually resulting in roof collapse, wall instability, and potential wall collapse.

- The out-of-plumb west wall of the building needs to be taken down and rebuilt. This process involves shoring the roof, replacing rotted roof joists and decking boards as required, and installing new roofing adjacent to the rebuilt wall. Before any rebuild, the condition of the exposed wall foundation will need to be assessed, and made sound as required.
- Removal and replacement of any rotted roof joists, ceiling joists, deck boards, and new roofing at all leaking locations.
- Tuck pointing loose and missing mortar joints in the exterior brick walls, where evidence of failed mortar bonding is present.
- Replacement of all steel lintels, which involves shoring of roofs and/or walls.
- Removal and replacement of unlevel interior floor slabs as required.

Considering the extent of the damage and safety risks involved, it is my professional opinion that demolition should be considered as the most effective way and practical solution to address these structural hazards.

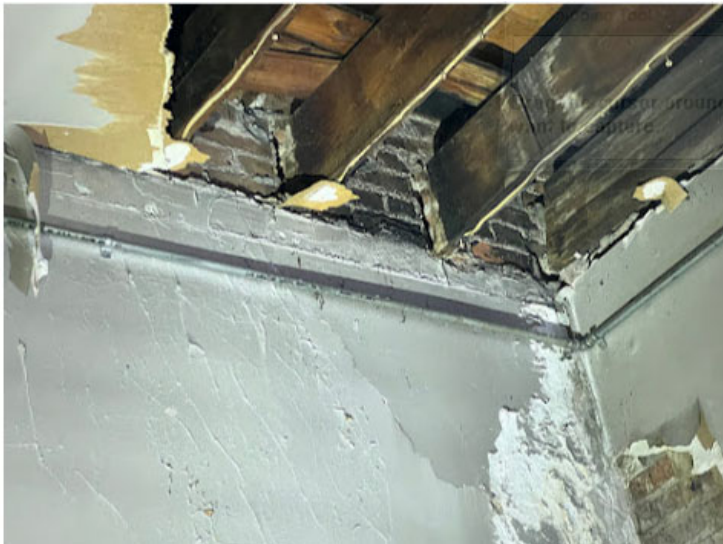
An interior view of this corner shows the roof joists are no longer bearing on the brick wall.

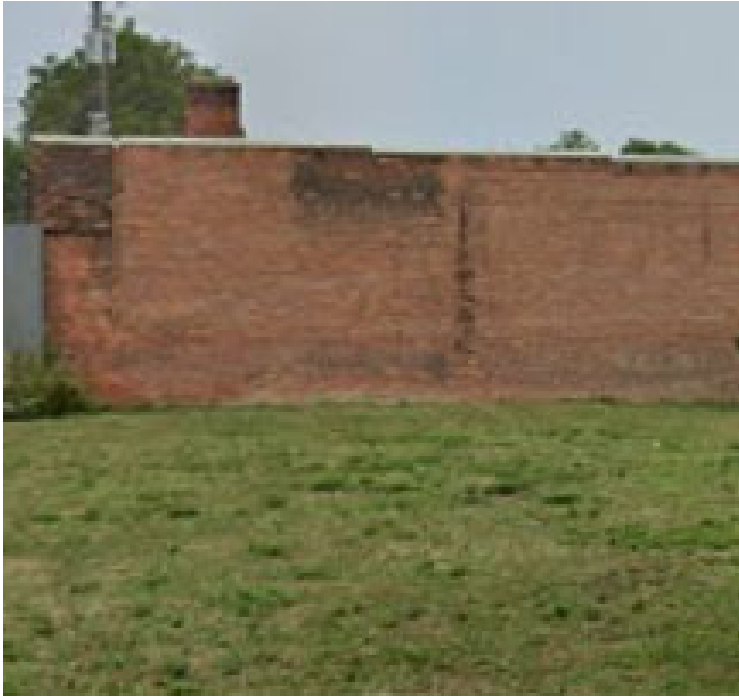
The west wall viewed from Alter Rd shows discoloration from water at the upper left corner and upper center.

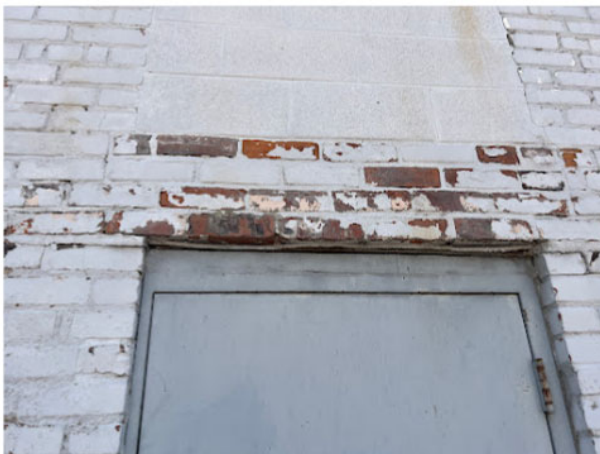
Steel lintels over doors have significant rust, and would require further investigation and possible replacement.

Steel lintel angle - over door exterior

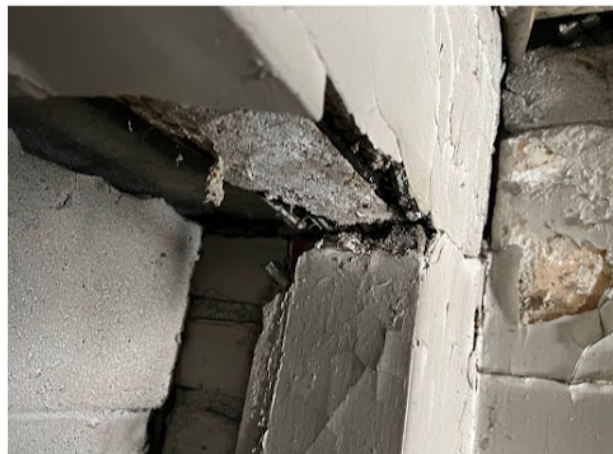
Steel lintel beam - over infilled vehicle door interior
