New insulation, siding and windows on north wall (ally side).

1423/1425

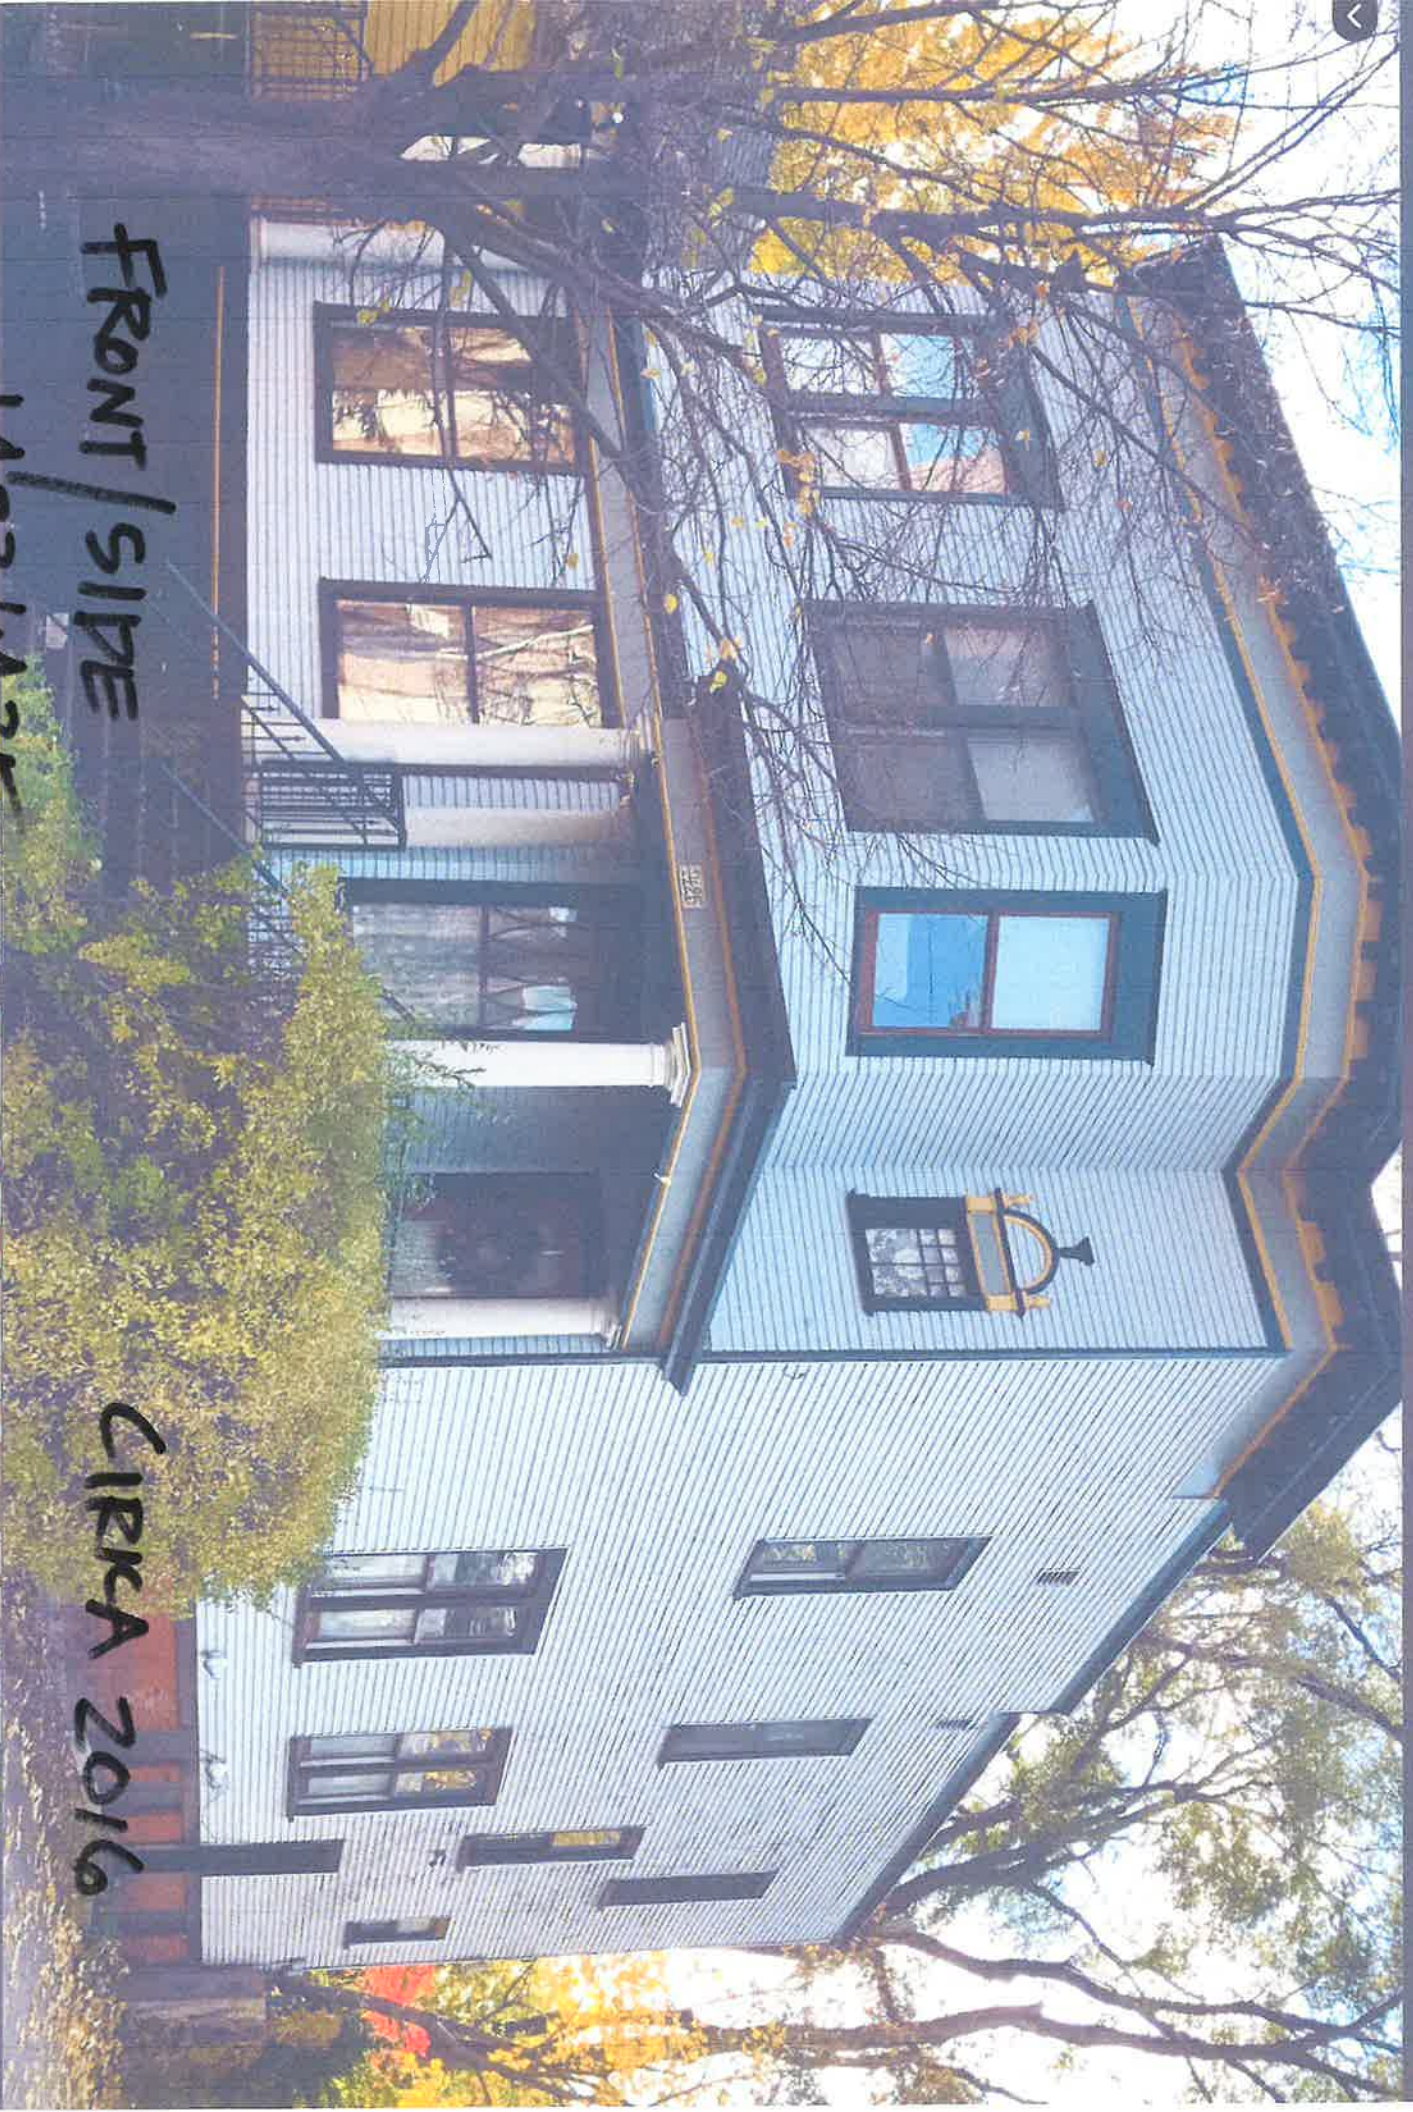
FRONT / SIDE

CIRCA 2016

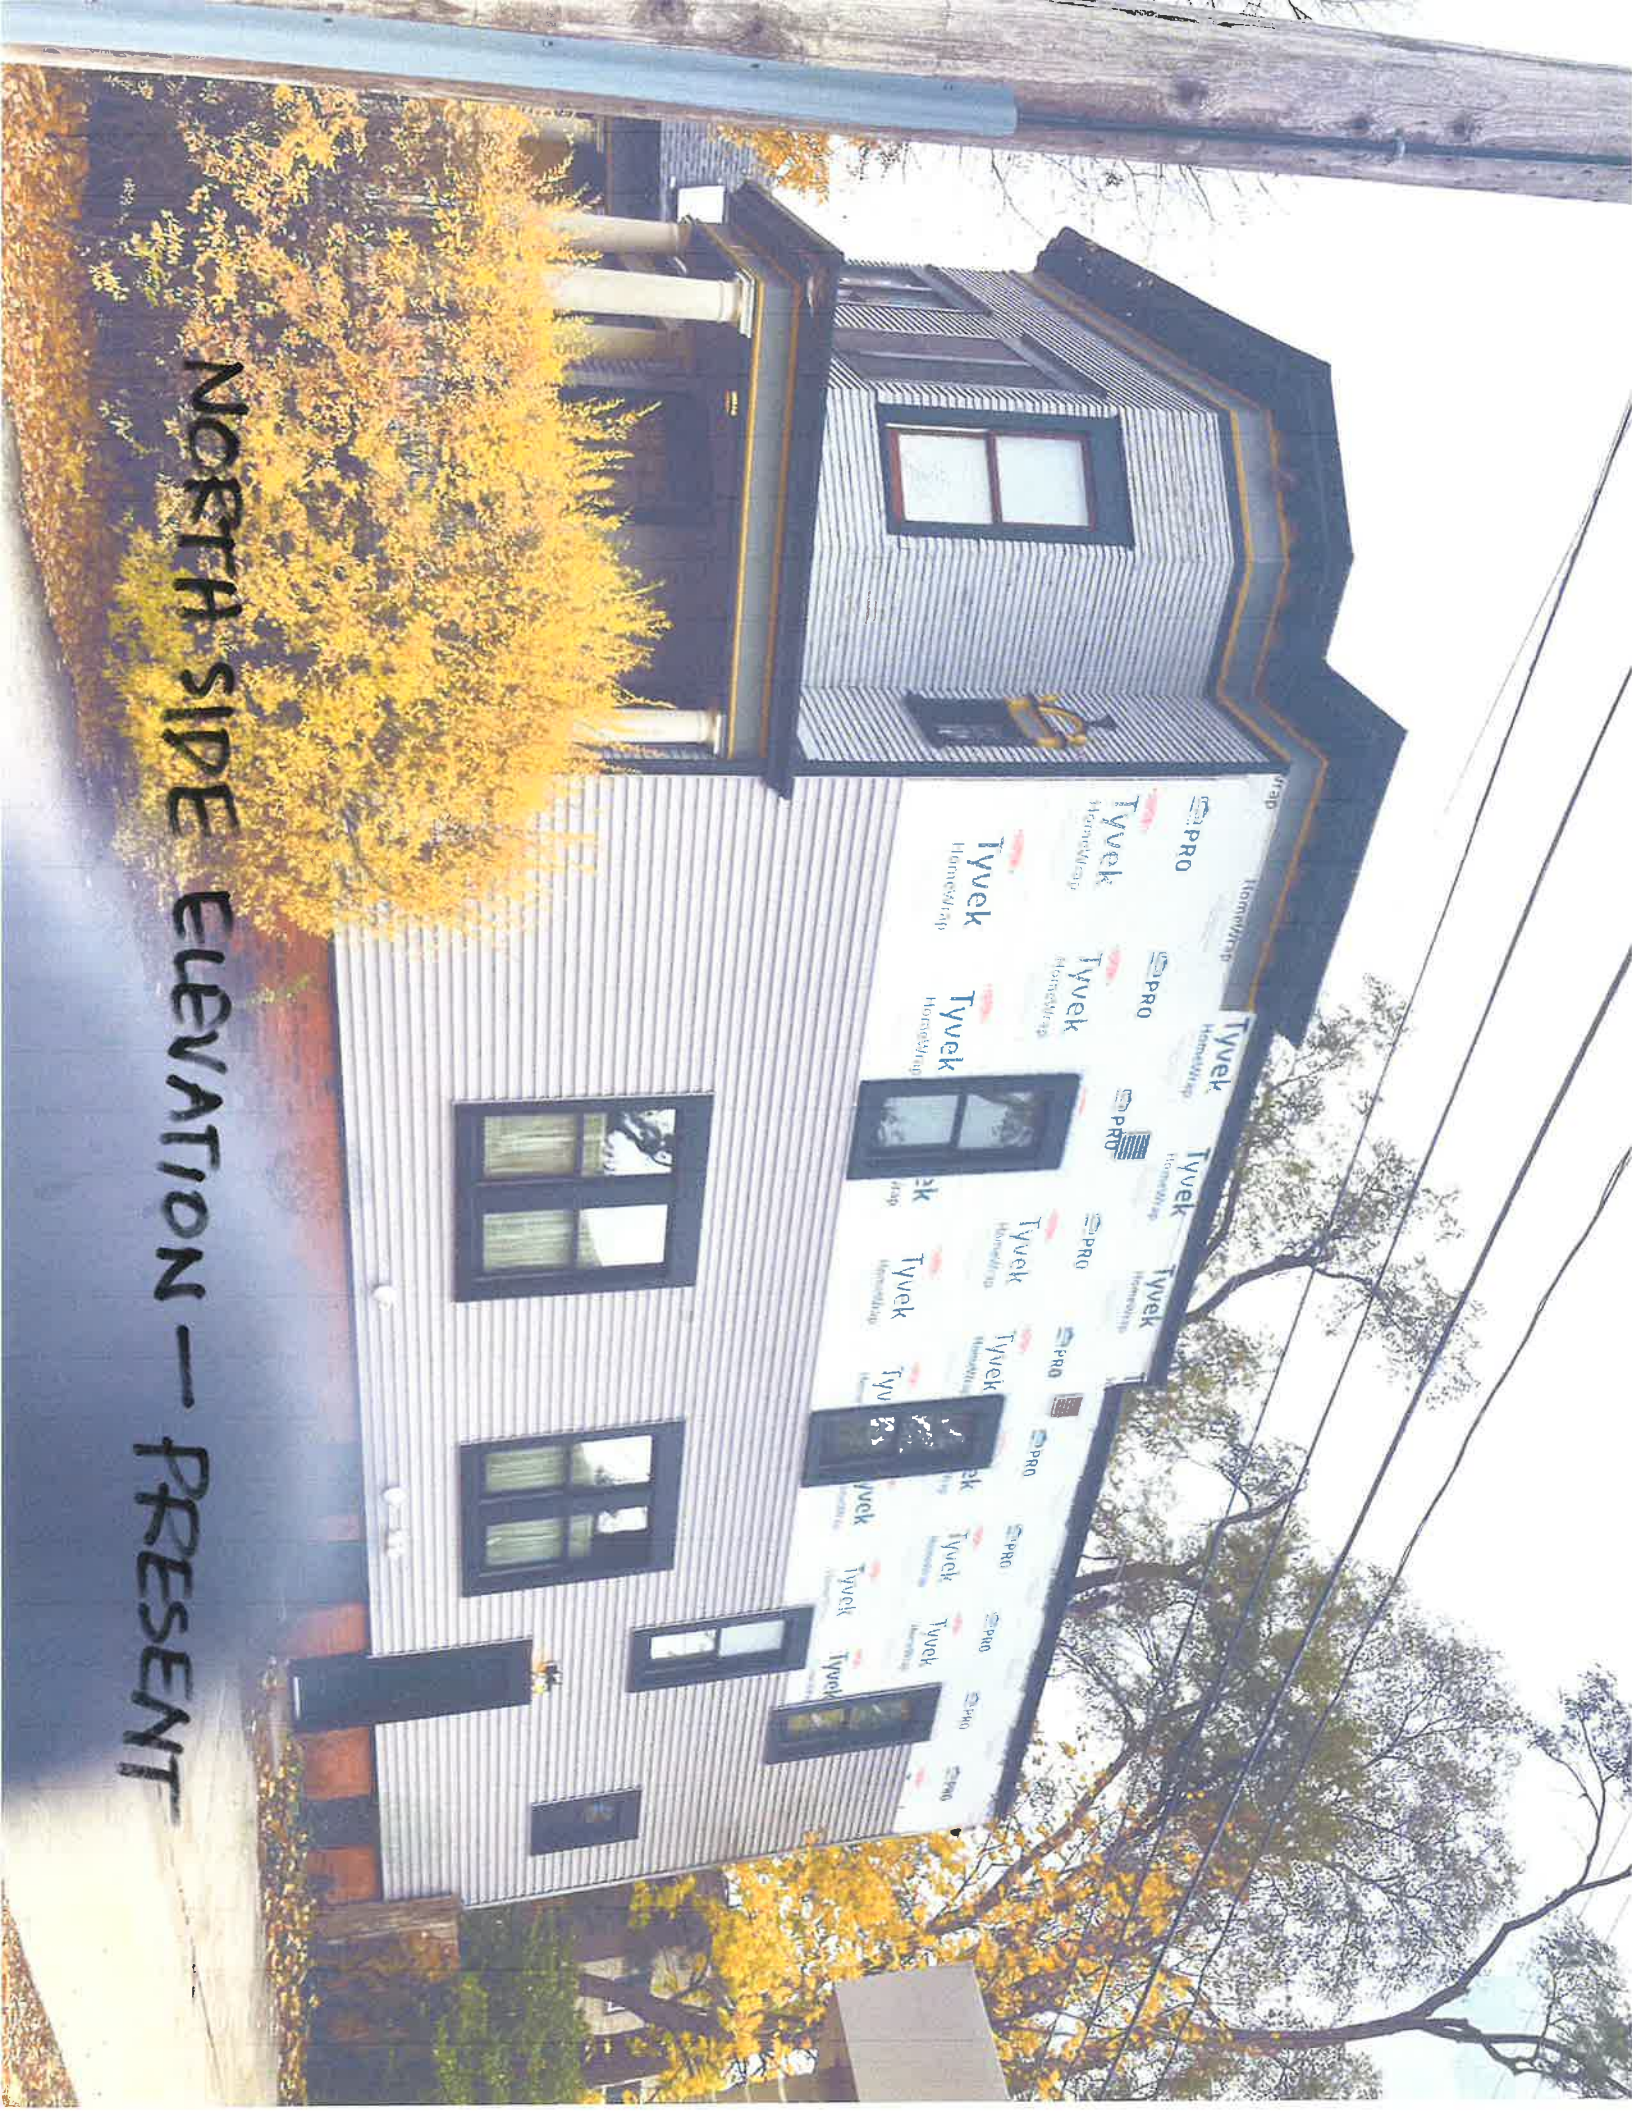
NORTH SIDE ELEVATION — PRESENT

North wall (alley) is approximately 70% covered in new siding matching material and color of previous siding.

New insulation and Tyvek on remainder.

9 new wooden double hung windows (Anderson)
