STRUCTURAL REPORT NOTES

SISTER PIE RENOVATION

ISSUED DATE Historic Commission Review 09/21/2023

EXISTING CONDITIONS

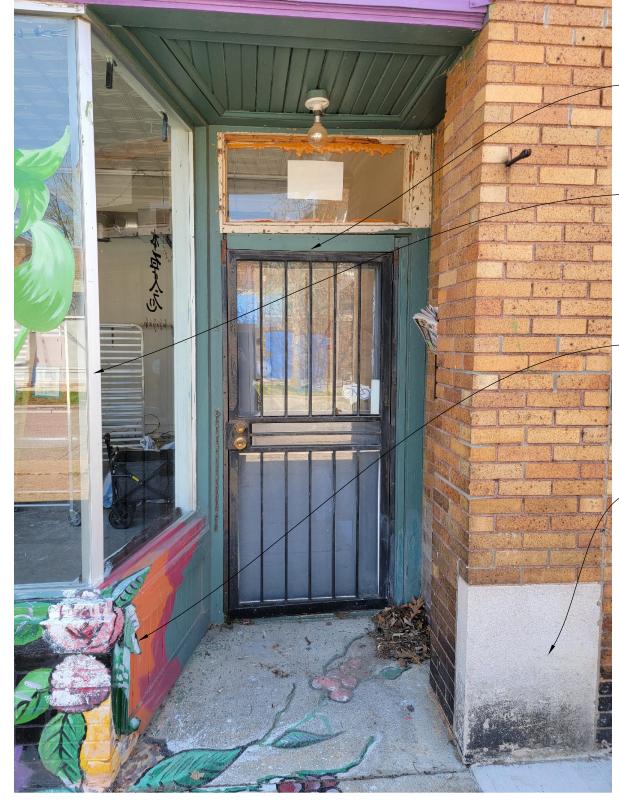
EXISTING ENTRY DOOR

EXIST. WD ENTRY DOOR W/ GLASS, TRANSOM, AND MTL. SECURITY GATE TO BE REMOVED

EXIST. ALUM. STOREFRONT TO BE REMOVED

STOREFRONT KNEEWALL TO BE REMOVED

CONC. BASE TO REMAIN, CLEAN AS REQ'D

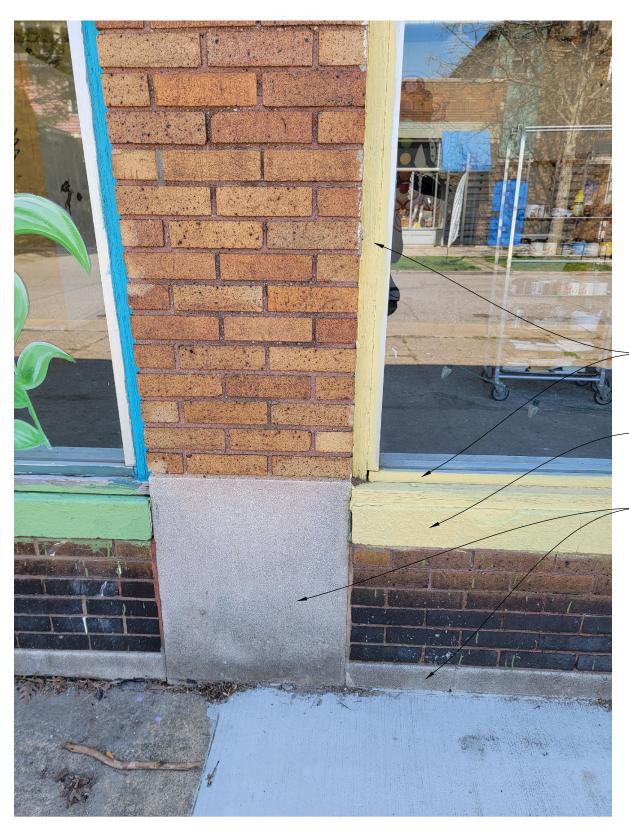
- SINGLE PANE ALUM WINDOWS W/ WOOD BLOCKING TO BE REMOVED
- STONE SILL TO REMAIN, CLEAN AS REQ'D
- CAST STONE BASE TO REMAIN, CLEAN AS REQ'D

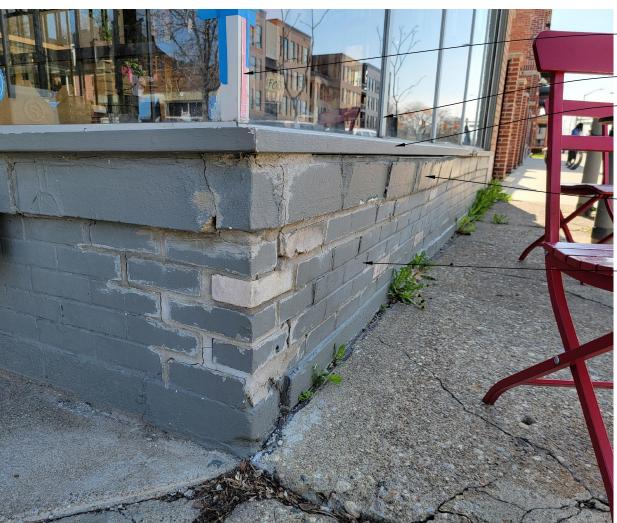
SINGLE PANE WOOD STOREFRONT TO BE REMOVED

- STONE SILL TO BE RESTORED TO MATCH EXIST.
- PRIOR BRICK REPAIR TO BE RESTORED TO MATCHING BRICK AS SPECIFIED
