3964 W Lafayette

Sunroom Rebuild Plan

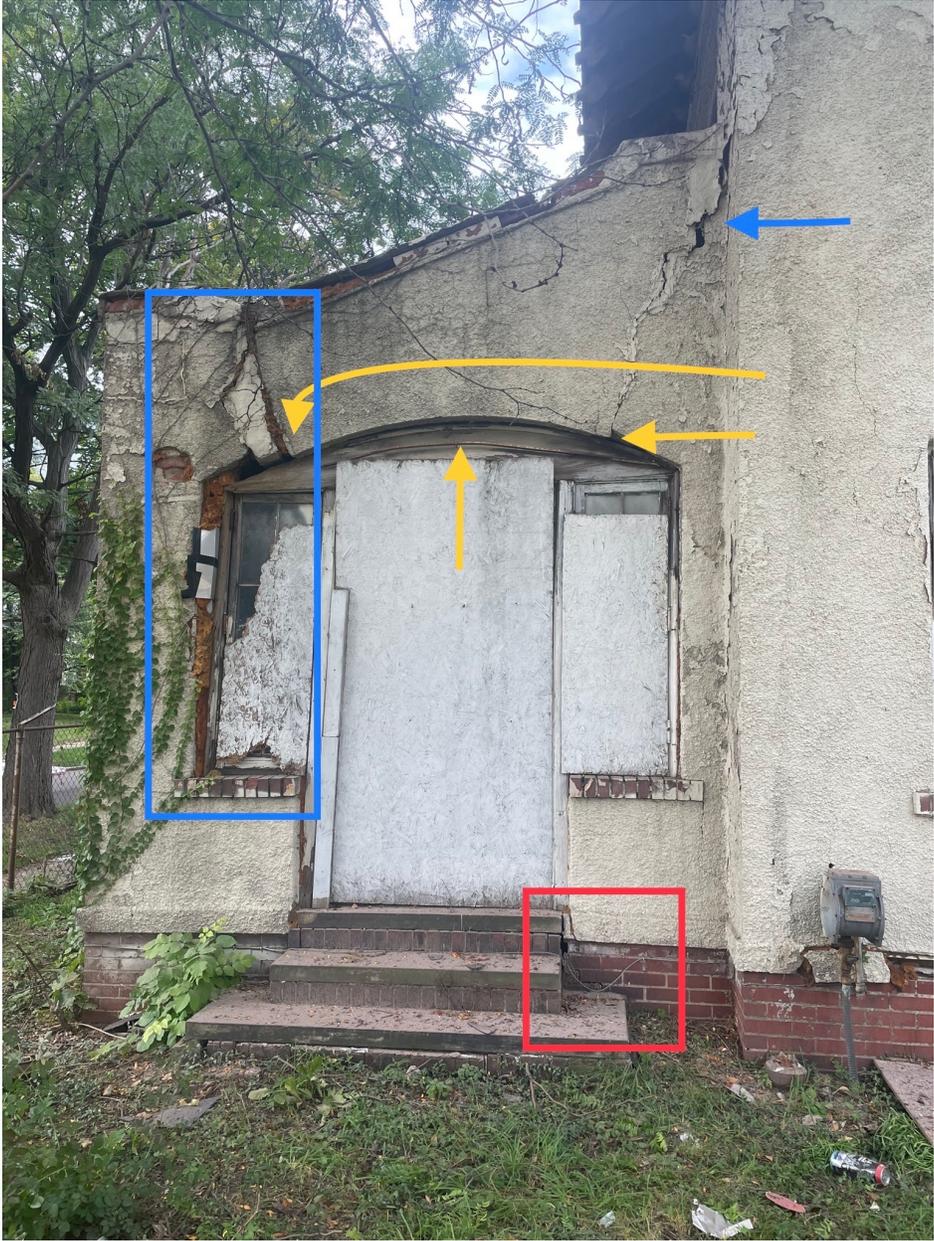
1. Masonry separated from the main house, clay blocks are sagging 1”+. The masonry above the doorway and window jambs is being held up by the wood framing below, causing the framing to buckle inwards.

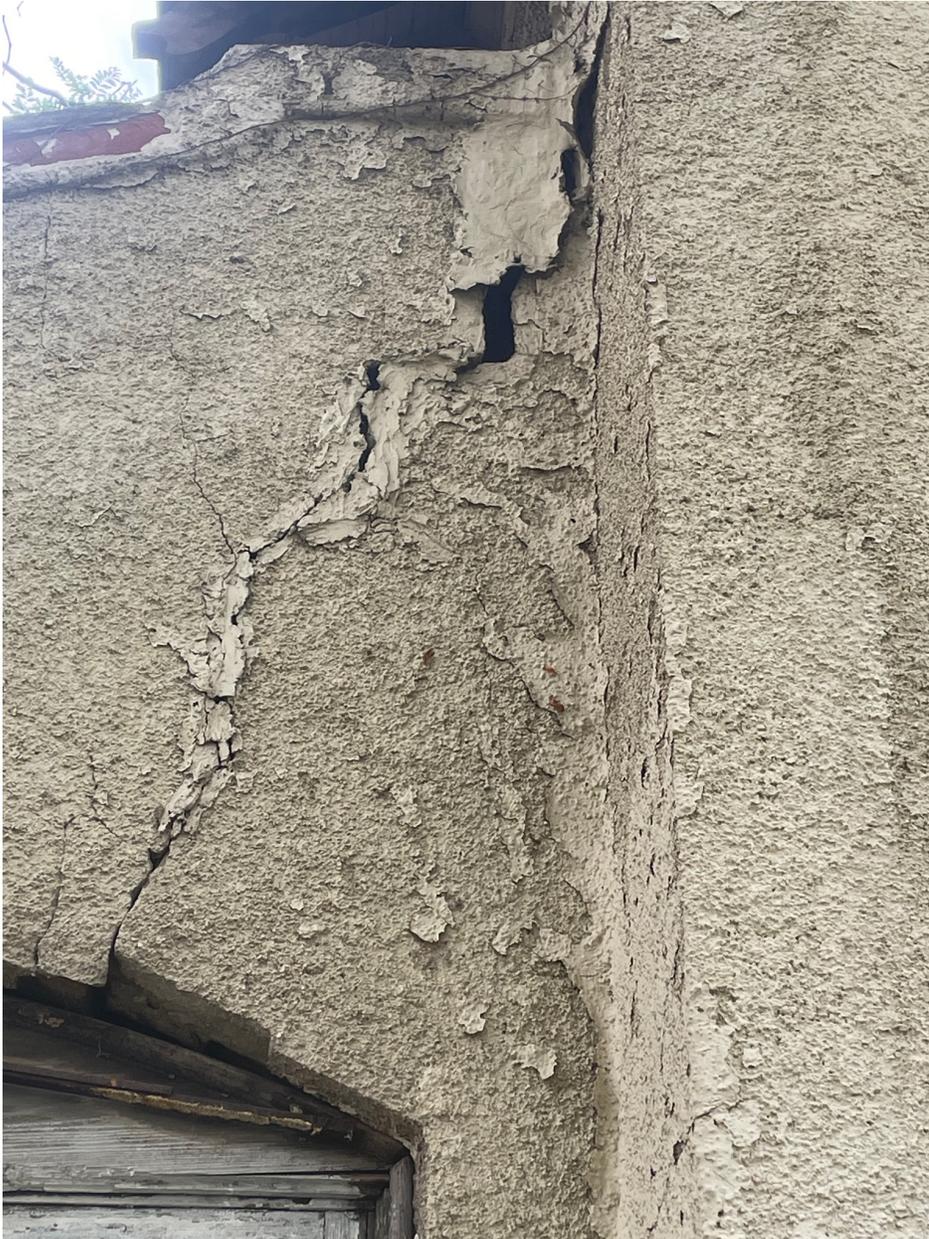
2. Clay blocks have fallen multiple inches and are resting on the window jambs and door. Failed attempts to block large air gaps in the past can be seen here.

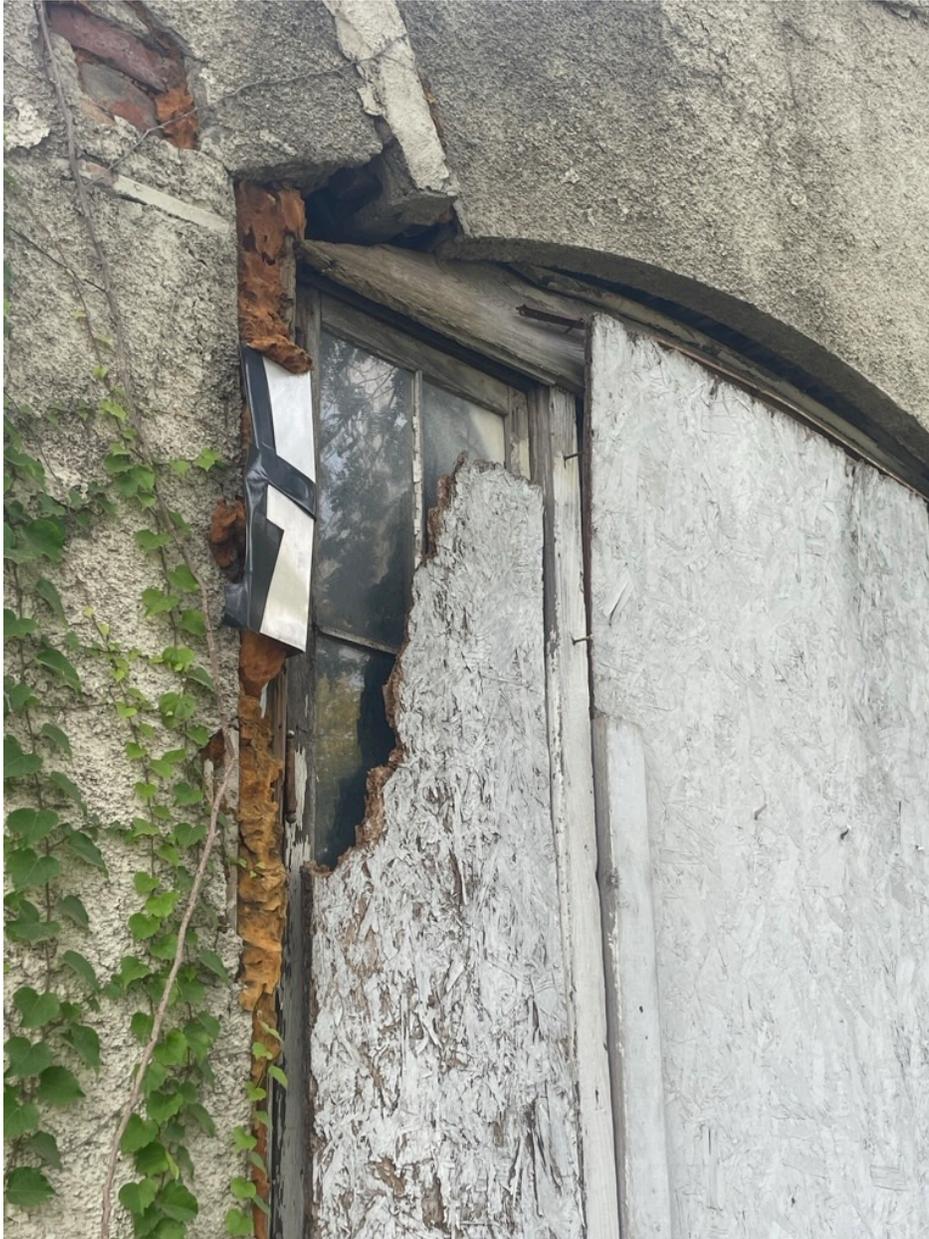
Southwestern column is leaning 5 degrees outwards and causing major structural failure at the corner of the roof line and the wall. Damage is beyond repair and dangerous to be left standing in this condition.

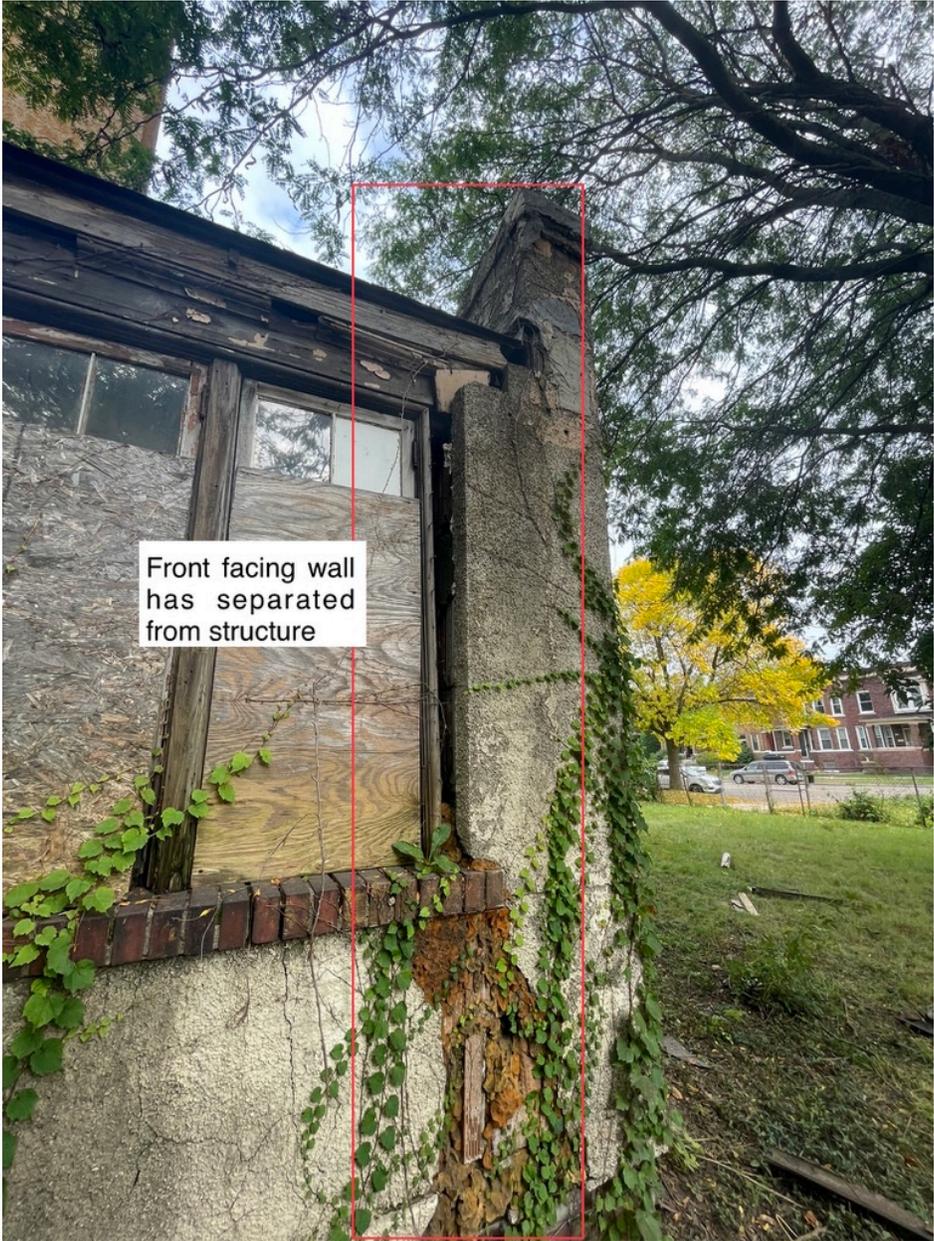
Foundation wall is cracked and leaning out 1”+ on the western face. It can be seen at the brick sill in this picture. The crack continues vertical to the roof line.

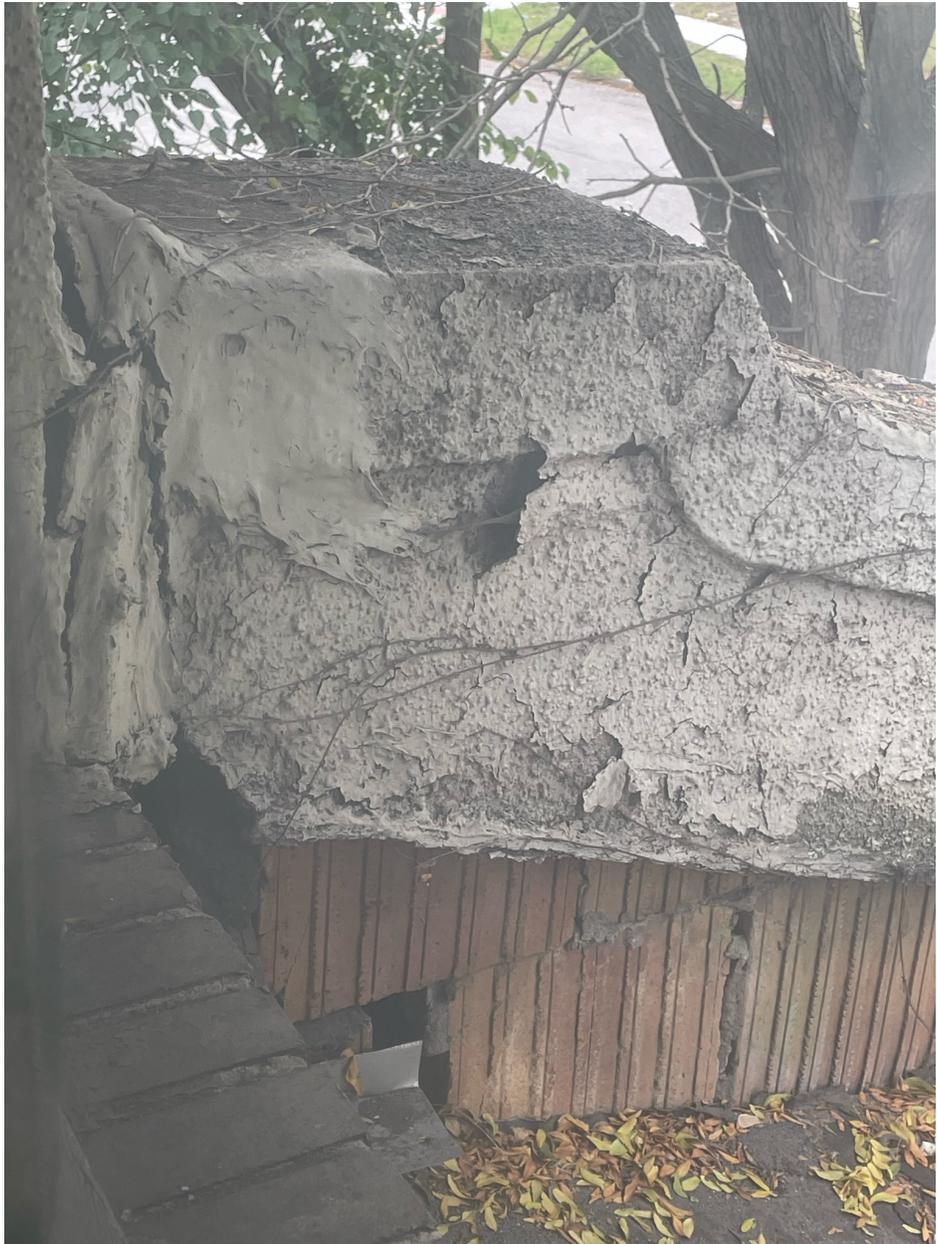
This wall is intact and will be preserved. Windows will be installed where clapboard siding is.
