**ADDRESS: 4440 E. CANFIELD****APPLICATION NO:****HISTORIC DISTRICT: SWEETEST HEART OF MARY ROMAN CATHOLIC PARISH****APPLICANT: LARRY WILK AND AL SEBASTIAN****OWNER: ARCHDIOCESE OF DETROIT****DATE OF STAFF SITE VISIT: 01/25/2024****DATE OF PROVISIONALLY COMPLETE APPLICATION: 01/15/2024****SCOPE: REPLACE SLATE ROOF WITH SYNTHETIC TILES****EXISTING CONDITIONS**

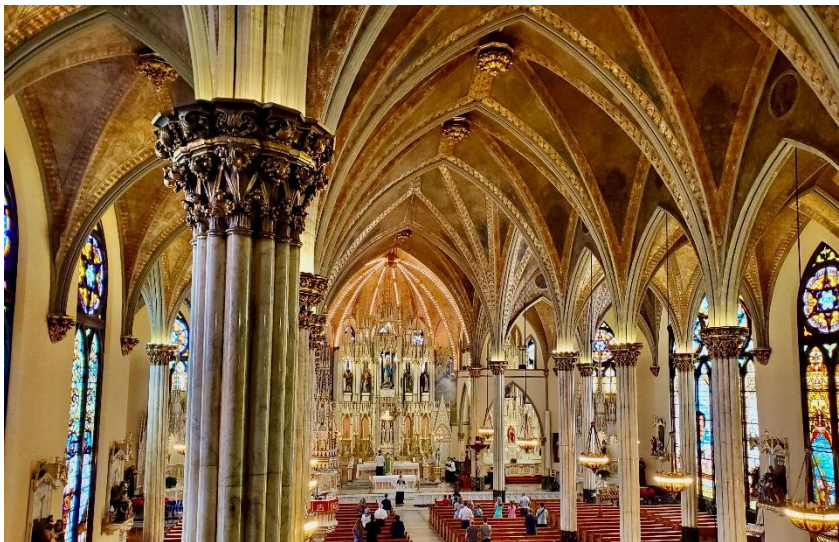
**Interior, current conditions. Photo by applicant**

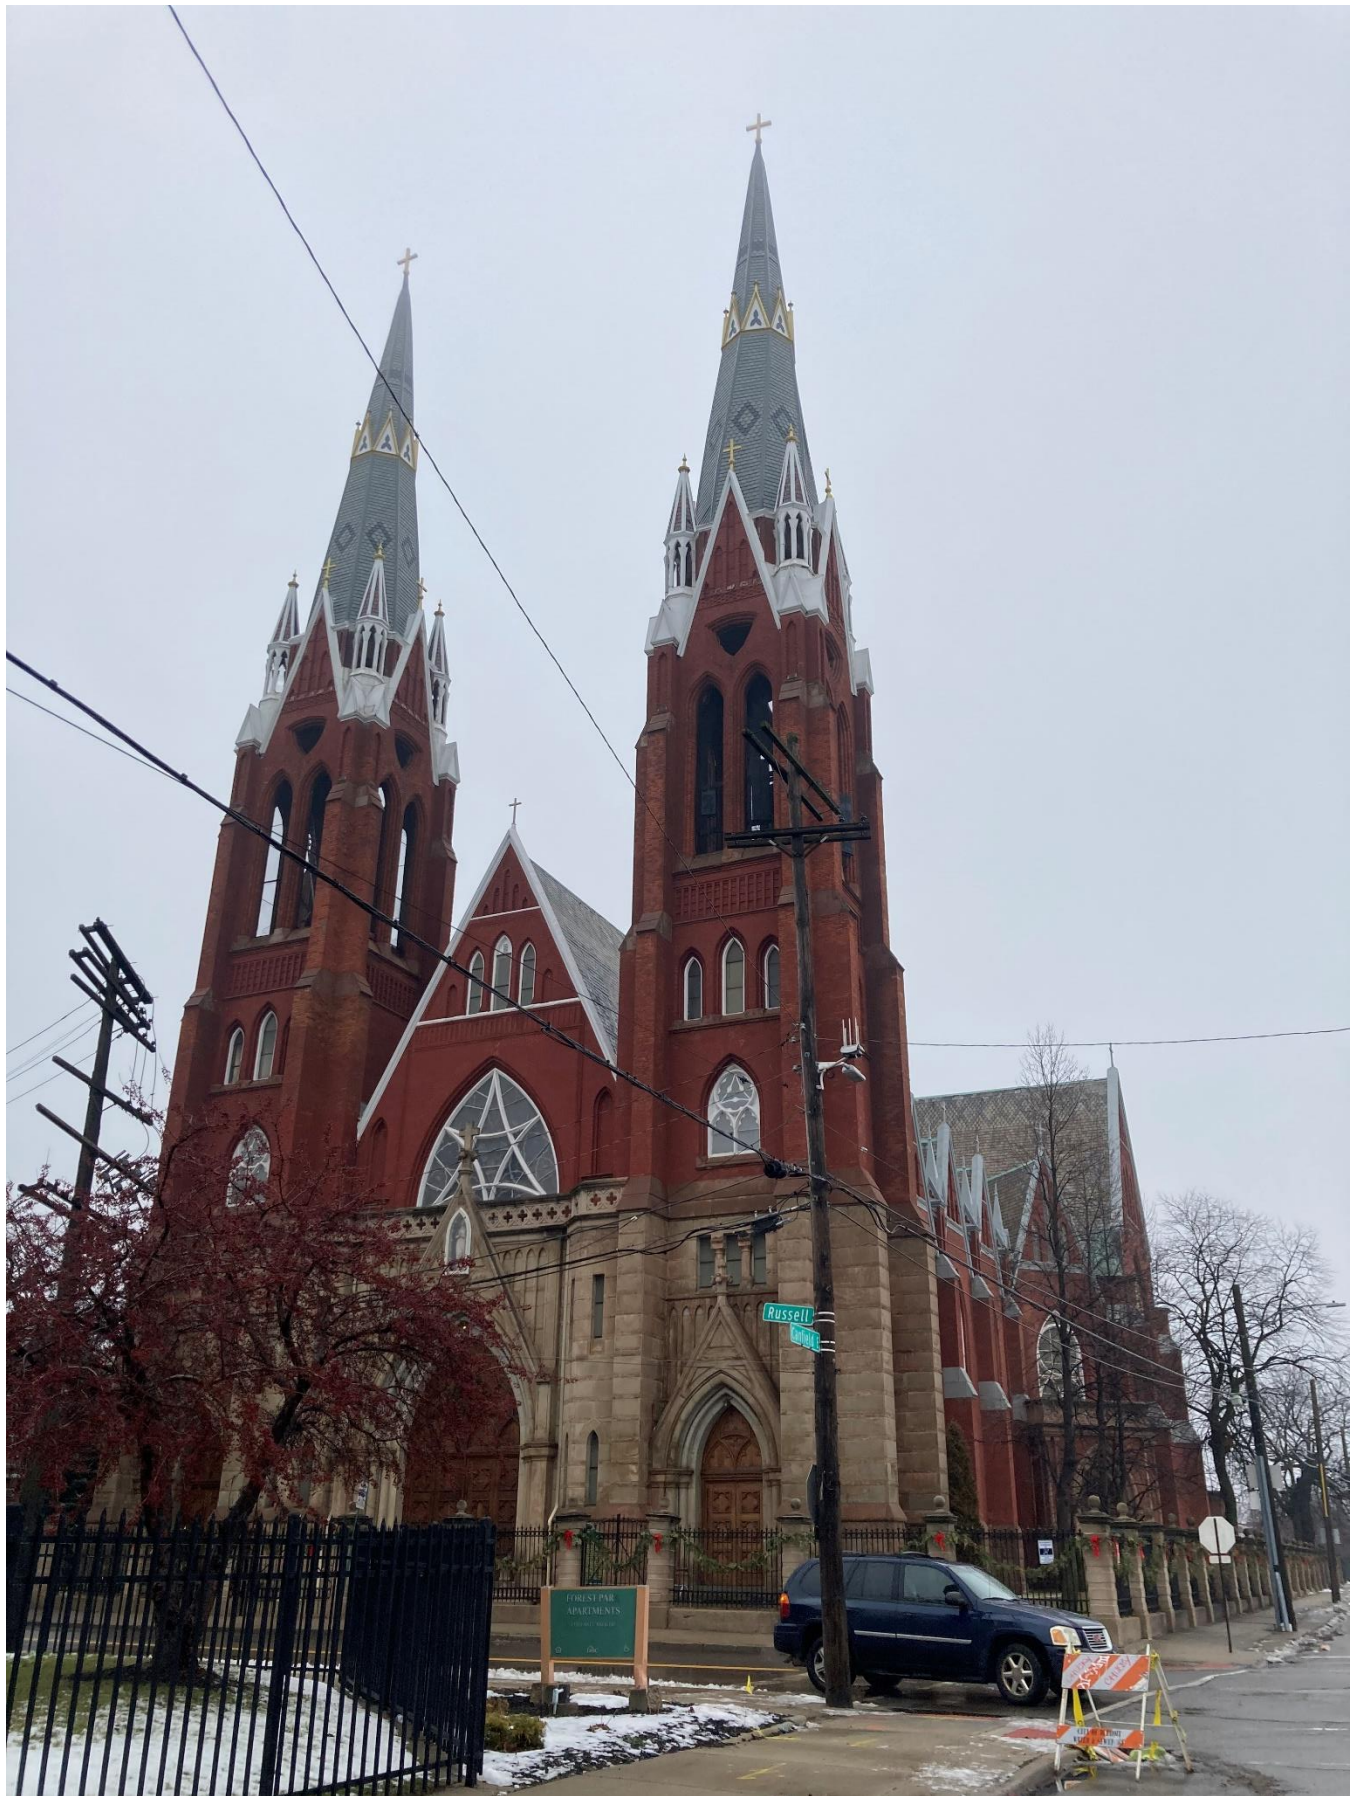
Current conditions, facing northeast showing primary façade. Staff photo taken 1/25/2024

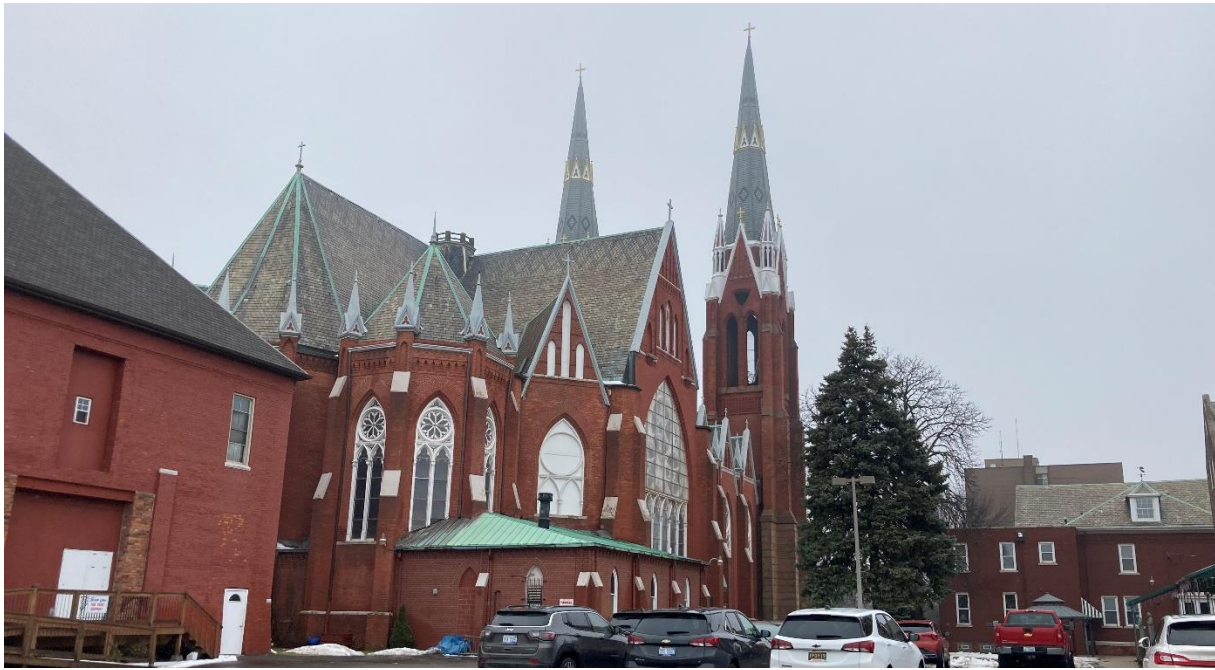
**Current conditions, facing southwest showing rear and north side. Staff photo taken 1/25/2024**

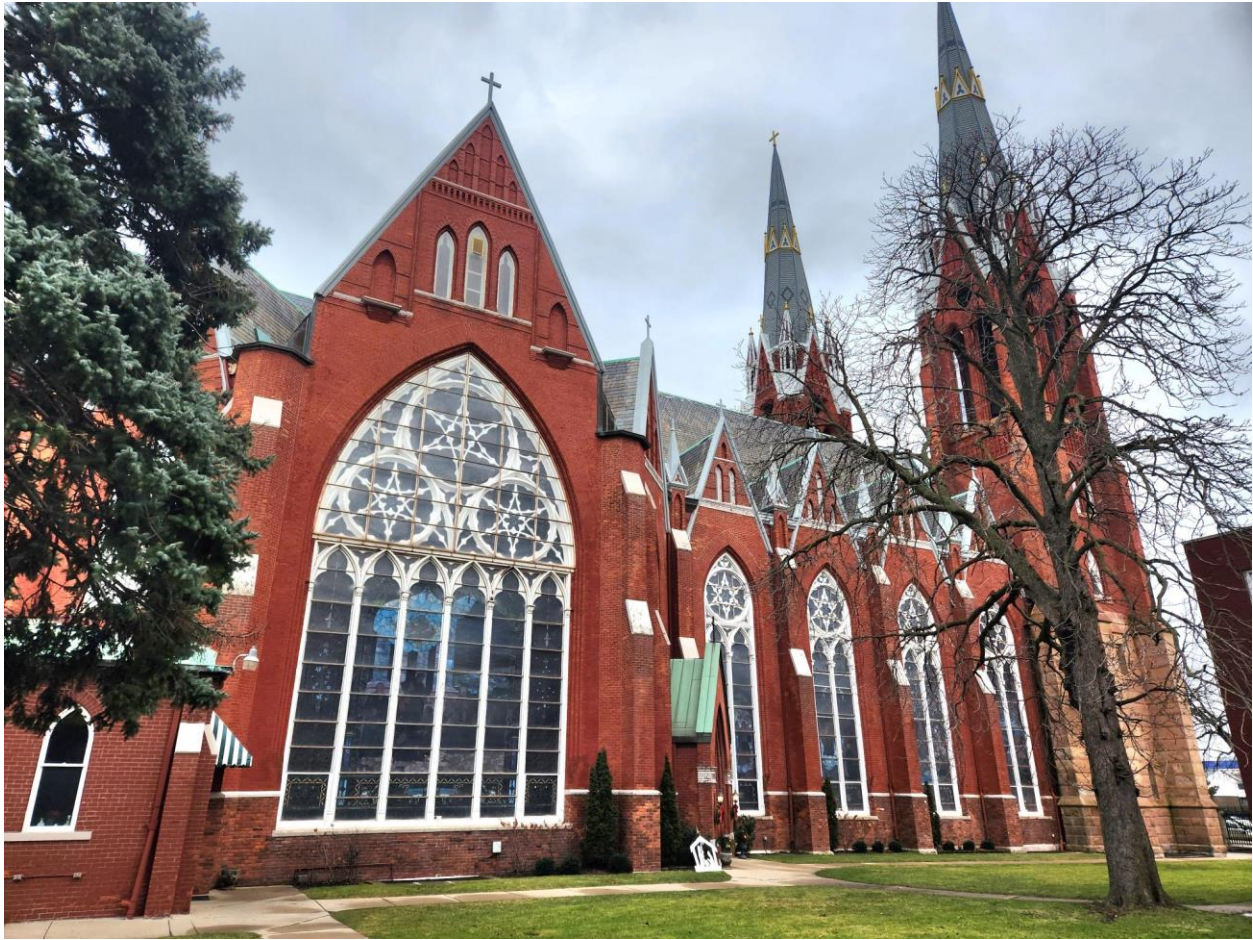
**Current conditions, facing southwest showing north side. Photo provided by applicant**

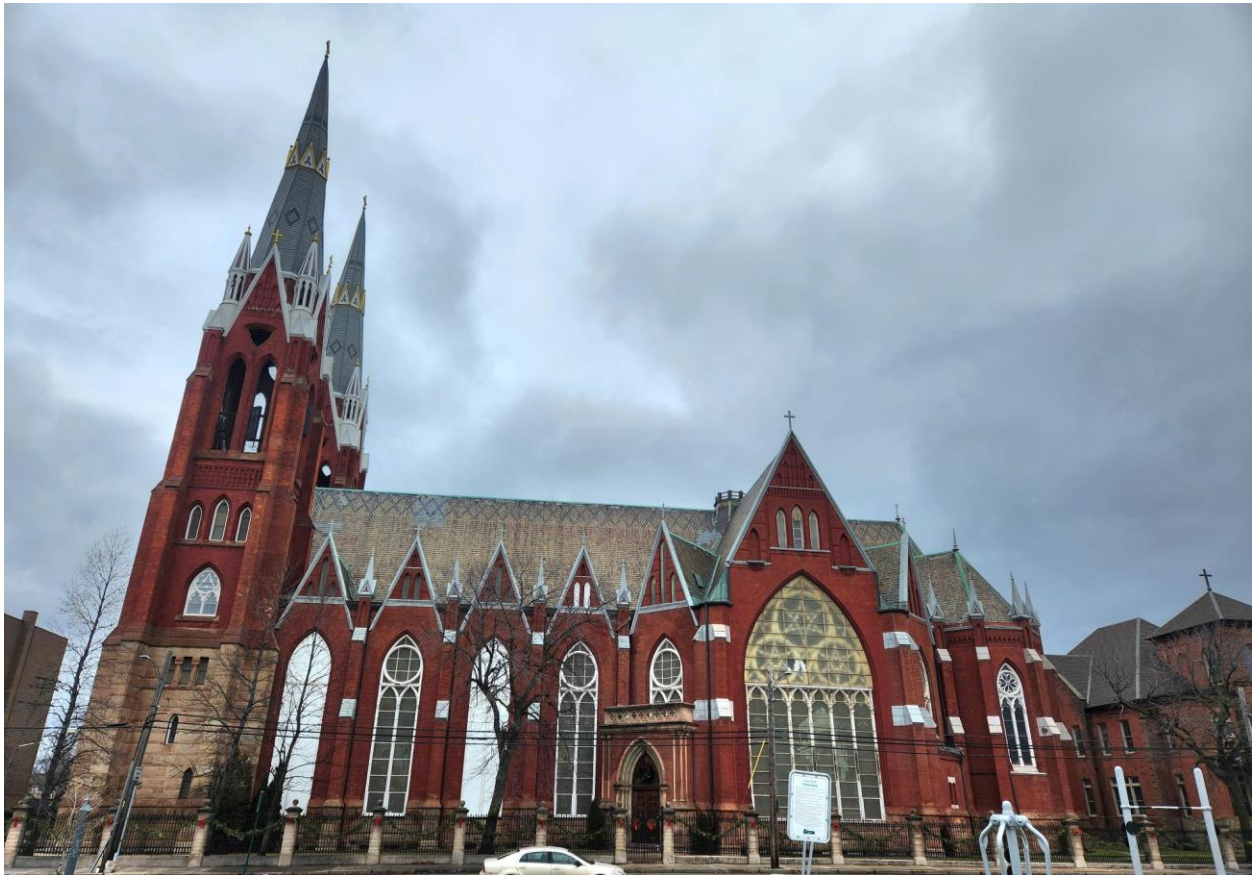
**Current conditions, facing north showing south. Staff photo taken 1/25/2024. Note decorative diamond pattern directly below ridgeline**

- As previously noted, it is staff's opinion that the current slate roof system, to include the use of multicolored shingles to create diamond patterns below the ridgeline, is a distinctive character-defining feature of the building. While the new roof will display both rectangular and scalloped shingles, which is in keeping with the current roof, the new shingles will only display a single color and the existing distinctive diamond pattern will not be replicated. It is staff's opinion that the deletion of this feature does not meet the Secretary of the Interior's Standards and/or the district's Elements of Design.

- The new roof shall replicate the distinctive diamond pattern through the use of multicolored shingles
- The applicant shall provide HDC staff a detailed narrative which clearly outlines the manner in which all roof elements, to include the shingles and decorative metal elements, will be fabricated and installed prior to the initiation of the work. If staff determines that any work item does not meet the Secretary of the Interior's Standards for Rehabilitation, the project will be routed to the Commission for review at a future regular meeting.

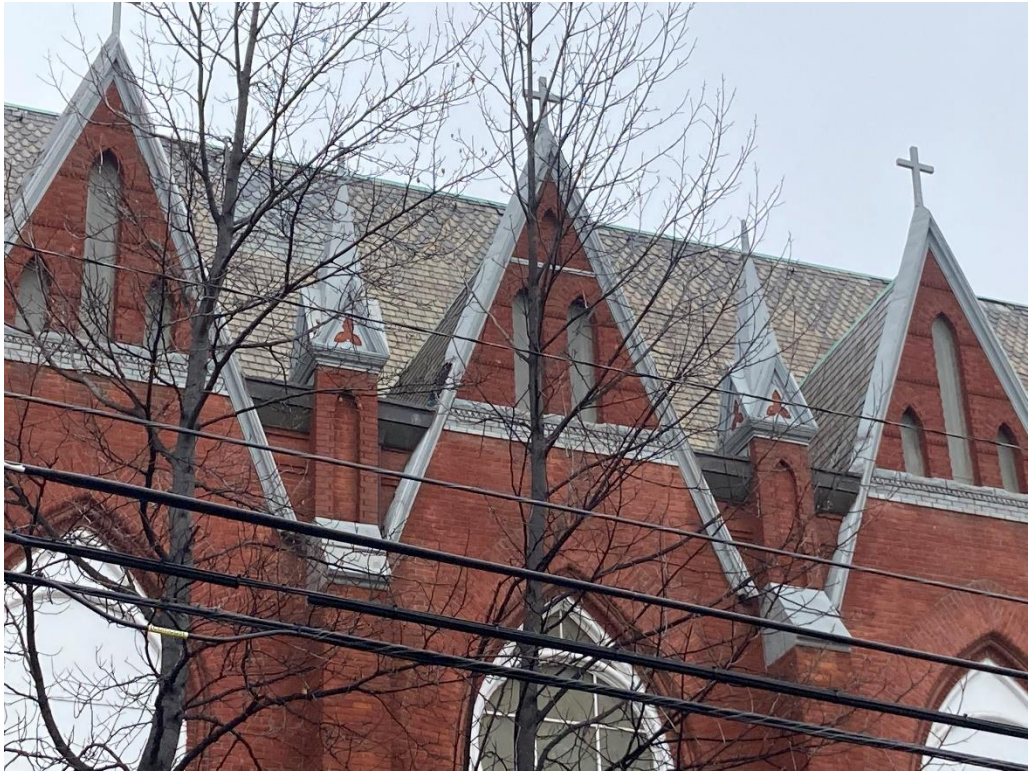
**Current conditions, facing northeast, detail showing metal fascia with cross-shaped finials, metal spires with trefoil detailing, and copper gutters typical at roof. These elements will be removed in whole/throughout and will be replaced with new copper elements to match the existing. Staff photo taken 1/25/2024**

- Replace all ornamental metal details to include cross-shaped finials and steeples with new copper elements, replicated to match existing
- Remove all existing flat roofing down to the wood deck. Install new EPDM roof system.

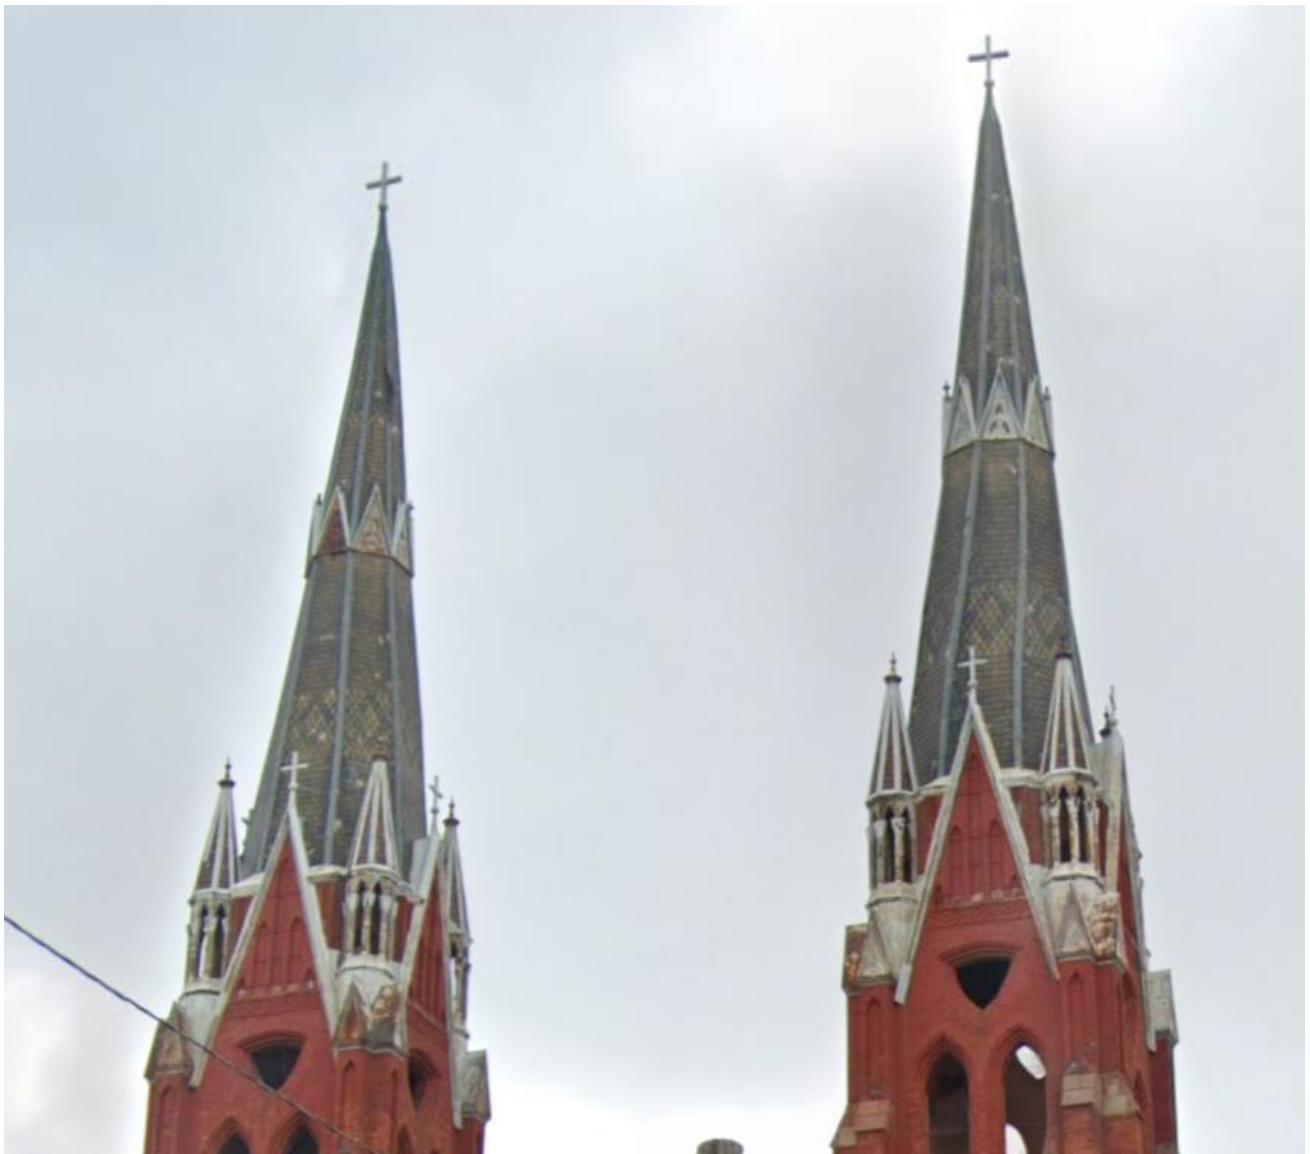
**Google Streeview, August 2018, prior to steeple repair**

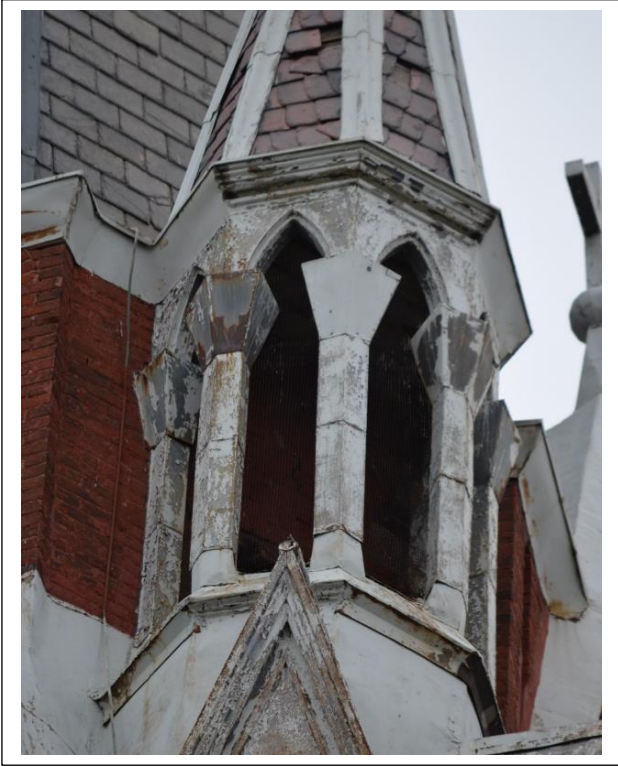
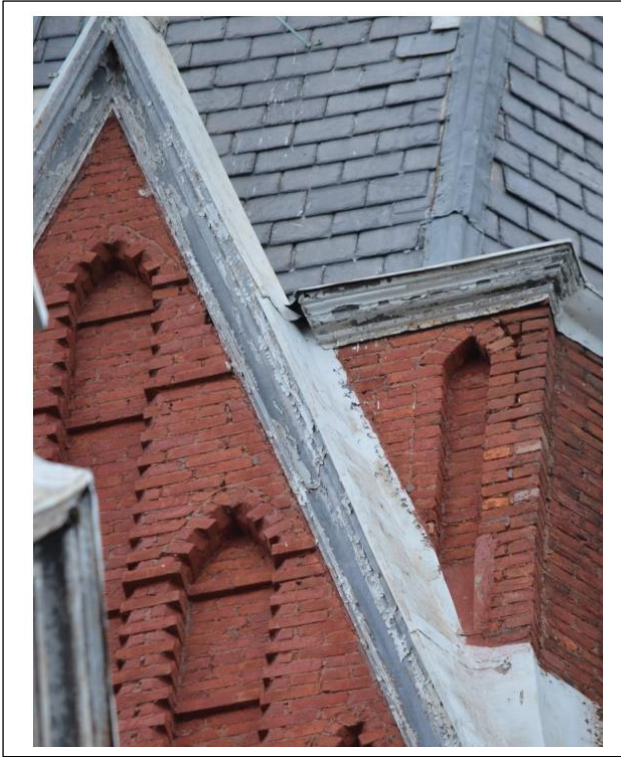
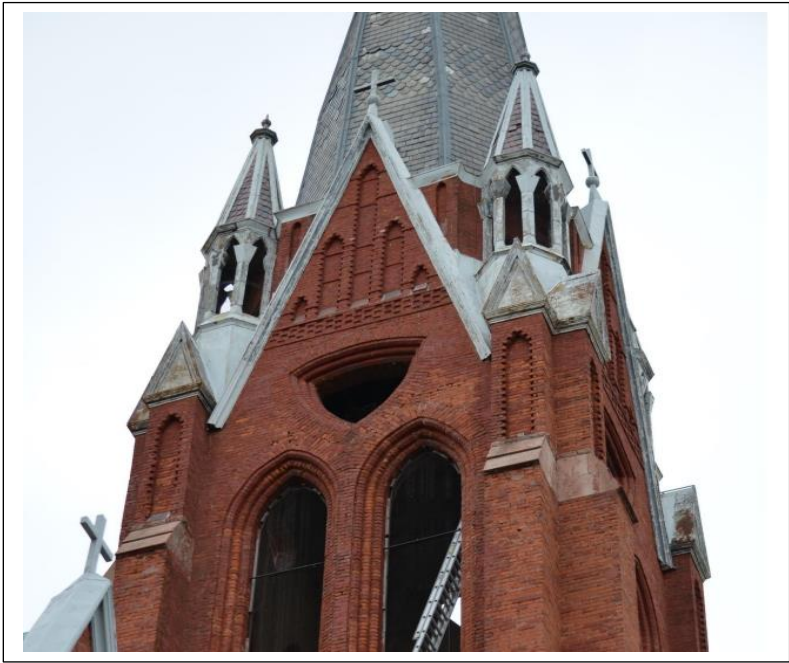
**Photos provided by applicant, 2017, prior to steeple repair**

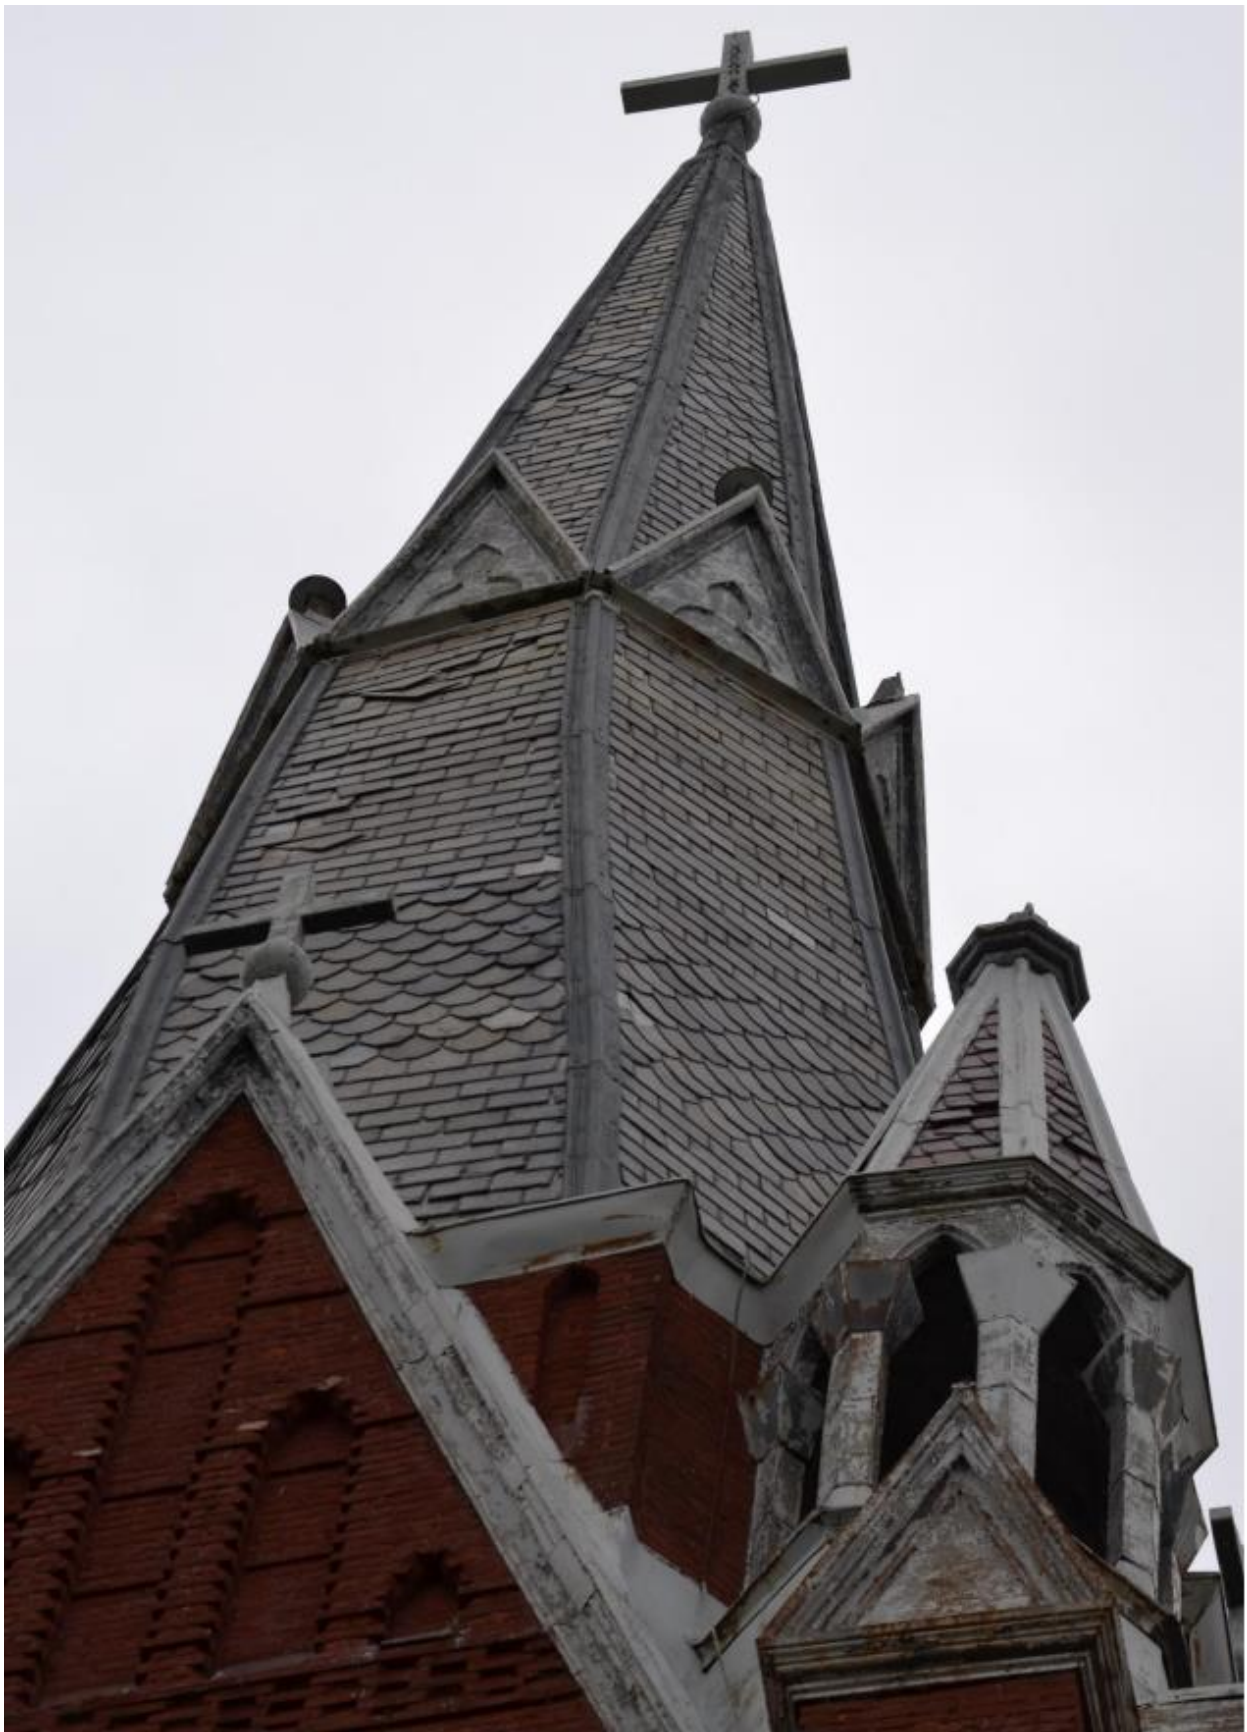
Photo provided by applicant, 2017, prior to steeple repair

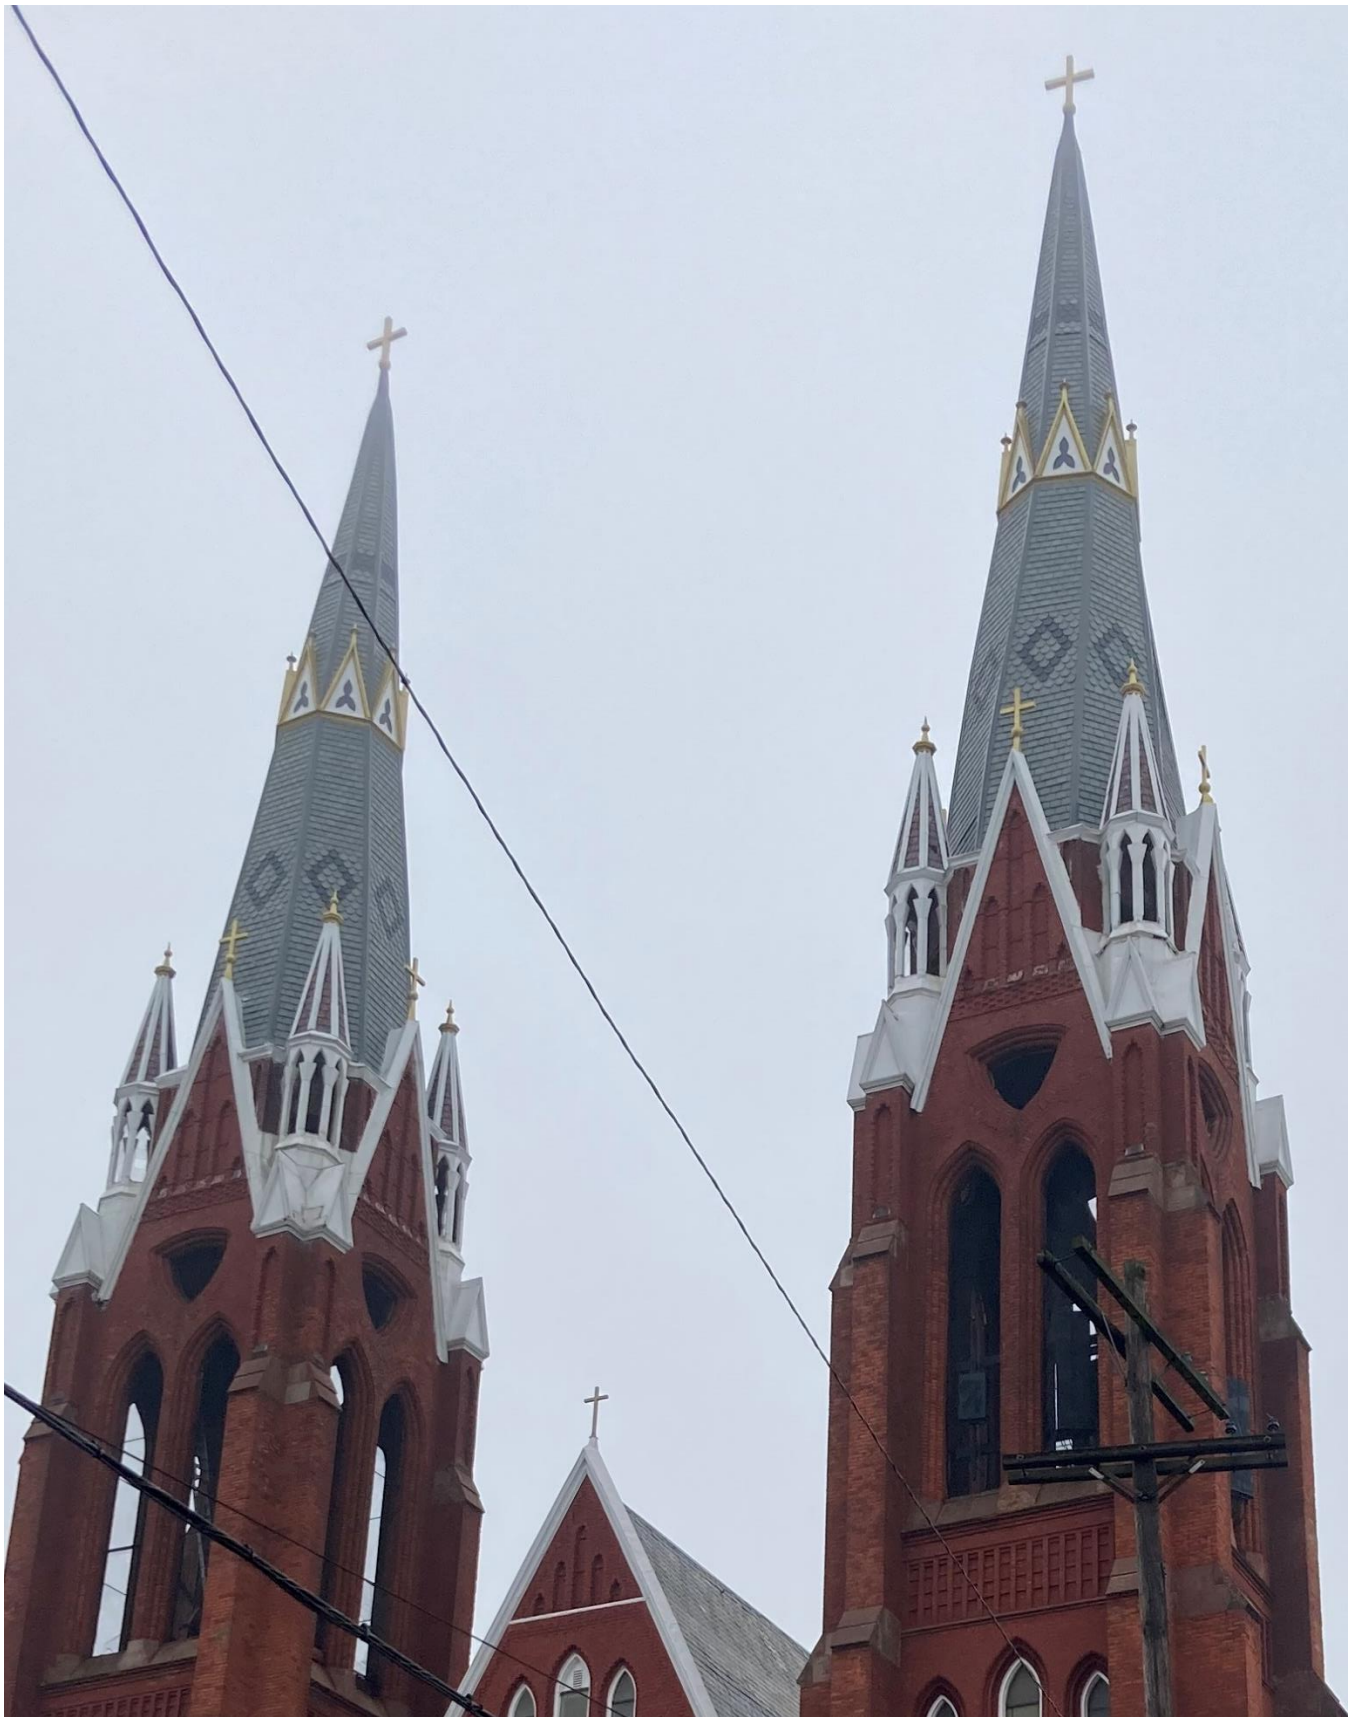
**Detail of spires with recently installed Davinci synthetic slate roofing, current conditions, photo taken on 1/25/2024 by staff.**

- As previously noted, the quote to install a new slate roof is \$1,094,000.00 versus \$337,000.00 for the proposed synthetic slate roof system. After an assessment of the synthetic slate and new metal elements installed at the steeples in 2018, staff concluded that the proposed synthetic slate product generally provides an adequate, economically feasible replication of slate.
