Project Name: Brewster Wheeler Recreation Center

Architect Project #: 1356-23

RE: Historic District Commission

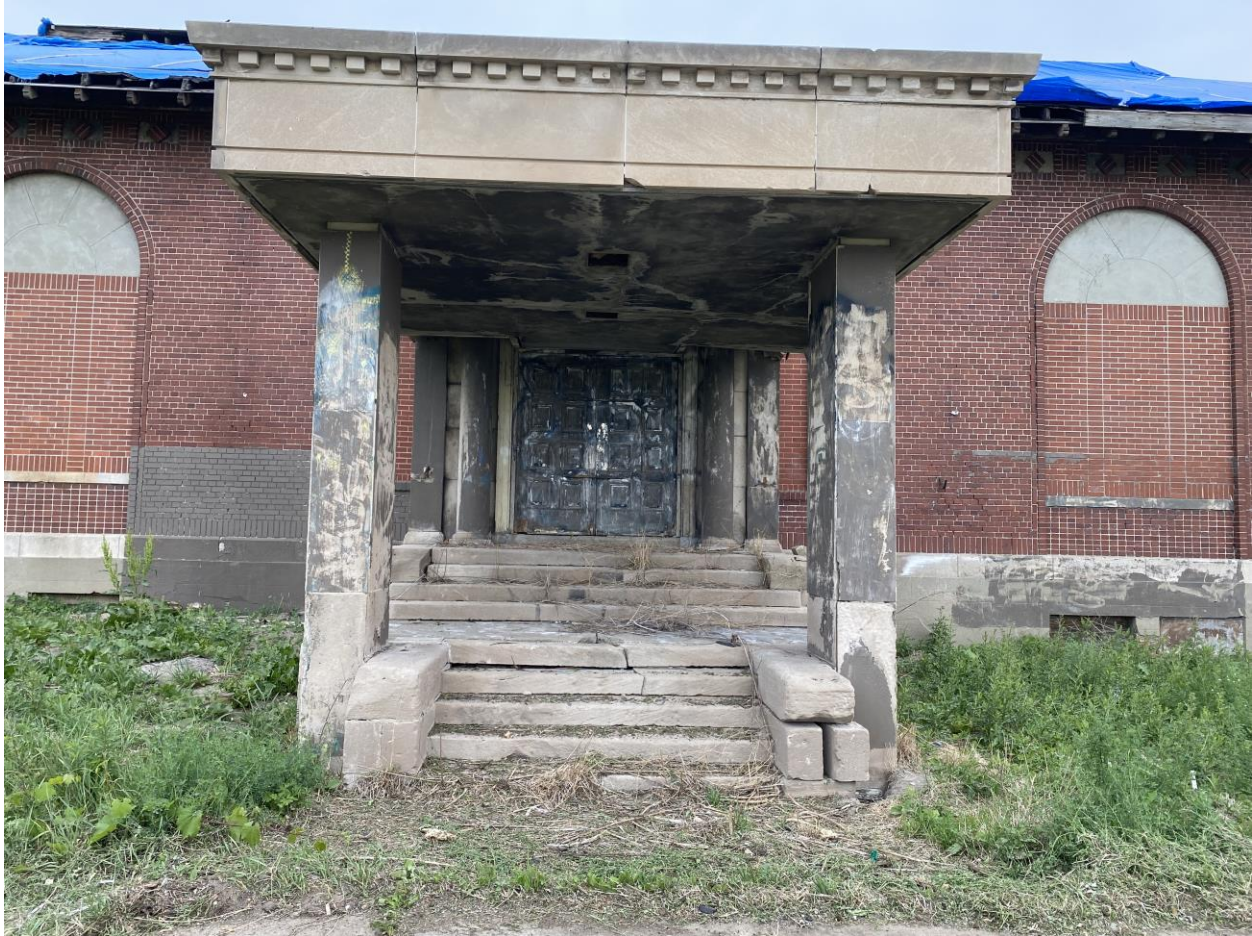
Existing Condition Photo 1: Original height of door & frame were lowered as a result of the existing canopy. A new door was also added in the existing frame to fit this reduced height.

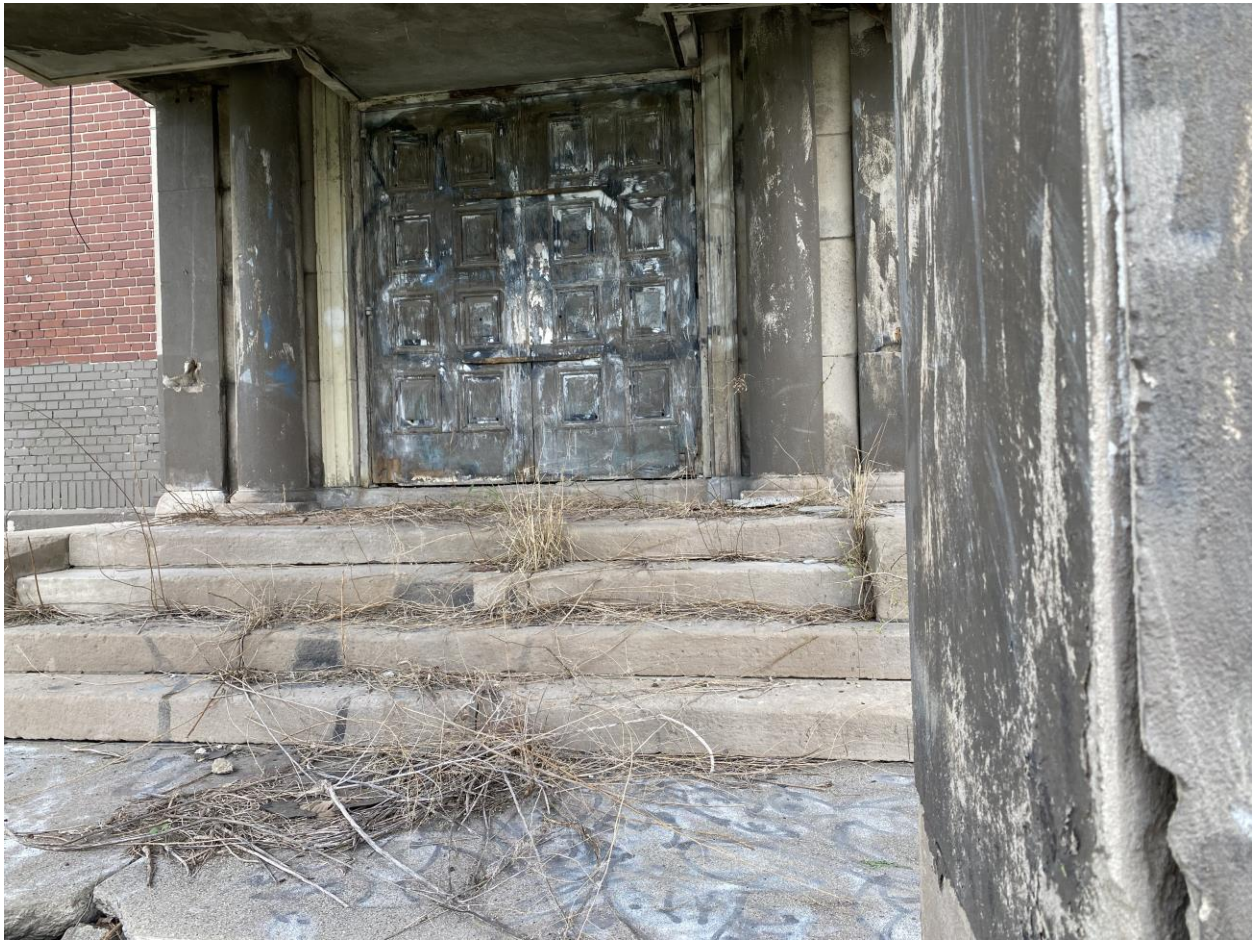
Existing Condition Photo 2: The existing door & frame were infilled in the original frame. The existing door has significant material loss through aging & weathering. With the removal of the canopy, the existing door in this photo (or a replica of this door) will not achieve a historically accurate façade.

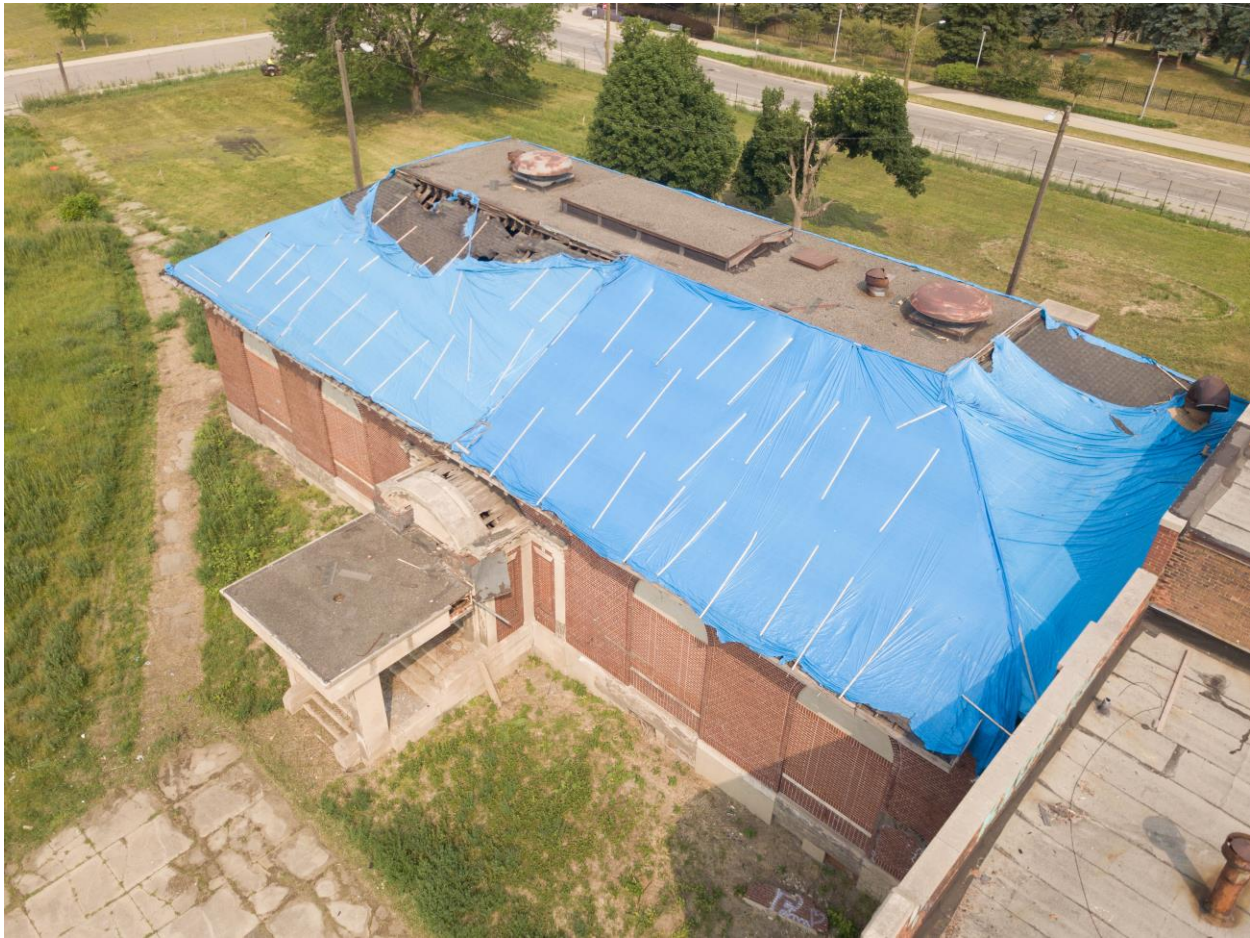
Existing Condition Photo 3: The canopy was added & decreased the height of the original entry.

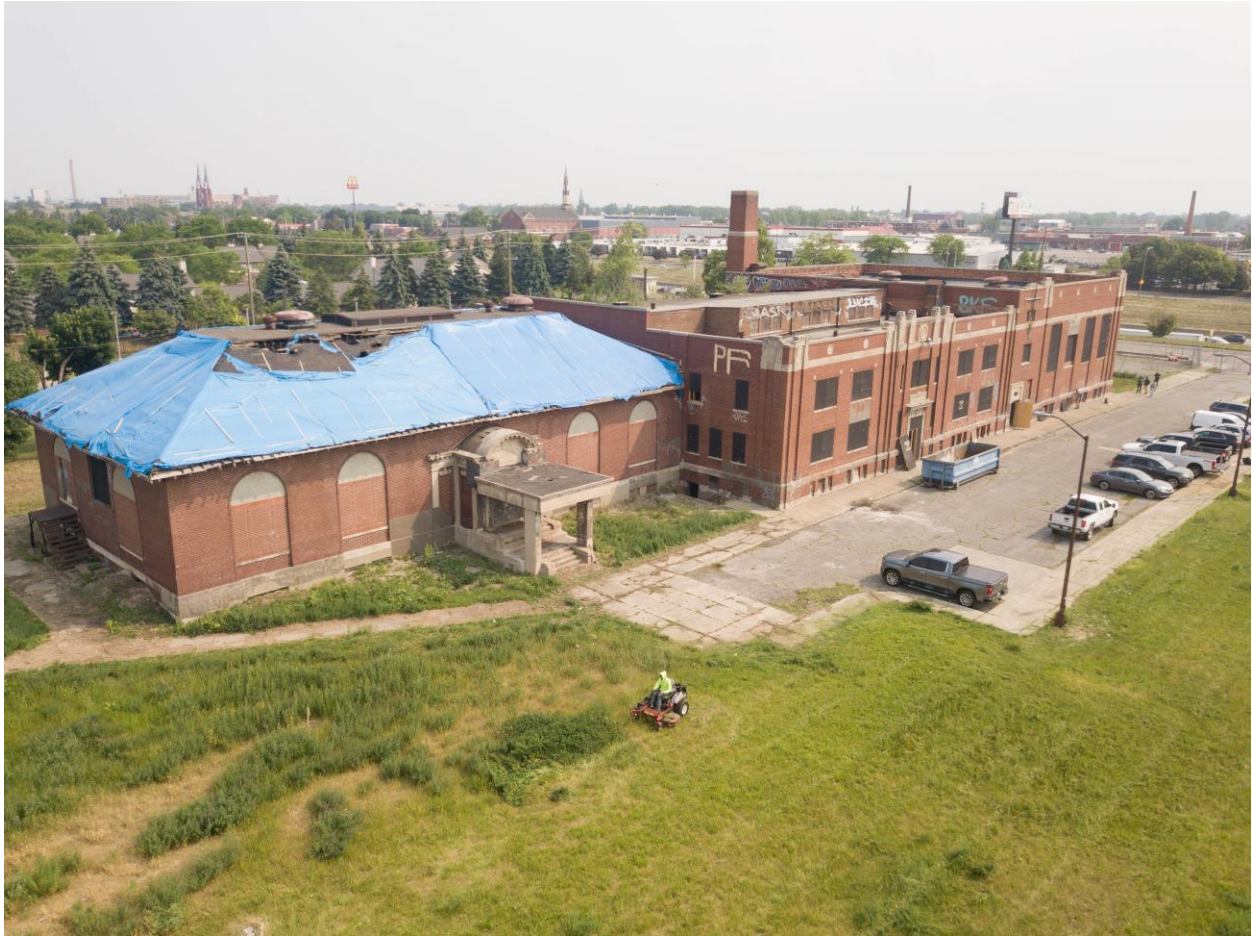
Existing Condition Photo 4: The canopy was added & decreased the height of the original entry.

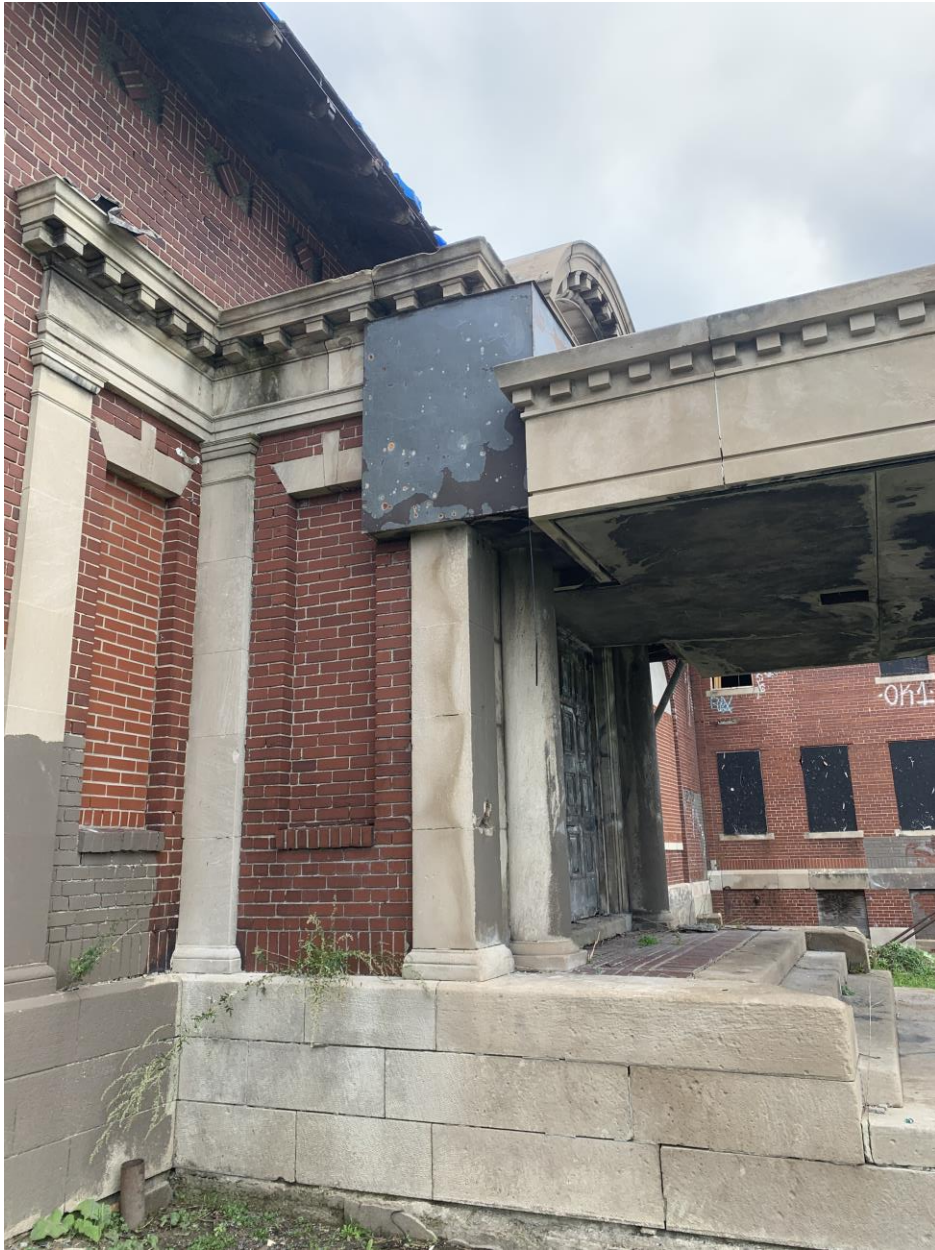
Existing Condition Photo 5: The canopy was added & decreased the height of the original entry. When the canopy was added, this metal flashing was also added. CDS proposes the added canopy, added door and added metal flashing be removed.

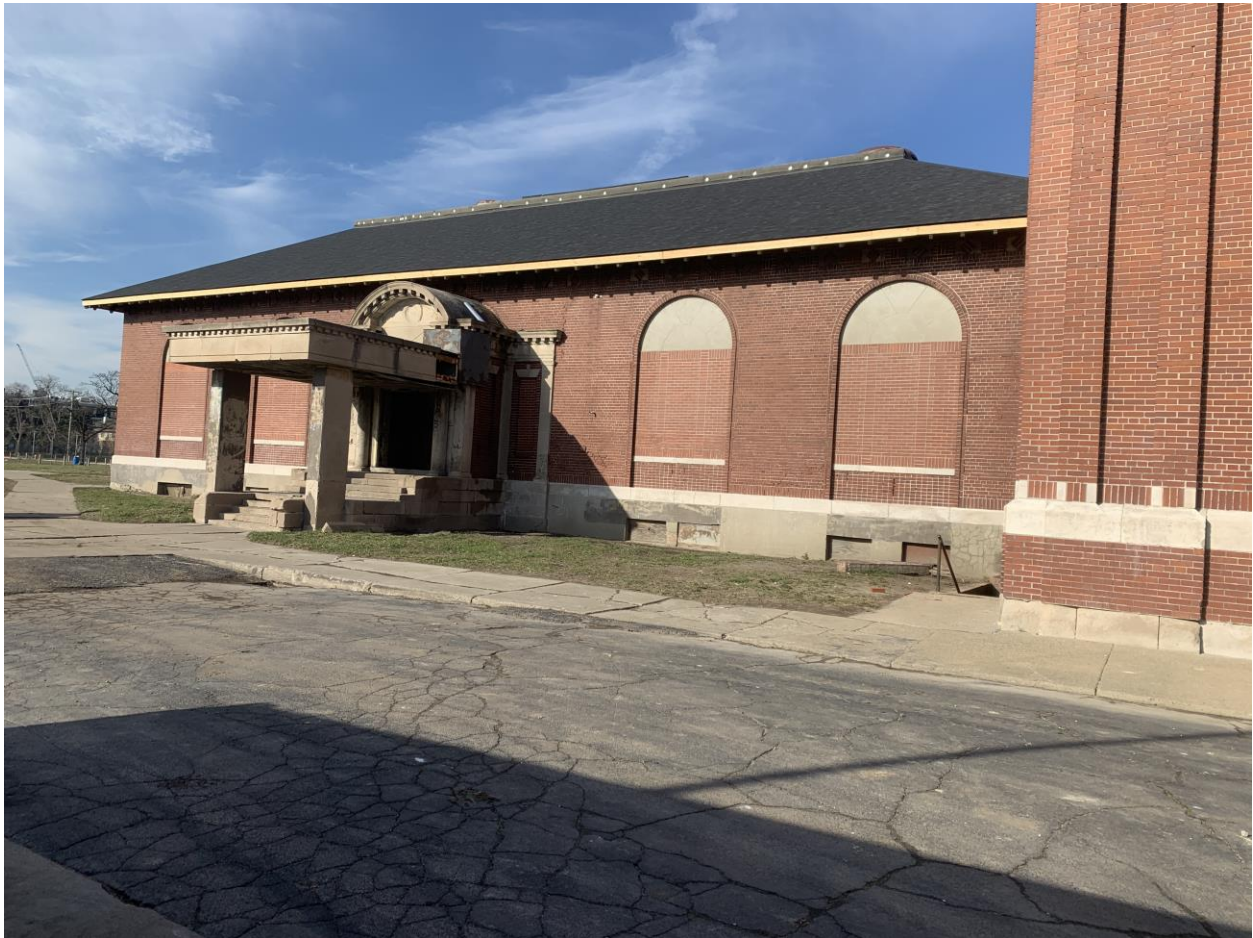
Existing Condition Photo 6: The canopy was added & decreased the height of the original entry. When the canopy was added, this metal flashing was also added. CDS proposes the added canopy, added door and added metal flashing be removed.

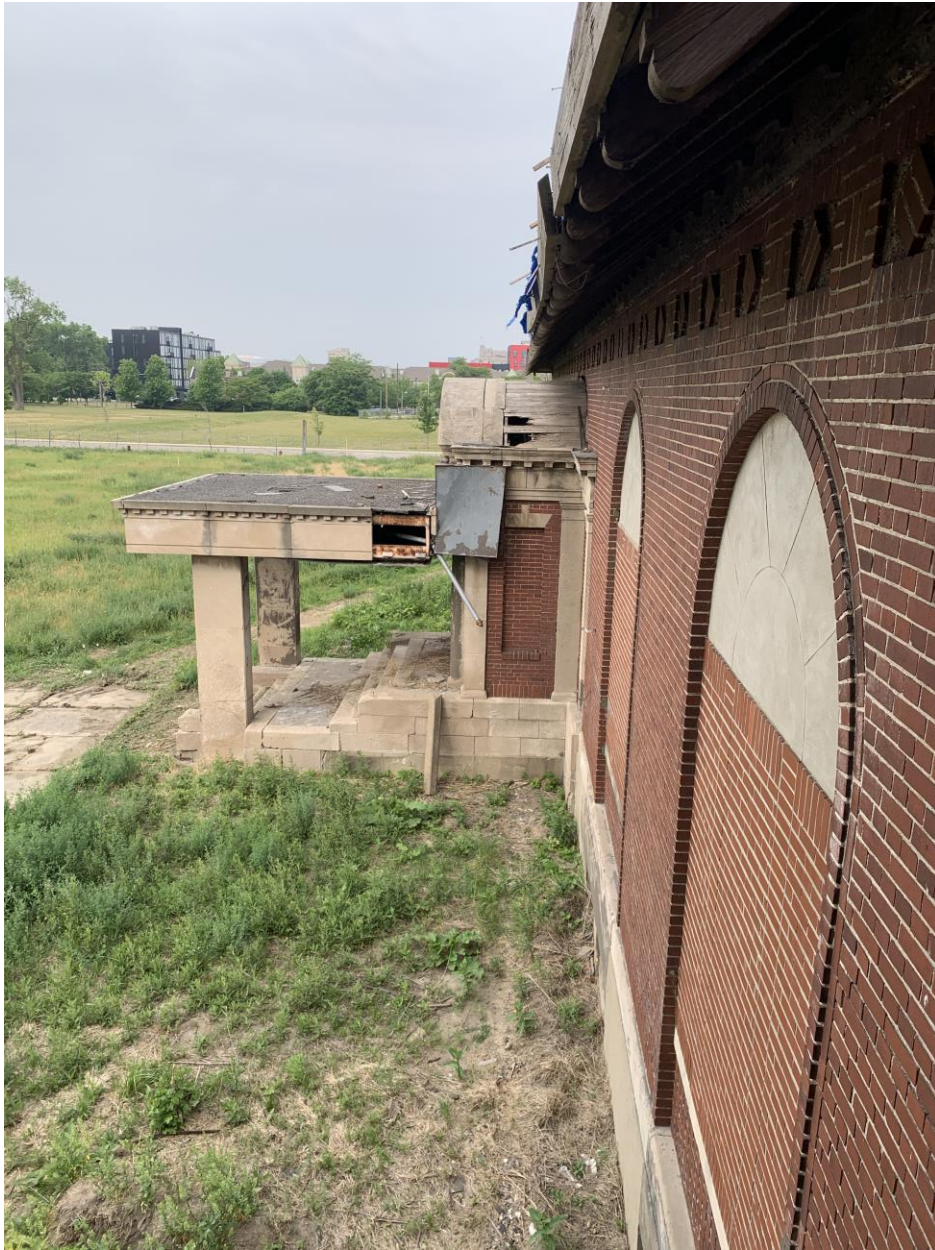
Existing Condition Photo 7: The canopy was added & decreased the height of the original entry. When the canopy was added, this metal flashing was also added. CDS proposes the added canopy, added door and added metal flashing be removed.

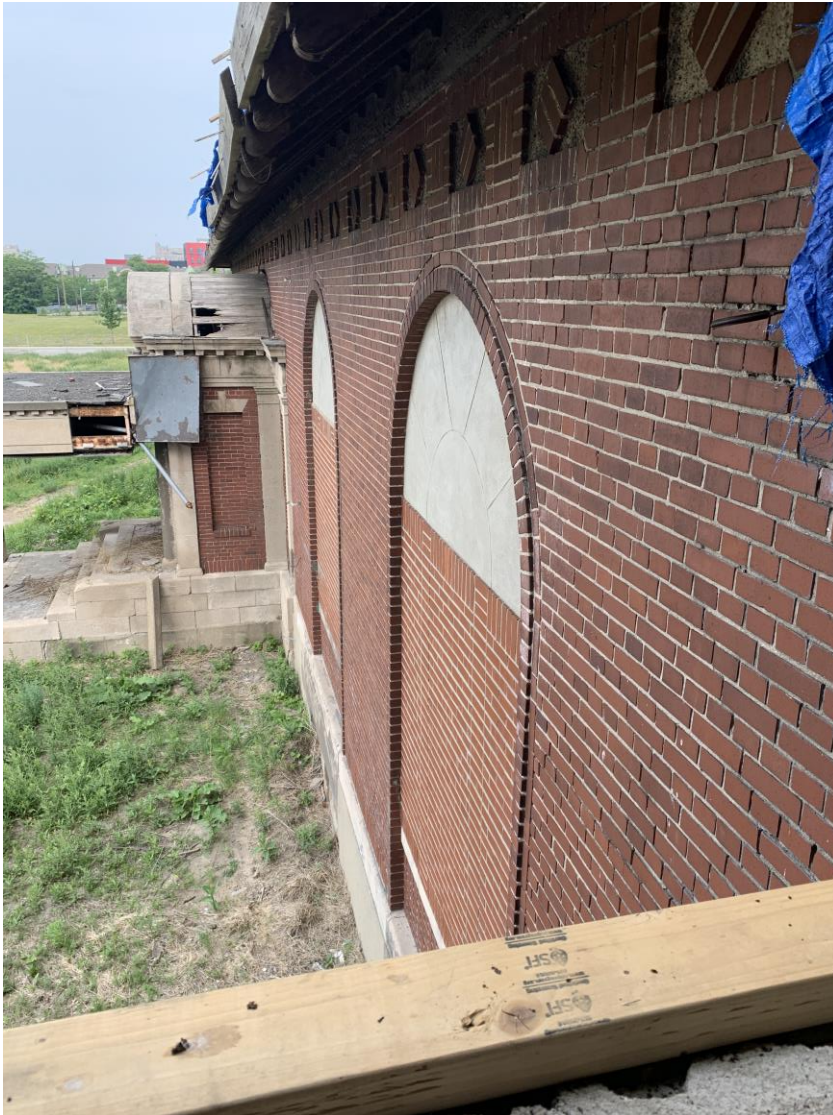
Existing Condition Photo 8: The canopy was added & decreased the height of the original entry. When the canopy was added, this metal flashing was also added. CDS proposes the added canopy, added door and added metal flashing be removed.
