HDC2024-00149

EXTERIOR IMPROVEMENTS APPROVAL, INCLUDING RESIDENTIAL GARAGE ASSESSMENT AND NEW CONSTRUCTION CONSIDERATIONS.

Project: Exterior Improvements and New Garage Improvements
570 Lodge Drive
Detroit, MI 48221

Joseph Berry Historic District
Lot 42
City of Detroit Project No. - RES2024 - 00816

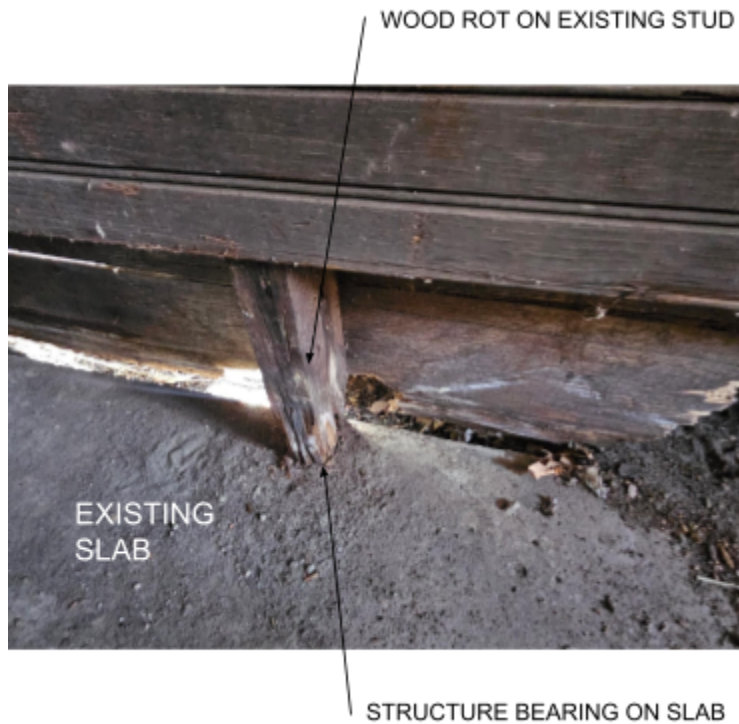
Fig. 7.0 - Existing Garage Photo by w/Purpose

The foundations of the existing garage and rear addition were similar in construction. The foundations observed had deteriorated due to period construction techniques and/or end of materials natural life cycle coupled with weather related factors (frost, moisture, etc.)

We found both foundations to be rotted wood. No visible mud plate or suitable footing. Footings observed were constructed out of wood /stone combination that have become exhausted from frost heave during cold winters where frost depth exceeded beyond 42" below grade.

Due to multiple structural issues identified at our visit we conclude that repair of the garage is not a viable option.

We conclude that demolishing the structure in its entirety and building a new structure is the best solution. The solution would bring the structure into compliance with a matching masonry structure with similar architectural roof style and pitch.

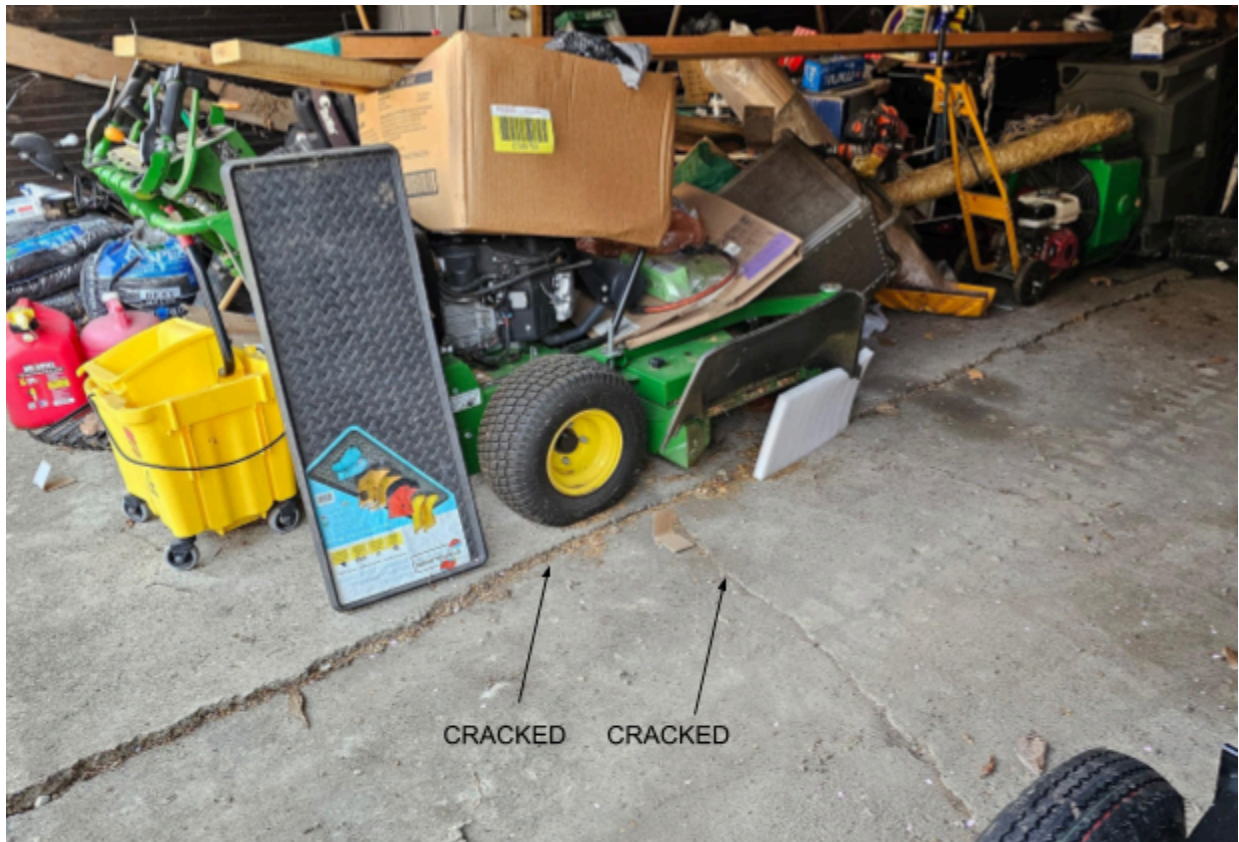
Fig. 10.0 - Existing Garage Slab

Existing cracks span the latitudinal/ longitudinal boundaries on the concrete slab. We measured the slab to be higher along latitudinal crack line.

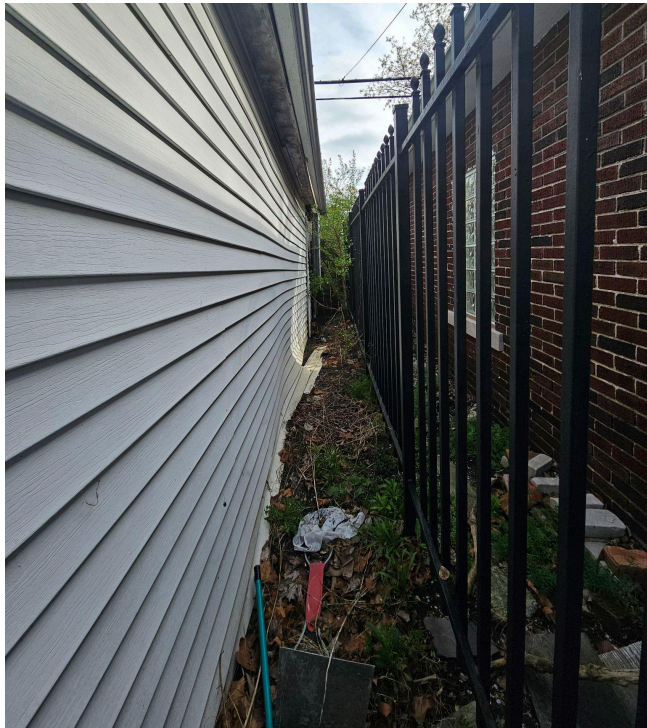
Fig. 11.0 - Existing Garage facing South

Garage exterior walls are massively out of plumb and appear “wavy”. Exterior walls of the garage and rear addition were clad in matching vinyl siding that is well beyond a life cycle.

Stud framed walls: Studs were observed to be floating at foundation and/or directly on concrete slab. Dry rot was also observed on the bottom. 2-4” of studs. See Fig.

A spanning double top plate at the rear is severely warped. Indicating foundation issues at edges. It also speaks to incorrect sizing of structural members at bearing walls.

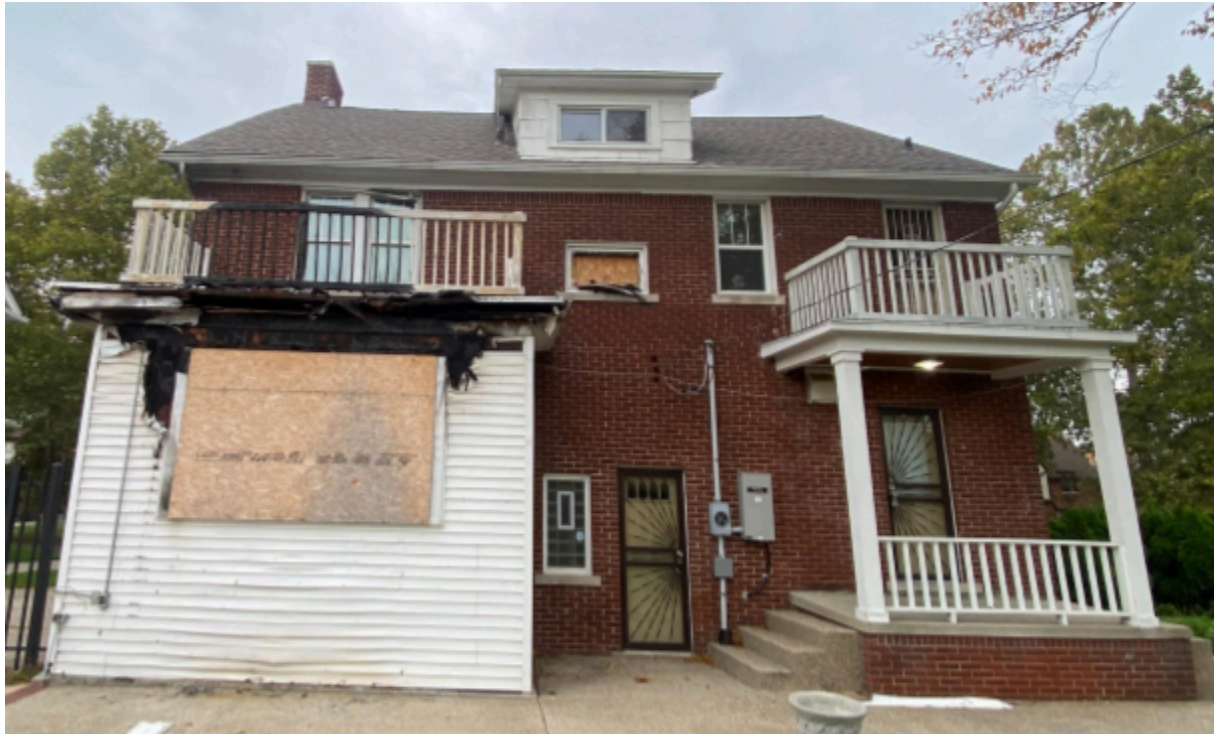
Existing Rear Office is 9' x 14'. The foundation of the existing porch was severely damaged prior to the house fire. Owner indicated the interior wood floors were sloping toward the back of the office. This highlights a failure of the foundation. Unfortunately, due to the fire the structure needed to be demolished.

Fig. 13.0 - Rear of 570 Lodge. The rear “office” was severely damaged in a fire. Exterior vinyl siding was damaged, as well as windows and soffit assembly.

Due to unsafe structural and fire related issues identified the owner moved to have the structure demolished.

Building a new “screen in porch” is the best solution and perhaps brings it closer to its original program use. The solution would bring the structure into compliance with a coordinated color scheme and Hardie Cement board lap siding at the porches base, Black Aluminum railing, and Trex Flooring.

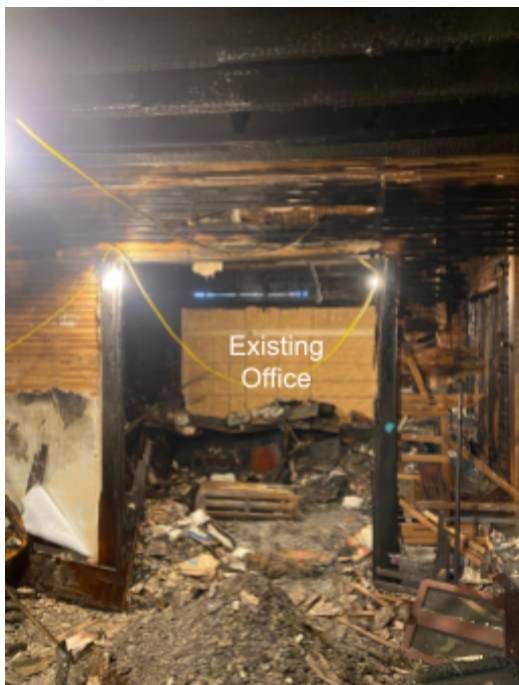
Fig. 14.0 - Fire severely damaged interior of “office”
