372 W. Grand Blvd.

This document has photos of many of the windows that are proposed to be replaced in our 1895 house in the Hubbard Farms historic district. We replaced the first "batch" of windows several years ago and would desperately love to replace the others before the weather gets cold, having begun this process in June. As they say in a popular HBO show, winter is coming.

The following photos are in existing conditions and evidence severe deterioration from weather, condensation (interior), and fire damage (historic and poorly restored many moons ago). We have not obtained quotes, and we *will not* obtain quotes, to restore these to historic standards, owing to the astronomical price points and timelines we received in requesting previous quotes (2.5x the price of replacement, months-out timelines, extremely poor customer service, and an emphasis from multiple parties on there being zero guarantees on operational performance plus the guarantee of inferior energy performance and air leakage, plus the fact that we'd now like the windows to all match).

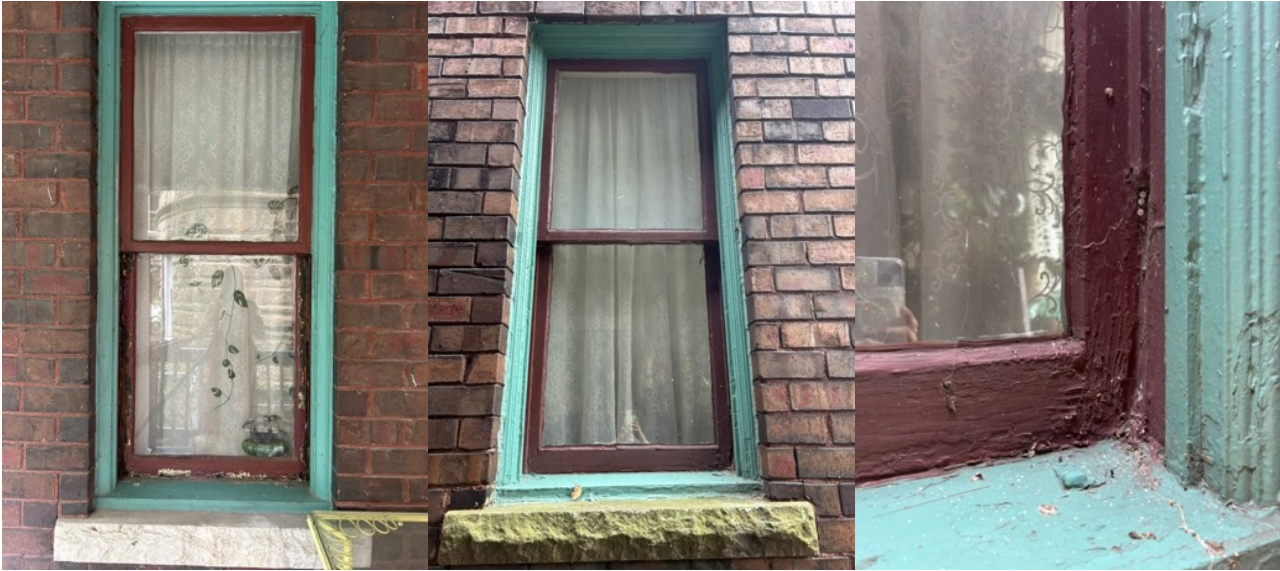
Window detail. First floor living room south (left); dining room left (center), dining room center (right); substantially damaged and inoperable

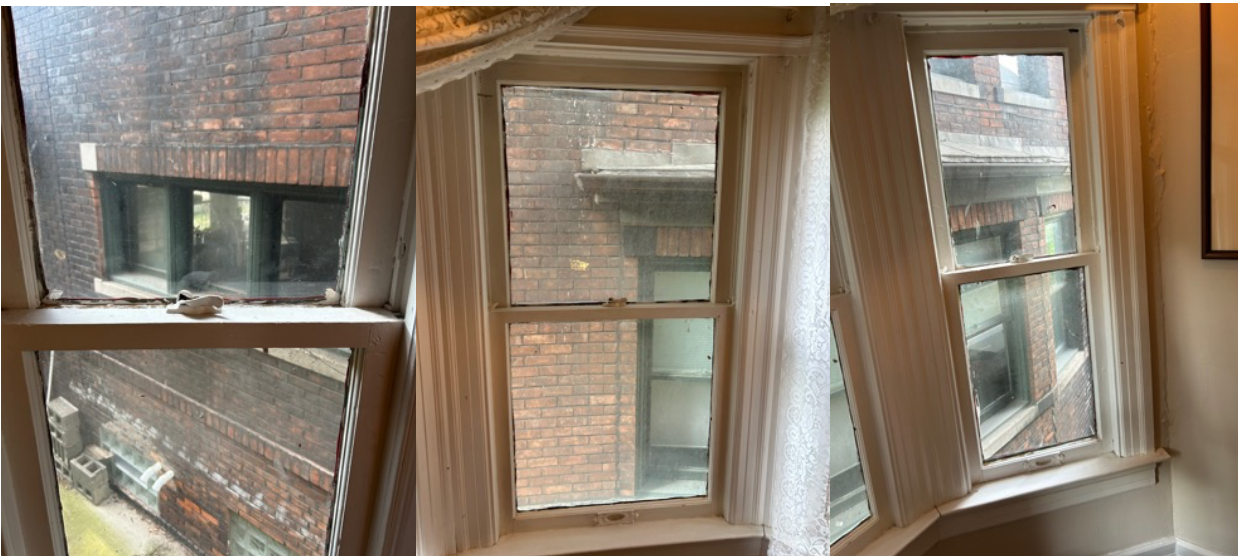
Interior detail: The same windows from the interior: Note how all of these windows are painted shut, and note how the top sashes are sagging below the top of the bottom sash. The stops range from intact to damaged to missing on all of these, and a lot of the glass has been replaced (indicated by some of sloppier edges and in one case where the original window was replaced with plastic).

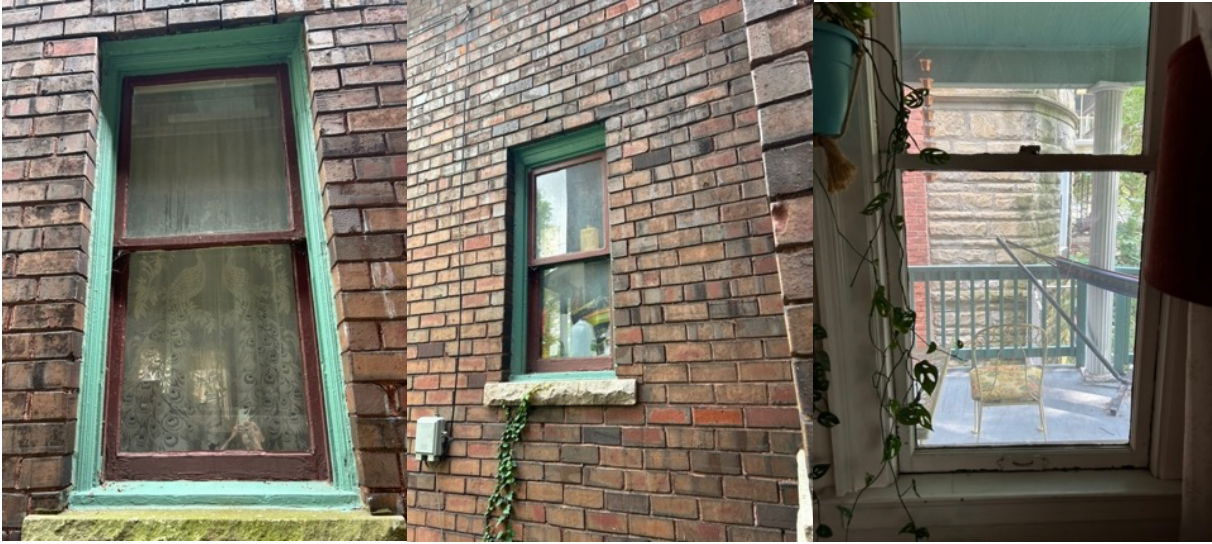
Window detail: Dining Room right (left); kitchen left (center); living room south (right); all inoperable and damaged ranging from minor dry rot to substantial fire and damage on the living room window).¹

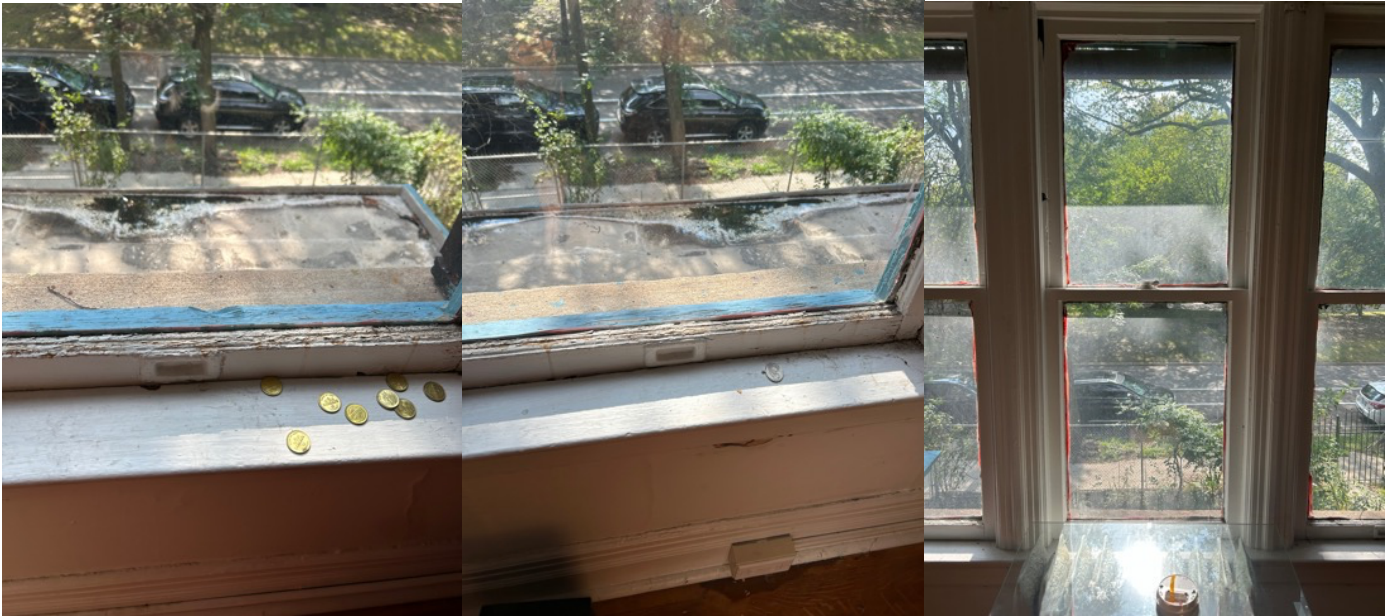
More window detail: 2F windows (Omar North). Note the serious water damage to the bottom of the bottom sashes, largely from condensation on the interior of the glass that has, very much unlike the Most Honorable Lord Mayor Mike Duggan's lavish subsidies for white suburban billionaires, « *trickled down* » to the bottom of the frame, irreparably damaging the wood.

Right: Another view of three completely inoperable windows, each evidencing various levels of sagging in the top sash, dry rot in the bottom sash wood, sloppy paint job from reglazing after the fire, and more. Also note the top left window that has two Plexiglas parts instead of real glass. Plastics! What a time to be alive.

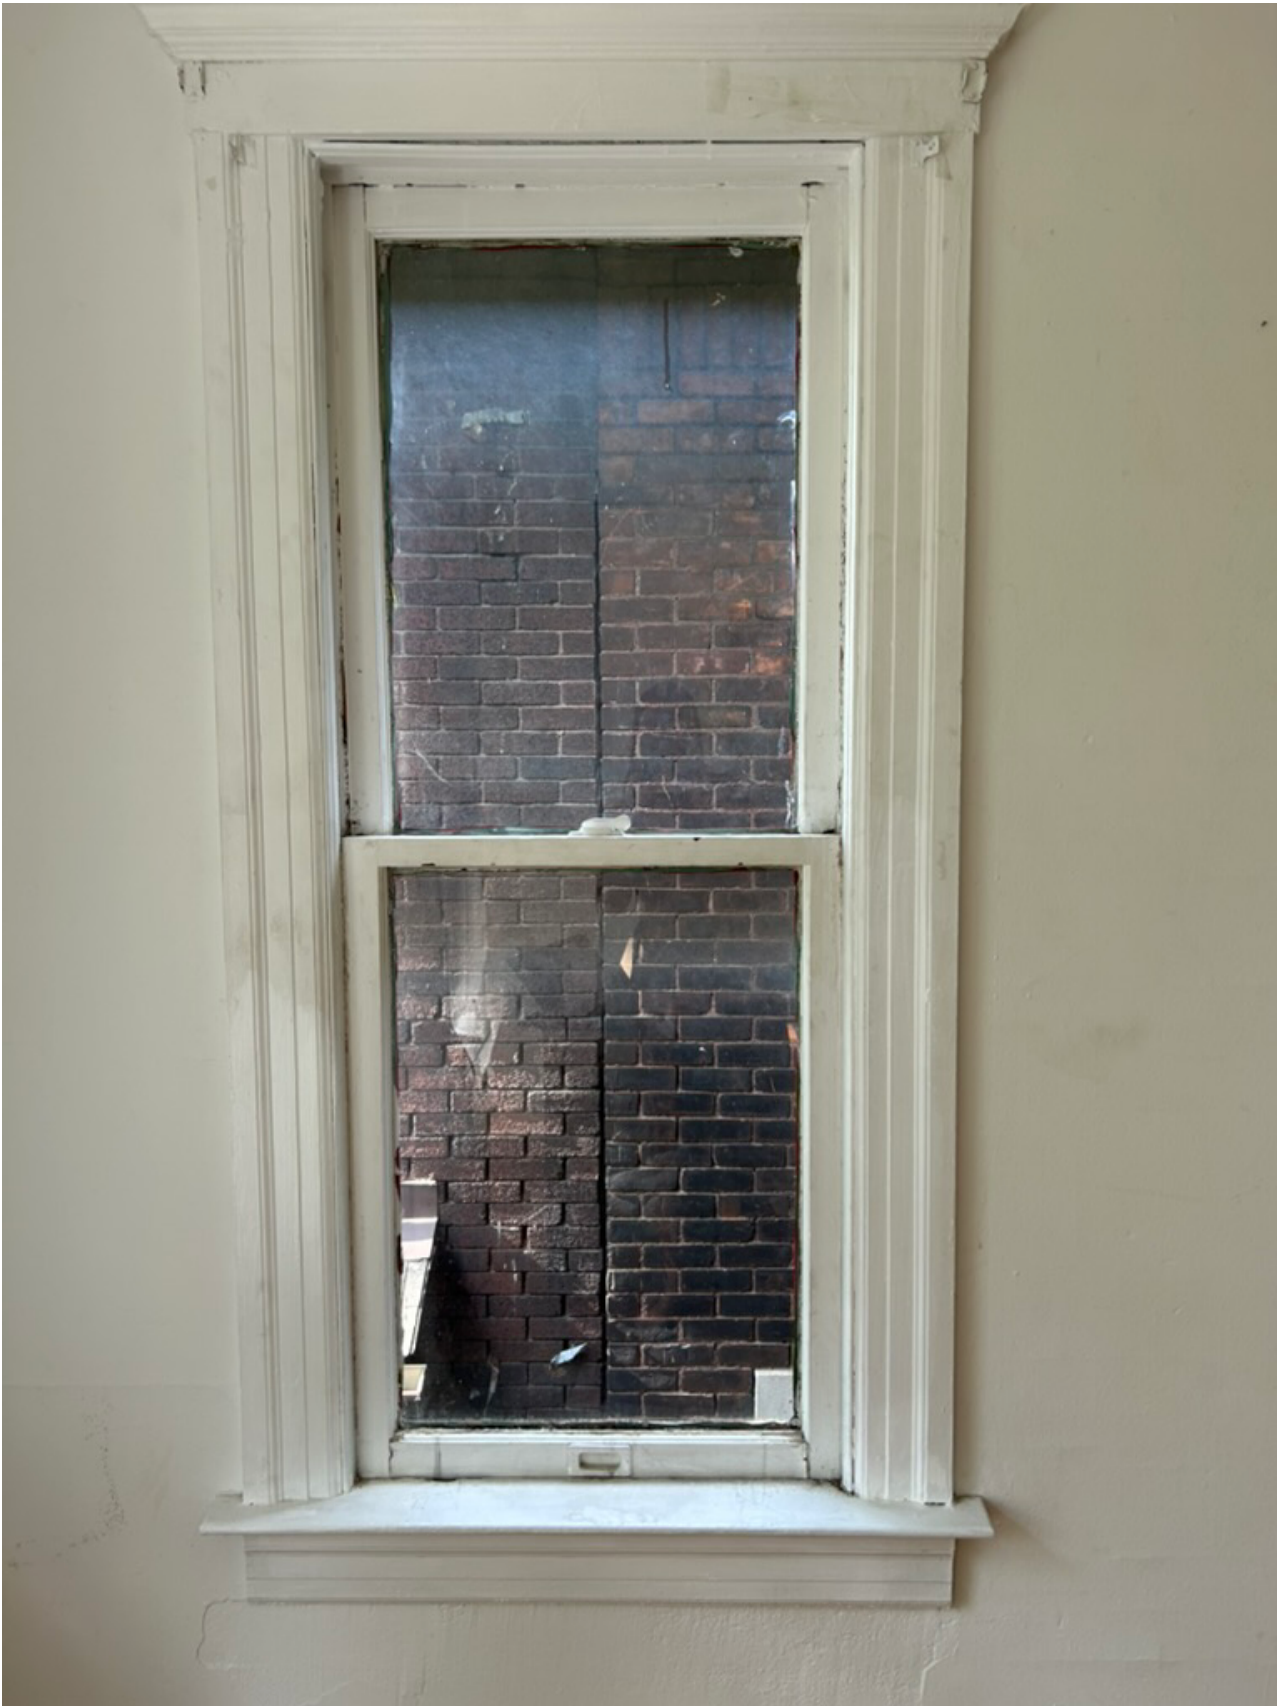
Below: Living room (north). On this window, we see separation on the stops on the top of the frame, and serious damage to the rail-and-stile joints on the bottom from decades of unmanaged moisture from the non-insulated glass (condensation on the interior from dewpoint). Various other deterioration is evident.
