## 932 edison meeting

**APPLICATION NUMBER:** HDC2024-00609

**ADDRESS:** 932 EDISON

**Scope of Work:** • Replace existing windows • Rebuild the rear porch • Replace siding • Install a new pool  
FRONT SIDE OF HOUSE

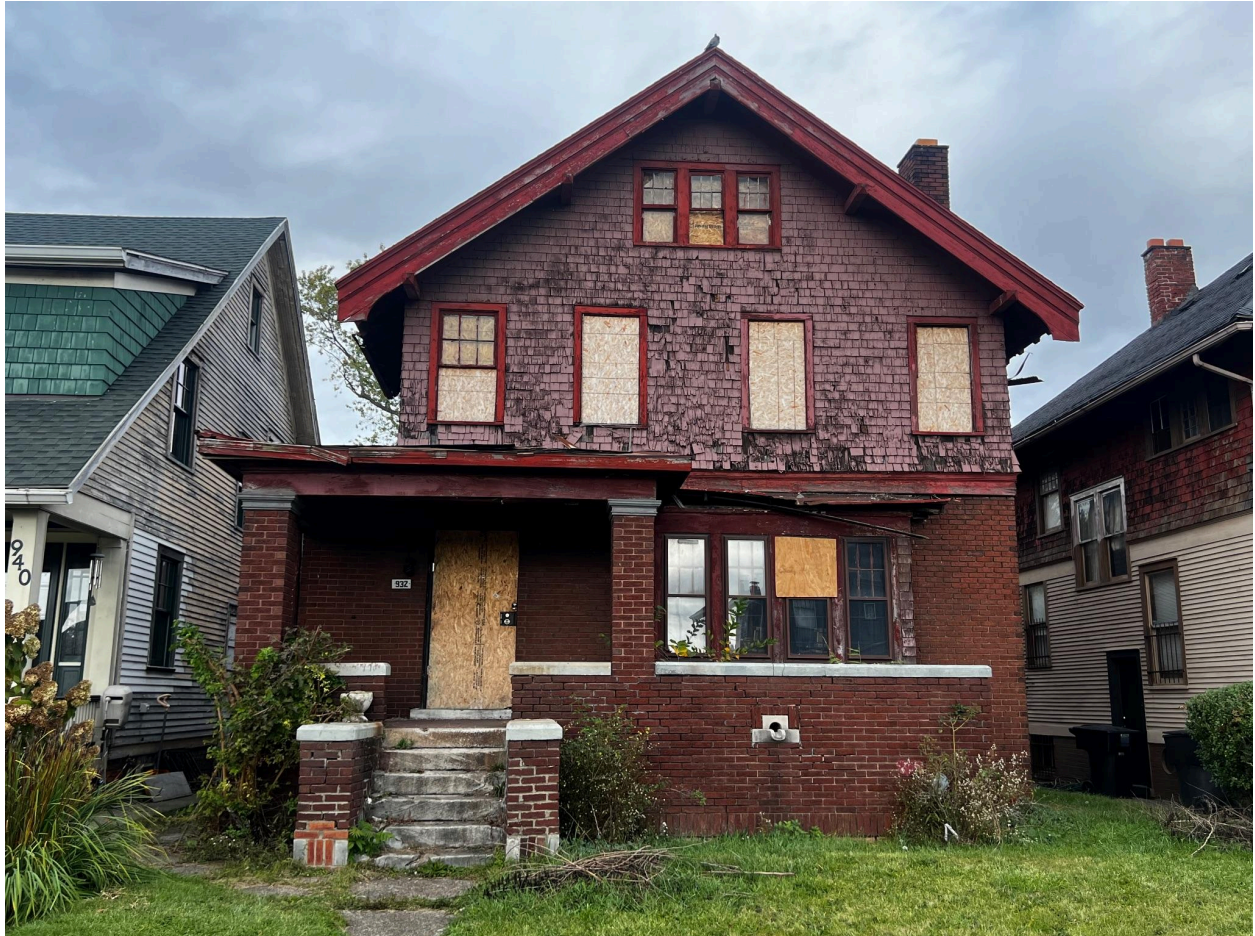
- **Attic Window:** Missing one lower sash.
  - **Second Floor Windows:** Missing three upper sashes and four lower sashes.
  - **First Floor Window:** Missing one upper sash.
  - **Fascia (Around Balcony and Bay Window):** Completely rotted.
  - **Soffit:** Extensively rotted and falling apart.
  - **Cedar Shake:** Damaged, rotted, missing, and falling down.
  - **Stairs:** Deteriorating and falling apart.
  - **Front Door:** Missing.

- **Balcony Roof:** Severely deteriorated and at risk of collapsing.
- Cause:** All issues appear to be due to prolonged water exposure.

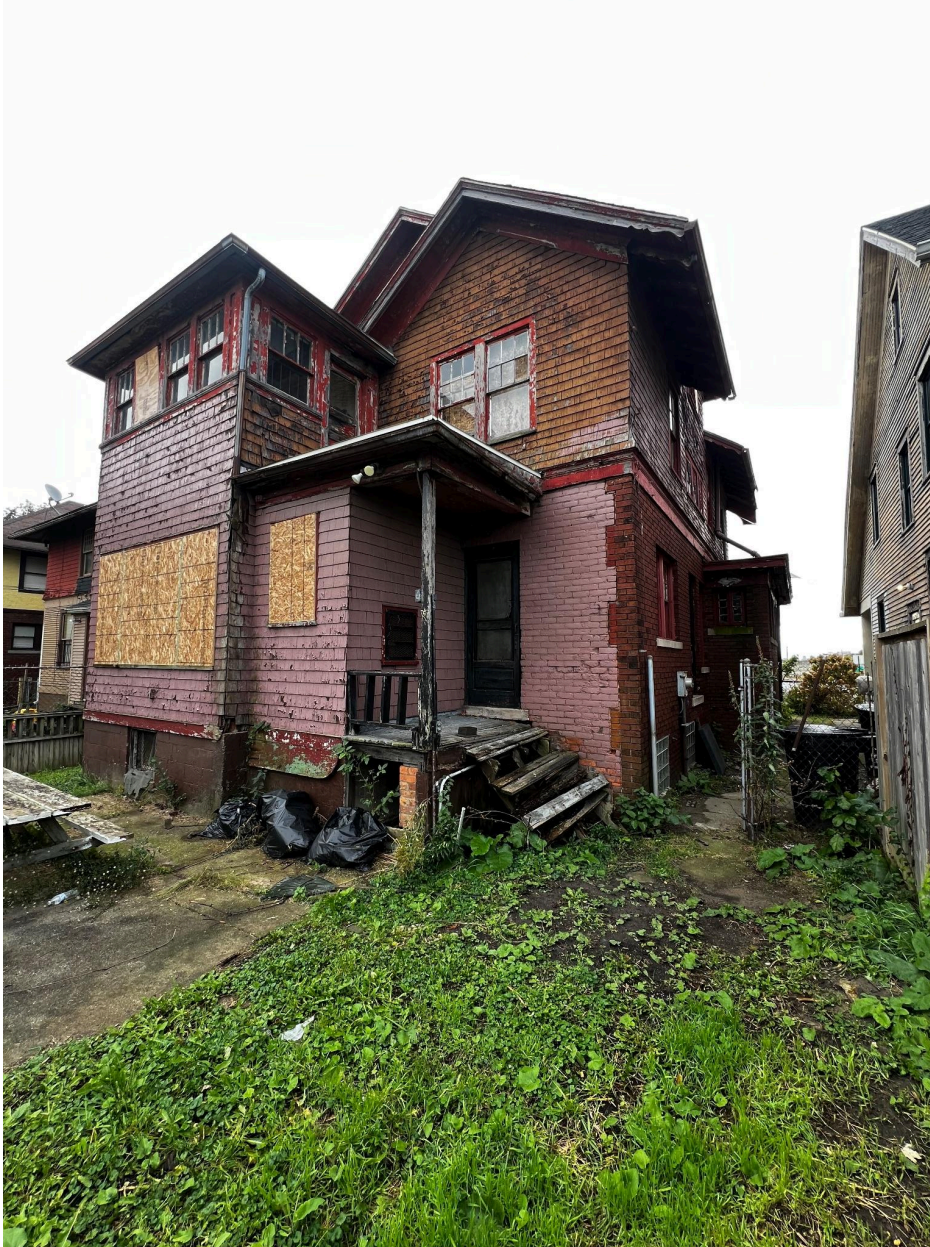
## REAR SIDE OF HOUSE

- Attic Window: Upper and lower sash missing.
- Second Floor Windows: Two lower sashes missing.
- First Floor Window: Upper and lower sash missing.
- Balcony Door: Damaged beyond repair.
- Cedar Shake Siding: Missing, rotted, and deteriorating.
- Second Floor Balcony: Rotted and collapsing.
- Back Porch: Collapsed; wood is rotted beyond repair.
- Basement Window: Missing.
- Gutters: Missing.

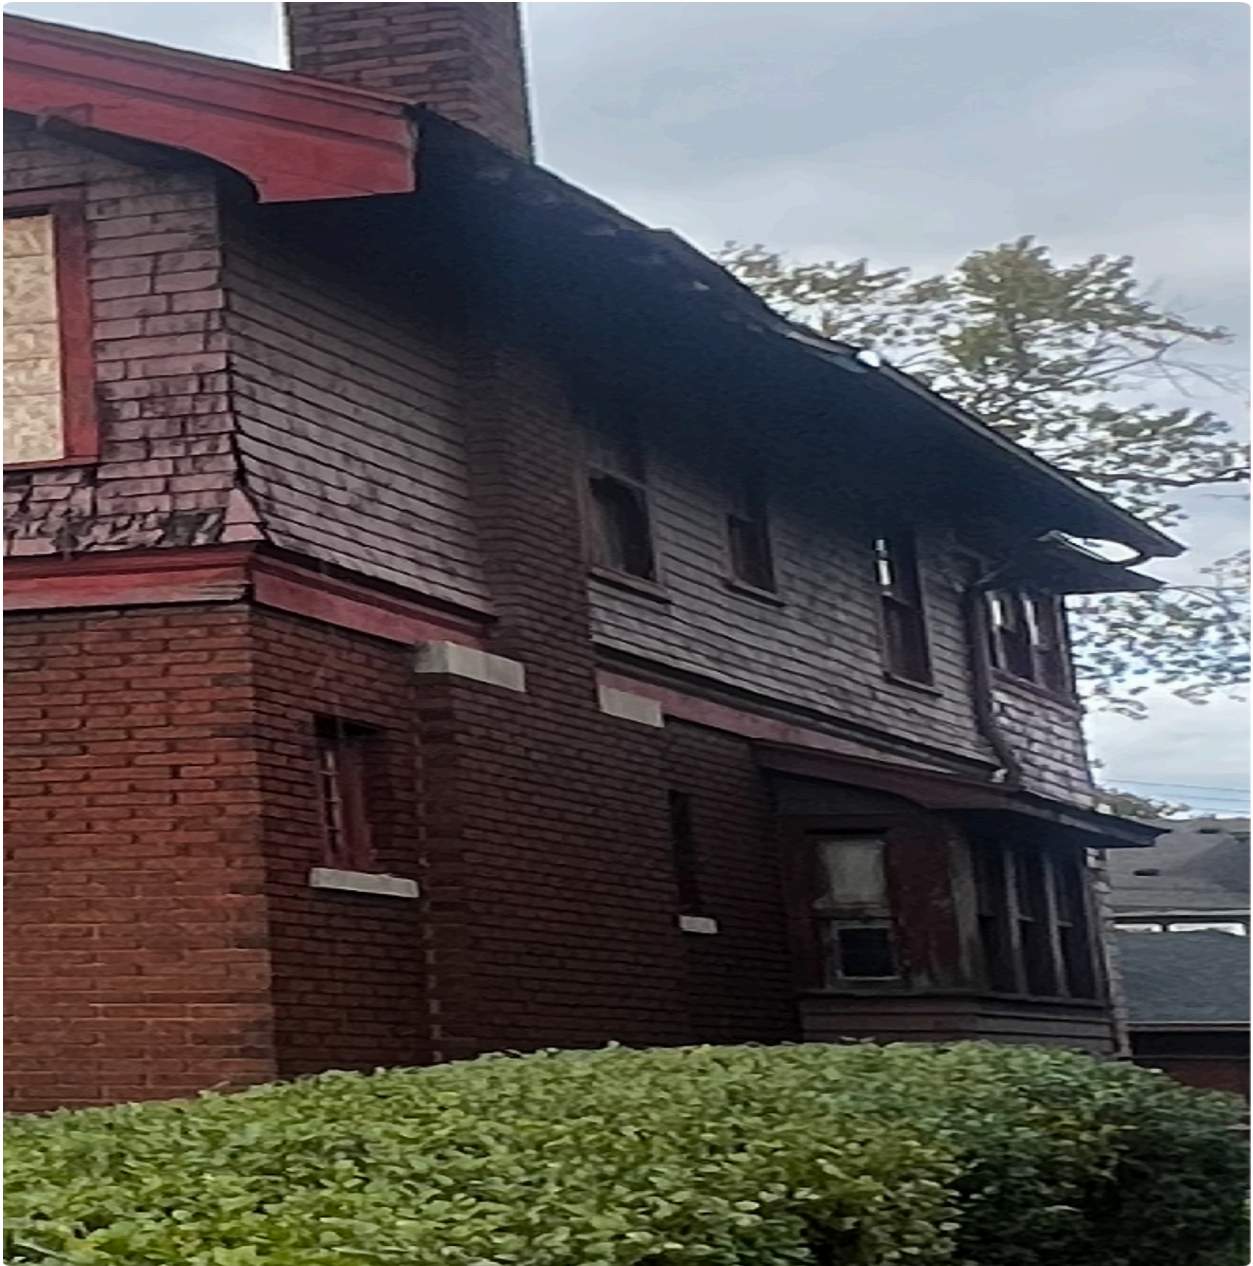
## RIGHT SIDE OF HOUSE

- **Second Floor Windows:** Four lower sashes are missing.
- **First Floor Windows:** Three lower sashes are broken.
- **Facia Boards and Gutters:** Hanging, needs reattachment or replacement.
- **Cedar Shake Siding:** Rotted, needs repair or replacement.
- **Mortar:** Cracking and missing throughout the first floor.

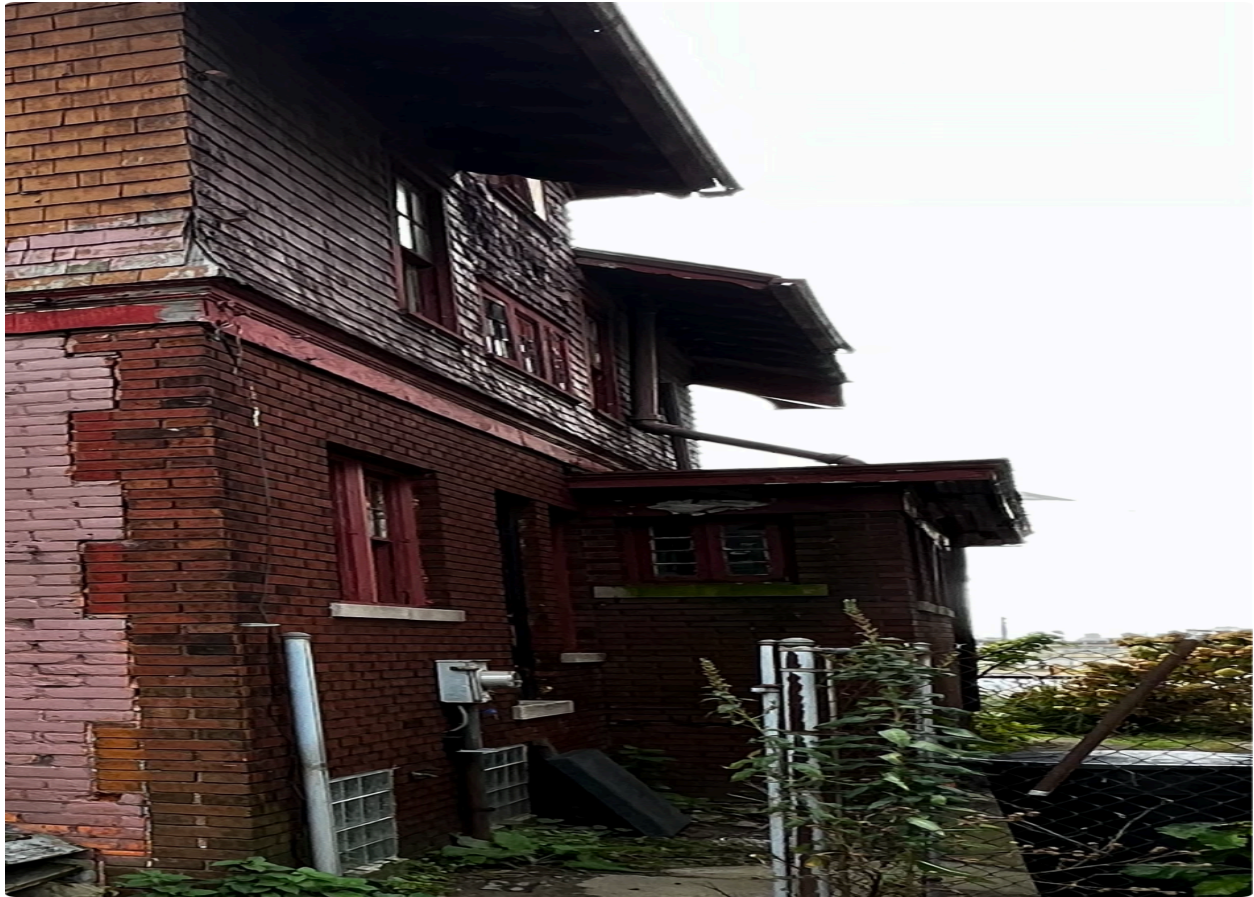
LEFT SIDE OF HOUSE

- Missing attic center casement window
- Second-floor lower sash missing
- Fascia and gutters are falling/rotted
- Balcony roof is caving in
- Porch is missing
- Cedar shake siding is missing and partially rotted

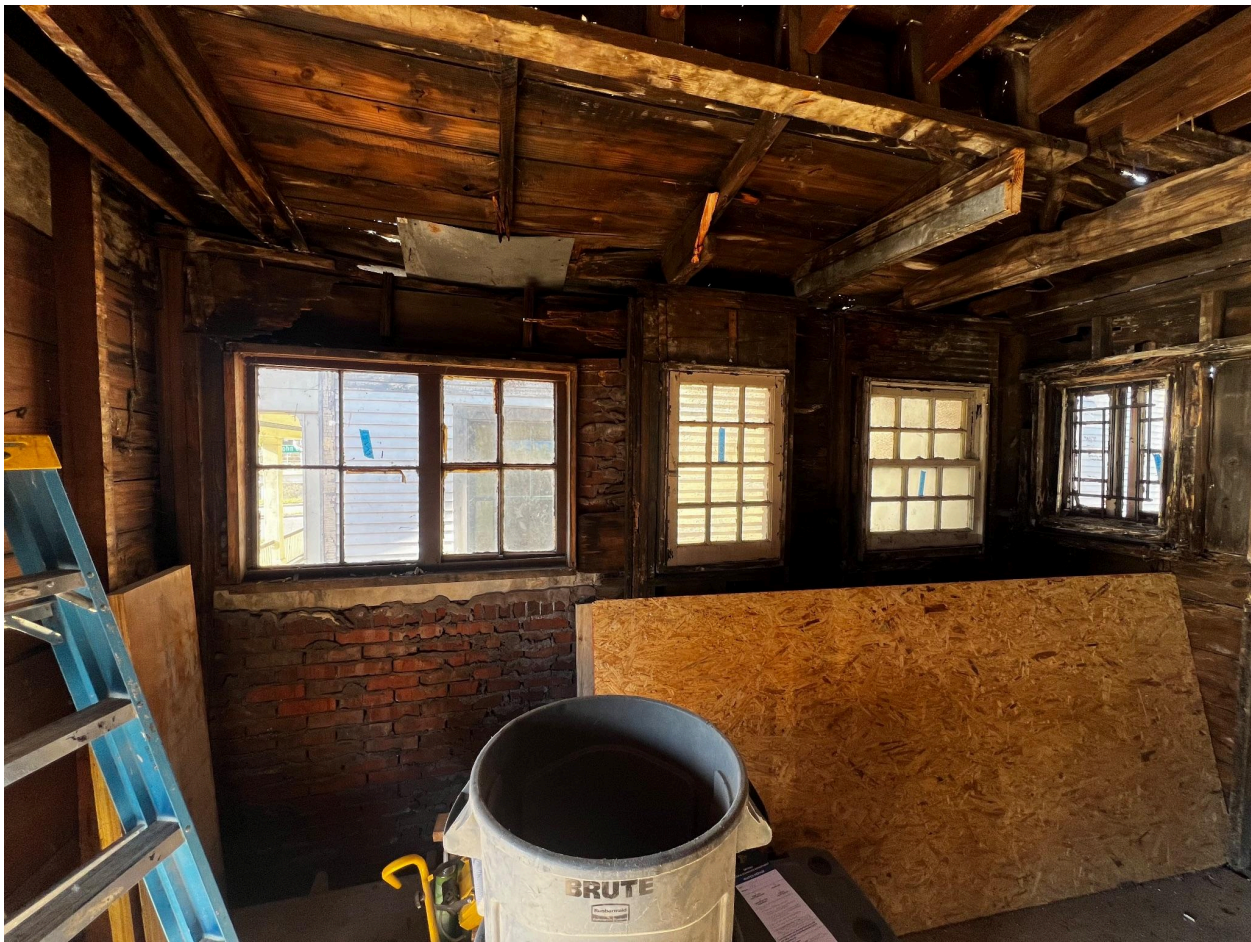
Foyer (UNDER PORCH BALCONY)

- Roof structure is collapsing and sagging.
- Constructed with undersized 2x4 lumber.
- Load-bearing exterior wall is directly resting on inadequate lumber.
- Water rot is present, further weakening the structure.
- Structural integrity compromised due to incorrect lumber sizing and moisture damage.

Front porch balcony Fascia soffit and roof replacement

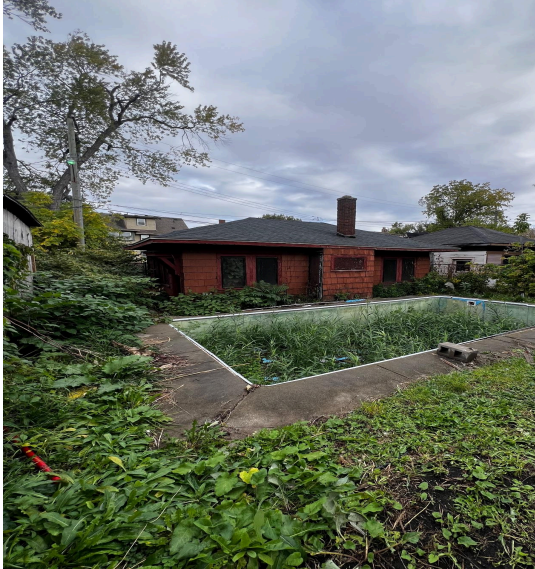
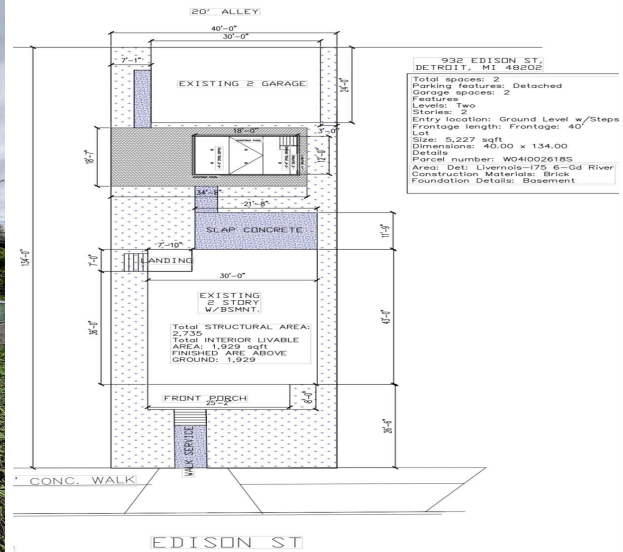
## Swimming pool

The existing pool is currently inoperable, with its waterline completely gone and concrete walls deteriorating and showing signs of structural failure. We propose reducing the pool size to 12'x18' to allow for a safe and accessible pathway to the garage. This adjustment will enhance both safety and functionality for the property.
