**RE: 19566 Canterbury
Detroit, MI
Formal Proposal**

Based on the inspection at 19566 Canterbury Road in Detroit, MI, more than 65% of the windows at the residence are **not** repairable due to the fact that we are unable to get the parts. My recommendation is to replace the windows with Quaker Historic.

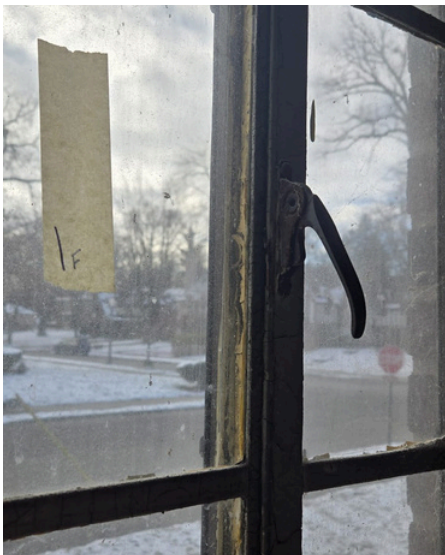
Window Number: 1F

Broken Panes: None

Operational: Yes

Hardware Condition: Operable

Notes: Window is functional and hardware is operation.

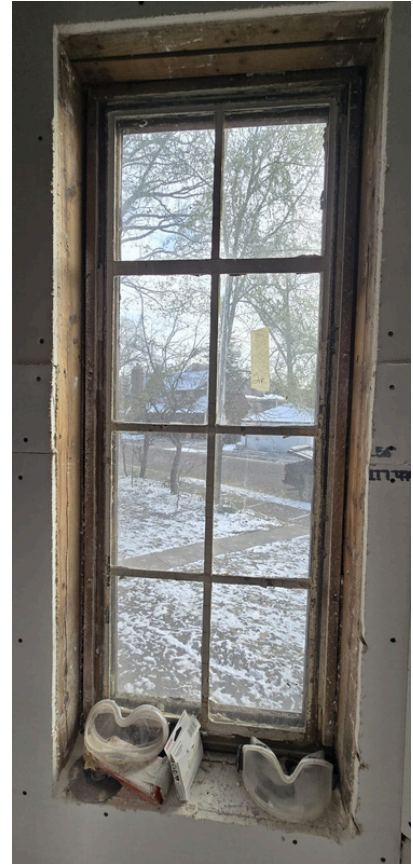
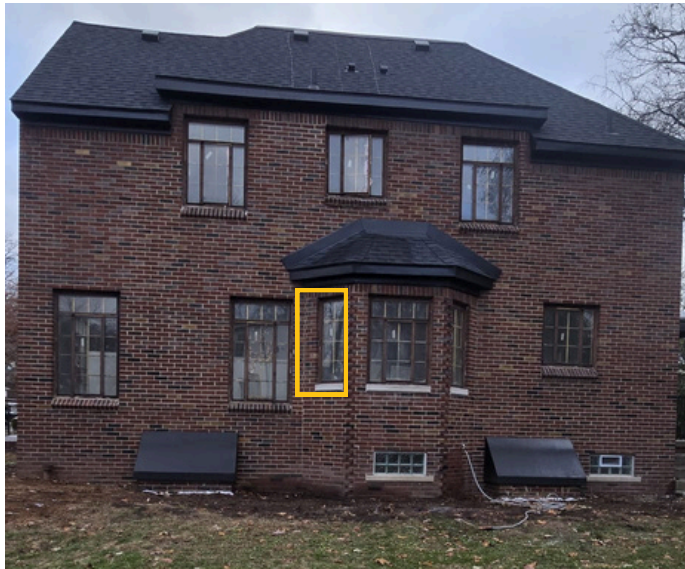
Window Number: 2F

Broken Panes: None

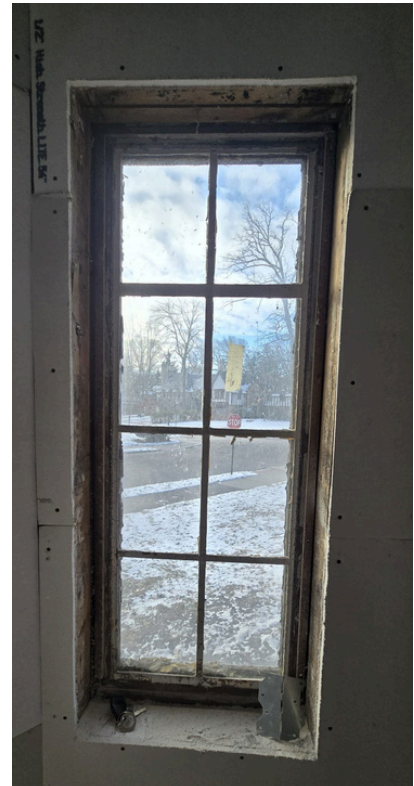
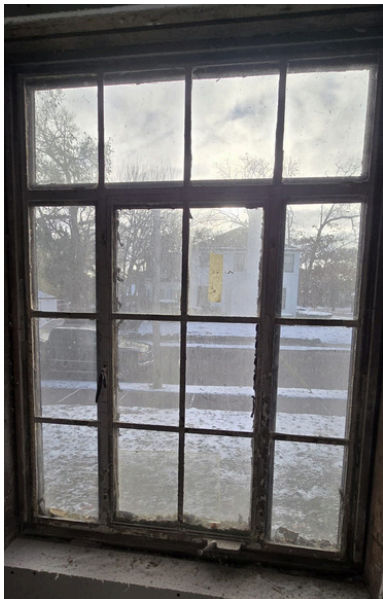
Window Number: 4F

Broken Panes: None

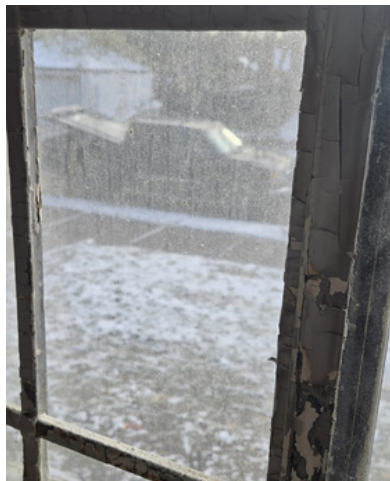
Window Number: 3F

Broken Panes: One Has Fallen Out but intact

Operational: Closes only when pushed from the outside.

Hardware Condition: Handle is broken

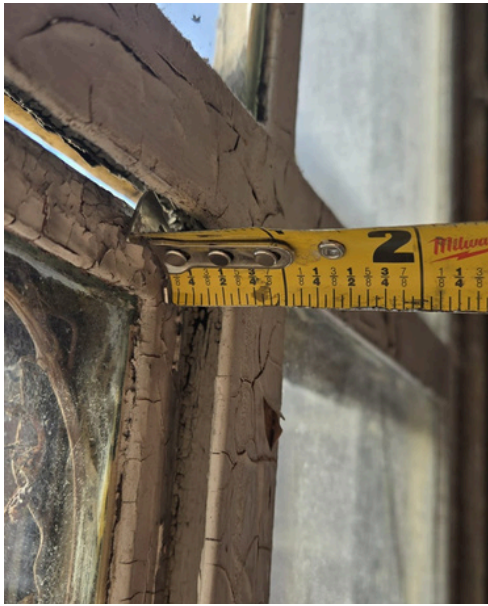
Window Number: 5F

Broken Panes: One

Operational: Cannot Latch

Hardware Condition: Fair

Notes: Window frame has a deformation with a span differential of one 1/2 inch between the top and bottom of the frame.

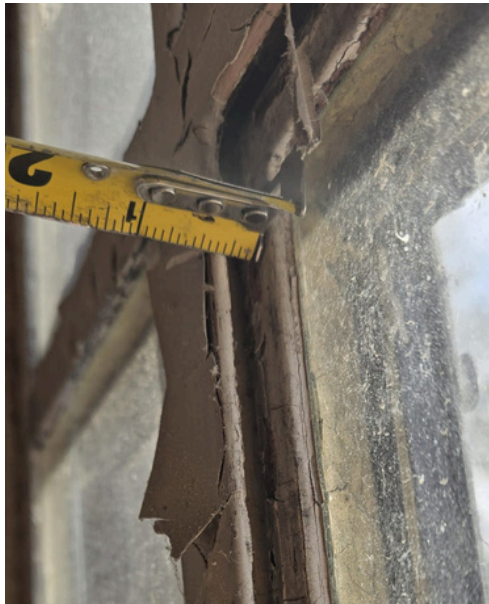
Window Number: 6F

Broken Panes: One

Operational: Latch is Bent but Operable

Hardware Condition: Bent

Notes: Window frame has a deformation with a span differential of one 1/4 inch between the top and bottom of the frame.

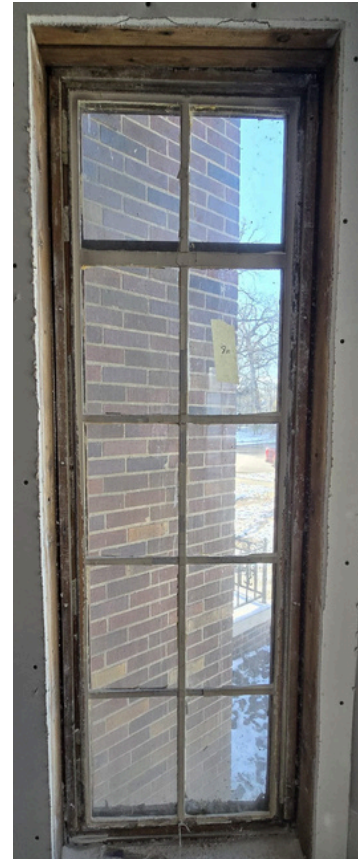
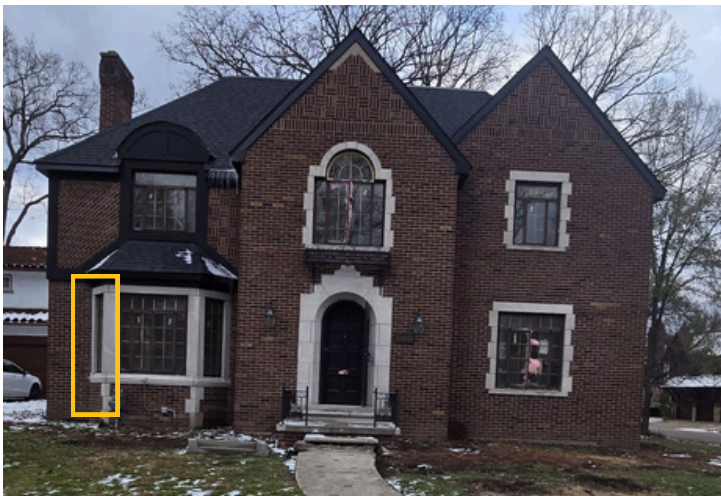
Window Number: 8F

Window Location: Living Room Broken Panes: None

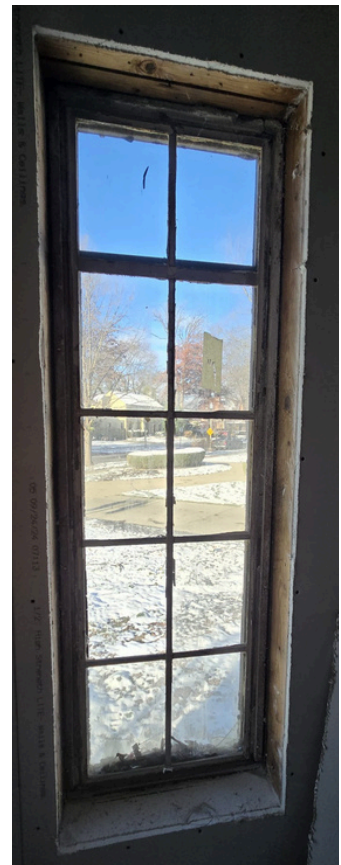
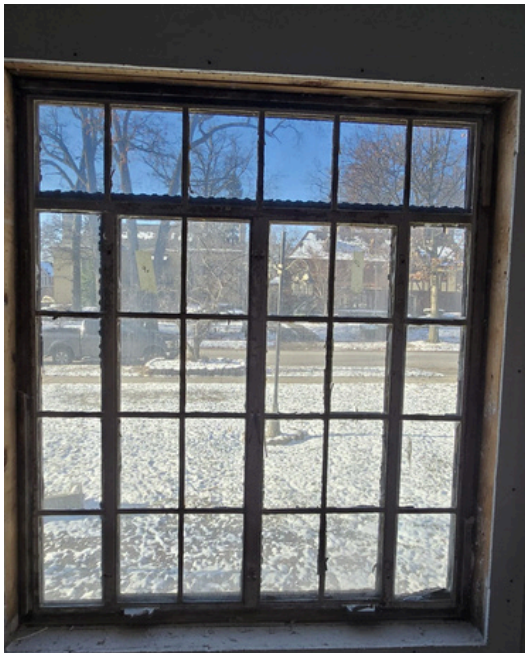
Window Number: 10F

Window Location: Living Room Broken Panes: One

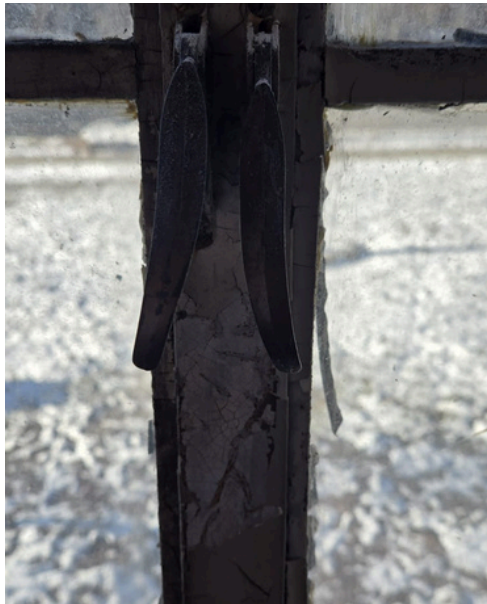
Window Number: 9&10F

Broken Panes: One

Operational: Latch is Severely Bent

Hardware Condition: Bent

Notes: Window frame has a deformation with a span differential of $\frac{3}{8}$ inch between the top and bottom of the frame.

The Left side cannot latch even with outside pressure applied. The right side does latch with outside pressure applied.

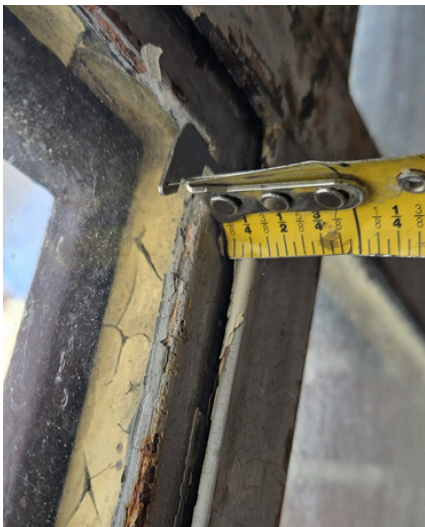
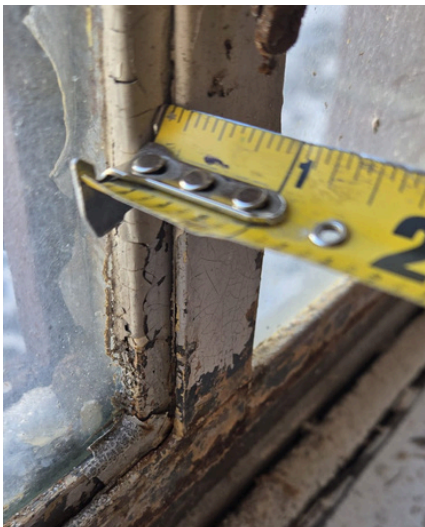
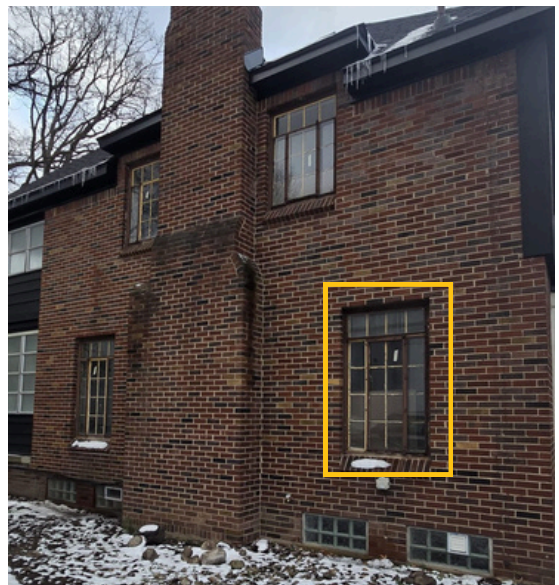
Window Number: 12F

Operational: Will Latch

Hardware Condition: Operable

Notes: Window frame has a slight deformation of 1/8 inch between the top and bottom.

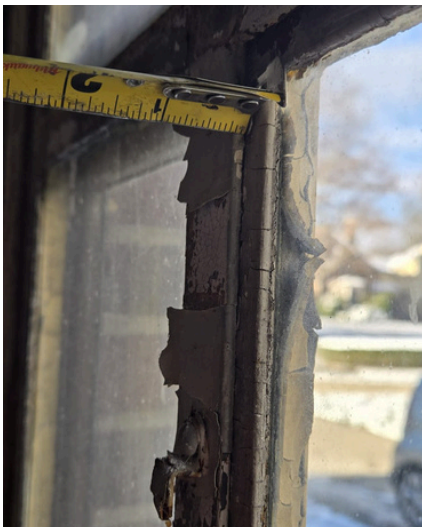
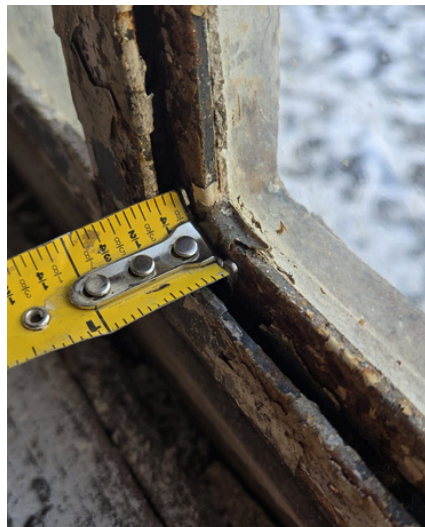
Window Number: 13F

Operational: Closes only with outside pressure applied

Hardware Condition: Bent and Latches only with extreme force applied

Notes: Window frame has a deformation with a span differential of 1/4 inch between the top and bottom of the frame.

The window frame is also bowed by almost 3/8 of an inch.

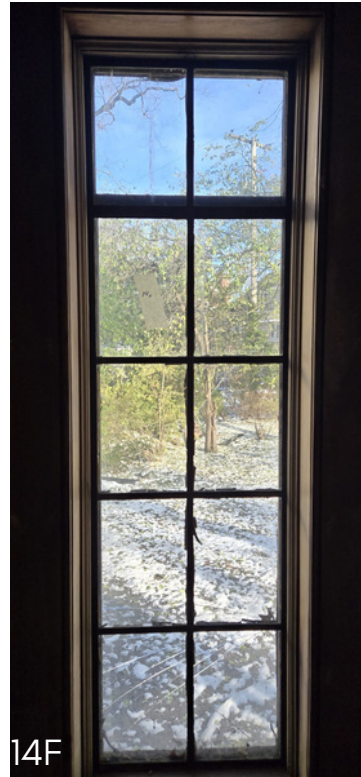
14F

Broken Panes: None

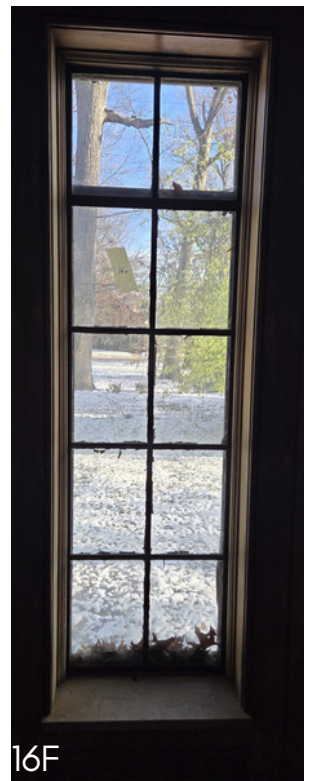
16F

Broken Panes: None

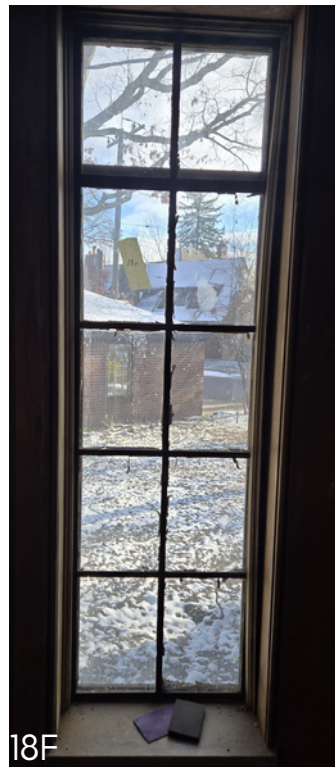
18F

Broken Panes: None

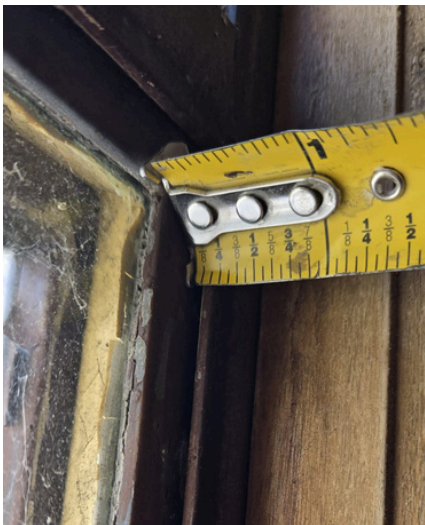
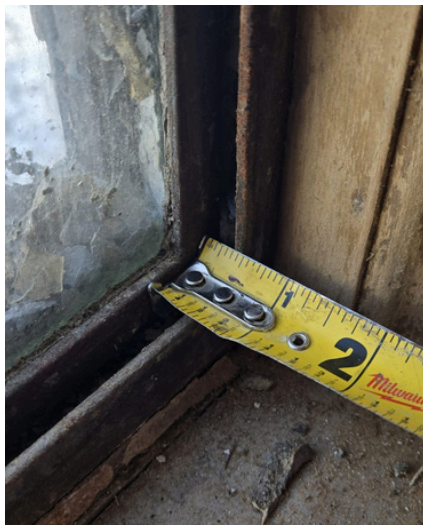
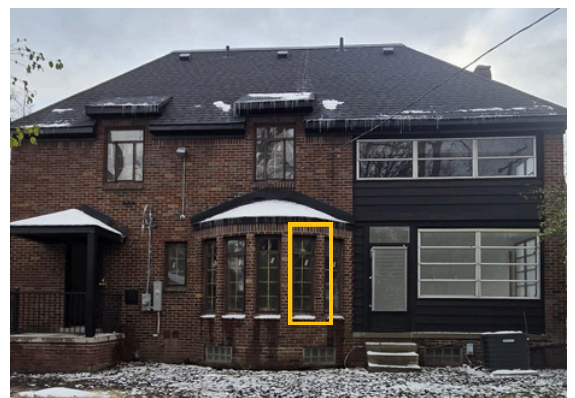
Window Number: 15F

Operational: Closes only with outside pressure applied

Hardware Condition: Bent and Latches only with extreme force applied

Notes: Window frame has a deformation with a span differential of $\frac{3}{8}$ inch between the top and bottom of the frame.

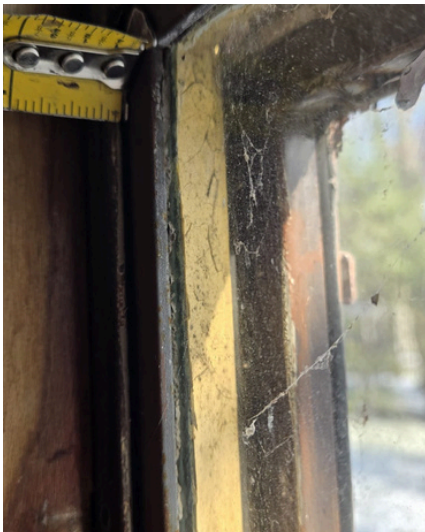
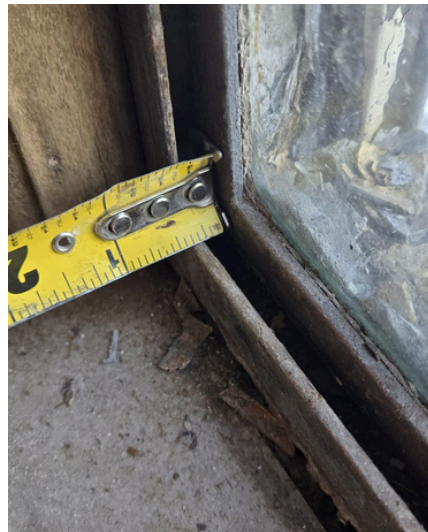
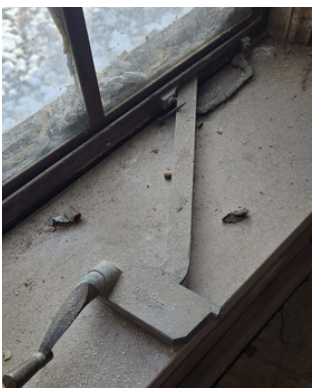
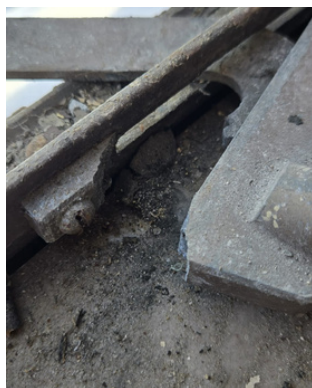
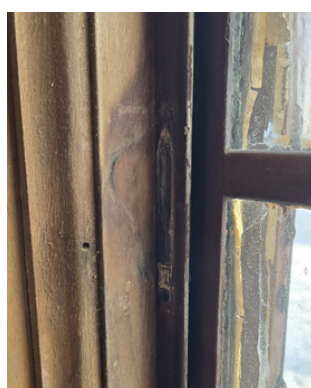
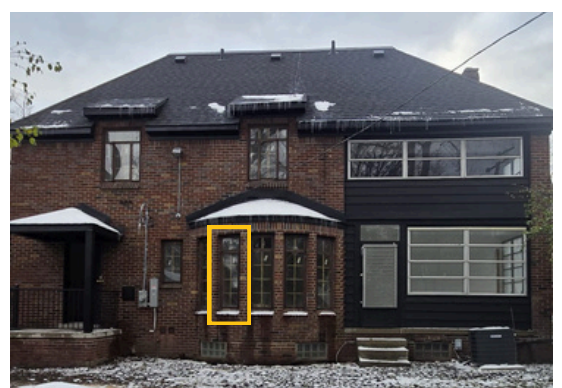
Window Number: 17F

Operational: Closes only with outside pressure applied

Hardware Condition: Latch is missing. Hardware is bent and broken.

Notes: Window frame has a deformation with a span differential of over 1/4 inch between the top and bottom of the frame. Gap is present even when pressure is applied from the outside to close the window.

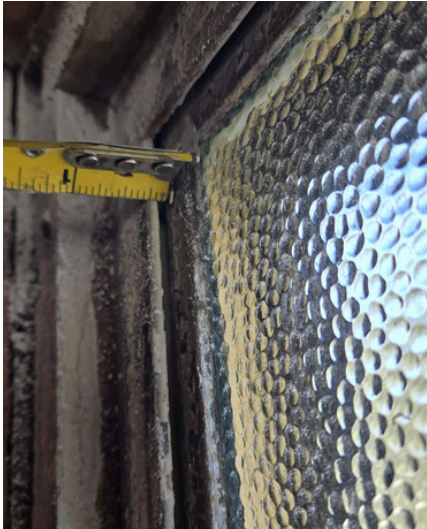
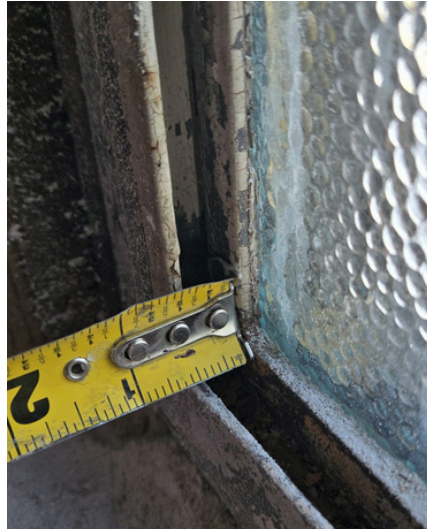
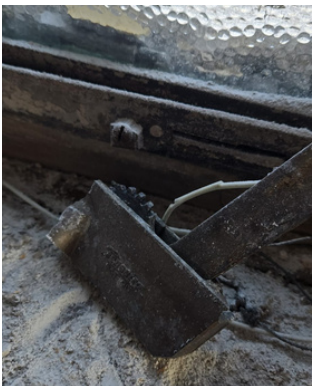
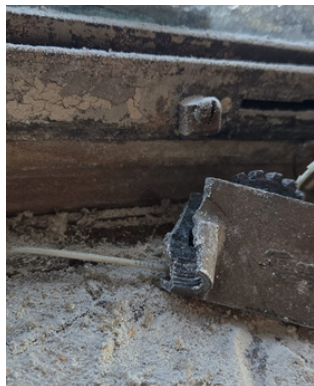
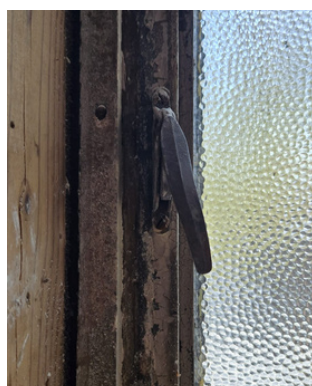
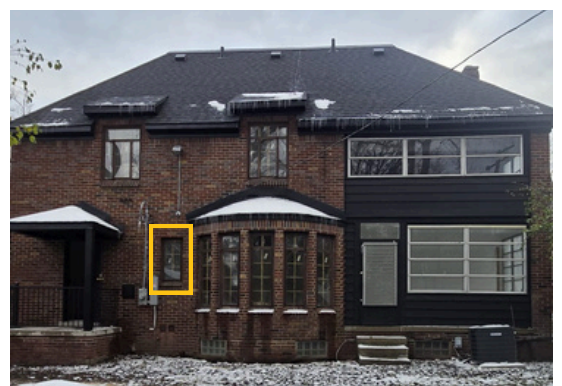
Window Number: 19F

Operational: Does not latch

Hardware Condition: Broken in multiple places

Notes: Window frame has a deformation with a span differential of one 1/2 inch between the top and bottom of the frame.

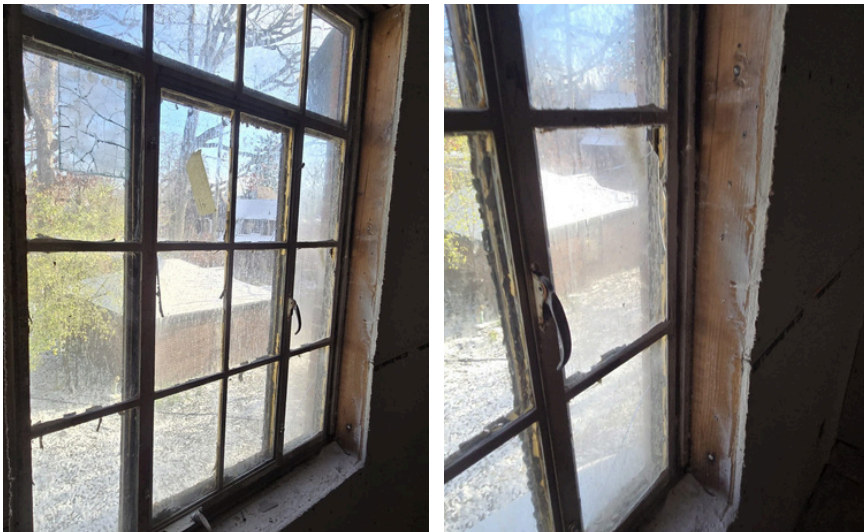
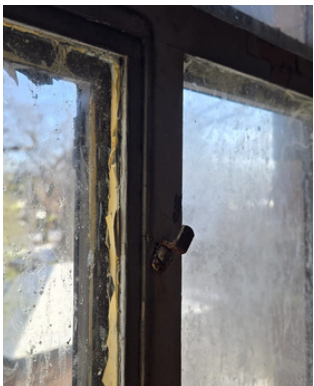
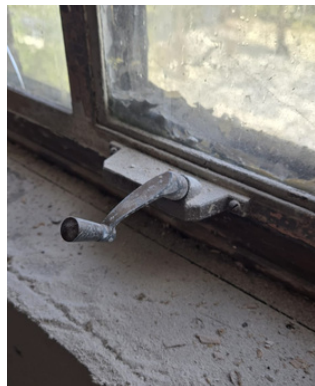
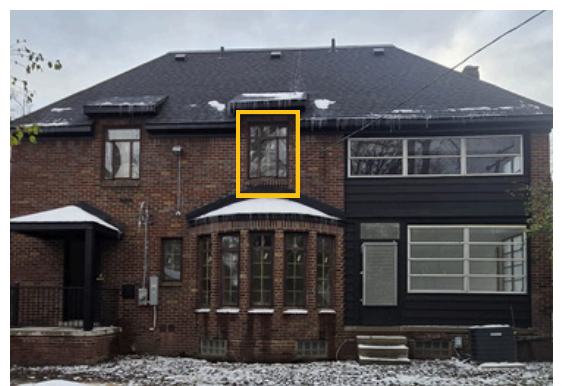
Window Number: 1S

Broken Panes: Two

Operational: Window closes and latches as intended

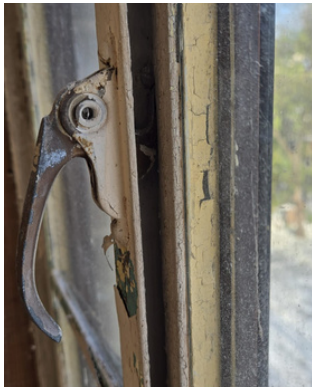
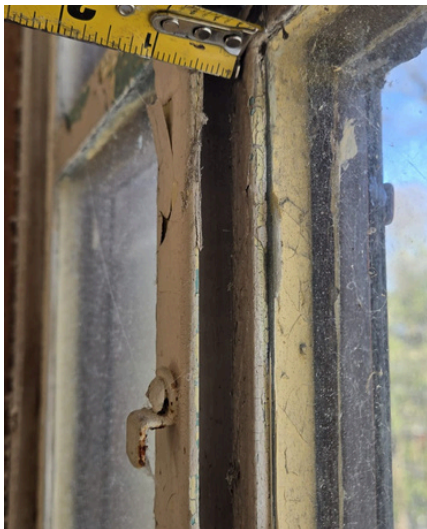
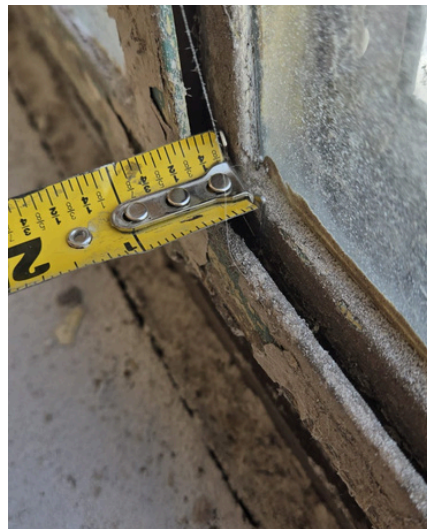
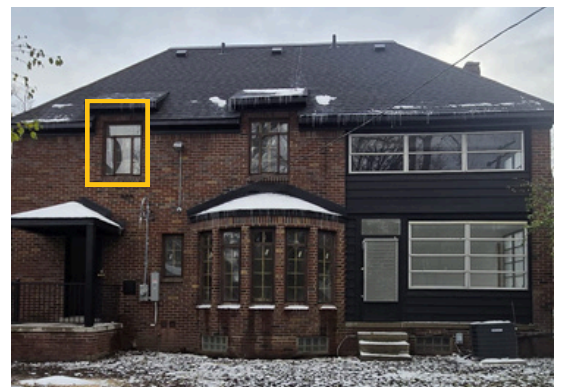
Window Number: 2S

Broken Panes: One

Operational: Window does not Latch

Notes: Window frame has a deformation with a span differential of just under 1/4 inch between the top and bottom of the frame.

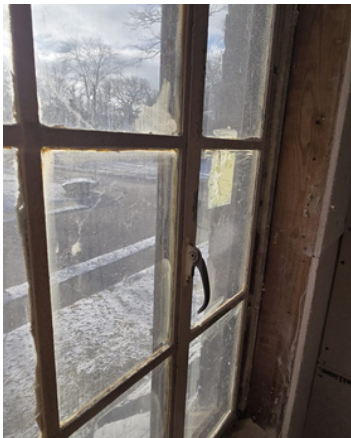
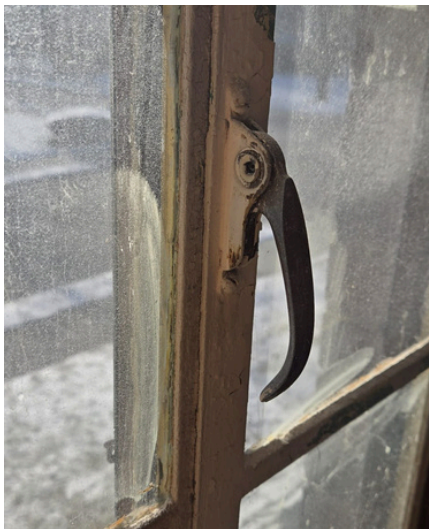
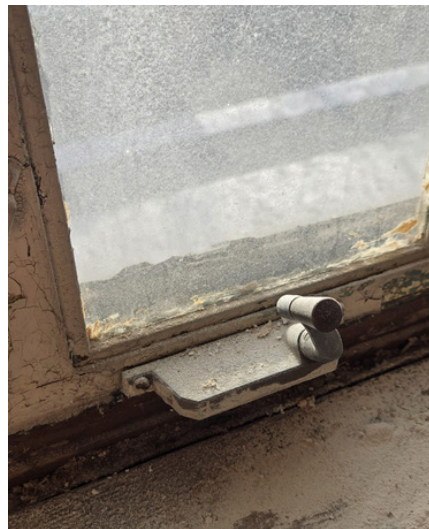
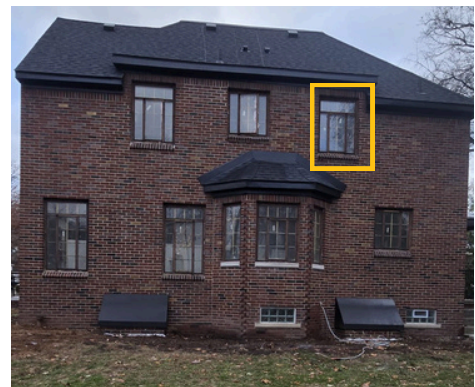
Window Number: 3S

Operational: Window closes and latches as intended.

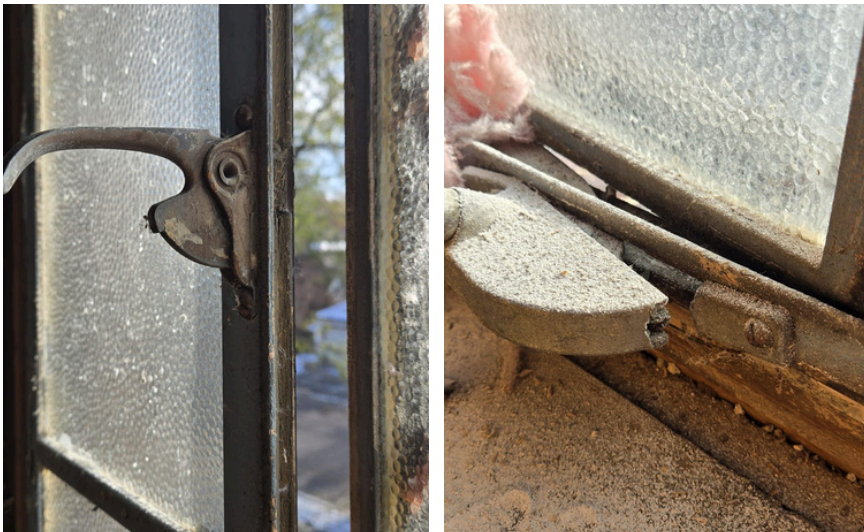
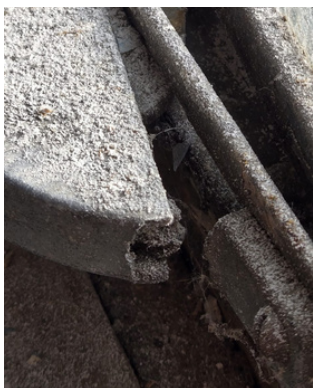
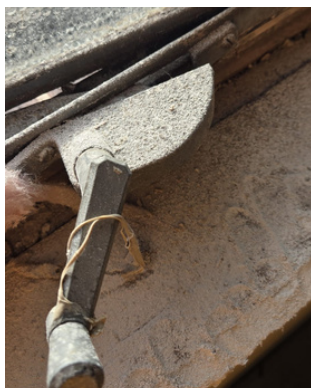
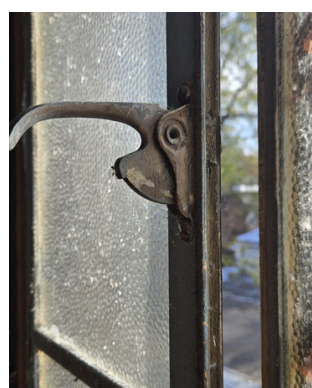
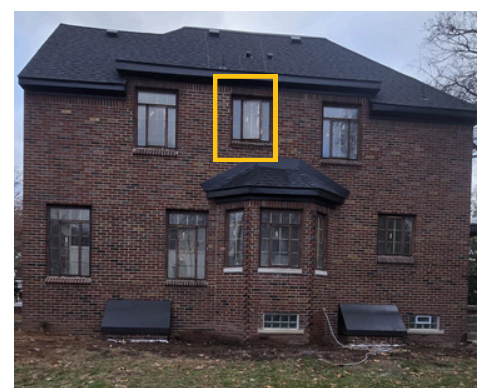
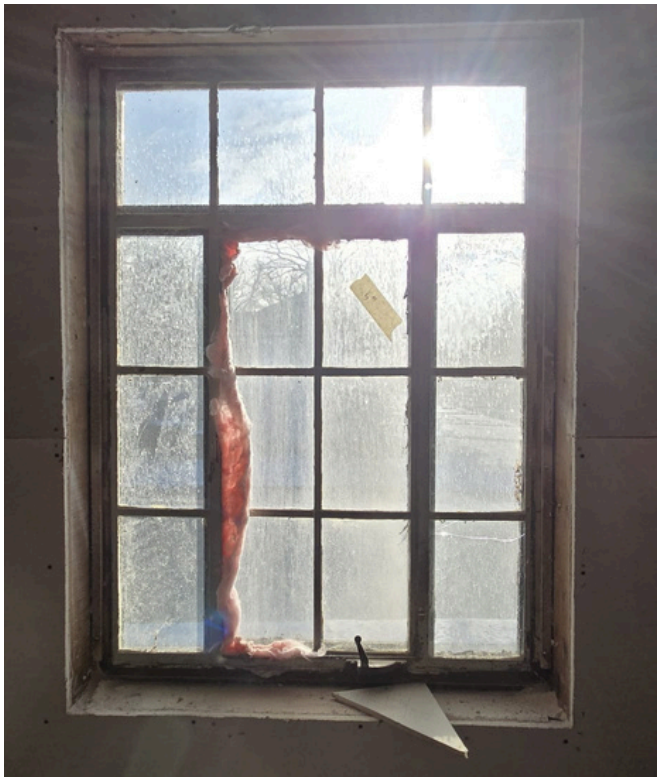
Window Number: 4S

Operational: Windows will not close completely, even with outside pressure pulling the window in.

Hardware Condition: Broken and missing pieces

Notes: Window cannot be secured due to broken hardware.

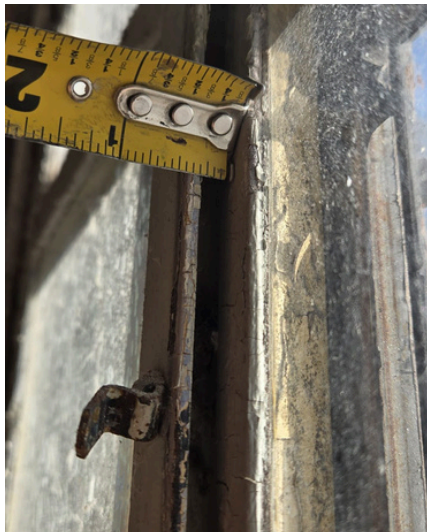
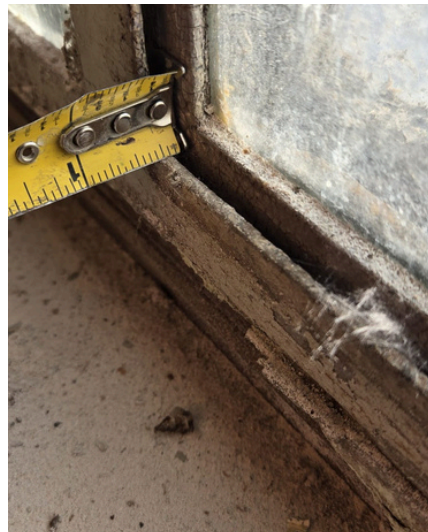
Window Number: 5S

Broken Panes: One

Operational: Windows will not close completely and cannot latch

Hardware Condition: Broken, unable to close.

Notes: Window frame has a deformation with a span differential of just under $\frac{3}{8}$ inch between the top and bottom of the frame.

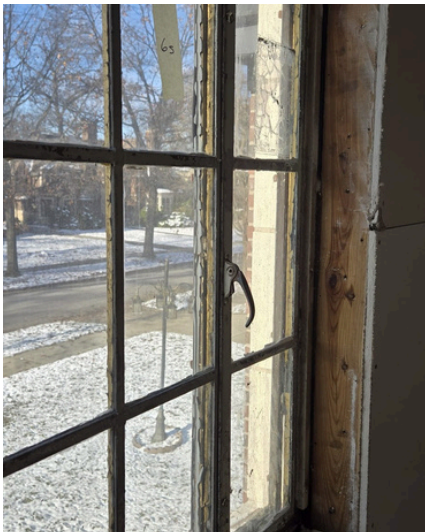
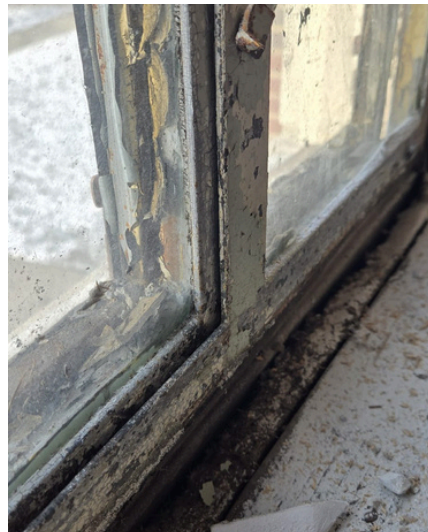
Window Number: 6S

Notes: Even though the window operates as intended, the frame still shows signs of neglect with a larger gap at the bottom than at the top.

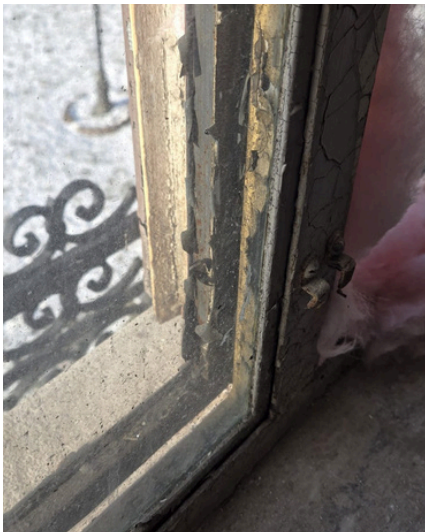
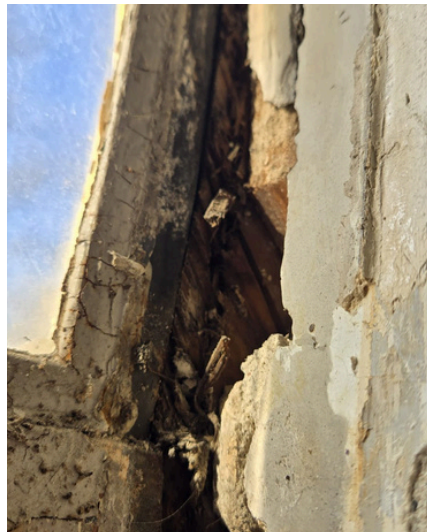
Window Number: 7S

Broken Panes: One

Operational: Left side of window closes and latches as intended. The right side of the window is unable to close completely, even with outside pressure.

Hardware Condition: Left side operational and Right side broken

Notes: Brick Molding on both sides of the window is actively wet and breaking apart.

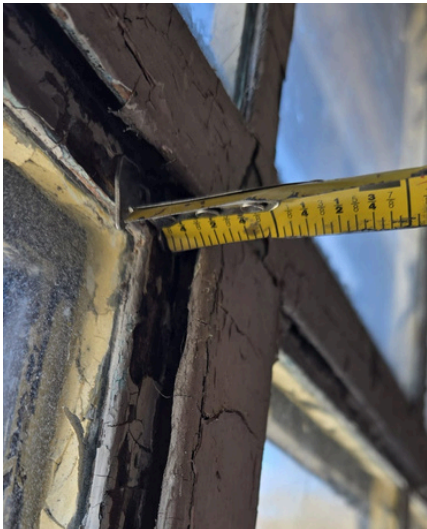
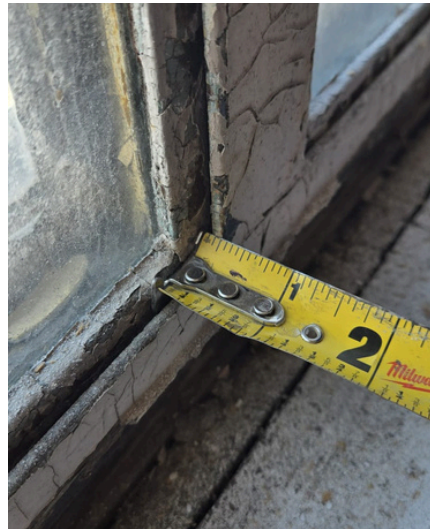
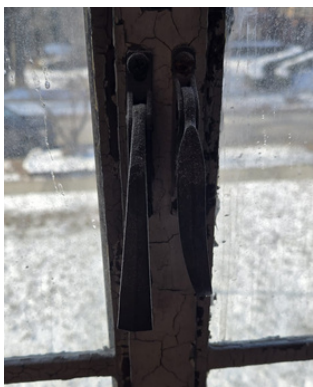
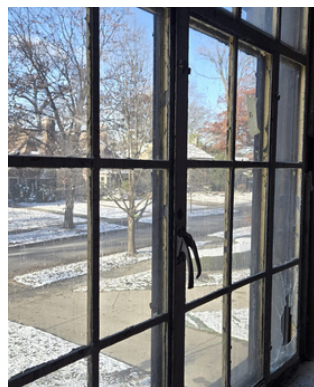
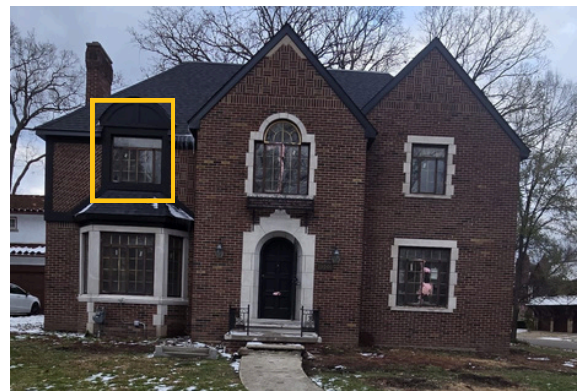
Window Number: 8S

Broken Panes: One

Operational: Left side has a significant gap and the right side closes as intended

Hardware Condition: Left is Broken and the Right side is operational.

Notes: hardware has been replaced and does not match.

Window frame has a deformation with a span differential of just under 3/8 inch between the top and bottom of the frame.

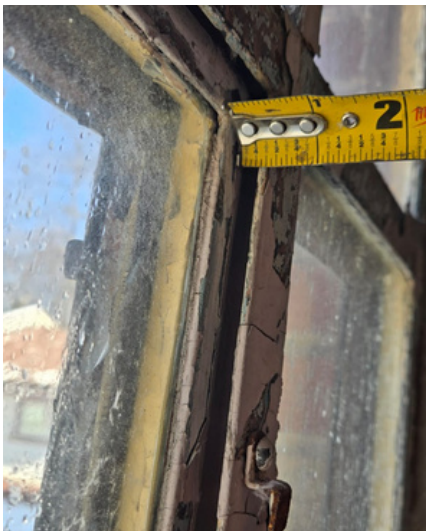
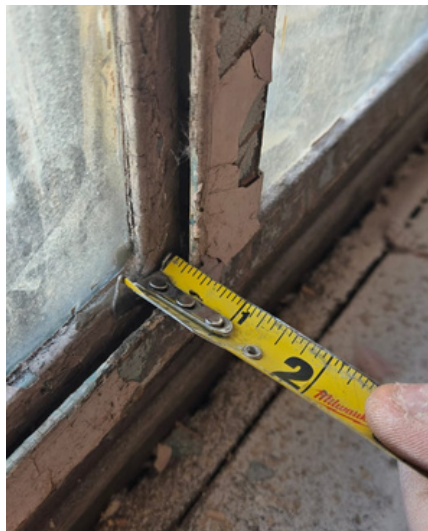
Window Number: 9S

Operational: Will open but will not close without assistance and does not latch

Hardware Condition: Mechanism arm is bent

Notes: Window frame has a deformation with a span differential of just under 1/4 inch between the top and bottom of the frame.

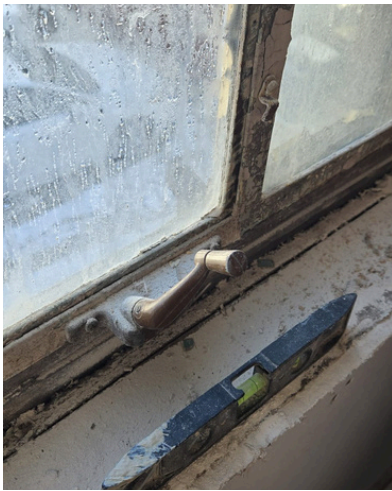
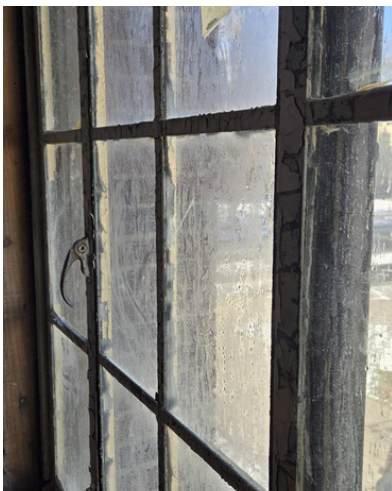
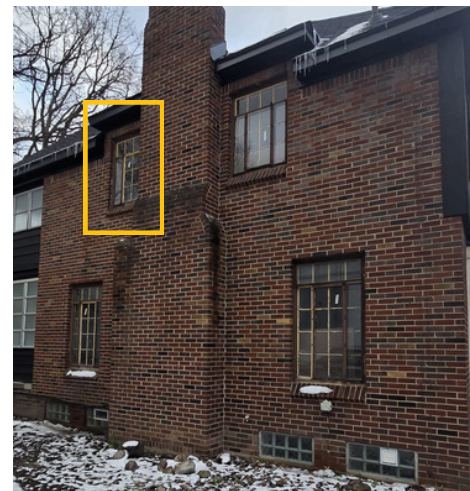
Window Number: 10S

Operational: Closes and Latches as
intended

Hardware Condition: Operational
