HISTORIC DISTRICT COMMISSION APPLICATION FOR WORK APPROVAL

APPLICATION ID
HDC2025-00014

ADDRESS(ES): 24293 Telegraph Road
HISTORIC DISTRICT: Russell Woods-Sullivan

Window & Siding Replacement

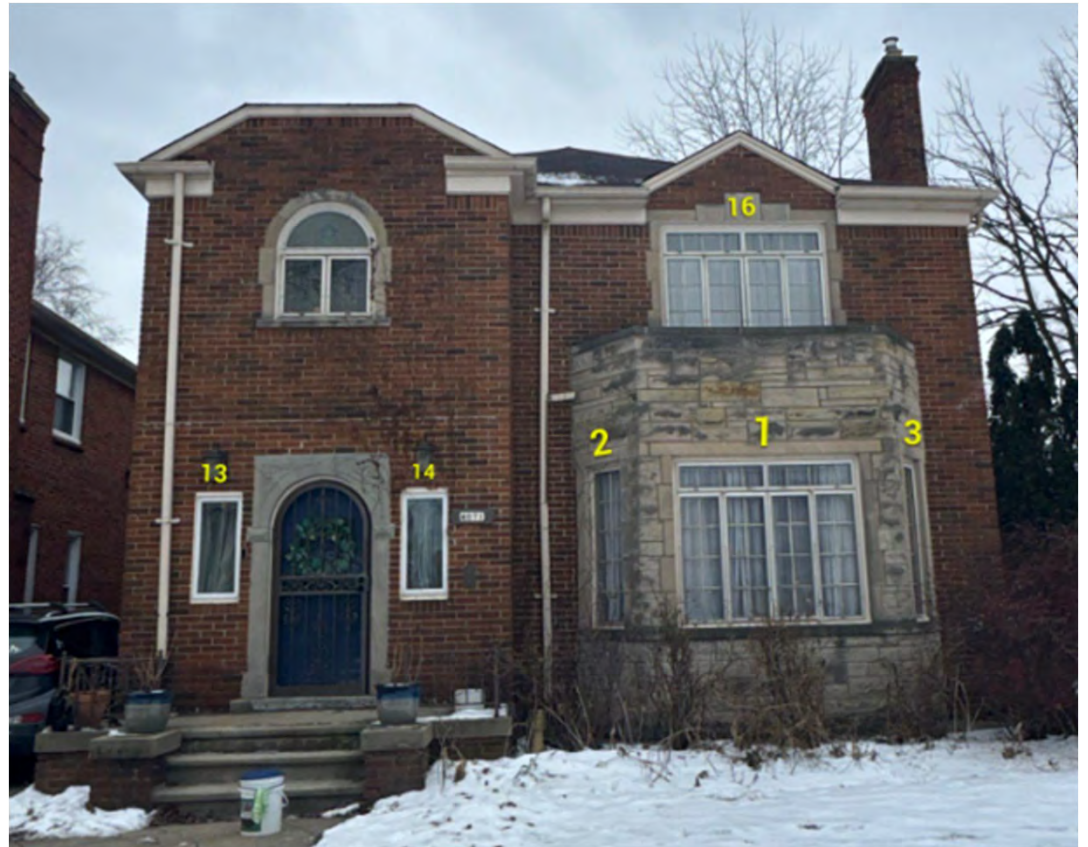
1- hardware and window rusted shut, inoperable. Fails to meet egress/code

2- Extreme structural damage from poor weatherproofing

3- Evidence of exterior wood rot, and evidence of mold

14- Vinyl: Not Historically Accurate

16- Master bedroom: substantial gaps in weather proofing, only one casement window opens due to hardware rusted shut, fails to meet egress/code

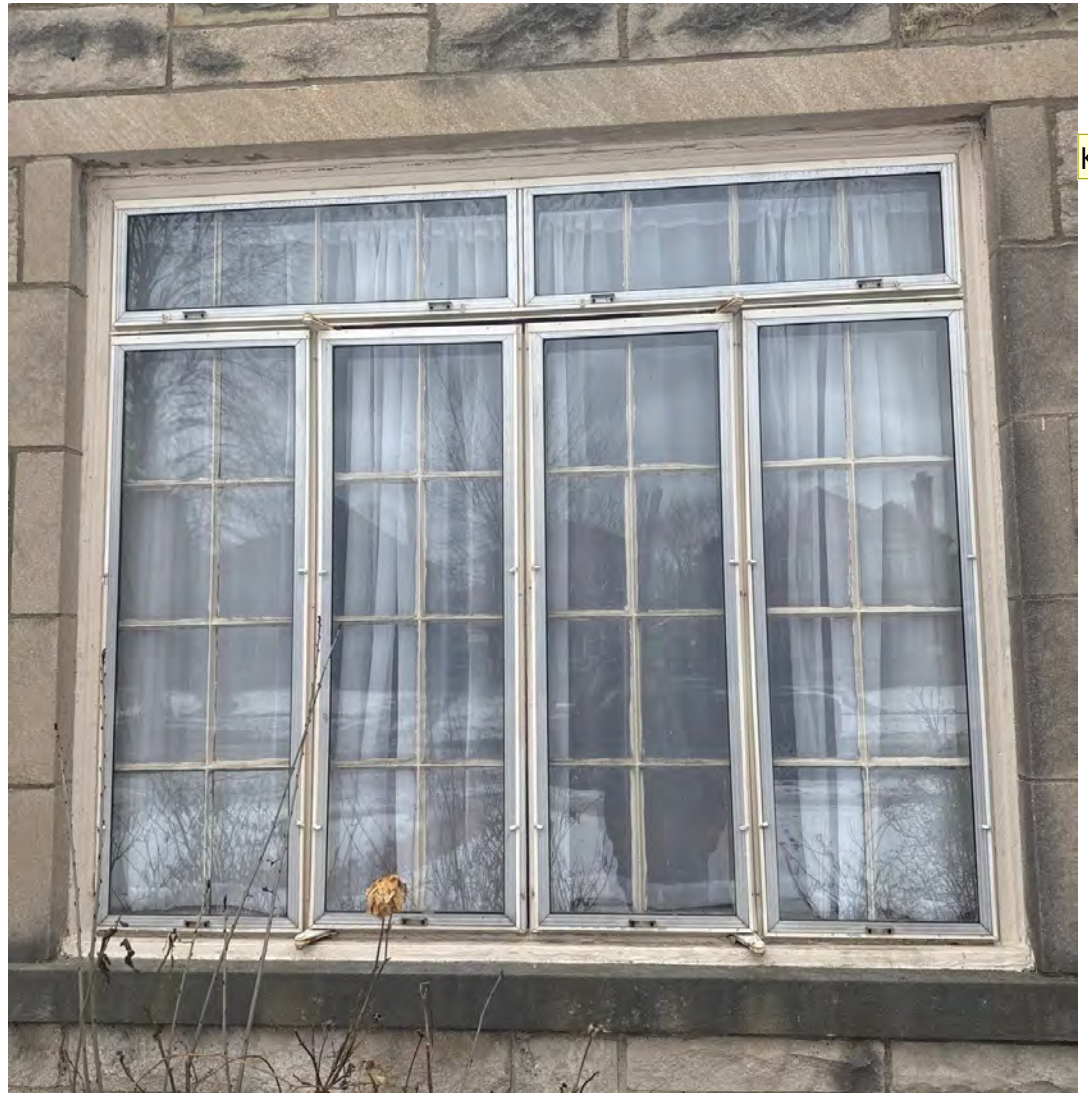
Window 1:

- Deteriorated wood in window frame compromising structural integrity
- Rusted gears in casement windows
- Inoperability: Window is sealed shut. Non-functioning windows exacerbate the non-compliance, as they cannot serve as emergency exits or provide adequate ventilation. Repair is not a feasible solution when operability cannot be restored due to structural and mechanical issues.
- Non code compliance: Failure to Meet Egress Standards: The windows do not meet egress requirements, making them unsafe and non-compliant with current building codes. This is particularly problematic for emergency escape routes.

1. Rusted Gear in Casement Window:

•**Functional Obsolescence:** A rusted gear in a casement window has lost its mechanical integrity, preventing smooth or reliable operation. Rust compromises the precise movement required for opening and closing, and repairs (e.g., lubrication or partial component replacement) often fail to restore full functionality due to corrosion spread across interconnected parts.

•**Safety Concerns:** A malfunctioning gear could lead to sudden failure, making the window unsafe for operation. As per guidelines, operability is essential to preserve the historic character of windows

- Holistic Solution:** Full replacement with wood windows featuring aluminum cladding ensures compliance with historic guidelines while addressing durability, functionality, and weatherproofing.
- Long-Term Preservation:** The new windows will match the original design while incorporating modern materials that prevent recurrence of these issues. Proper water grading, operability, and protection against further deterioration are integral to preserving the building's structural and historical integrity

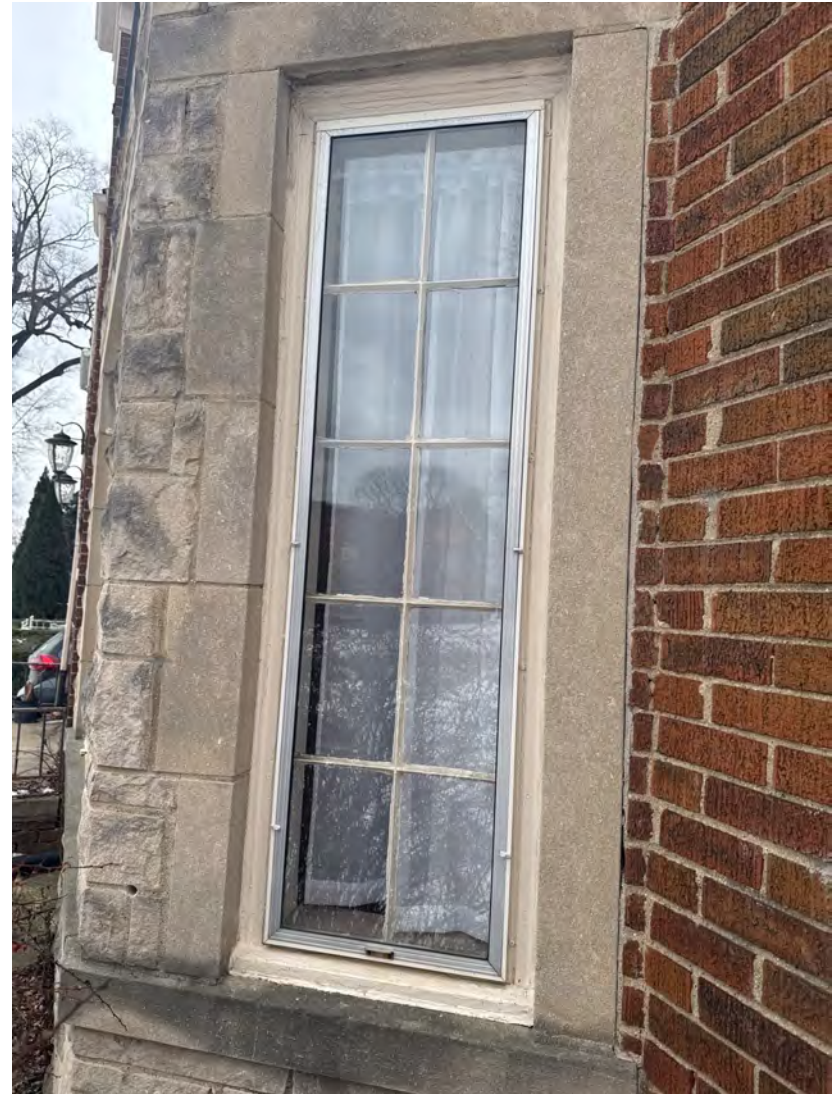
Window 3:

- Evidence of exterior wood frame rot
- Evidence of mold between storm window and original window

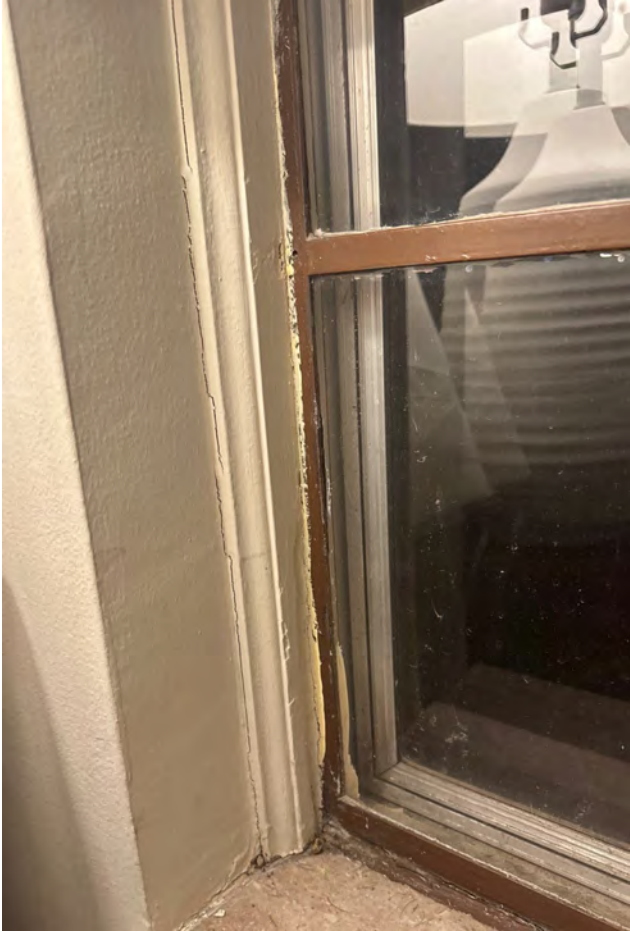
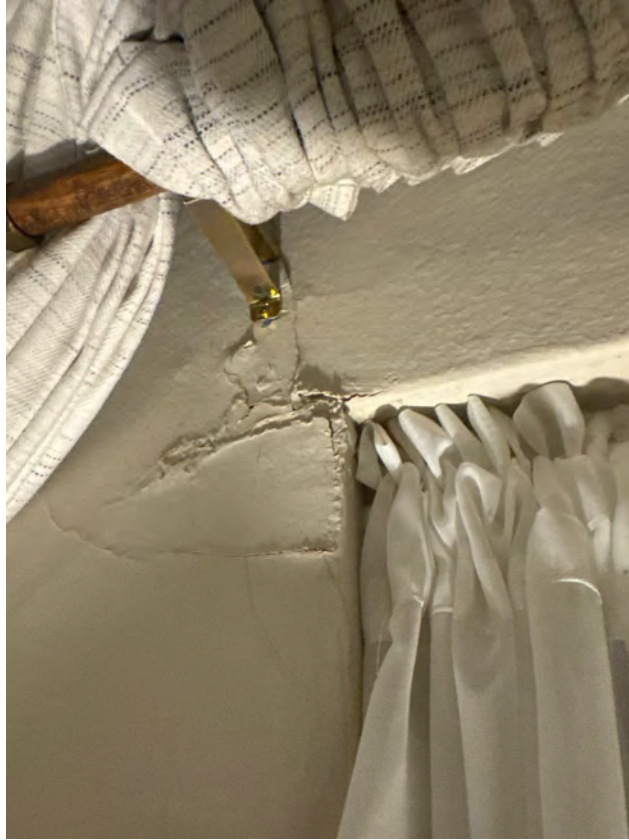
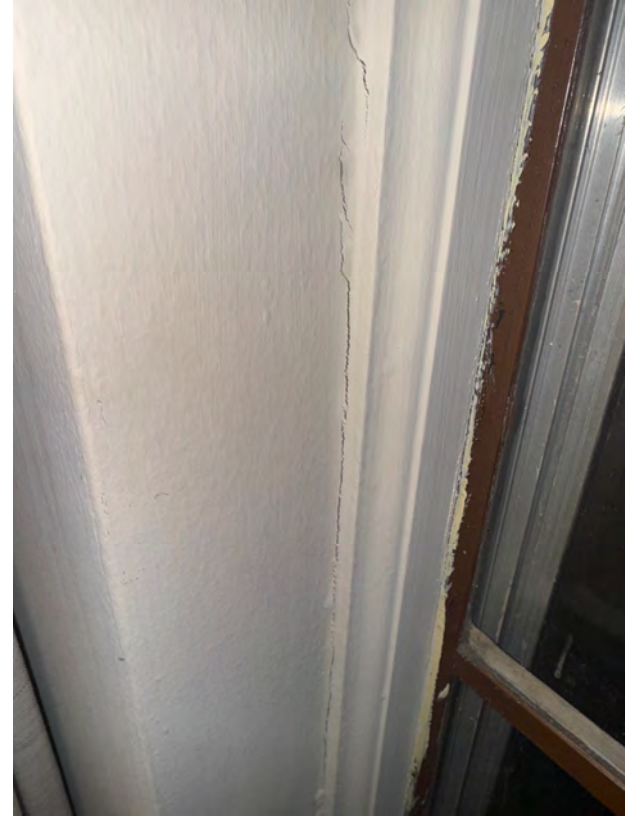
Window 3 (Continued)

- **Deteriorated Wood on exterior:**
- **Loss of Structural Integrity:** Wood that has deteriorated due to moisture, mold, or rot no longer provides adequate support for the window assembly. This compromises the entire frame's stability and may pose a safety hazard.
- **Guideline Requirements:** Replacement is necessary when repair is not technically feasible or when deterioration affects the window's ability to retain its shape, support glass, and maintain weatherproofing. Aluminum-clad wrapping further ensures long-term durability by protecting against future moisture and weather-related damage

Why Mold Warrants Window Replacement Instead of Repair:

- **Compromised Integrity:** Mold indicates prolonged moisture exposure, often leading to weakened or deteriorated materials that cannot be effectively repaired, necessitating full replacement.
- **Health Hazards:** Mold poses significant health risks (e.g., respiratory issues) and can persist in porous materials, making replacement essential to fully eliminate the issue and prevent recurrence.
- **Underlying Moisture Issues:** Mold is often caused by structural defects like improper grading or seals, which require replacement to correct and ensure future moisture resistance.
- **Code and Safety Compliance:** Replacement ensures compliance with modern building codes and health standards, providing a safe, mold-free environment while preventing further damage.

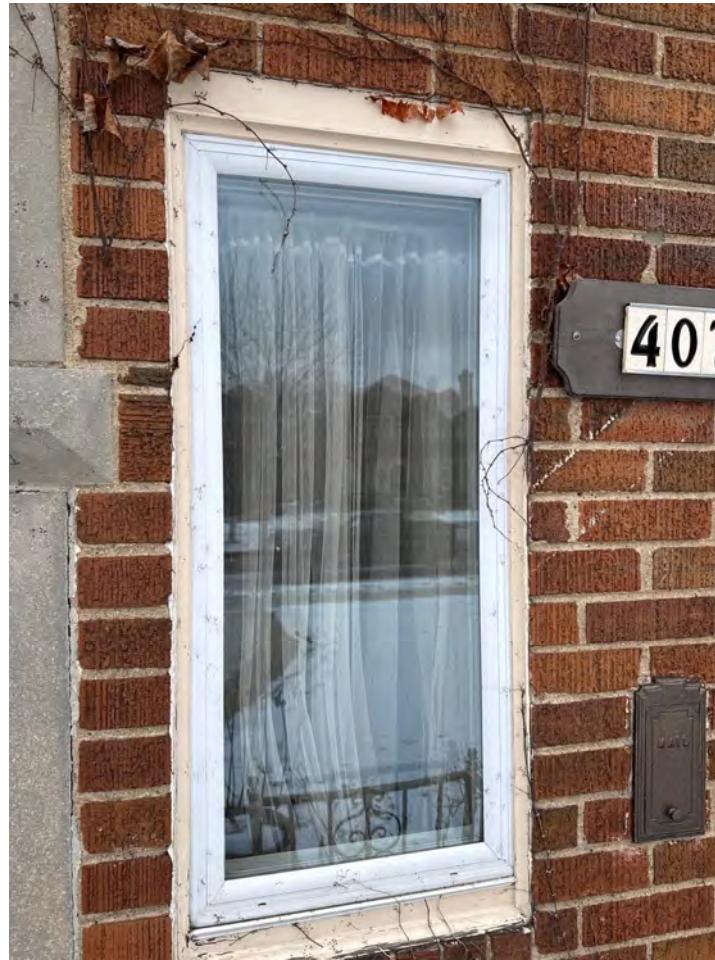
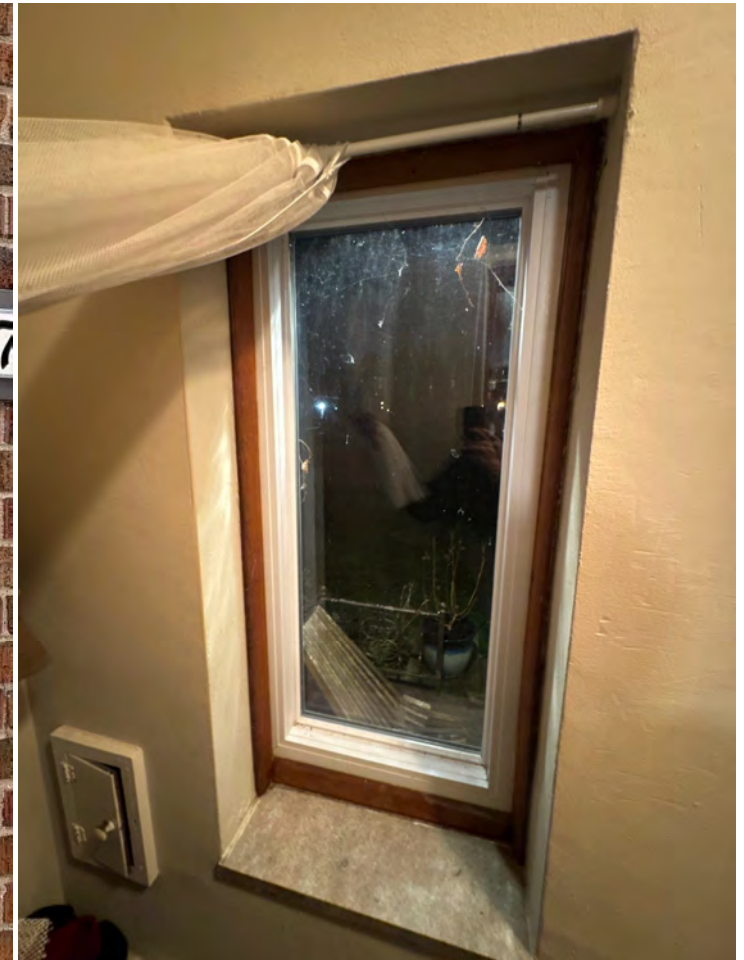
Window 14:

- Vinyl
- Marble sill will be preserved to maintain historical correctness

- Repairs with clear silicone caulk were attempted
- vinyl

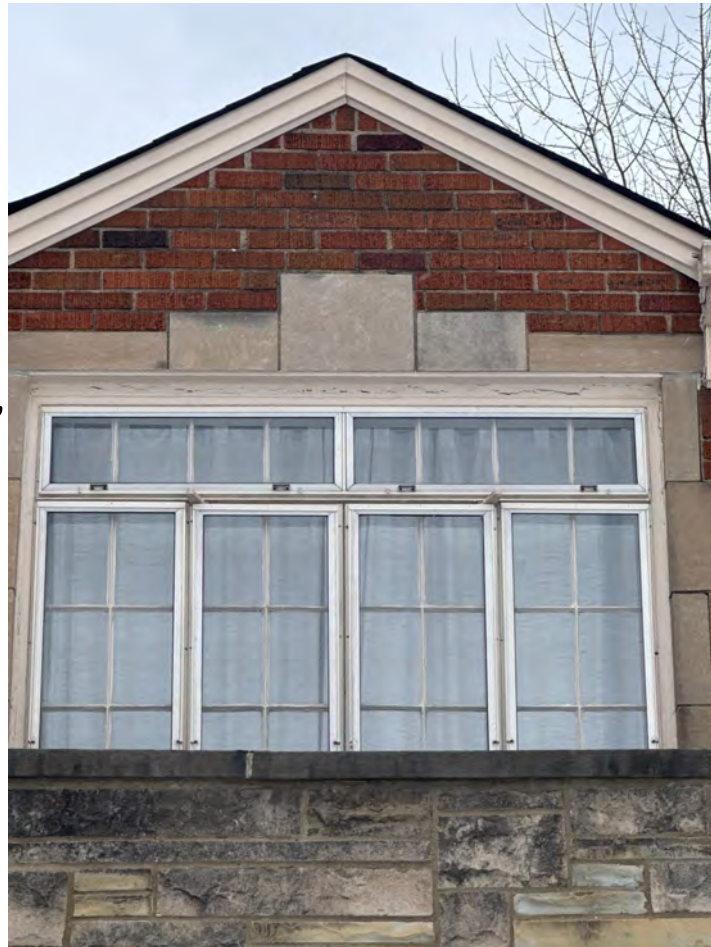
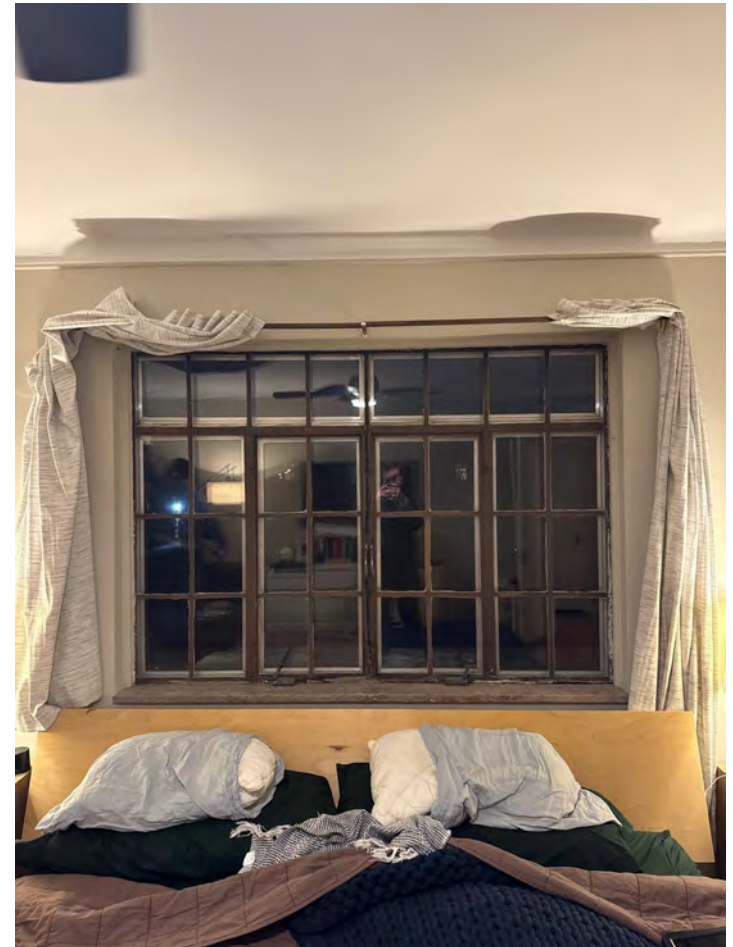
Window 16:

- substantial gaps in weather proofing,
- only one casement window opens due to hardware rusted shut,
- fails to meet egress/code

- Substantial gaps
- Substantial rusting

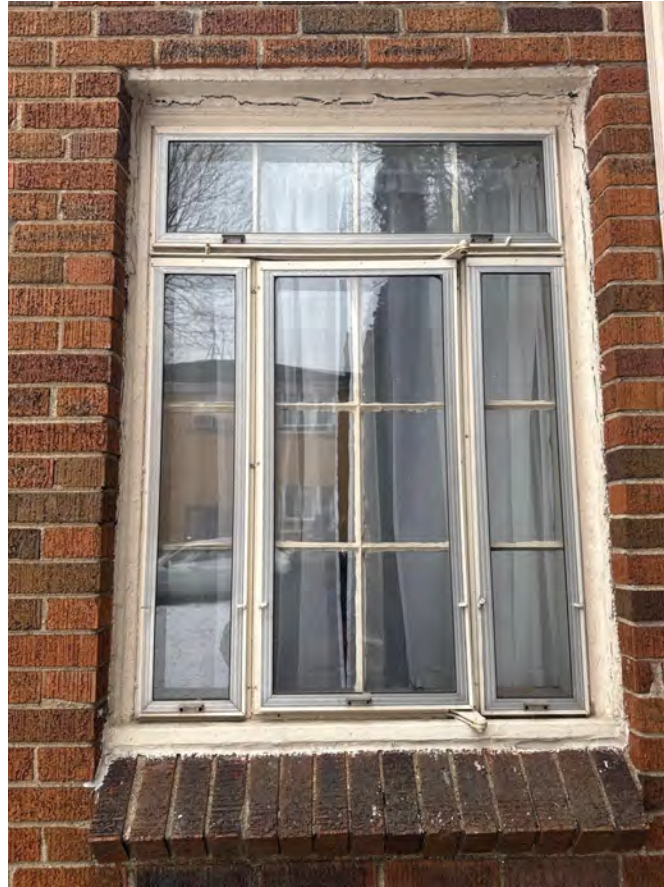
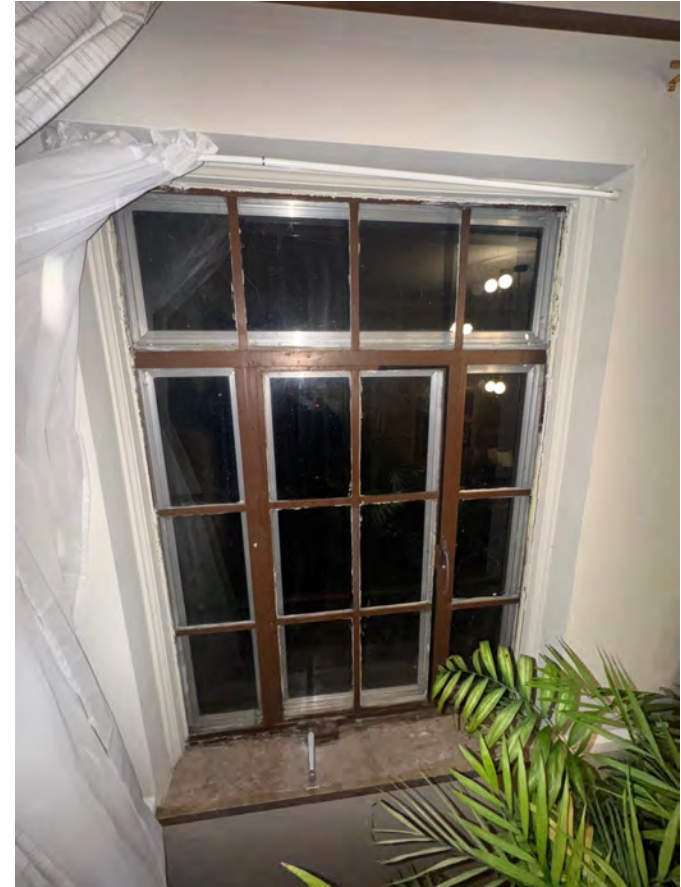
Window 7

- Handle no longer works, gears rusted shut

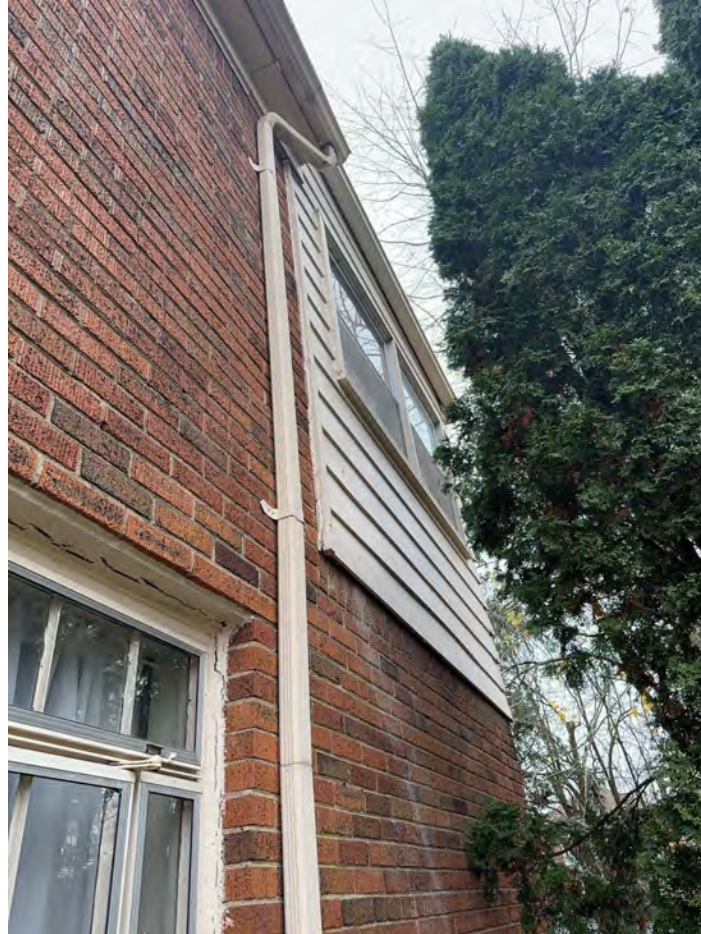
Window 19

- Vinyl, historically incorrect

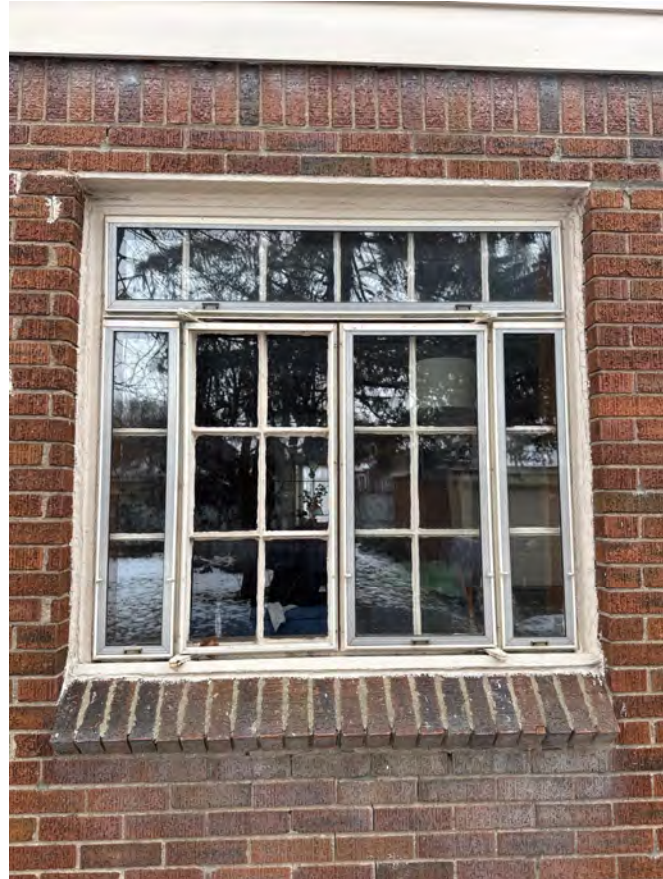
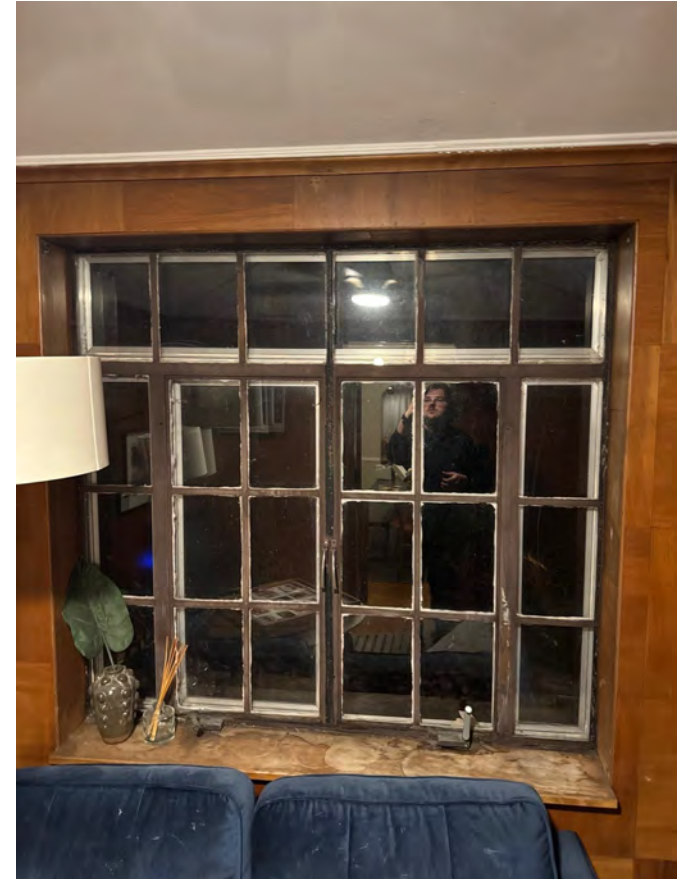
Window 8

- Exterior sill not grading water properly, caused water to damage interior sill
- Hardware receiver rusted out and stripped, repair of handle no longer possible
- Evidence of mold
- Exterior hinges all rusted out, only one casement opens. Does not meet egress/code. Extremely drafty.

Bottom Stud Not Grading Water Properly:

- **Water Pooling and Structural Risk:** The bottom stud is incorrectly angled inward, allowing water to collect rather than drain away from the window. This design flaw exacerbates water retention and encourages wood rot, mold growth, and potential damage to surrounding structures, including the interior walls.
- **Necessity of Replacement:** Adjusting the stud's angle retroactively is not a feasible repair solution due to its integration into the structural frame. Full replacement of the window frame ensures proper water grading and long-term protection against water infiltration

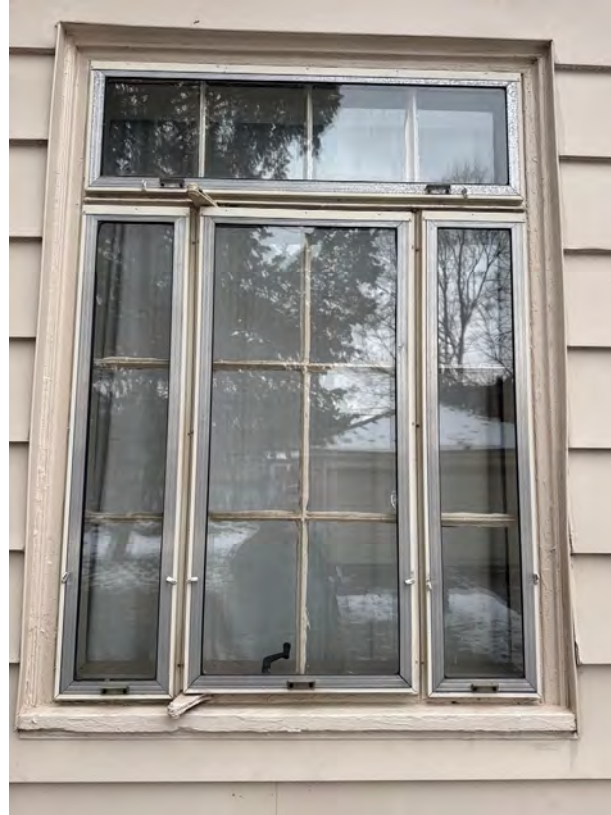
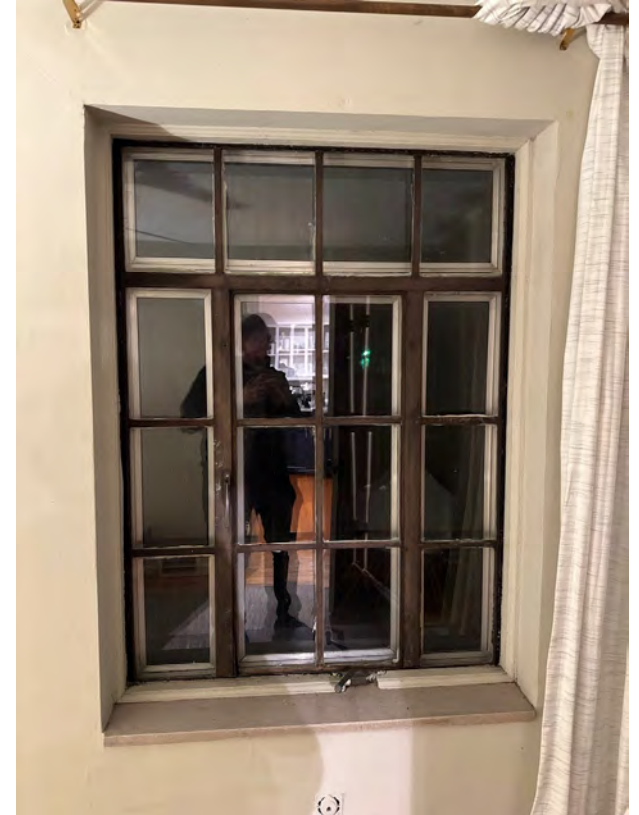
Window 9

- Deterioration of bottom exterior sill
- Evidence of mold
- Window not level with home, home has shifted, only remedy is replacement
- Window not flush, needs to be flush for proper siding replacement

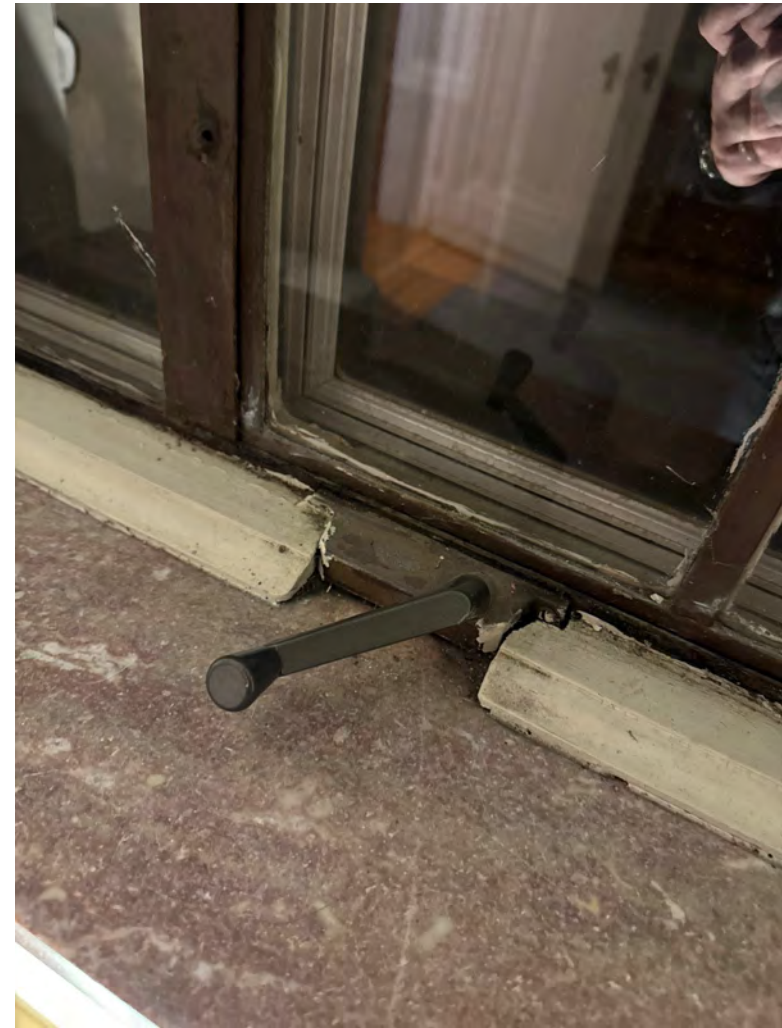
Window 10 (Continued)

- New weather stripping was attempted, did not fix the issue

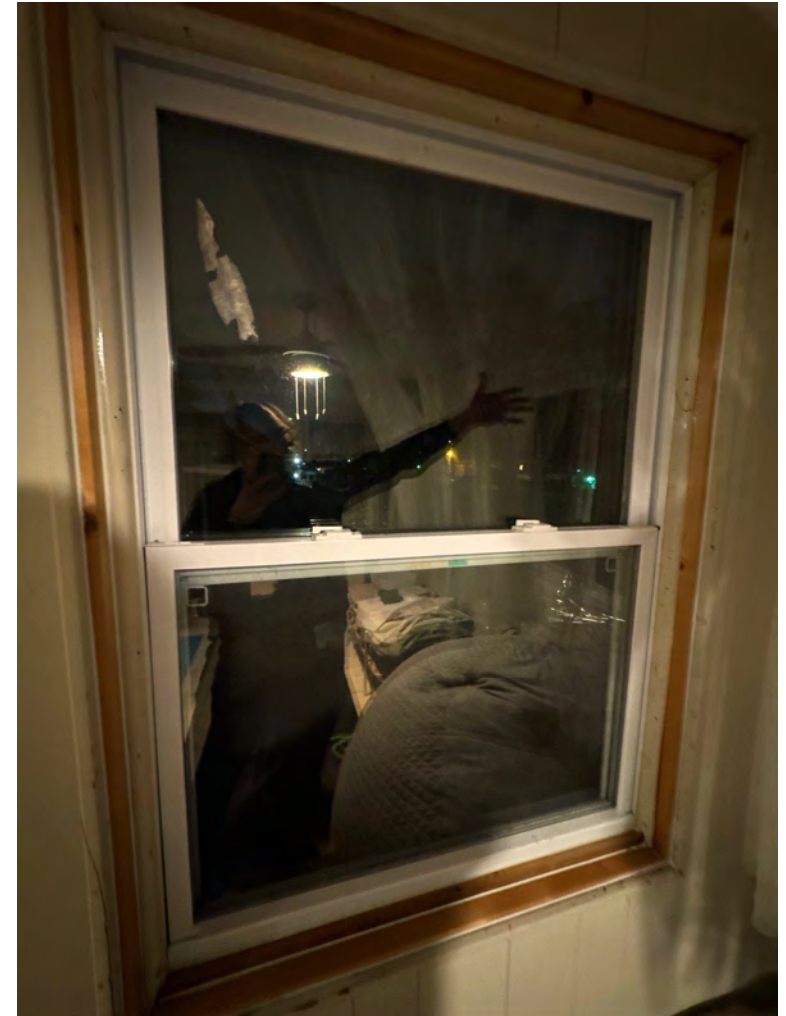
Window 21

- Vinyl; historically incorrect

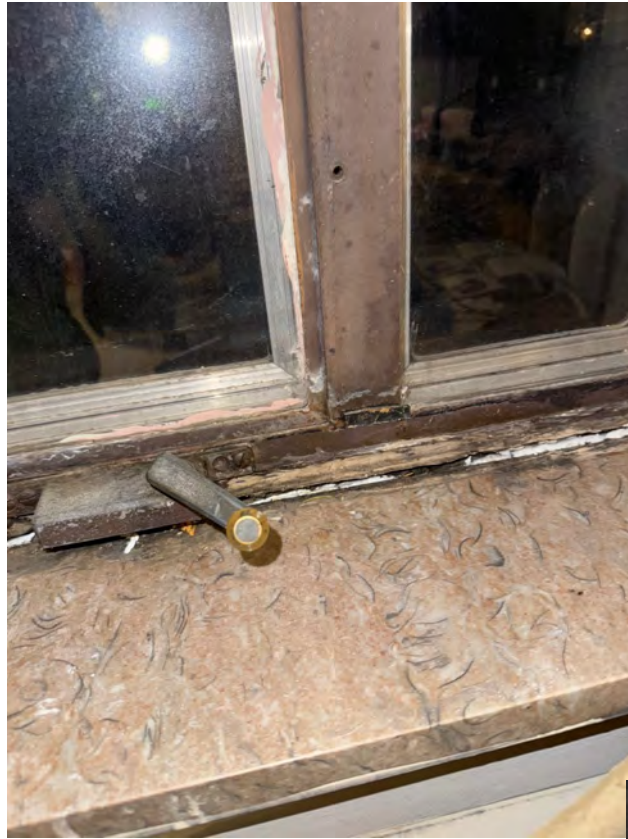
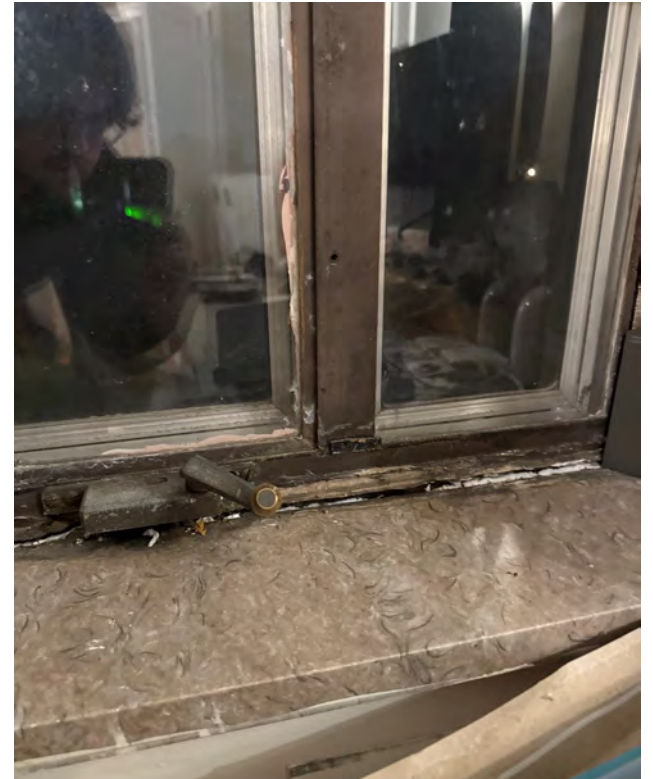
Window 22 (continued)

- evidence of water damage,
- substantial rust is present
- broken glass

- Evidence of water damage present,
- Broken glass
- Substantial rust, compromising integrity of the window

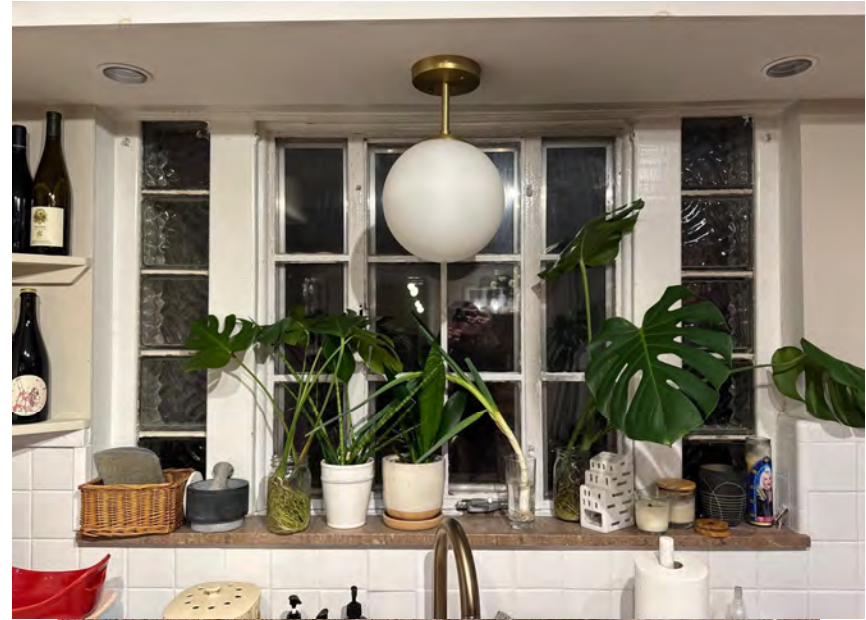
Window 11

- Glass block are not original to home, therefore not historically accurate. Requires replacement of entire opening.

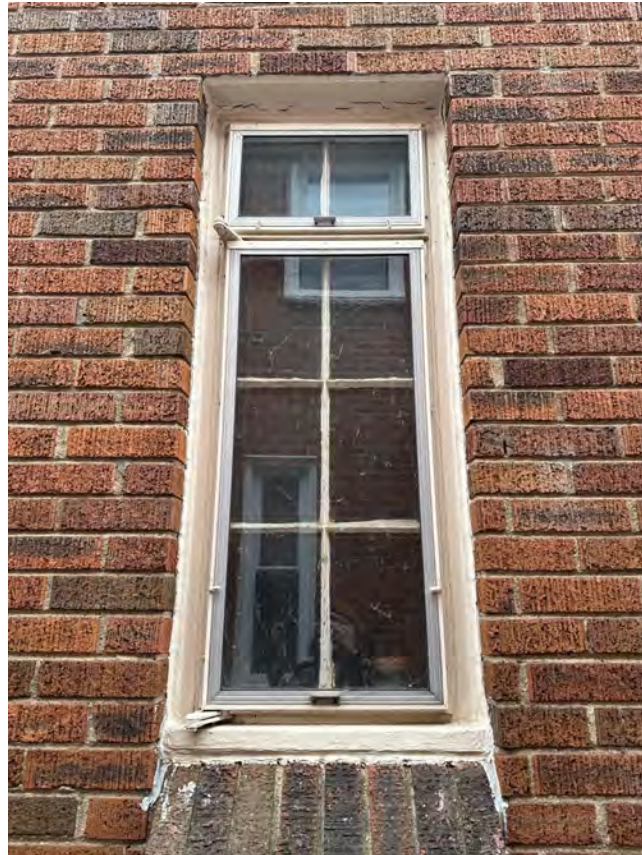
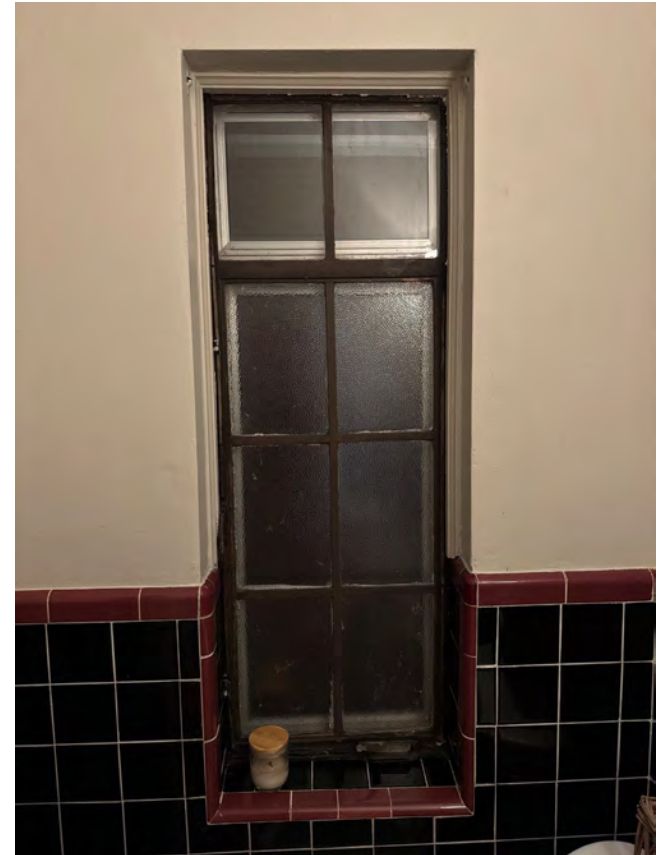
Window 12

- Sealed shut, has never been able to be opened
- Substantial gaps, very drafty.
- Severe structural rust

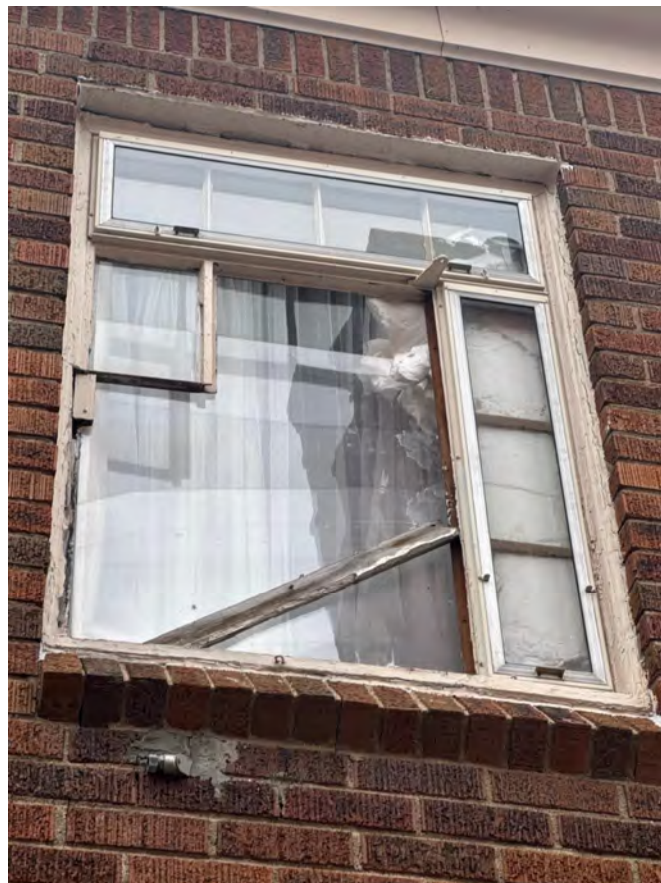
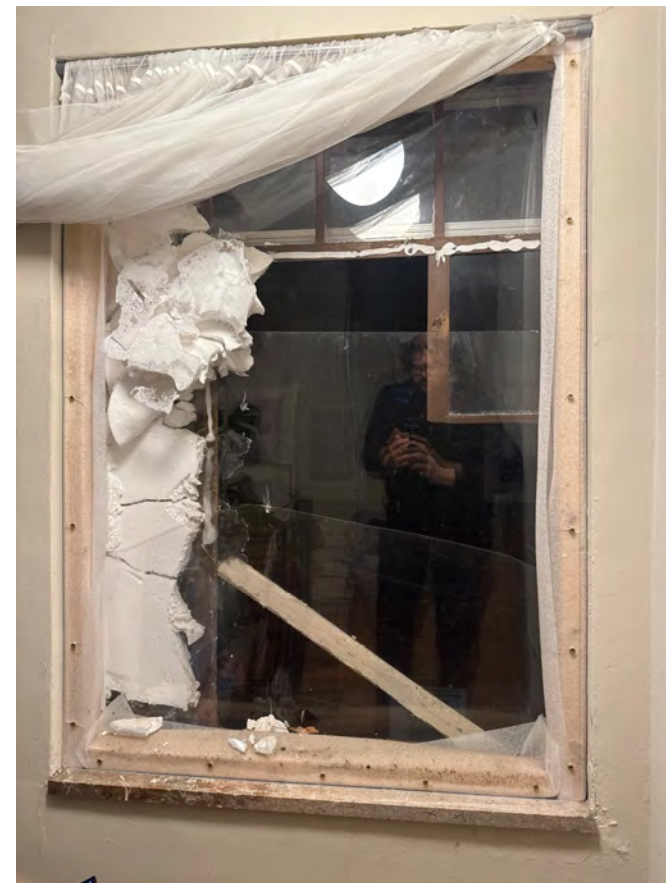
Window 15

- Beyond repair. Most of window is missing.

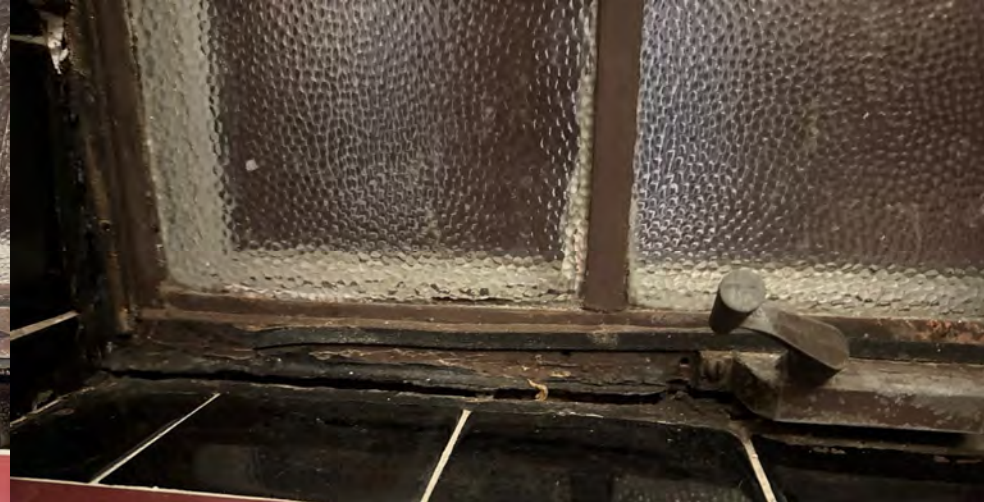
- Sealed shut, has never been able to be opened
- Substantial gaps, very drafty.
- Severe structural rust

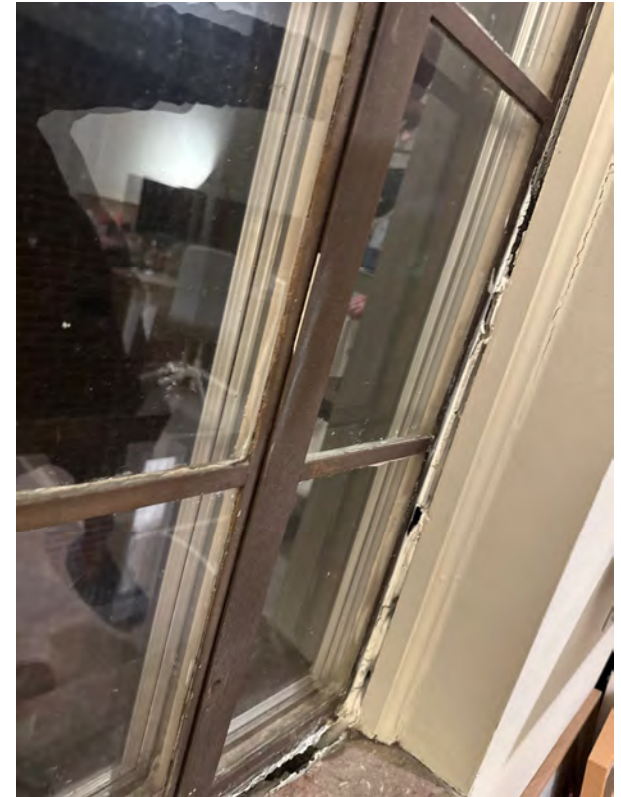
Window 23 (continued)

- Substantial rust contributing to large gaps
