**From:** [nafshar@comcast.net](mailto:nafshar@comcast.net)  
**To:** ["Ellen Thackery"](#)  
**Cc:** [Madani, Bardia \(B.\)](#)  
**Bcc:** [Neda48324@gmail.com](mailto:Neda48324@gmail.com); [afshar\\_ghazal75@gmail.com](mailto:afshar_ghazal75@gmail.com)  
**Subject:** RE: 4758 Sturtevant--historic district application update and several questions  
**Date:** Tuesday, August 26, 2025 3:21:00 PM  
**Attachments:** [image001.png](#)  
[4758 Sturtevant Gutter System.pdf](#)  
[4758 Sturtevant Gutter Locations.pdf](#)

**Subject:** 4758 Sturtevant--historic district application update and several questions

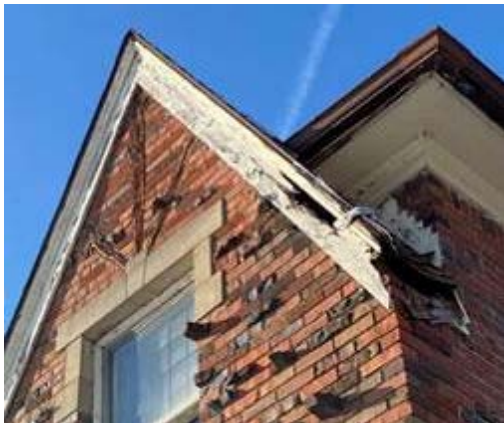
- All the gutters, fascia and soffits are damaged and in disrepair. Some have already been patched with splices to the point where repairs are quite visible and distract from the beauty this house once possessed.

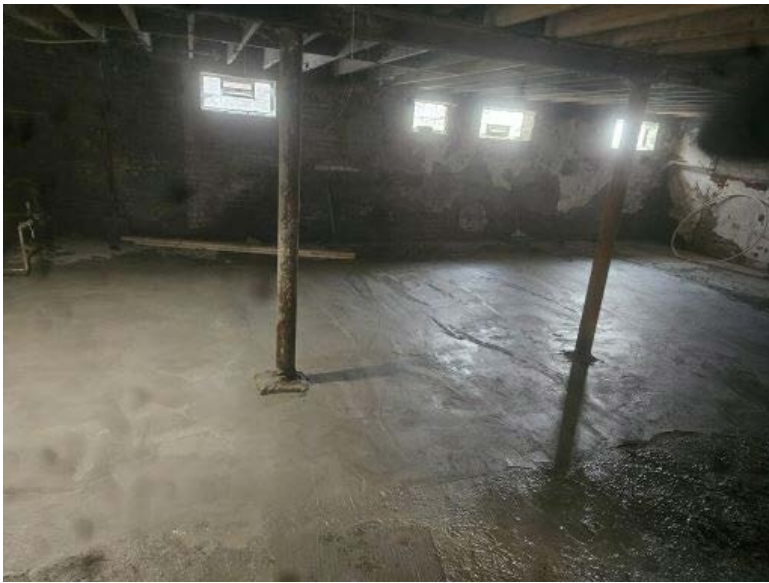
- The basement had floor damage with much of the floor raised and turned brittle to the point where a hard stump by foot would crack the cement. We had to break up the cement and repour it.

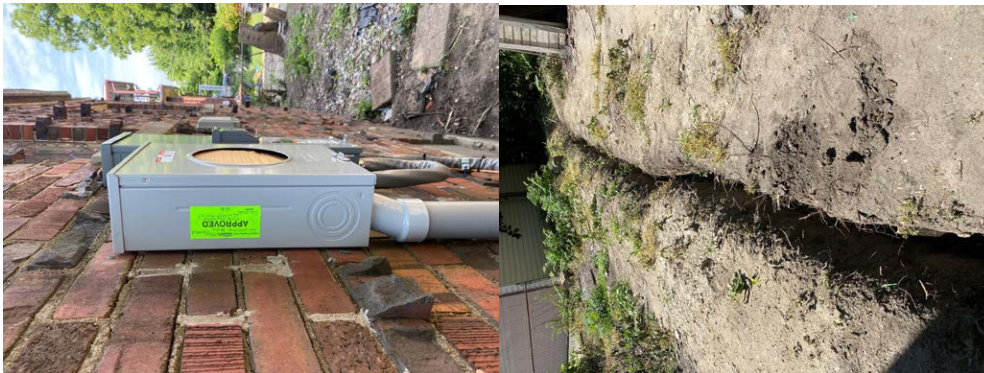
- All pipes and wiring in the house had to be removed for structural repair, as such a total rewiring and plumbing is required to bring the house up to code.
- The main power supply line has been buried below ground to avoid power outages due to storm.

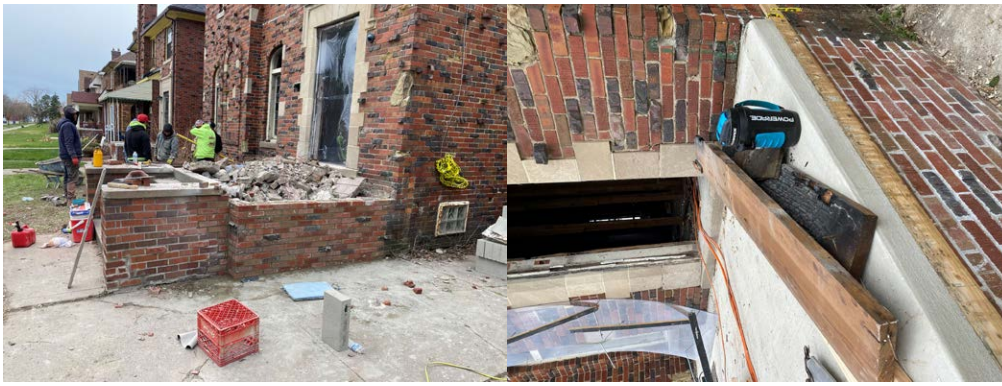
- The driveway is completely cracked and damaged, with water collecting on the sides of the house, seeping into the basement. The entire driveway has to be dug up and repoured.
- The front porch had completely collapsed, which we had to repair with the same brick style as the original on the house. See below:

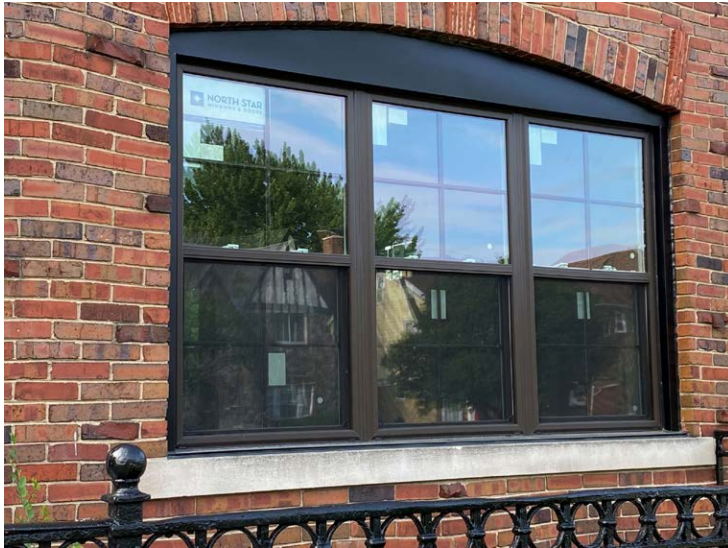
In a project across the street from our house a similar window style and material has been approved with 2-wide and 2-high configuration.
