HISTORIC DISTRICT COMMISSION APPLICATION FOR WORK APPROVAL

HDC2025-00591

PROPERTY INFORMATION**ADDRESS(ES):** 2233 Park Avenue**HISTORIC DISTRICT:** Park Avenue Local**SCOPE OF WORK: (Check ALL that apply)**

Existing Building Widnow Survey

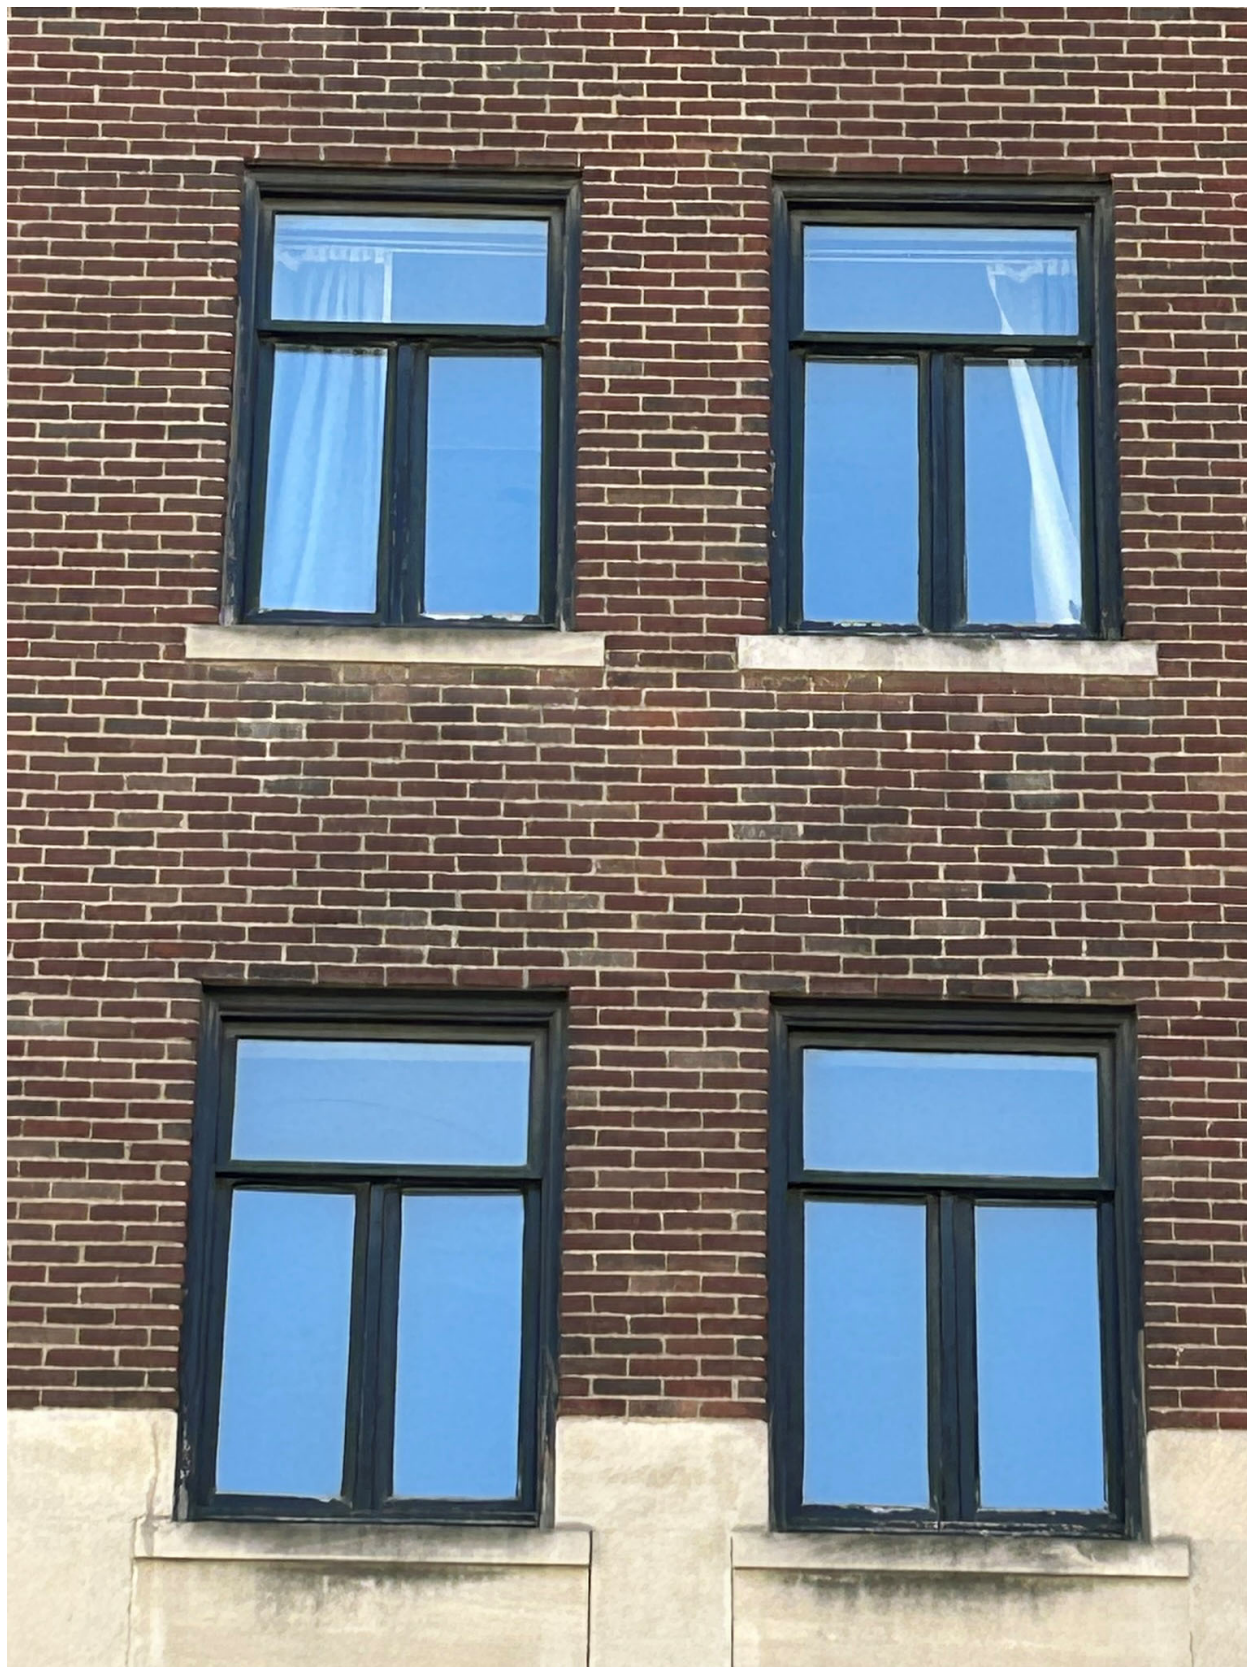
The existing wood windows are deteriorating, proper lacking weatherization and unsafe. The window sashes that were replaced in 2006 were installed with poor workmanship and using a soft wood windows that were painted, have not fared well with the extreme weather conditions that a high-rise building faces. The many of the sashes are warped and do not open or open properly. The weather stripping on the jambs, sill and head are greatly deteriorated or missing.

Exterior close up view of existing windows
