Response to HDC Staff Recommendation

Re: Appeal of Staff Recommendation – Application #HDC2025-00639

Property: 949 Chicago Blvd, Detroit, MI (Boston-Edison Historic District)

Subject: Appeal of Staff Recommendation and Clarification Regarding Rear Wing Rehabilitation

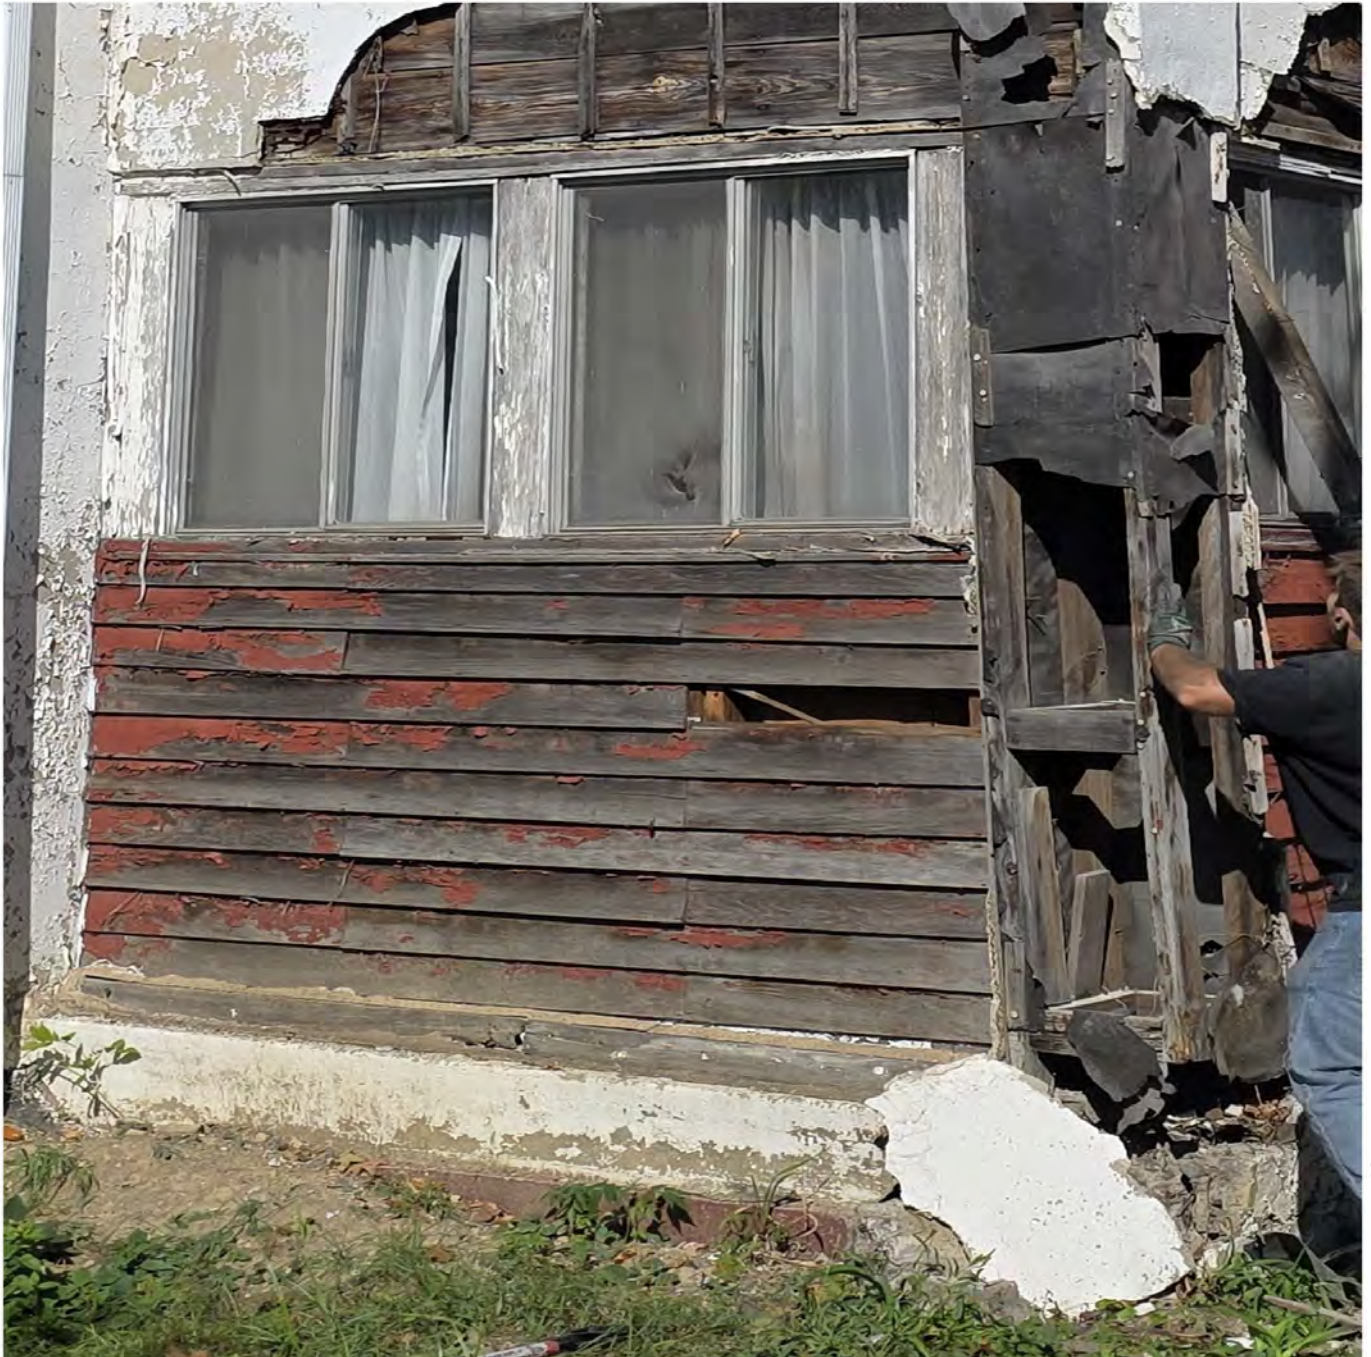
Ground-level deterioration

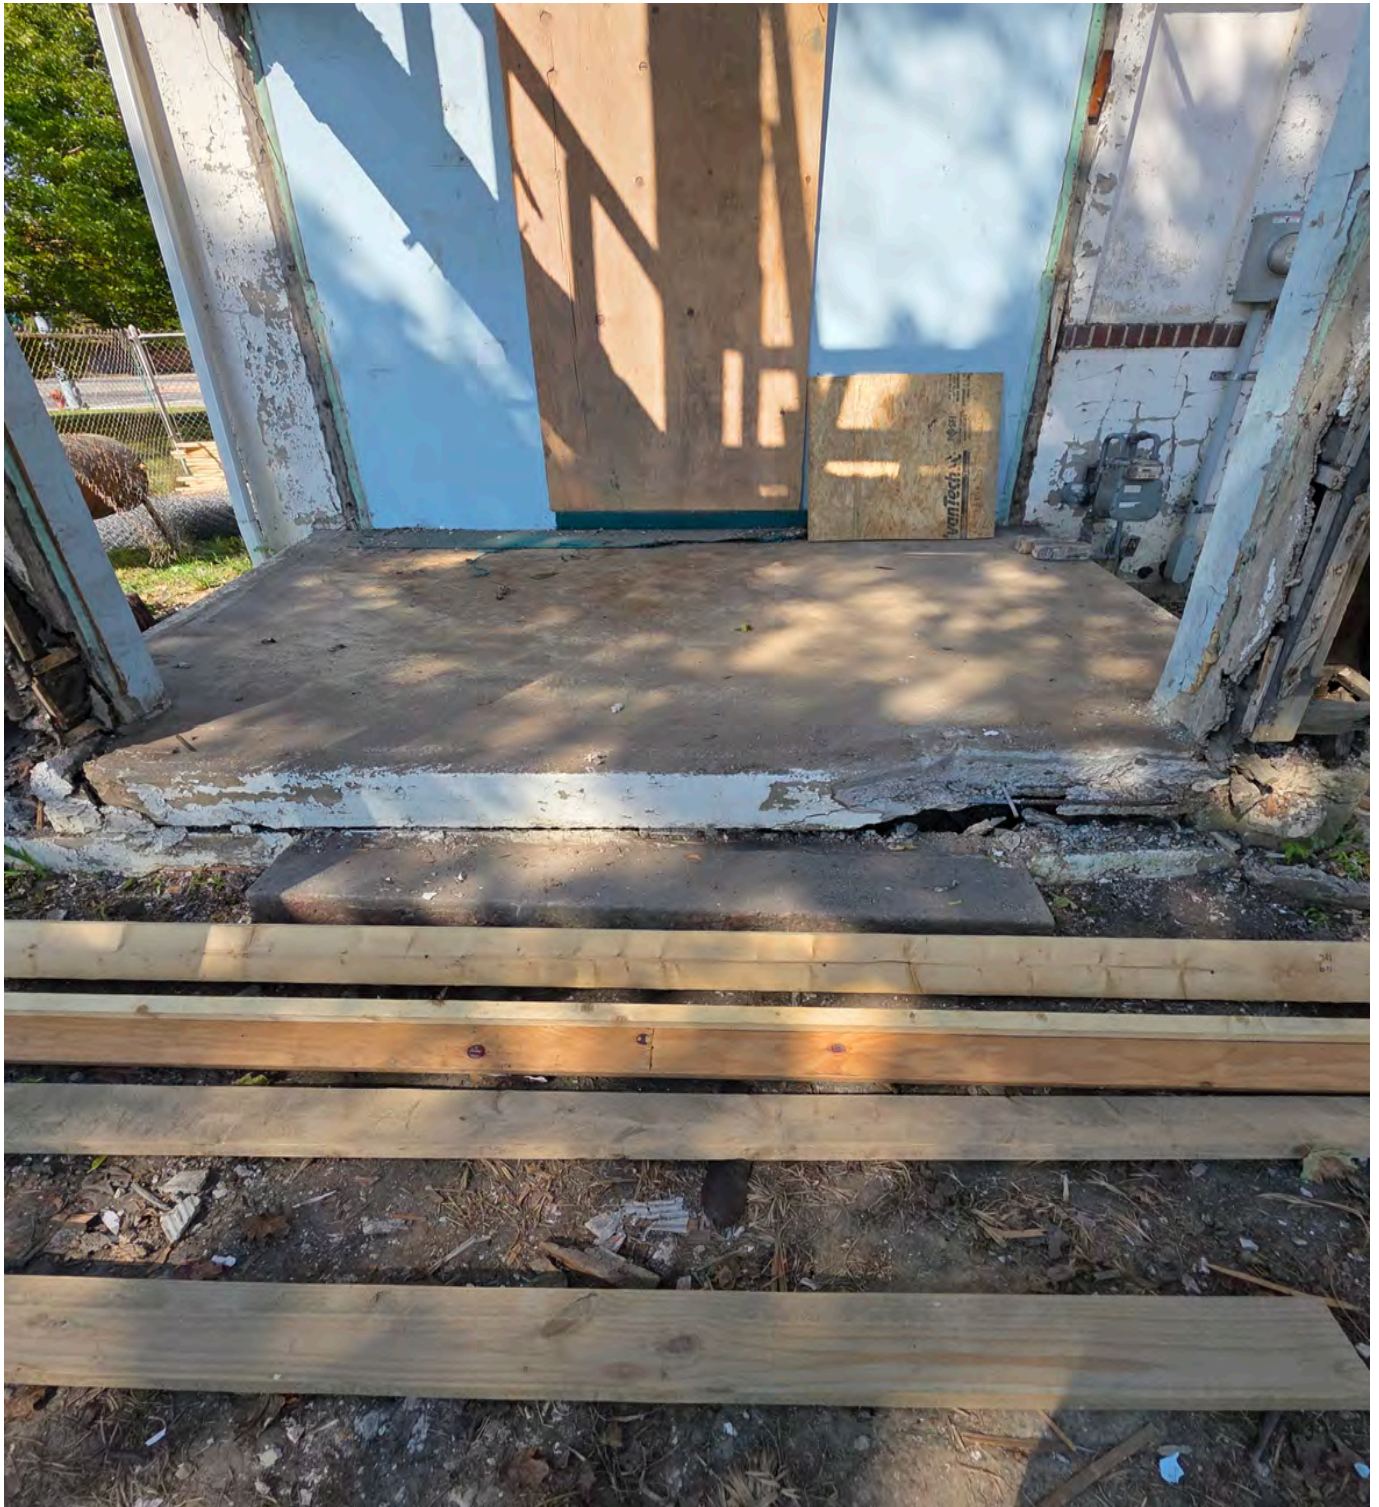
Differential Settlement Due to Freeze-Thaw Cycling

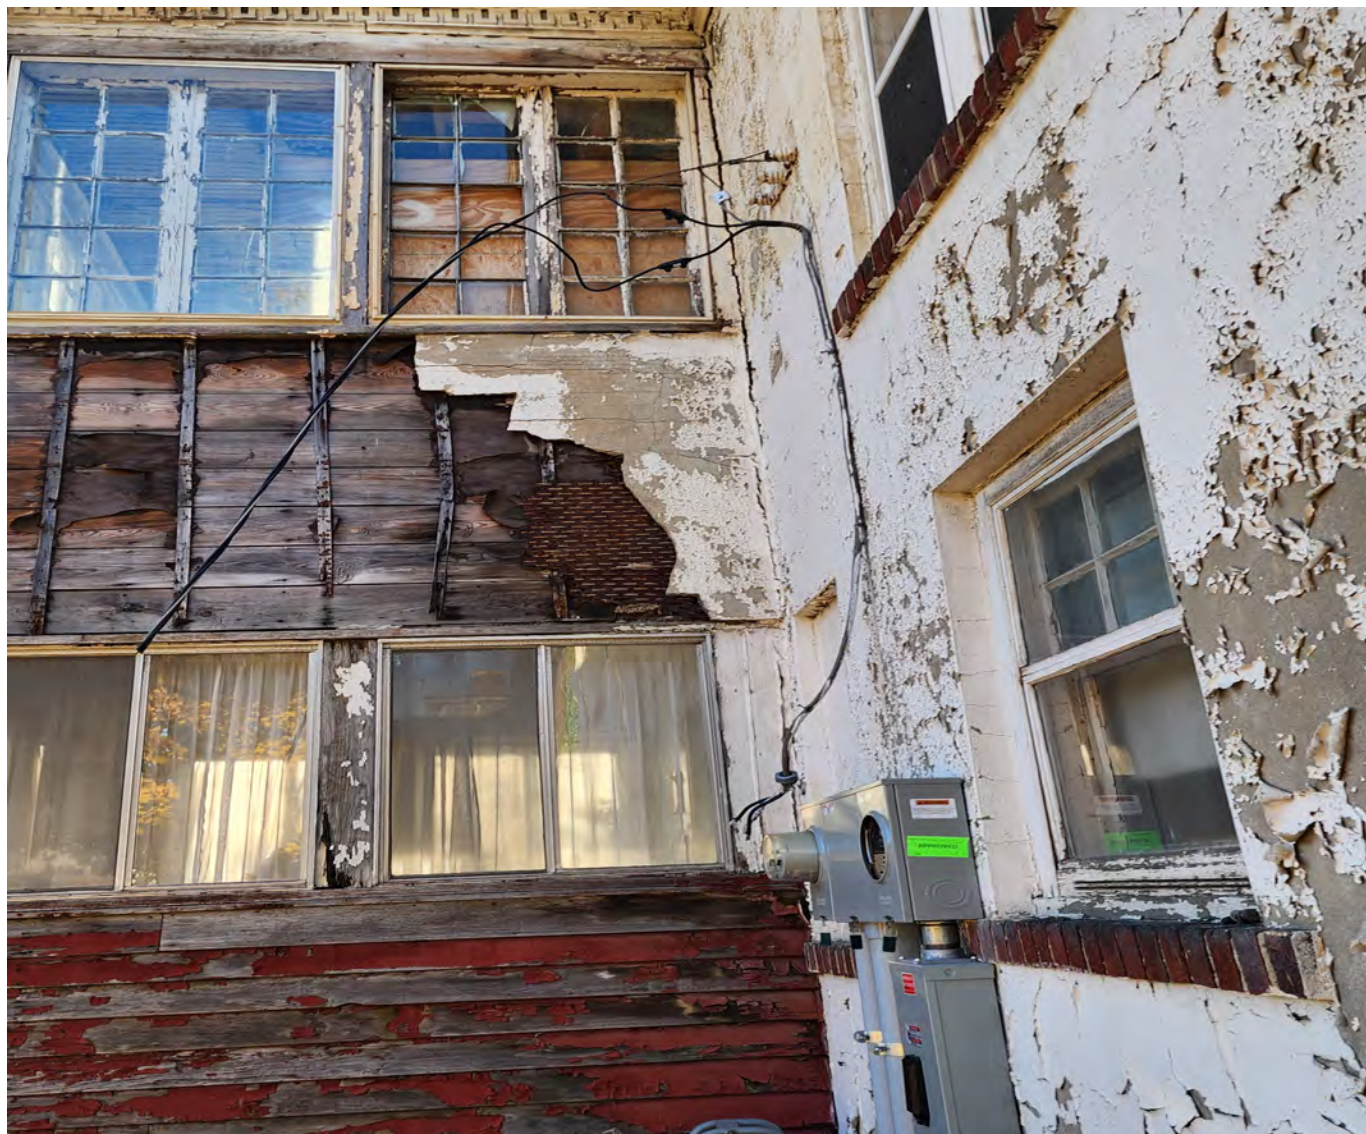
Structural Separation Caused by Differential Settlement

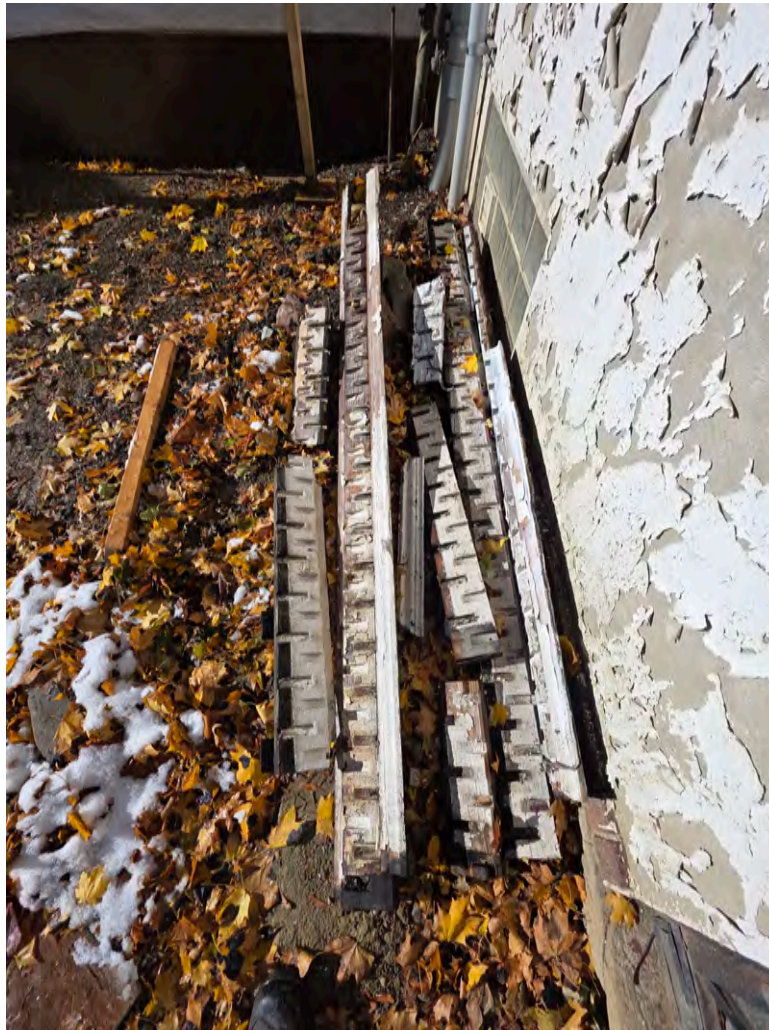
Salvaged Dentil Cornice for Reinstallation

#2 – Retain and preserve historic character: The work retains the form, materials, and function of the long-standing rear wing. **It does not alter or remove any 1913 historic materials. In fact, exterior molding from the original building has been salvaged and will be restored to preserve this key historic design feature.**

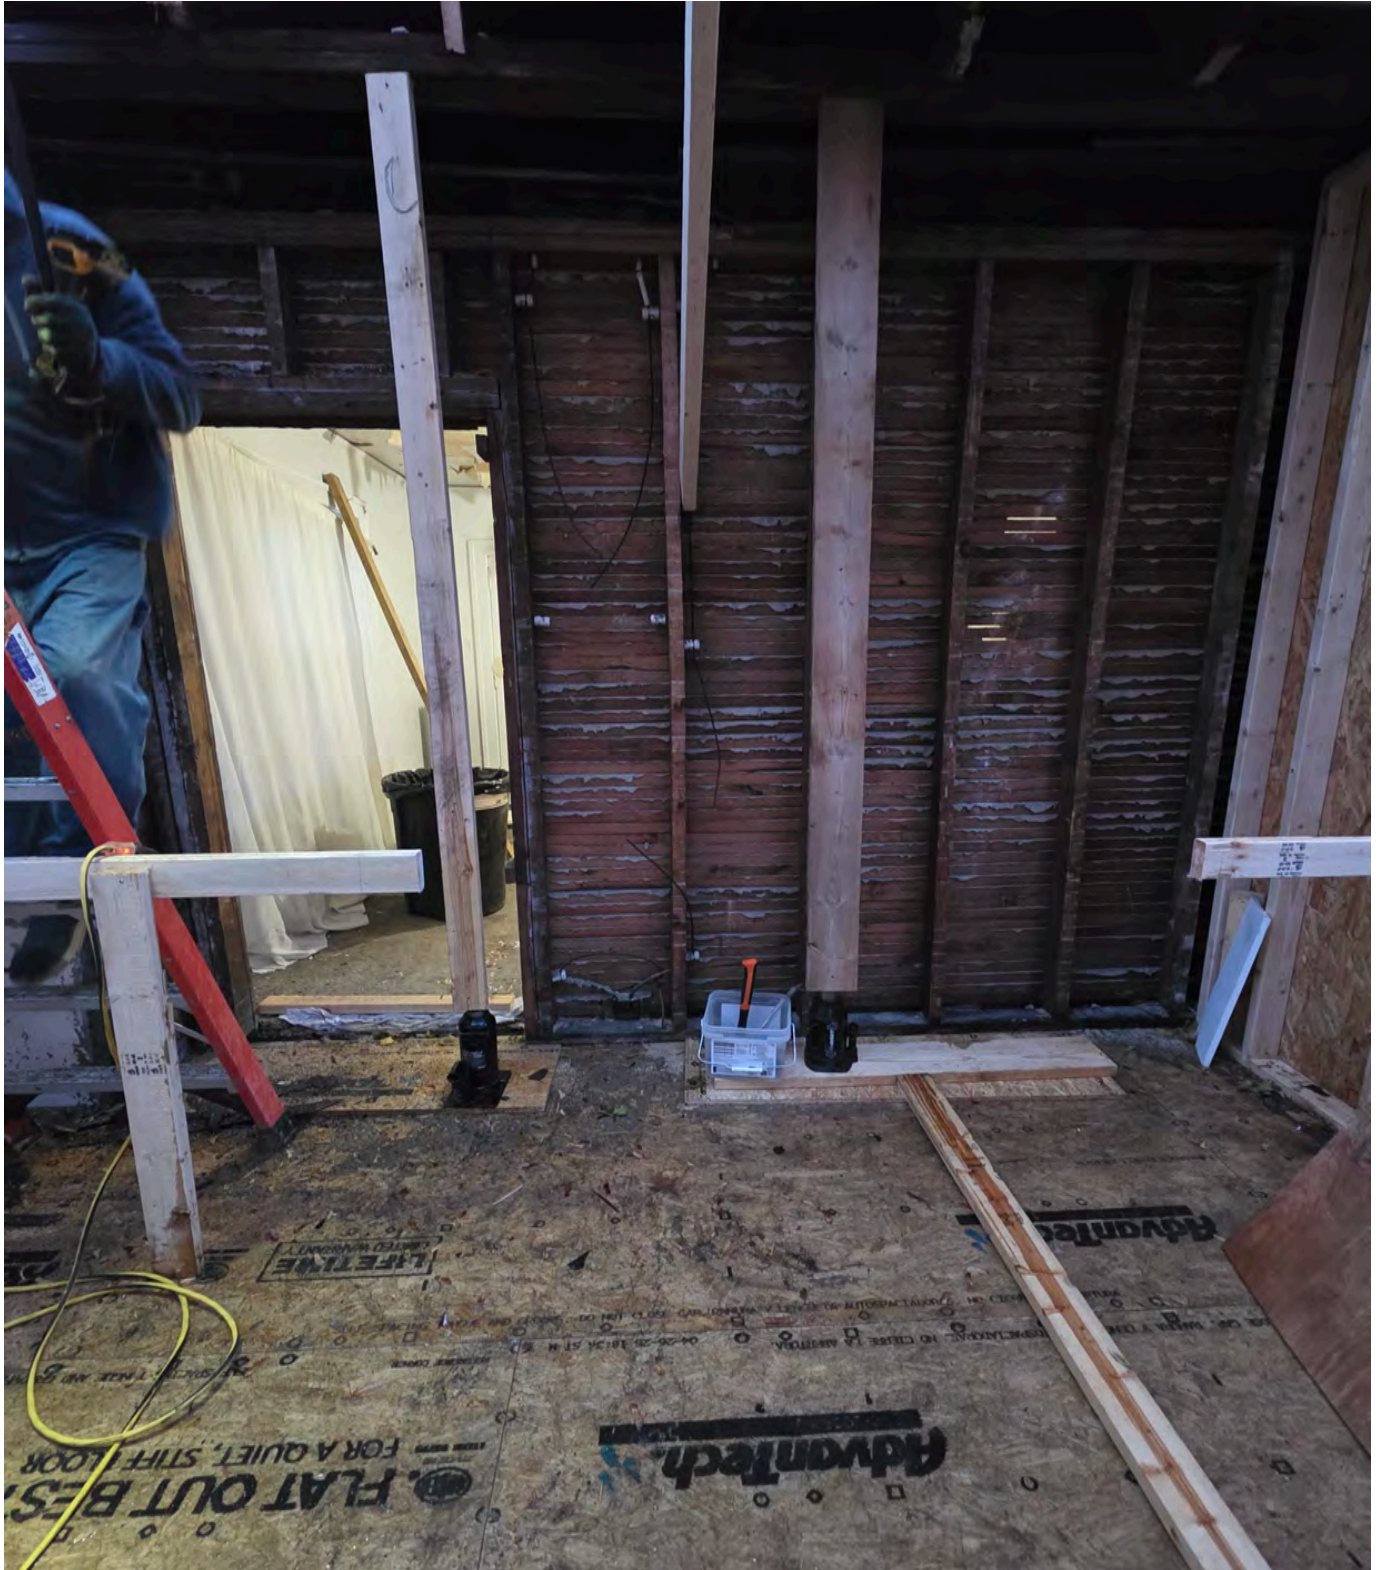
Jacks placed to correct 3-4 inch sag

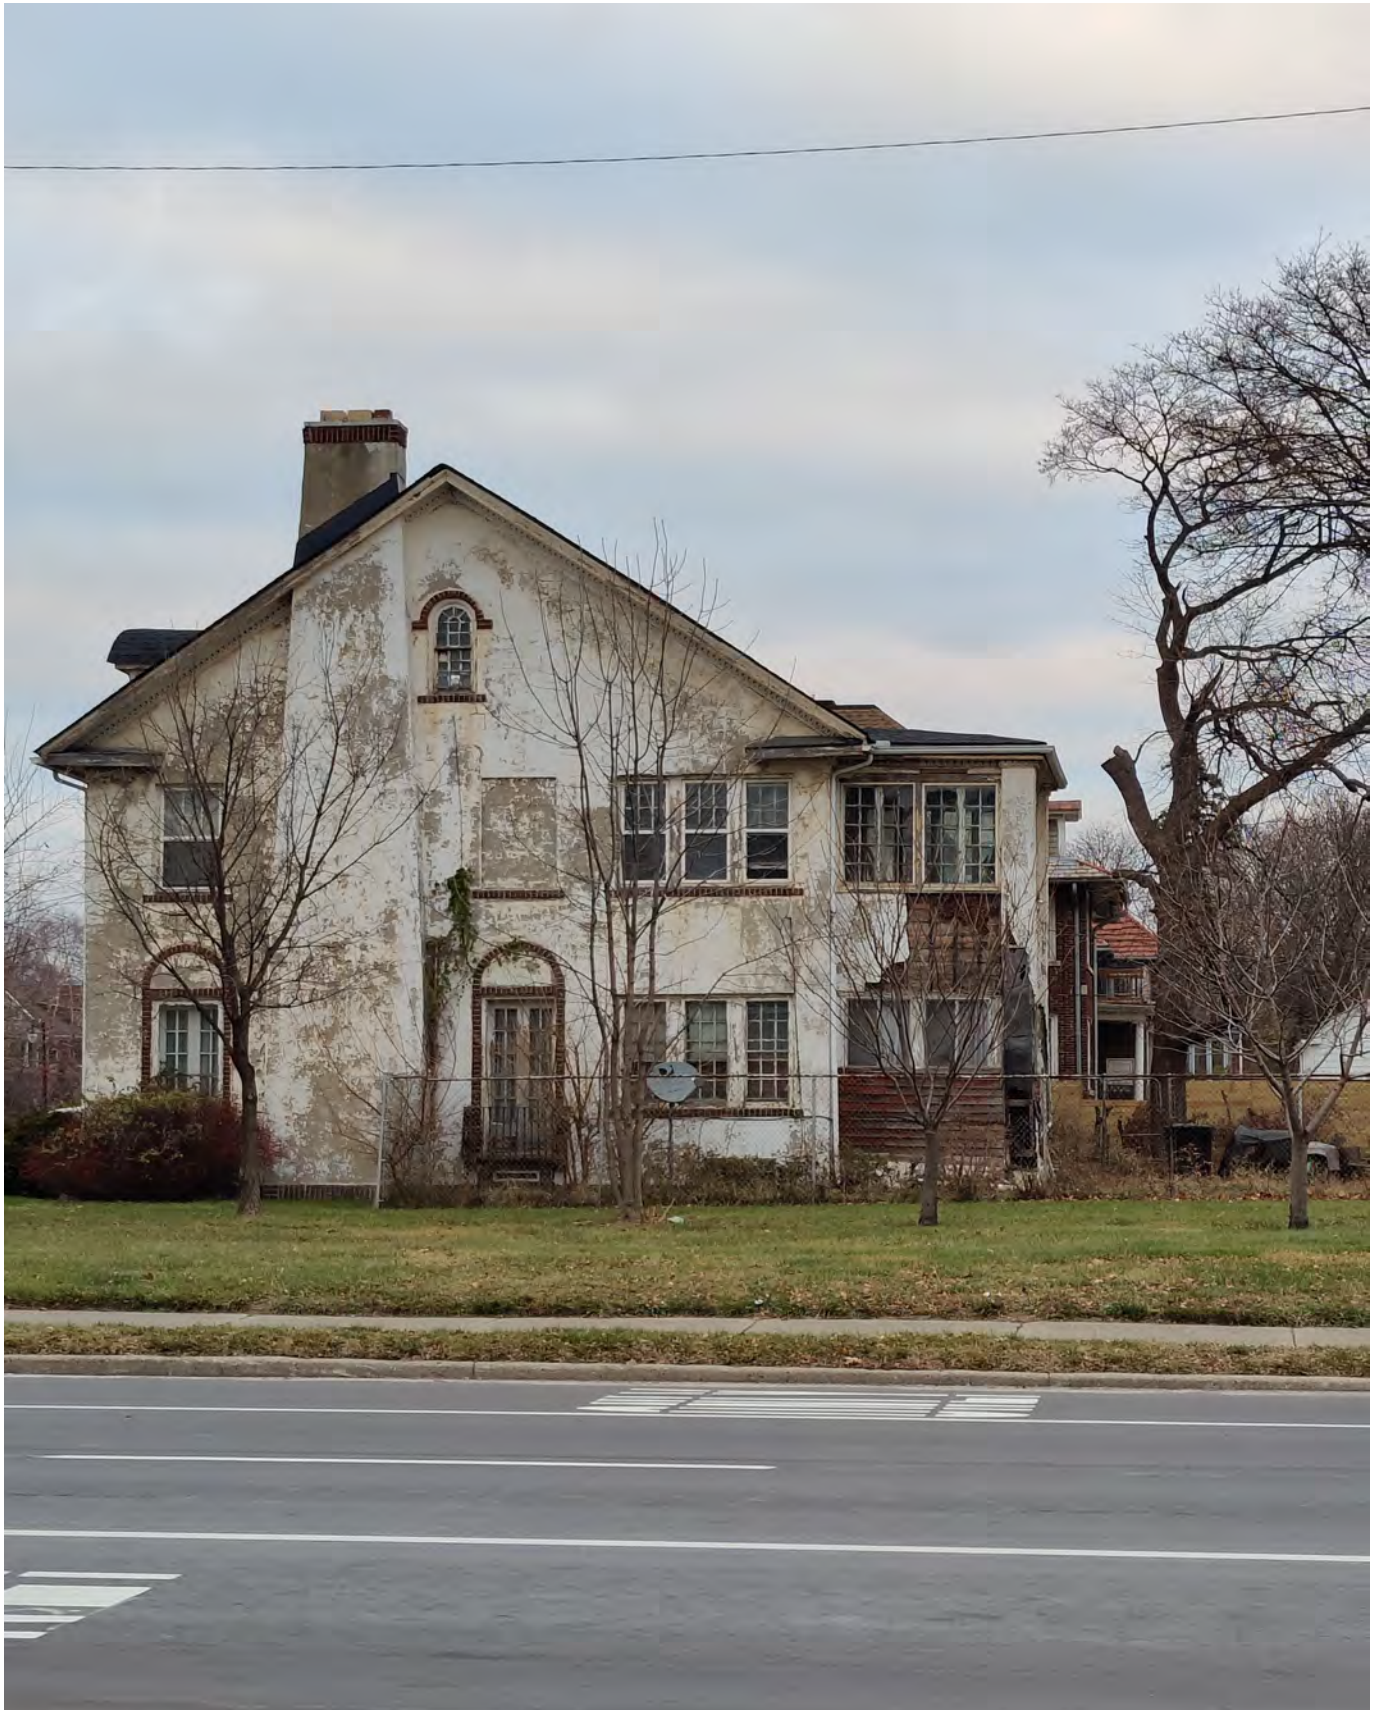
West elevation: Observed separation at the extension joint resulting from foundation instability
