HISTORIC DISTRICT COMMISSION APPLICATION FOR WORK APPROVAL

HDC2026-00018

ADDRESS(ES): 4314 W. Vernor

RE: 4314 W Vernor – Structural Evaluation Report
4314 Vernor W
Detroit, MI 48209
Use Group: Commercial
Project No. 25-1086

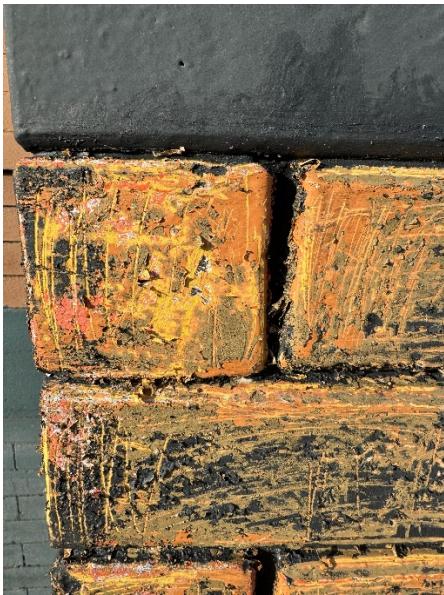
- **Exhibit A – Brick Removal Test Area (Close-Up):** Photograph documents partial paint removal revealing severe surface scarring, loss of fired brick face, pigment ghosting from multiple historic paint layers, and irreversible texture damage.

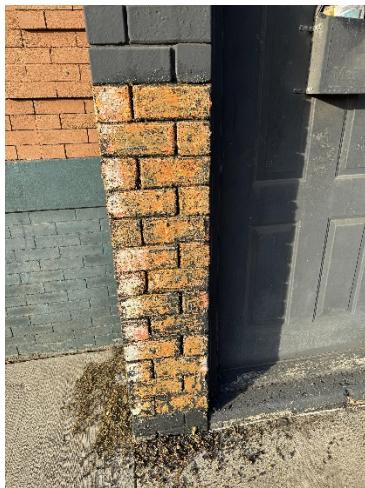
- **Exhibit B – Brick Removal Test Area (Context View):** Photograph shows broader test area adjacent to storefront opening, illustrating inconsistent brick coloration, widespread staining, mortar deterioration, and lack of recoverable original brick appearance.

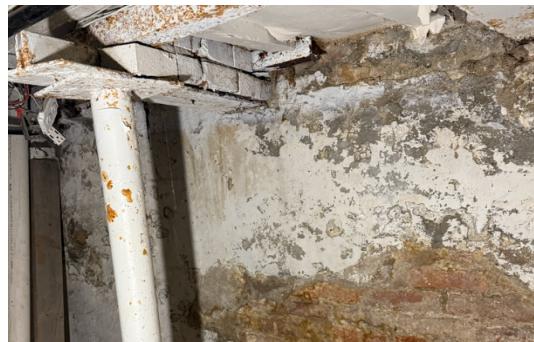
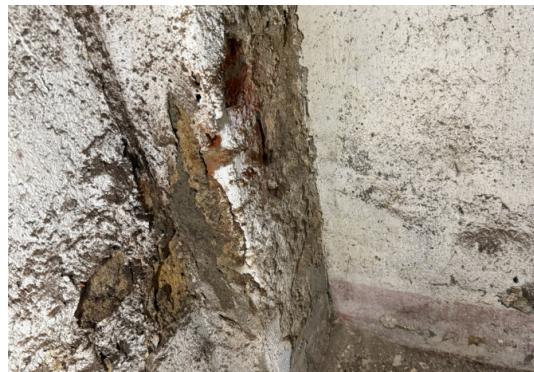
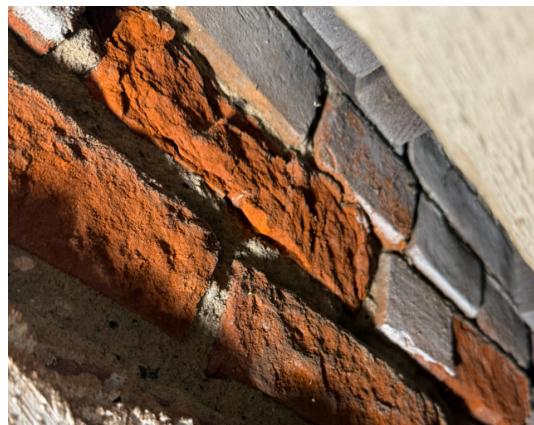
The basement walls are constructed with brick and coated with plaster in some areas. The existing masonry walls along the street side of the building are in poor condition structurally, the brick units have begun to lose their integrity, and their mortar joints have softened. Efflorescence was observed on the surface of the exposed walls in some locations due to prolonged exposure to freeze thaw cycles, deicing salts, and water infiltration due to failing masonry sill joints. The age of the construction and careful inspection of the mortar materials strongly indicate a hydraulic lime type mortar was used in the construction of the original building. Accordingly, Portland cement-based materials must be prohibited from the repair works. Refer to photographs P2.1.1A, P2.1.1B, P2.1.1C.

Note: Retrofit of the basement walls is required for safety and serviceability of the structure. It is recommended that the mortar joints be repaired/ tuckpointed and the damaged brick be replaced/repaired in kind. It is also recommended to expose the walls and coat them with an approved penetrating sealer that is compatible with hydraulic lime-based mortars and the masonry walls at select locations. Temporary support of the 1st floor structure and existing masonry walls will be required before construction. Lateral support at the top of the existing masonry wall may be necessary

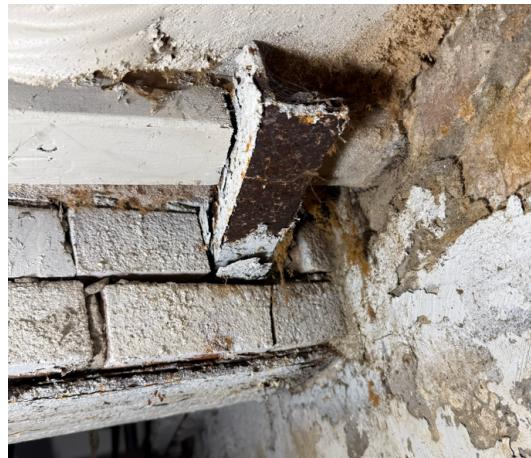
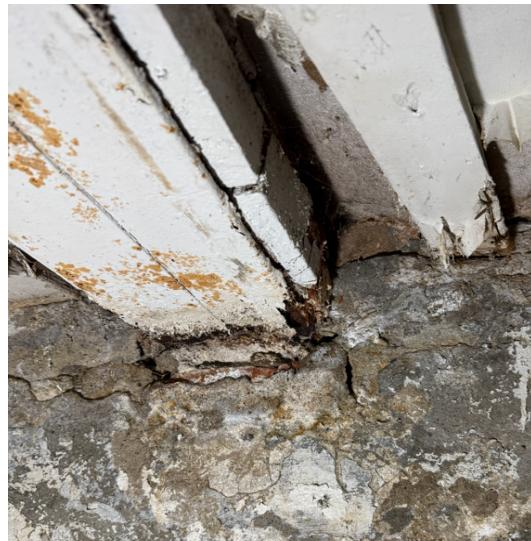
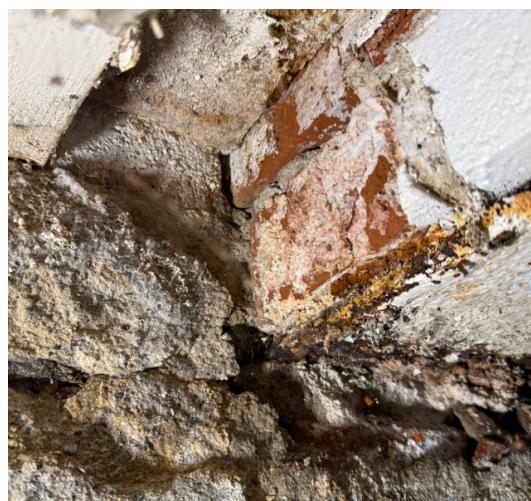
The steel angles in the basement supporting the masonry knee walls underneath the existing storefront and the concrete supported entrance slab are in poor condition structurally. The steel structural members are showing signs of intergranular delamination (pack rust) and surface rust. It is recommended that the members that are showing signs of surface rust be cleaned and painted with a zinc rich primer to prolong their life and prevent further deterioration. The angles that are showing signs of pack rust are in poor condition structurally. It is recommended that these members be removed and replaced in kind. Temporary support of the existing masonry walls and first floor system will be required before construction can begin. The beams bearing pockets are also in poor condition and are required to be restored/ grouted solid to prevent further deterioration/ movement of the beam. Refer to Photographs P2.1.2A, P2.1.2B & P2.1.2C

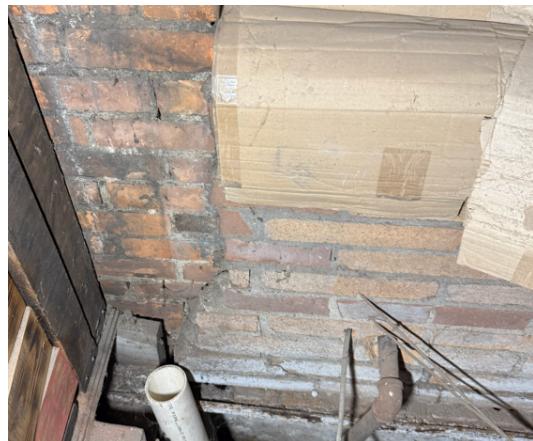
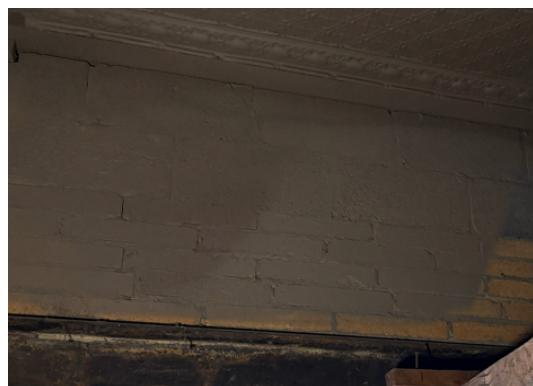
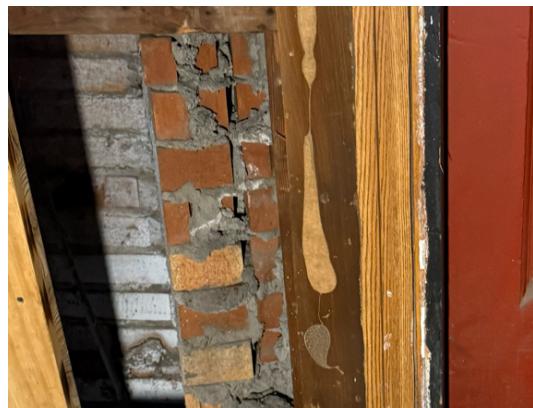
There are several areas where the masonry walls are in poor condition structurally. The brick units have begun to lose their integrity, and their mortar joints have softened. Masonry wall cracks were observed in multiple areas. The existing knee walls supporting the storefront system are in poor condition structurally and need to be removed/ replaced. Refer to photographs P2.2.1A, P2.2.1B, and P2.2.1C.

Note: Retrofit of the masonry brick walls is required for safety and serviceability of the structure. It is recommended that the bricks that have begun to lose their structural integrity be removed and replaced in kind, and mortar joints thought the first floor be tuckpointed. It is also recommended that the cracks observed along the masonry wall be patched/ repaired.

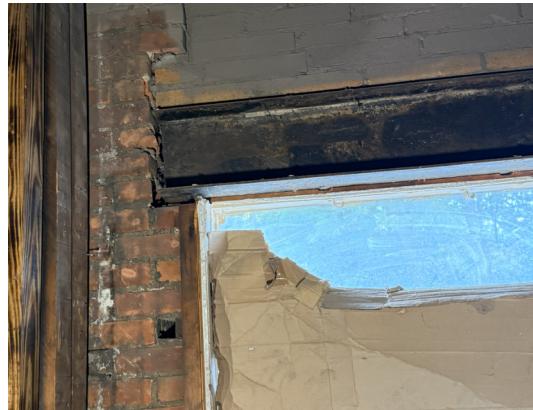
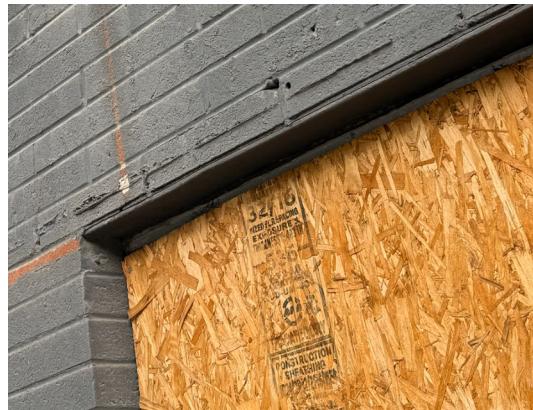
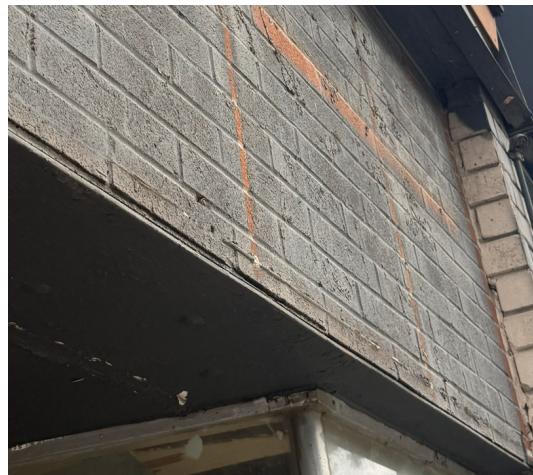
The lintel supporting the masonry above the existing storefront appears to be in good condition overall. The lintel is made up of a steel beam with a steel plate fixed to the bottom flange with steel rivets. The masonry joint above the steel plate is opening up and is in poor condition overall. The plate is also starting to deform/ deflect evidenced by a growing mortar joint and cracks throughout the masonry wall. All of these signs hint that the plate is deteriorating and pack rust is starting to form behind the masonry wall. As the rust forms the plate deteriorates further and starts to deflect. Refer to photographs P2.2.2A, P2.2.2B, and P2.2.2C.

Note: Retrofit of the existing steel lintel is required for the safety and serviceability of the structure. It is recommended that the existing masonry wall and second floor be temporarily supported and the existing deteriorated steel plate be removed and replaced. The existing steel beam is also required to be inspected and restored as needed during this process.

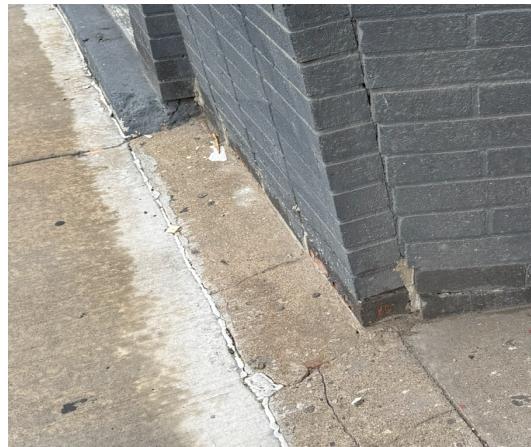
Photograph P2.3.1A

The masonry sill joint around the building is in poor condition and has eroded, spalled, and cracked in many locations. The deterioration of the sill joint is one of the sources of the water observed in the basement. Refer to photograph P2.3.1A

Note: Restoration of masonry sill joints and damaged units is required for the serviceability of the façade system and the overall building envelope.

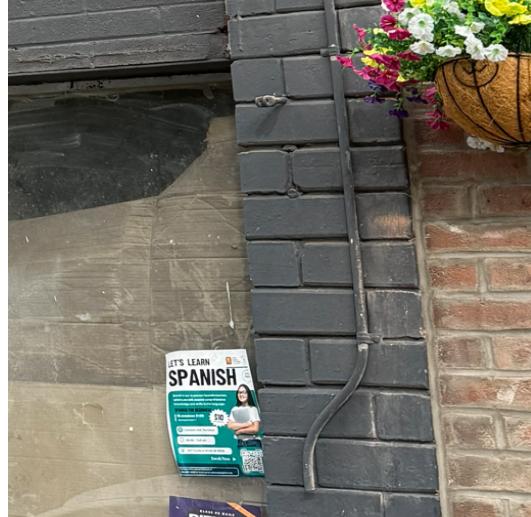
Photograph P2.3.2A

There are multiple areas throughout the Façade where old anchors/ clips and conduit are present. The rusted old inclusions within the building are causing accelerated deterioration of the building's façade. Refer to photograph P2.3.2A

Note: Retrofit of the masonry affected by the rusted clips/anchors is recommended to maintain serviceability of the façade system and the overall building envelope.

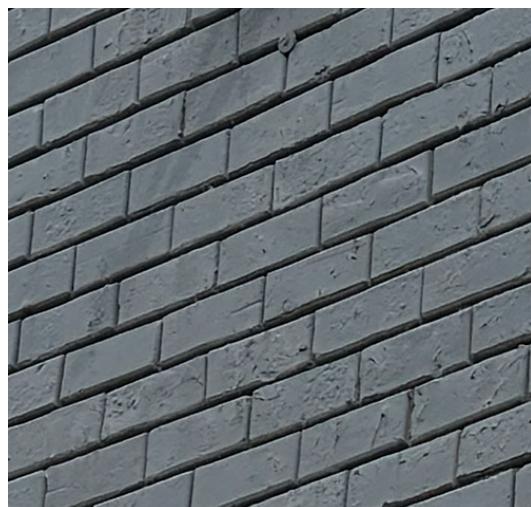
Photograph P2.3.3A

The joints through the masonry wall are in overall poor condition and should be repointed. Refer to photograph P2.3.3A

Note: Retrofit of the masonry joints is required to prolong the serviceability of the façade system and the overall building envelope. It is recommended that the joints be repointed as needed.

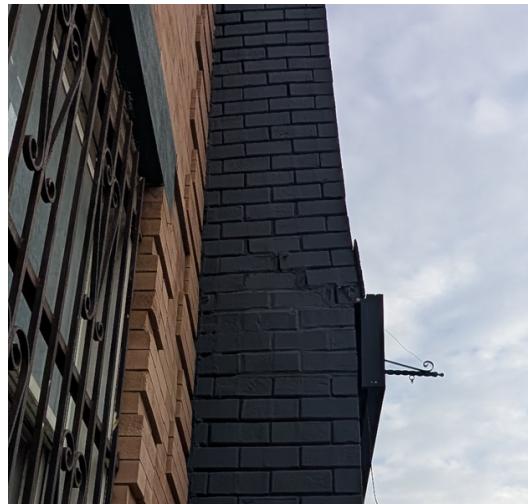
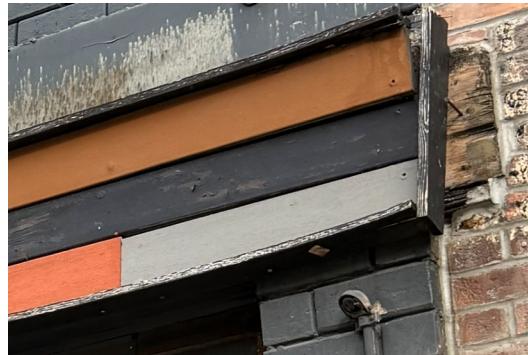
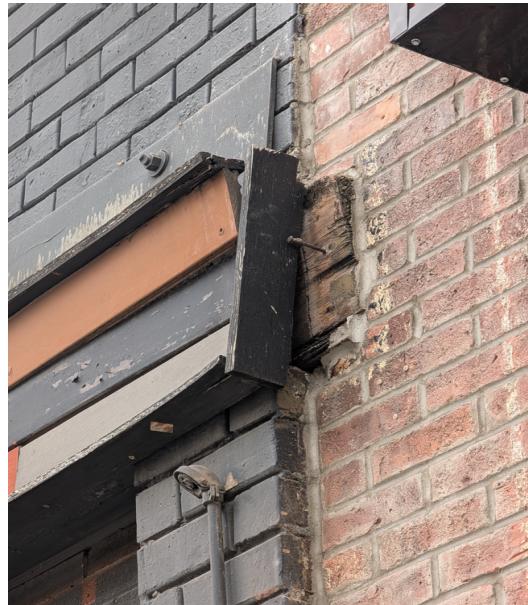
The steel beam supporting the masonry at the second-floor level is concealed by architectural finishes and is required to be exposed for further inspection. Based on the condition of the masonry above the beam and the notable bulge present at the second-floor line, it is likely the steel beam has deteriorated and requires structural restoration. The bulge in the masonry appears to have been stabilized previously via the addition of a through-bolted steel plate. The bulge in the masonry is continuing to grow, indicating that additional restoration is required. The additional restoration can only be determined after exploratory demolition. The nature of the second-floor lintel and its location relative to the sidewalk and main entrance to the building poses an immediate safety concern. Refer to photograph P2.3.4A, P2.3.4B, and P2.3.4C

Note: It is recommended that the beam be uncovered for further inspection. Restoration/ replacement may be required depending on its current condition to maintain the building's overall safety and serviceability
