# HISTORIC DISTRICT COMMISSION ADDITIONAL INFORMATION REQUEST

**Application Number:** HDC2025-00648

**PROJECT ADDRESS:** 19170 Warrington

Subject: Exterior Renovation - Front Balcony

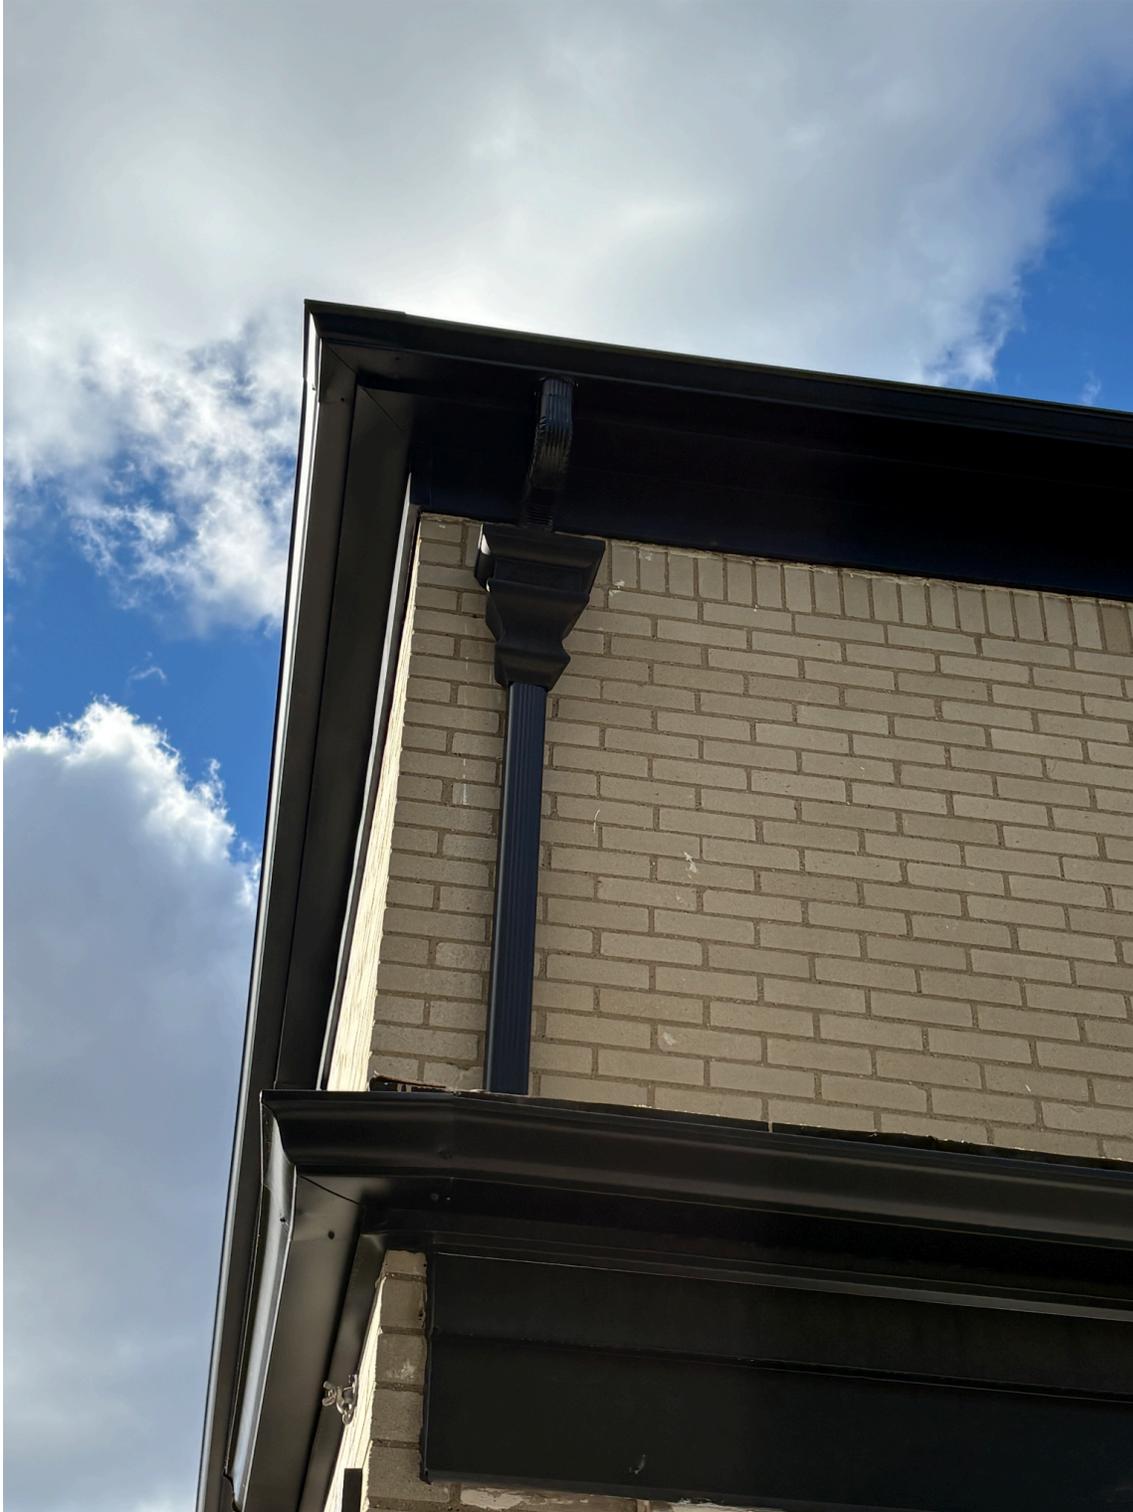
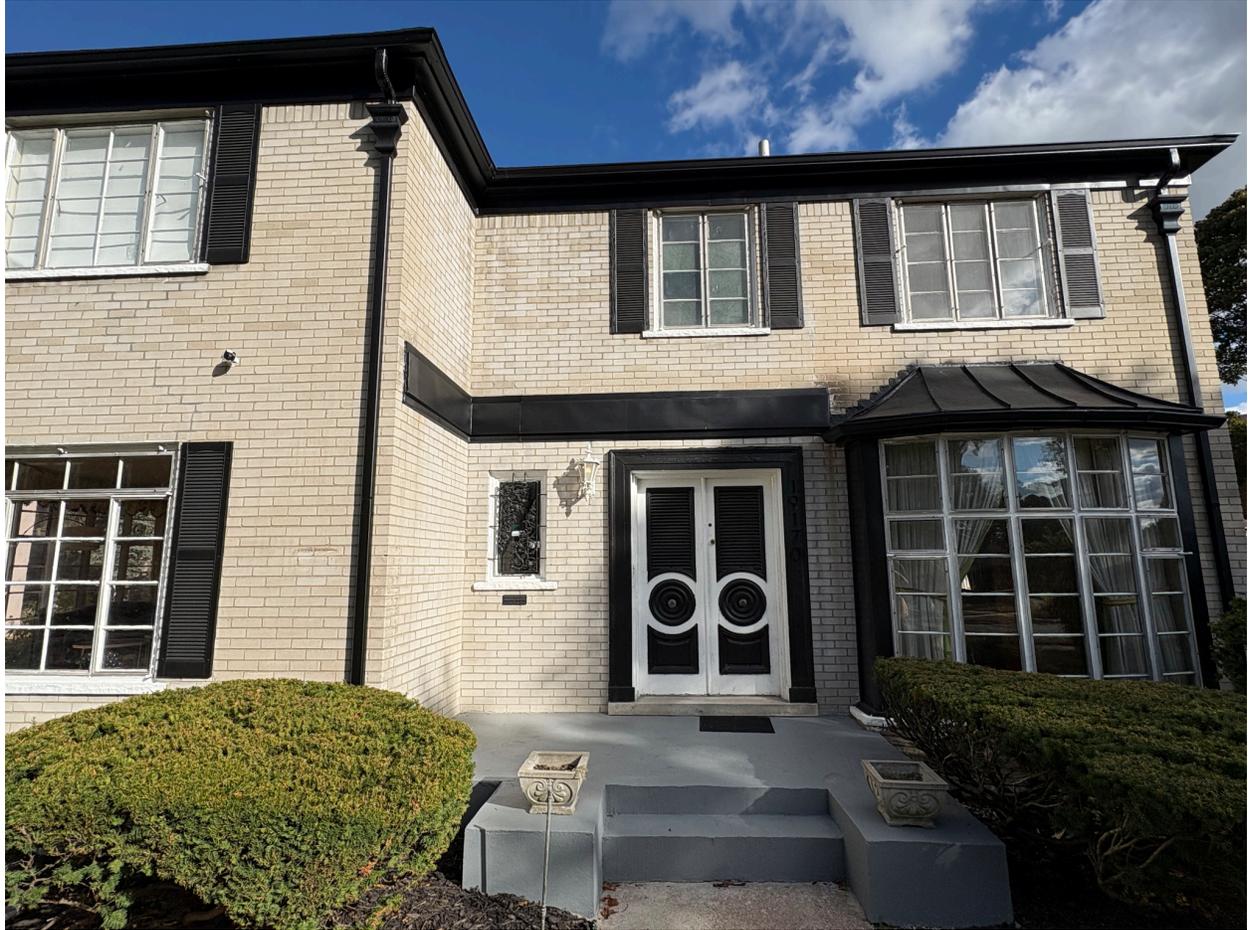
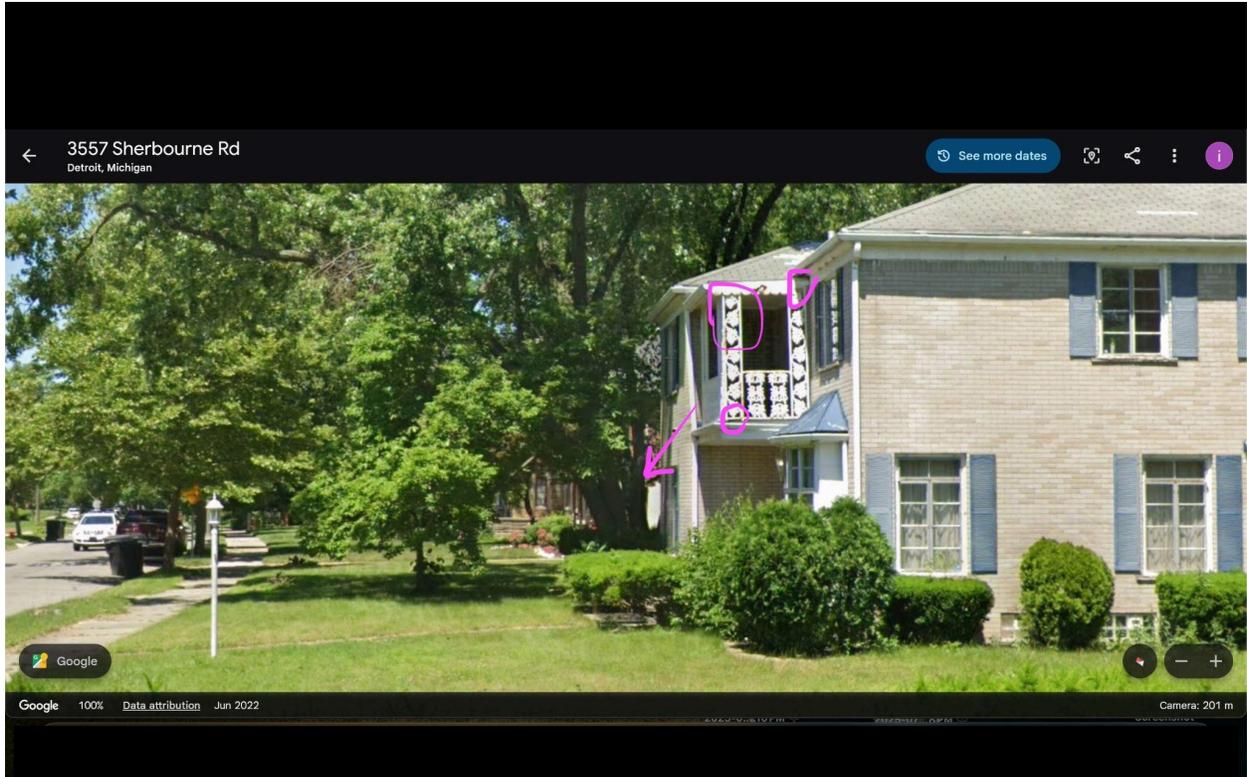
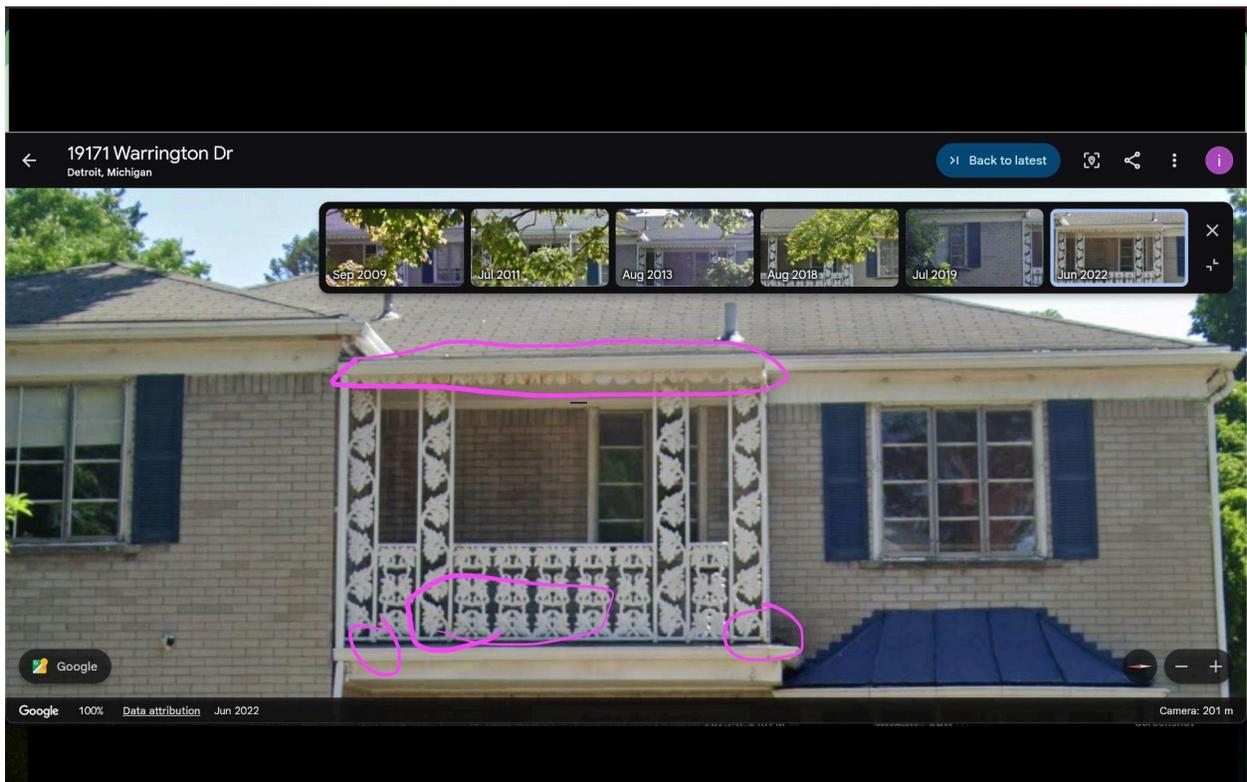
## Damage Needing Attention

- The existing false front porch structure in poor and unsafe.
- Supporting framework and metal components show rust and corrosion.
- Structural instability.
- Railing and supporting poles heavily oxidized, visible pitting
- Loose poles at the base.
- Due to the extent of deterioration and deterioration of anchor points, complete removal of false porch.

- The exposed fascia area will be repaired and finished with custom-fitted aluminum trim designed to match the existing trim.
- Aluminum fascia will improve durability and protection against weathering.
