# HISTORIC DISTRICT COMMISSION ADDITIONAL INFORMATION REQUEST

**Application Number:** HDC2025-00648

# Inspection Report

**Property Address:**  
19170 Warrington  
Detroit MI 48221

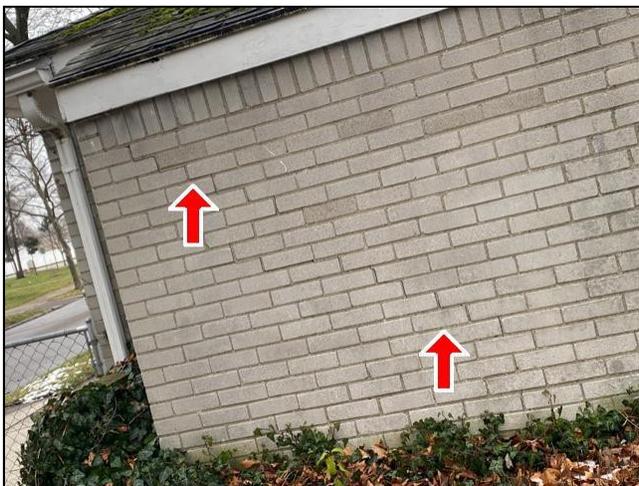
2.1 Item 1(Picture)

(1) Small amount of step cracking noted in the brick veneer. This should be repaired to seal against the weather and monitored. If further cracking occurs, a qualified specialist should evaluate and make repairs as needed.

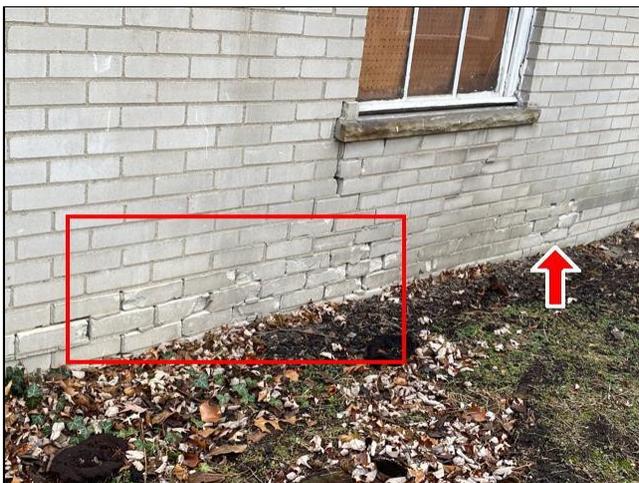
2.1 Item 6(Picture)

(2) Heavy brick and mortar deterioration noted at garage. A qualified contractor should evaluate and repair/replace as needed. Cost estimates should be obtained.

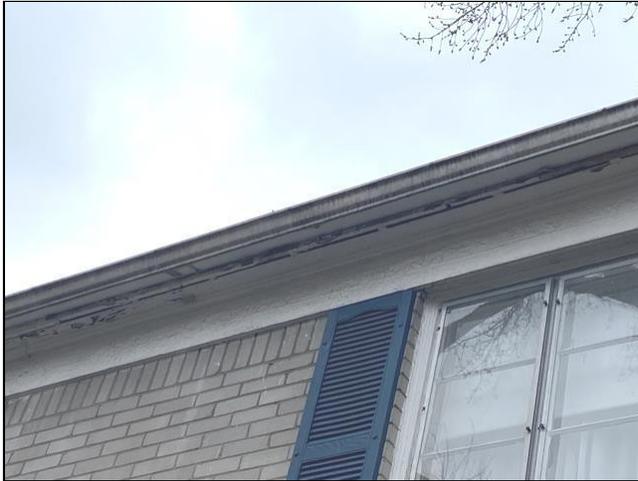
2.2 Item 1(Picture)

(1) The exterior trim needs painting soon. Paint always lasts longer when preceded by proper preparation. Make sure the wood is completely dry before painting; remove any loose paint and prime bare wood areas before applying a finish coat. Paint maintenance is especially important to prevent decay in the "paint grade spruce" wood trim now in common use. When areas are painted expect the painters to possibly find some soft wood from water damage that might need replacement. Budget for isolated wood replacements as part of the painting process.

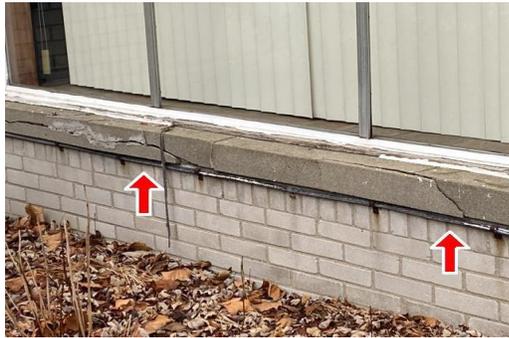
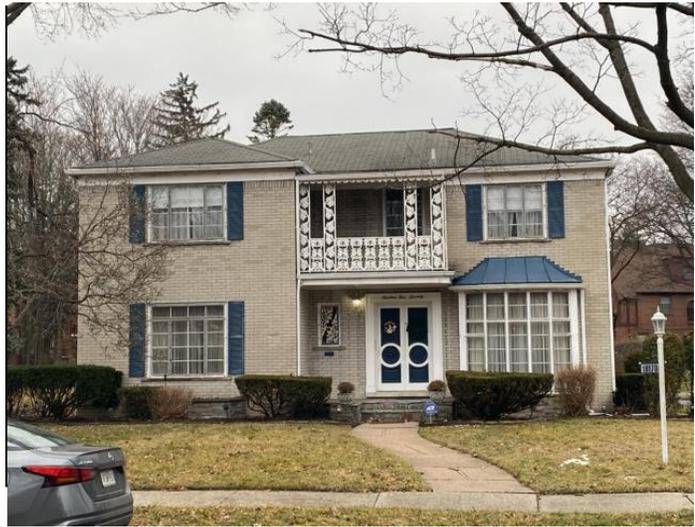
(2) Spot decay/deterioration noted at Upper porch support and rear window ledge repair and refinishing needed These should be keep well sealed Against the weather to prevent damage.

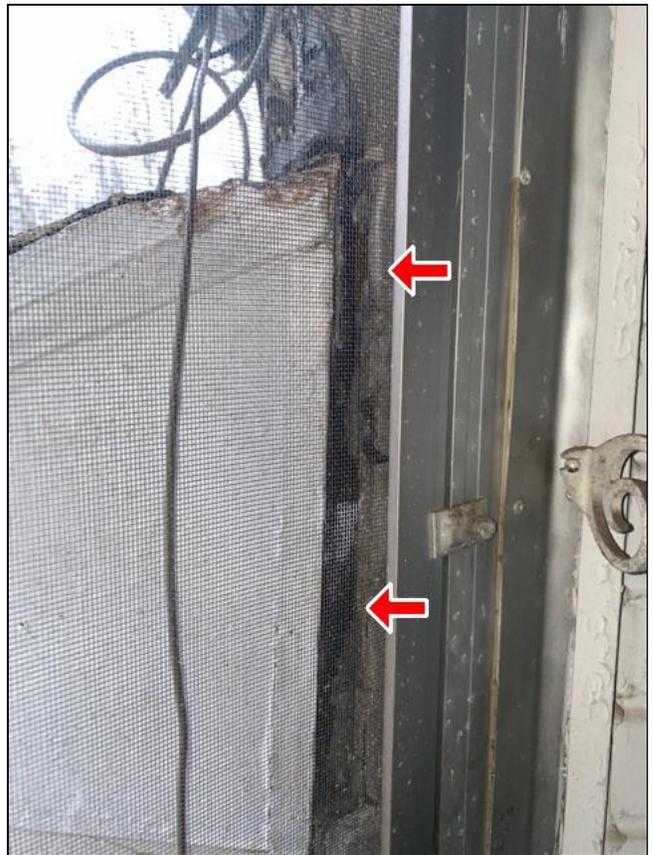
2.2 Item 8(Picture)

(3) Gaps/holes should be sealed against the weather.

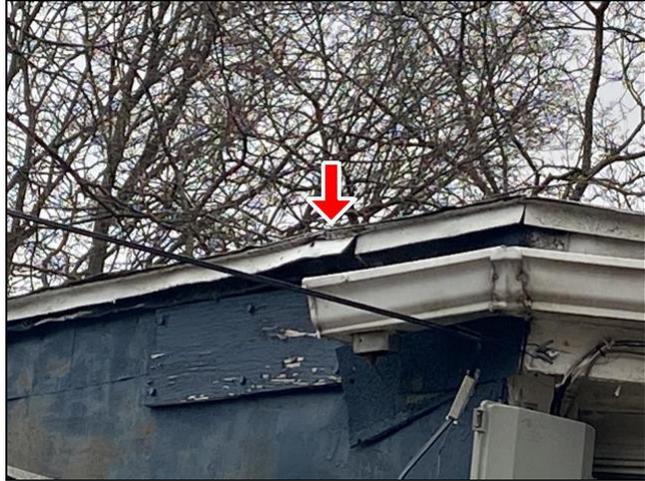
2.2 Item 9(Picture)

(4) Loose panels at rear should be repaired as needed.

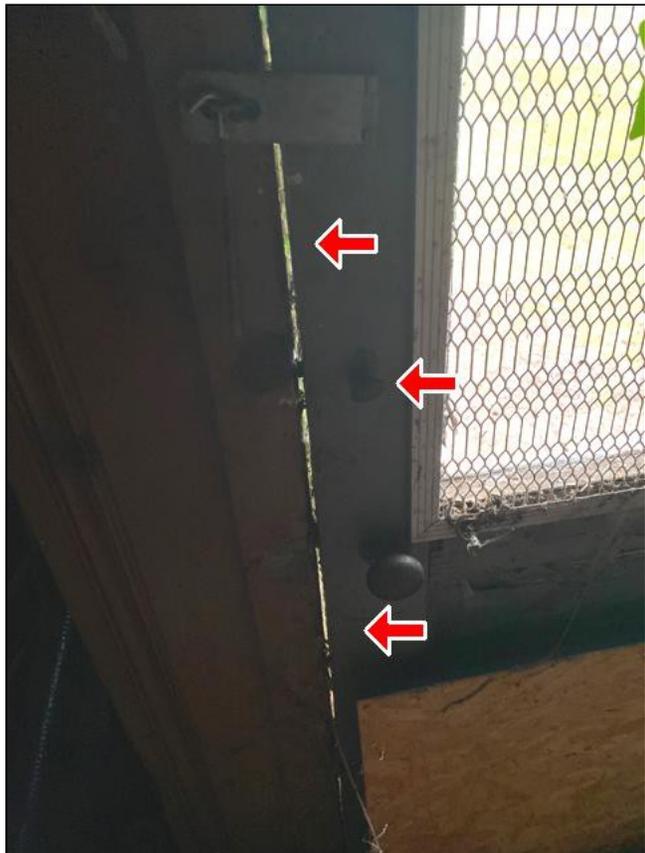
2.3 Item 1(Picture)

(1) The garage does not lock and has loose/missing weather-stripping. Repairs are needed. A qualified contractor should repair or replace as needed.

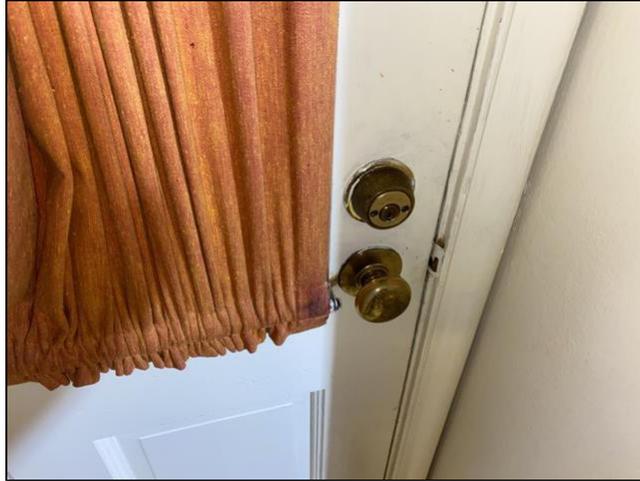
2.3 Item 2(Picture)

(2) Keyed deadbolt(s) noted (lock requires a key from the inside to operate). These are no longer considered suitable because they can prevent quick exit in an emergency. We suggest upgrading to locks which can be operated with a hand motion. Typically this can be done when you have the locks rekeyed upon occupancy.

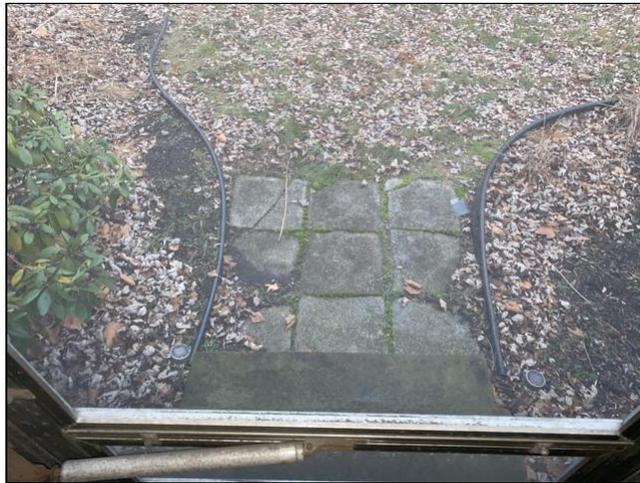
2.5 Item 1(Picture)

Common cracking and minor settlement noted. Sealing the cracks and gaps between slabs can help reduce the chances of settlement from water intrusion. If the settlement threatens to become a trip hazard it should be corrected.

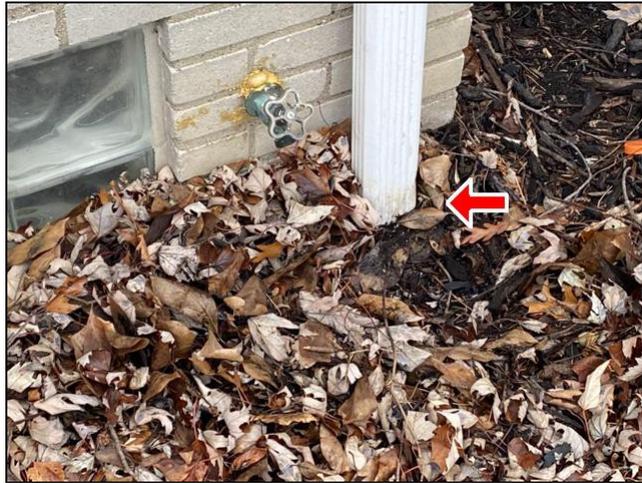
2.7 Item 1(Picture)

(1) The below ground drain lines for downspouts are old and we are unable to determine if drains will function properly. It is common for these to become blocked, which can lead to foundation water intrusion. Many communities require these to be disconnected because municipal sewers are at or near capacity. As a proactive step, we suggest you disconnect and attached downspout leaders to direct water away from the structure.

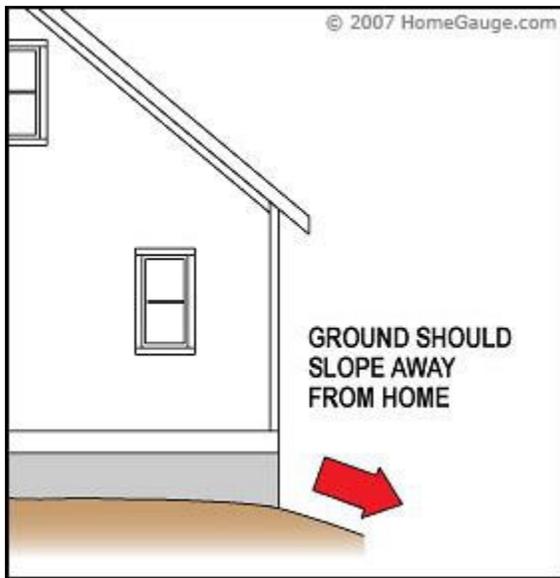
2.7 Item 2(Picture)

(2) We suggest regrading as needed to assure all water drains away from the foundation without covering siding. Controlling water around the foundation is the single biggest factor in reducing the chances for water infiltration into the structure. Nearly every structure we inspect has room for improvement.

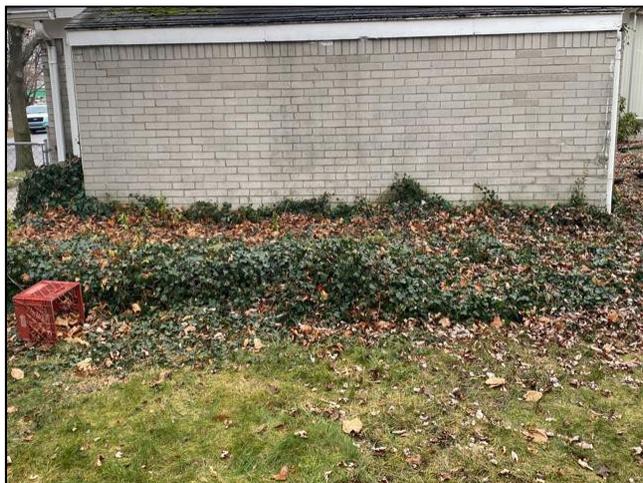
2.9 Item 1(Picture)

We suggest trimming vegetation well away from the structure to provide free airflow, reduce chances of damage and allow for routine observation and maintenance.

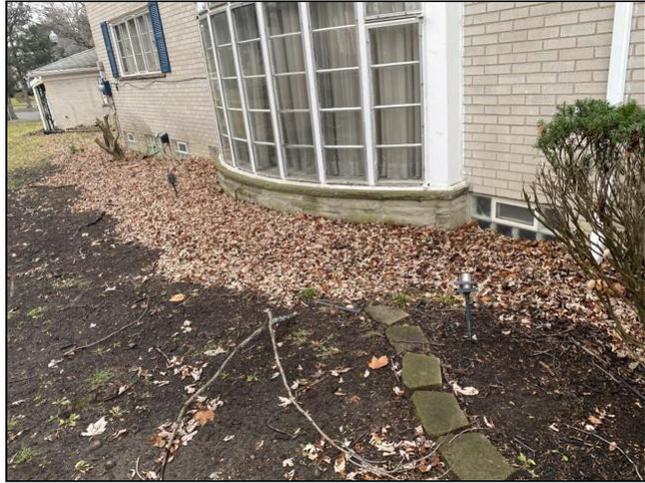
2.15 Item 1(Picture)

Portions of the building exterior and/or the grounds at the left side of the building are obstructed by dense piles of dead leaves and could not be inspected. The vegetation should be trimmed for inspection and maintenance purposes.

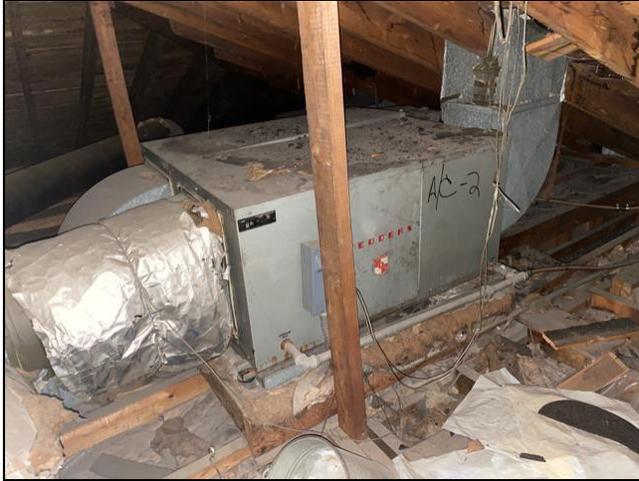
3.3 Item 1(Picture)

Old A/C unit found in the attic. Due to winter temperatures it was not tested but unit looks to be at the end of its useful life.

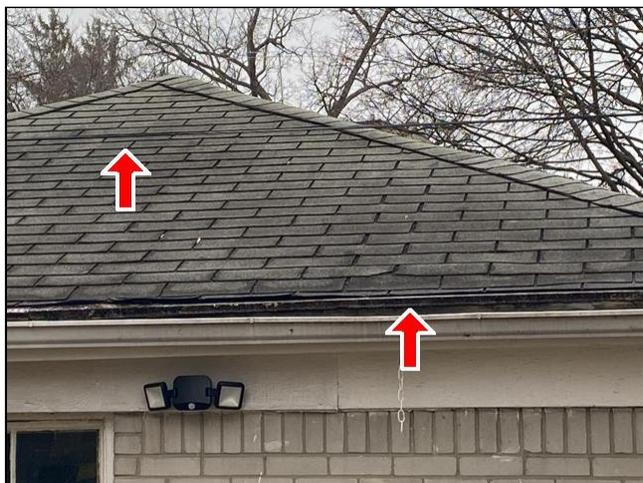
4.2 Item 1(Picture)

(1) Damaged shingles should be replaced to reduce risk of leaks.

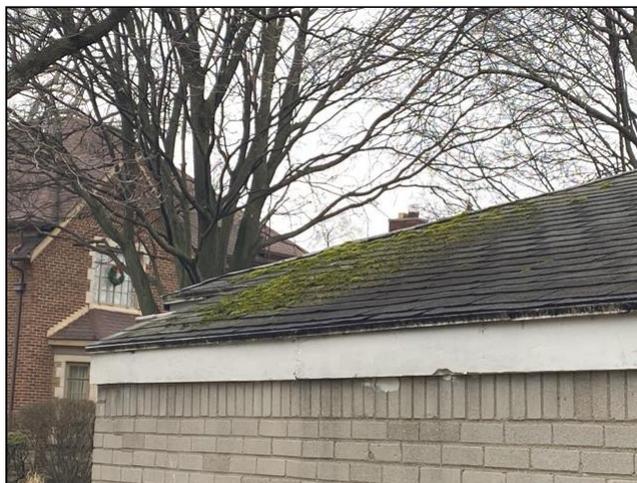
4.2 Item 8(Picture)

(2) Moss/lichen growth noted. An approved cleaner should be applied to kill off the growth as this can cause deterioration of the roofing materials. Appropriate roof safety caution is needed when working on the roof.

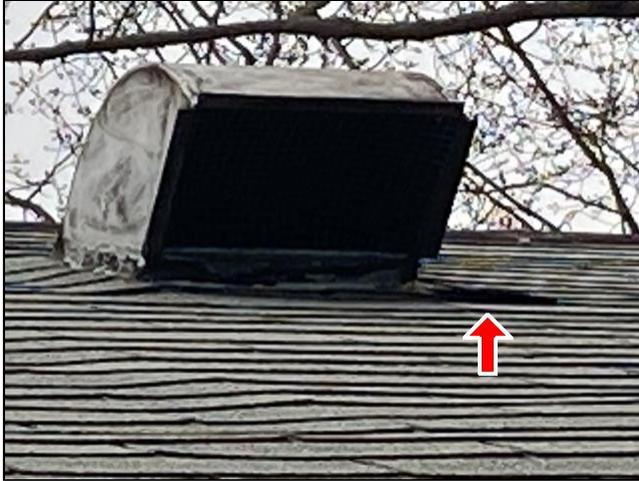
4.3 Item 1(Picture)

We suggest securing/sealing the apron flashing to help prevent leaks. This is typically an easy

repair for the roofer.

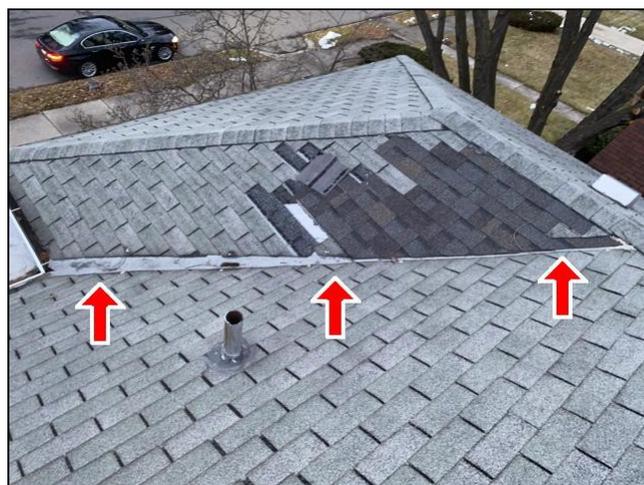
4.4 Item 1(Picture)

Uneven valley cut noted; correction advised. Standard roof practice is to trim a straight line 2 inches back from the valley center-line to help properly shed water.

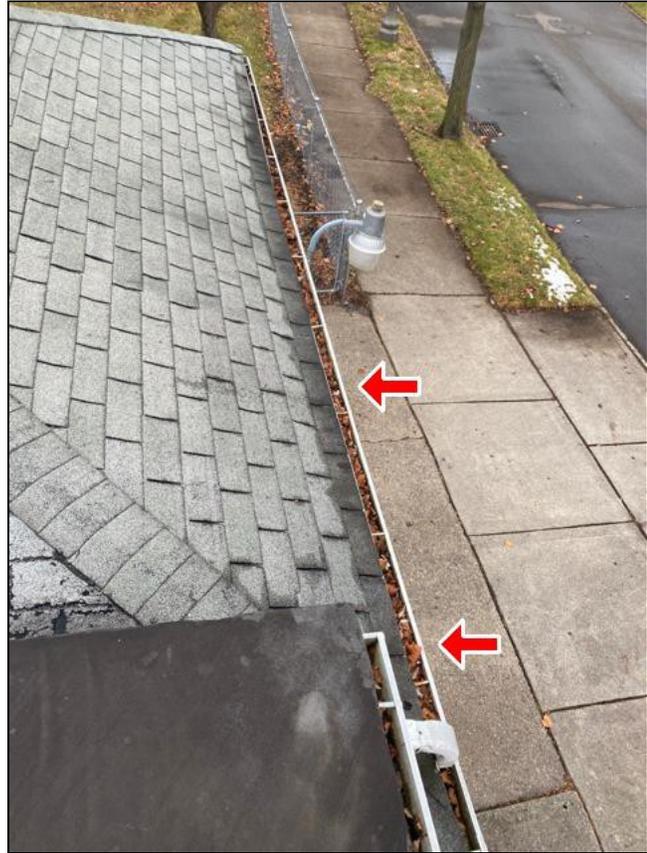
4.5 Item 1(Picture)

(1) The gutters are full of debris in areas and need to be cleaned. The debris in gutters can also conceal rust, deterioration or leaks that are not visible until cleaned.

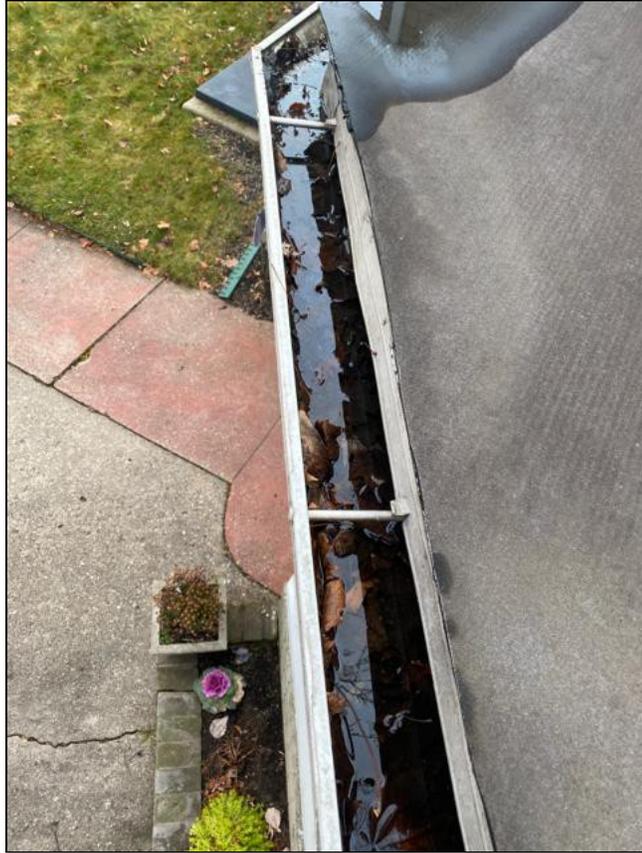
4.5 Item 2(Picture)

(2) A section of the gutters were filled with water at the time of this inspection, indicating improper drainage, which could promote water penetration of the building and damage to exterior and interior building elements and finishes.

-SUGGESTION: All gutters should be cleaned. The condition of the gutters can be evaluated after the debris has been removed.

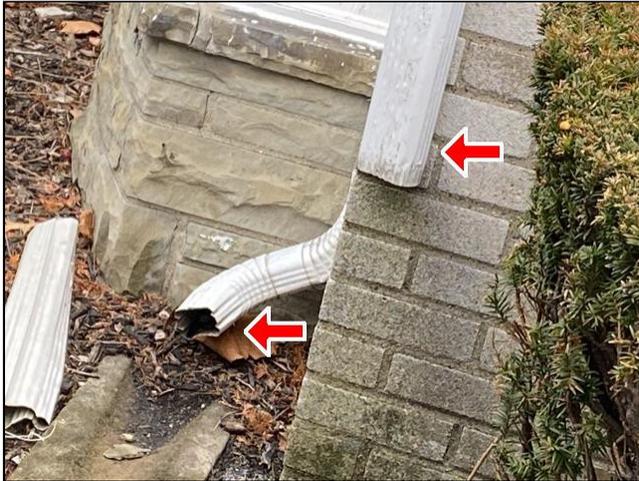
4.5 Item 3(Picture)

(3) We suggest extending downspout drainage well away from the foundation to reduce the chances of water intrusion into the structure.

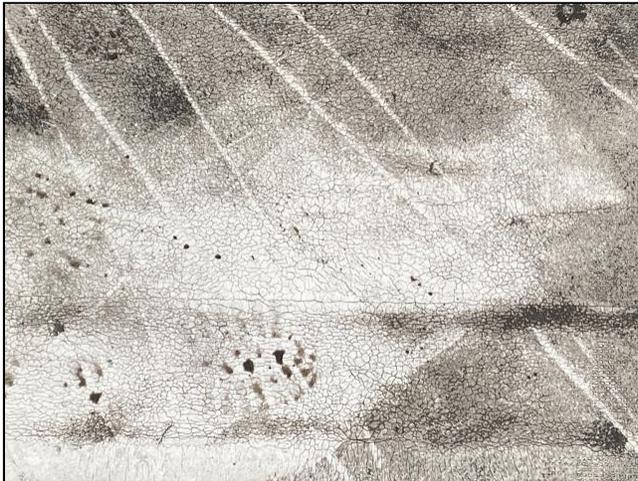
4.6 Item 1(Picture)

(1) Alligatoring (scaly cracking of exposed bitumen). Such areas should be regularly maintained with an approved sealer. This helps prevent stress cracks in the membrane, particularly in cold weather.

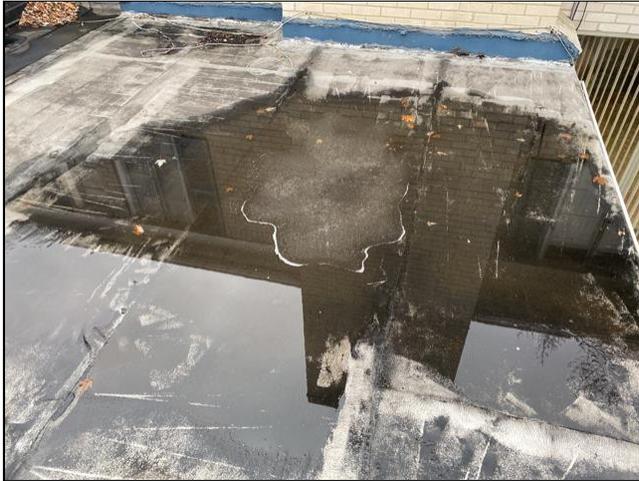
4.6 Item 3(Picture)

(2) Areas appear to have an on-going "ponding" problem. When water remains on a roof longer than 48 hours there is an increased risk of leaks and accelerated roof wear. Steps should be taken to pitch the roof for adequate drainage.

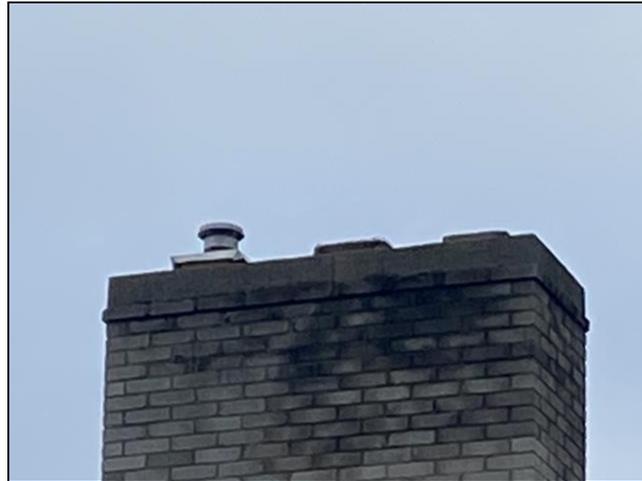
5.1 Item 3(Picture)

(2) Metal weather cap for furnace vent/flue is missing. This can allow water and debris to enter the flue. Should the vent become obstructed, unsafe flue gasses can enter the home. The flue interior should be checked by a qualified contractor and a proper cover installed.

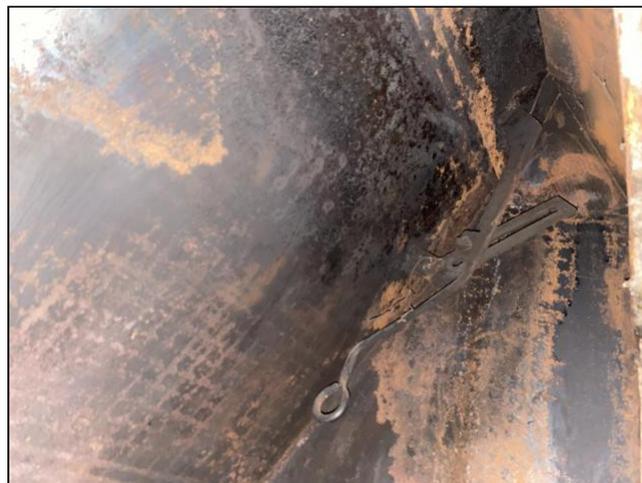
5.2 Item 1(Picture)

The damper arm and linkage for fireplace at the living room will fall out of alignment when operating. Repairs should be made so unit works properly. A qualified technician should inspect and repair as needed.

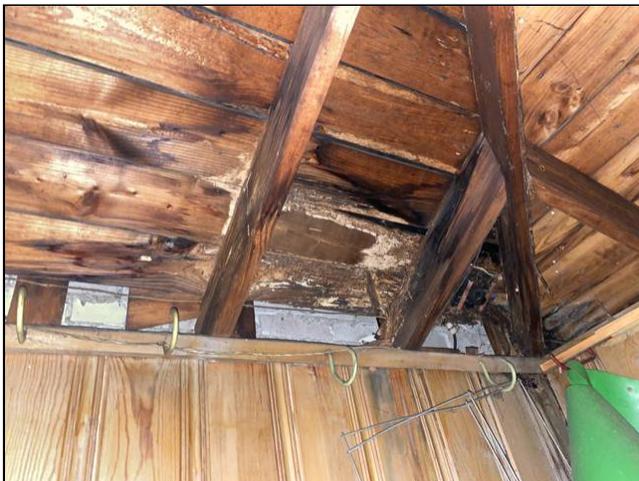
6.1 Item 1(Picture)

The ceiling is deteriorated and reveals a water stain indicating a leak did or still exists. Repairs are needed. A qualified contractor should repair or replace as needed.

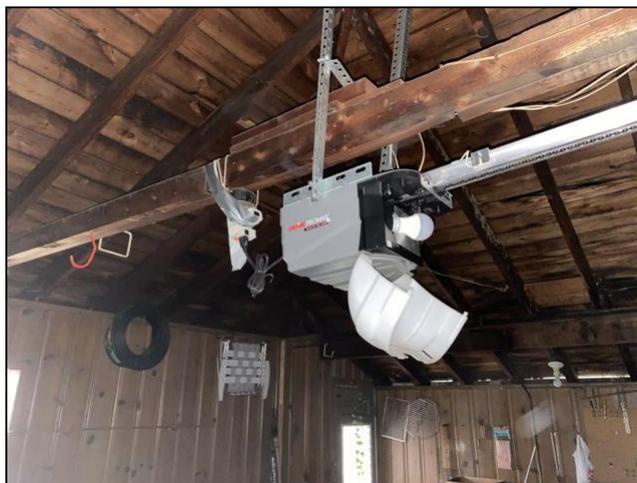
6.5 Item 1(Picture)

The garage door opener raised and lowered the door, and it stopped and reversed when the light beam was interrupted. However, it did not stop or reverse when meeting resistance. Typically, this condition can be remedied by a simple adjustment of the door sensitivity. The sensitivity on the closing (downward) force exerted by the opener mechanism should be adjusted to a safe level.

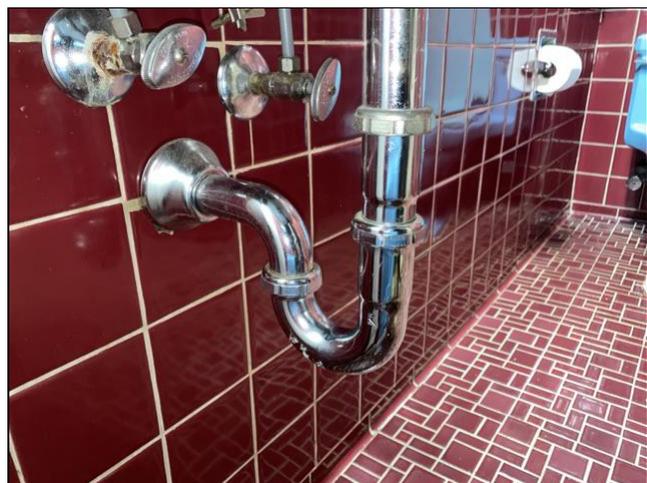
8.1.A Item 1(Picture)

The trap on waste line is leaking at the second floor hall bath sink. Repairs advised to help prevent damage.

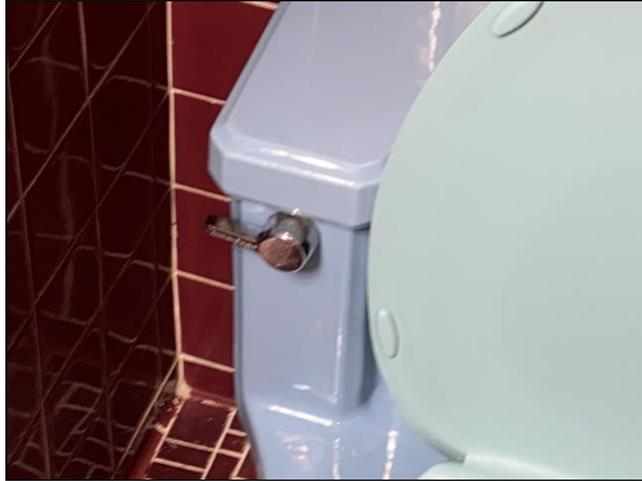
8.4.A Item 1(Picture)

The toilet in the hall bathroom won't flush unless lever is held down. Repairs are needed. A qualified licensed plumber should repair or correct as needed.

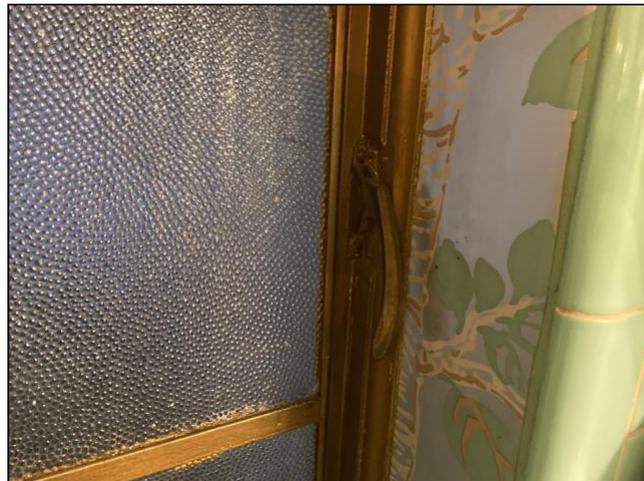
8.3.B Item 1(Picture)

The bathroom has a sealed window and no vent fan. A lack of adequate ventilation in a bathroom can cause a variety of problems, including deterioration of interior finishes and the growth of mold. We suggest having adequate ventilation provided.

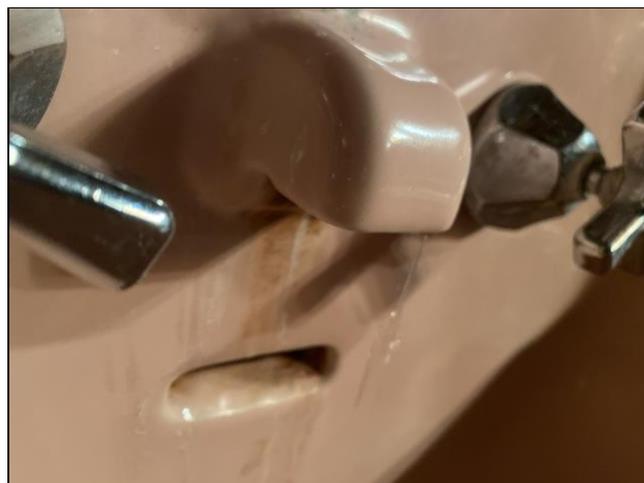
8.1.C Item 1(Picture)

The faucet is leaking at the master bath sink. Repairs advised to help prevent damage.

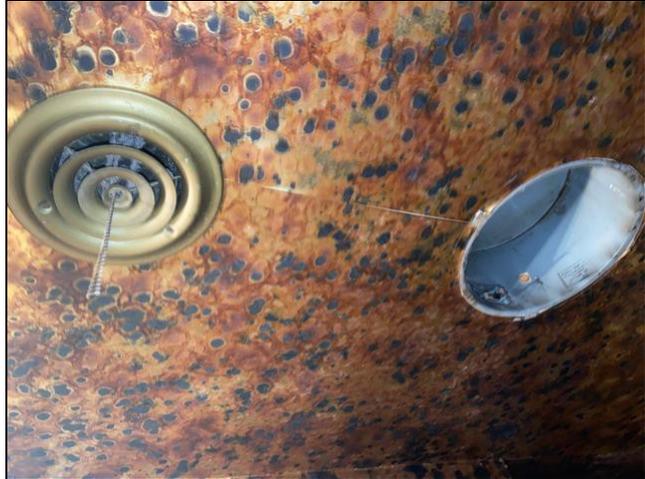
8.3.C Item 1(Picture)

The fan in master bathroom is inoperable and should be repaired or replaced to help prevent excess moisture build up in the structure.

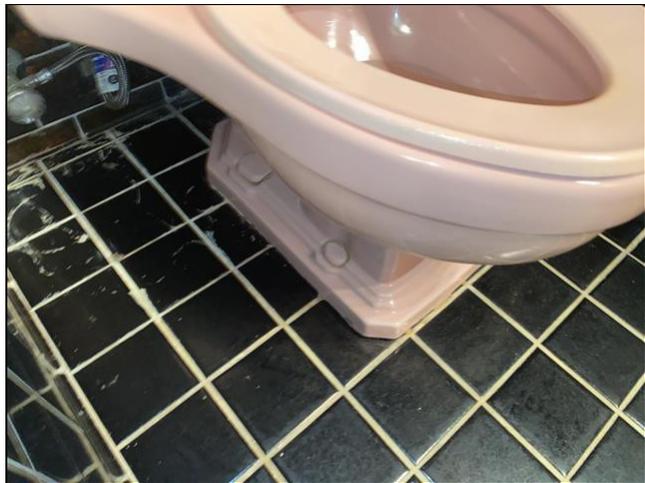
8.4.C Item 1(Picture)

The toilet bowl in the master bathroom is loose at the floor anchor bolts. The wax ring inside the unit must have a snug, secure fit in order to prevent leaks and damage. Resealing, leveling and re-securing this unit is advised, prior to use. The flooring in this area should be checked for damage.

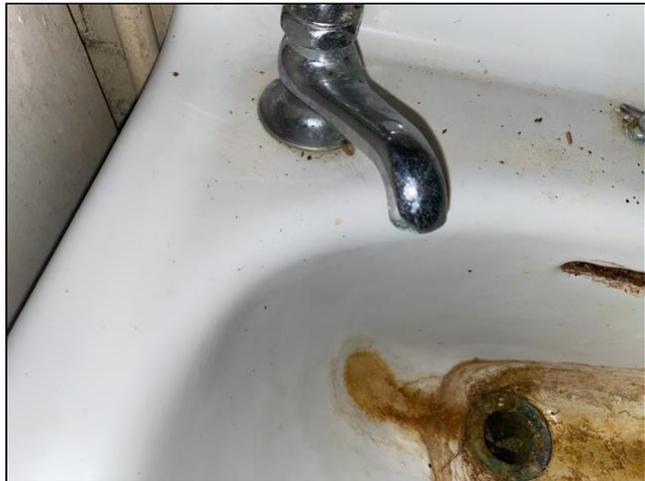
8.1.D Item 1(Picture)

The faucet is leaking at the basement bathroom. Repairs advised to help prevent damage.

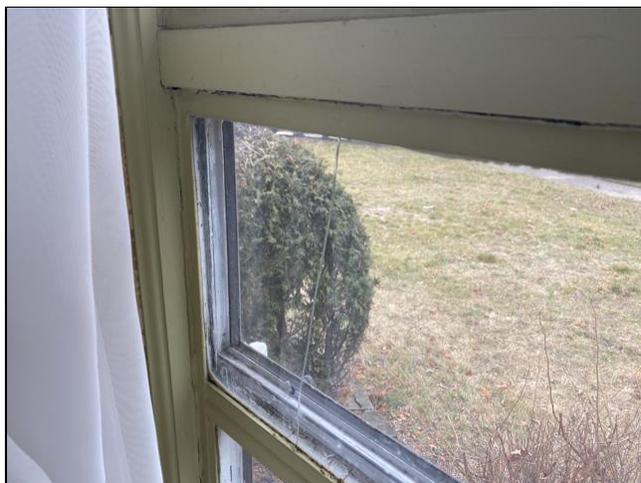
9.2 Item 1(Picture)

(1) One window at the dining room and others in the right front and left middle bedrooms are both cracked at glass pane. A repair is needed. A qualified contractor should repair or replace as needed.

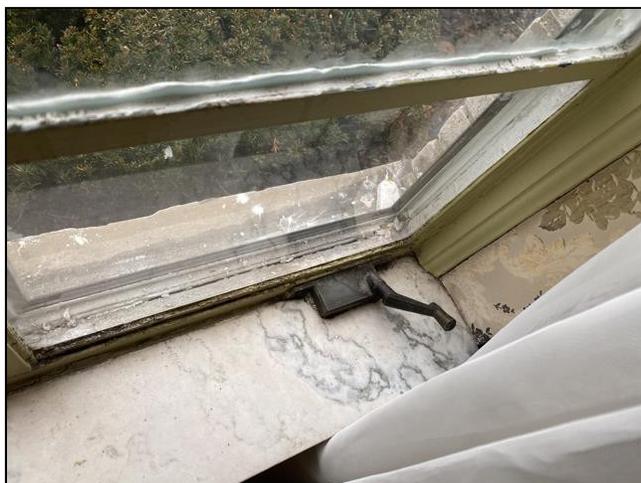
9.2 Item 3(Picture)

(2) "Be advised that casement windows tend to operate inconsistently and have a tendency to stick dependent upon type of hardware, sash/frame design, paint thickness and humidity level; be prepared for this occurrence. Be sure to keep the window jamb and bottom areas of the windows well sealed to prevent wood rot. Also, the bottom edge and hinge area of the windows can become water damaged and it's difficult for the inspector to see and many times screens or other items prevent feeling the bottom edge; keep bottom windows wedges well painted/sealed".

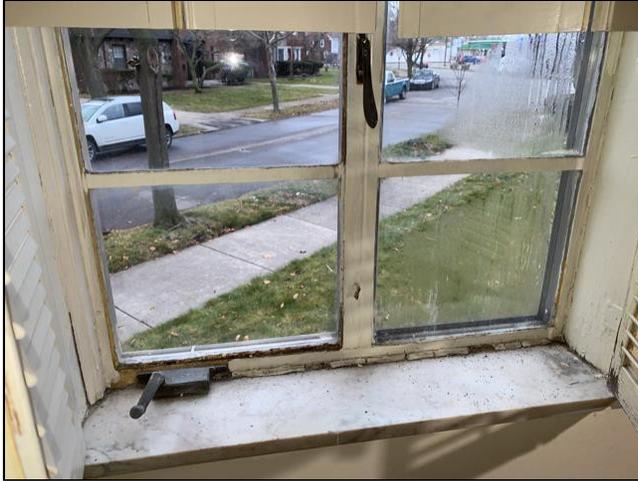
9.2 Item 5(Picture)

window and storm unit in each room for fire egress.

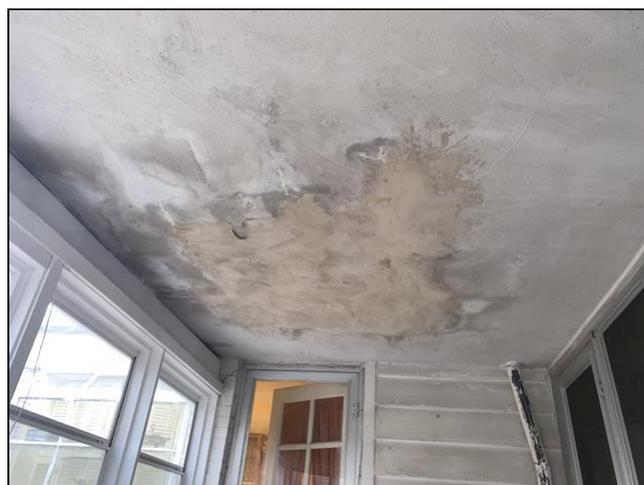
9.3 Item 1(Picture)

(1) Patching noted at breezeway.  
We suggest obtaining the  
maintenance history.

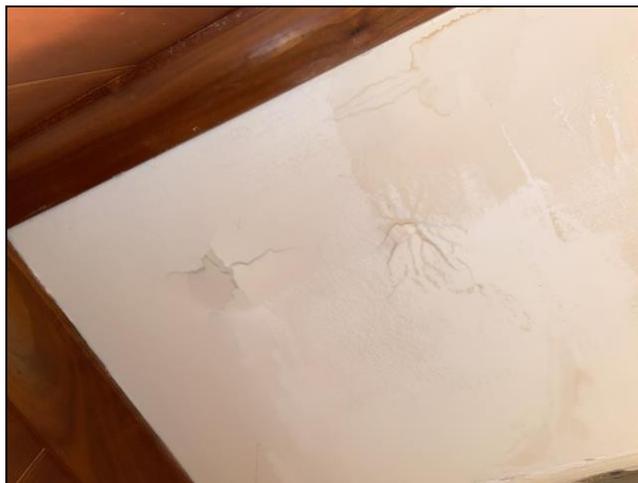
9.3 Item 2(Picture)

(2) Water stains noted underneath upstairs hall bathroom. We suggest obtaining the maintenance history and having corrected as needed.

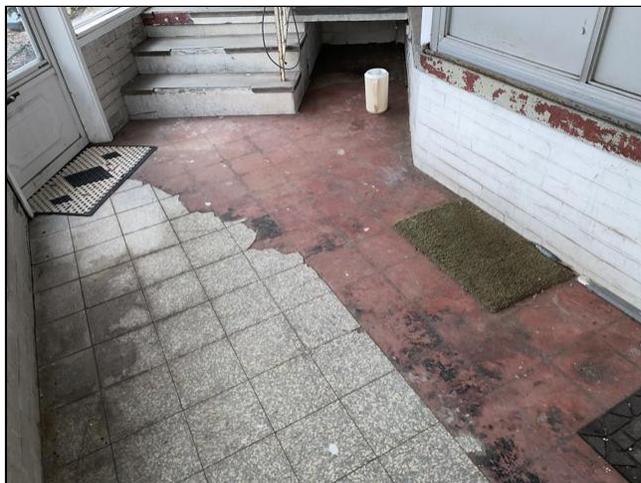
9.6 Item 1(Picture)

Cracked tiles noted at the breezeway and in basement should be checked for asbestos and repaired/replaced as needed.

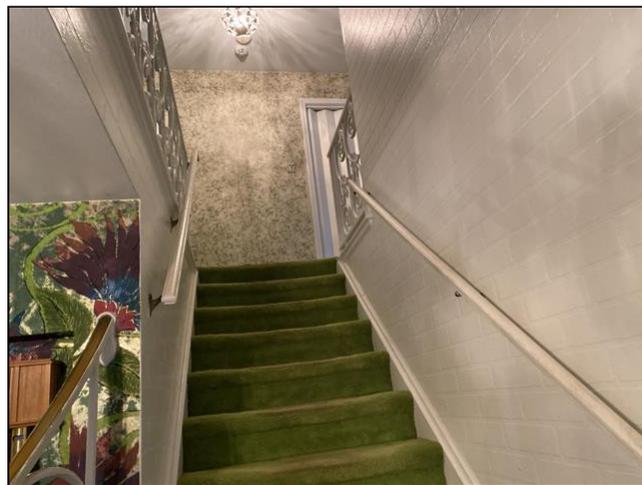
9.7 Item 1(Picture)

Loose railing(s) at the stairs to second story should be properly secured to help prevent slip and fall

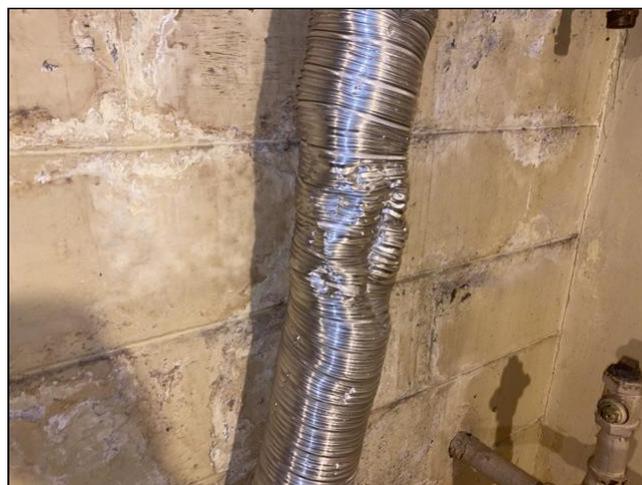
11.1 Item 1(Picture)

The clothes dryer vent is kinked/ restricted. Clothes dryer vents that are not vented properly can cause moisture/lint problems and could be a fire hazard. A qualified contractor should repair or replace as needed.

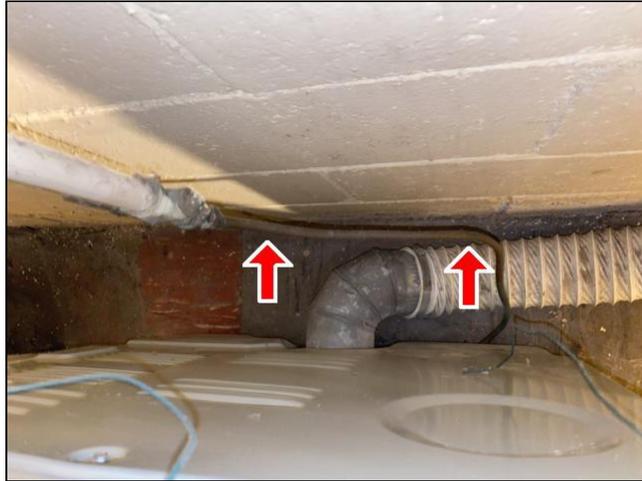
11.2 Item 1(Picture)

Copper/Aluminum gas line should be replaced with approved flexible appliance gas connector. We suggest you look for one with an excess flow valve that help prevents leaks to further enhance safety.

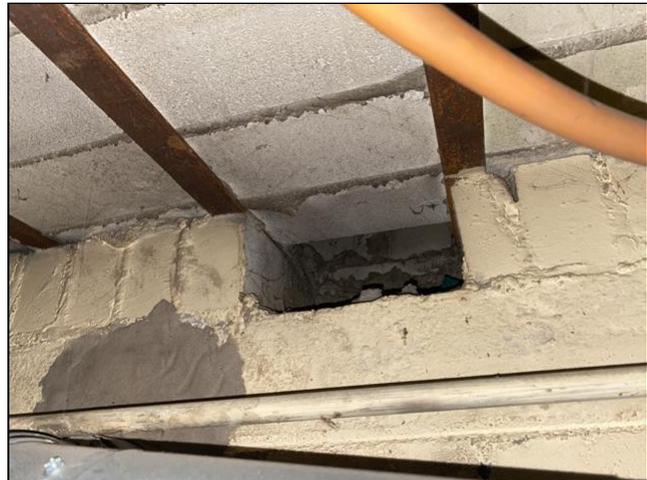
13.6 Item 1(Picture)

Advise properly sealing where the vent enters the chimney to help prevent toxic flue gas escape. Although important, this is typically an easy repair.

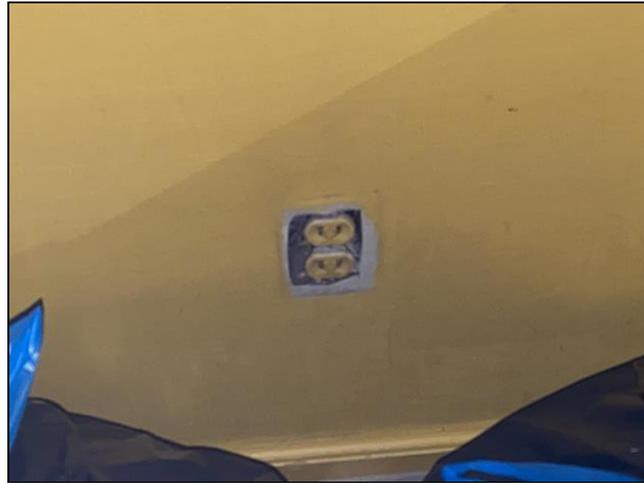
14.3 Item 1(Picture)

(1) Missing coverplates should be installed to prevent accidental contact with electrical wires.

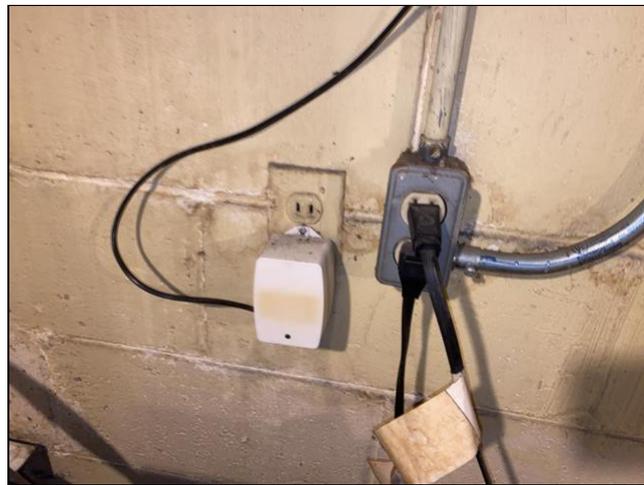
14.3 Item 2(Picture)

(2) Some receptacle outlets are not a three-prong GFCI (Ground Fault Circuit Interrupt) in the basement. Electrical issues are considered a hazard until repaired. We recommend further evaluation by a qualified electrician who can make any repairs as needed.

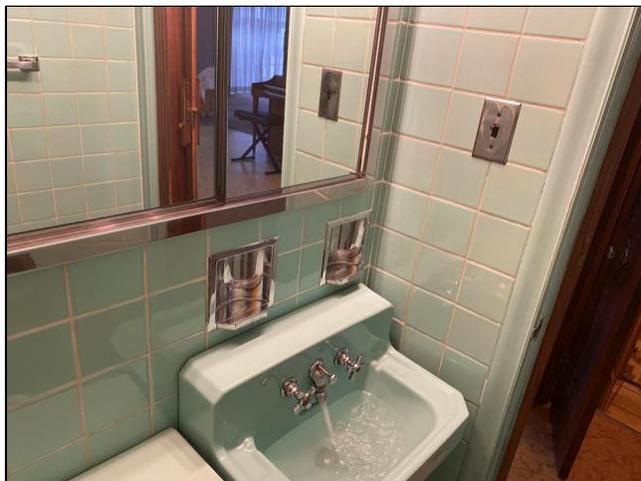
14.4 Item 1(Picture)

GFCI protection is missing at all bathrooms. Correction advised. GFCI receptacle outlets are relatively inexpensive but are an important modern electrical safety component.

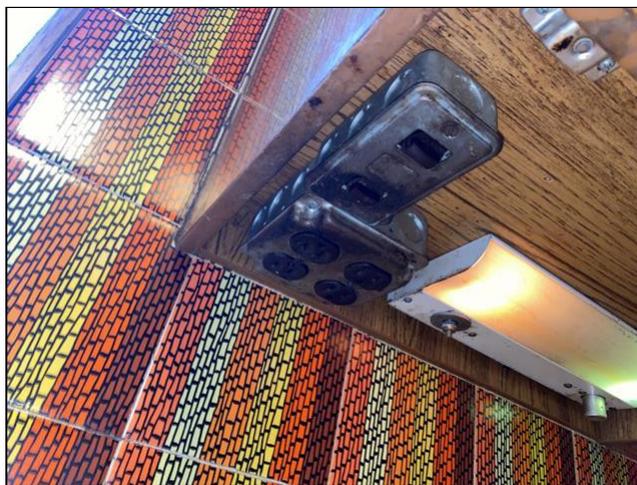
14.5 Item 1(Picture)

(1) GFCI protection is missing at the kitchen. Correction advised. GFCI receptacle outlets are relatively inexpensive but are an important modern electrical safety component.

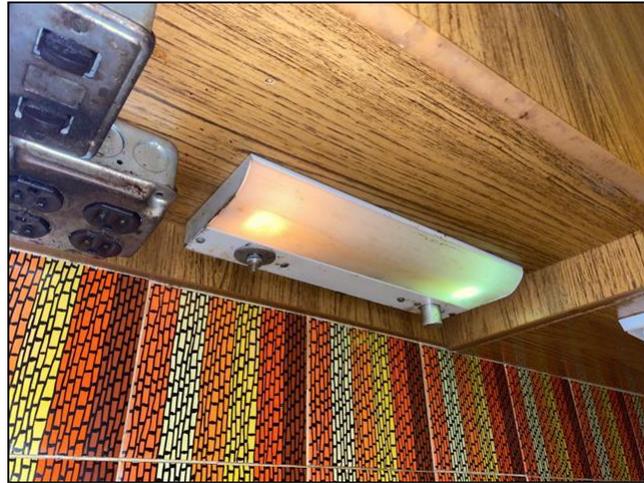
14.5 Item 2(Picture)

(2) Light flickering under cabinet needs repair.

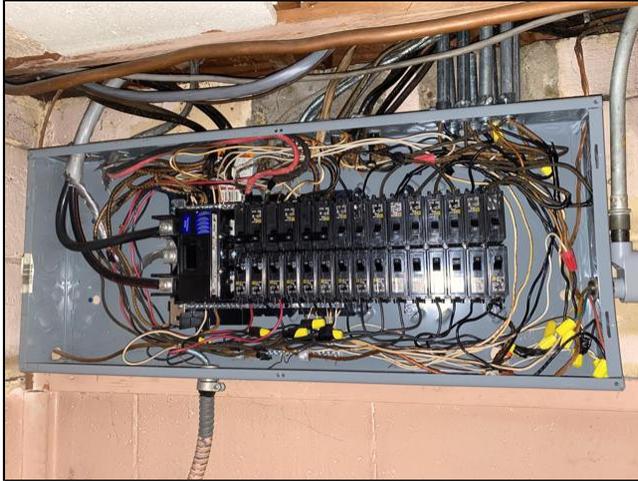
14.7 Item 1(Picture)

Multiple wires are installed on one or more terminals. The connectors do not appear to be designed to accommodate two circuits. This can overload the circuit and/or cause loose connections and should be corrected by a qualified electrician. In cases where there is no overloading, this can often be fixed with a minor wiring change.

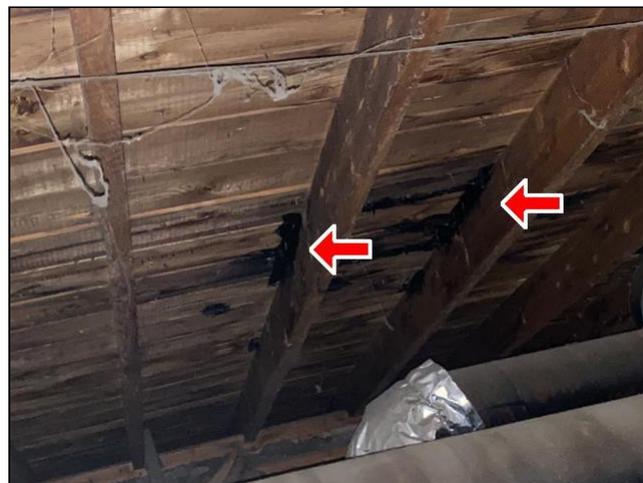
15.8 Item 1(Picture)

Tar was found in the attic on the underside of the roof sheathing. Recommend further evaluation by qualified contractor to repair/replace as necessary.

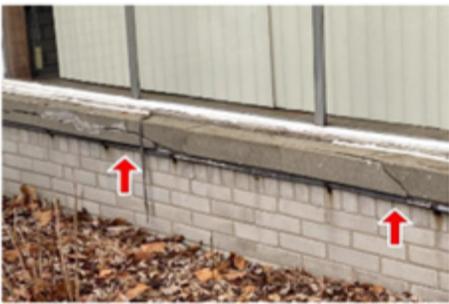
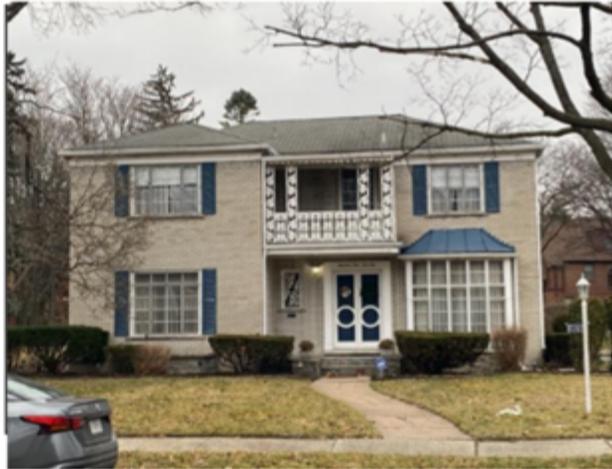
(2) Spot decay/deterioration noted at Upper porch support and rear window ledge repair and refinishing needed These should be keep well sealed Against the weather to prevent damage.
