HISTORIC DISTRICT COMMISSION APPLICATION FOR WORK APPROVAL

HDC2026-00001

ADDRESS(ES): 1806 Leverette St

Window Condition Report

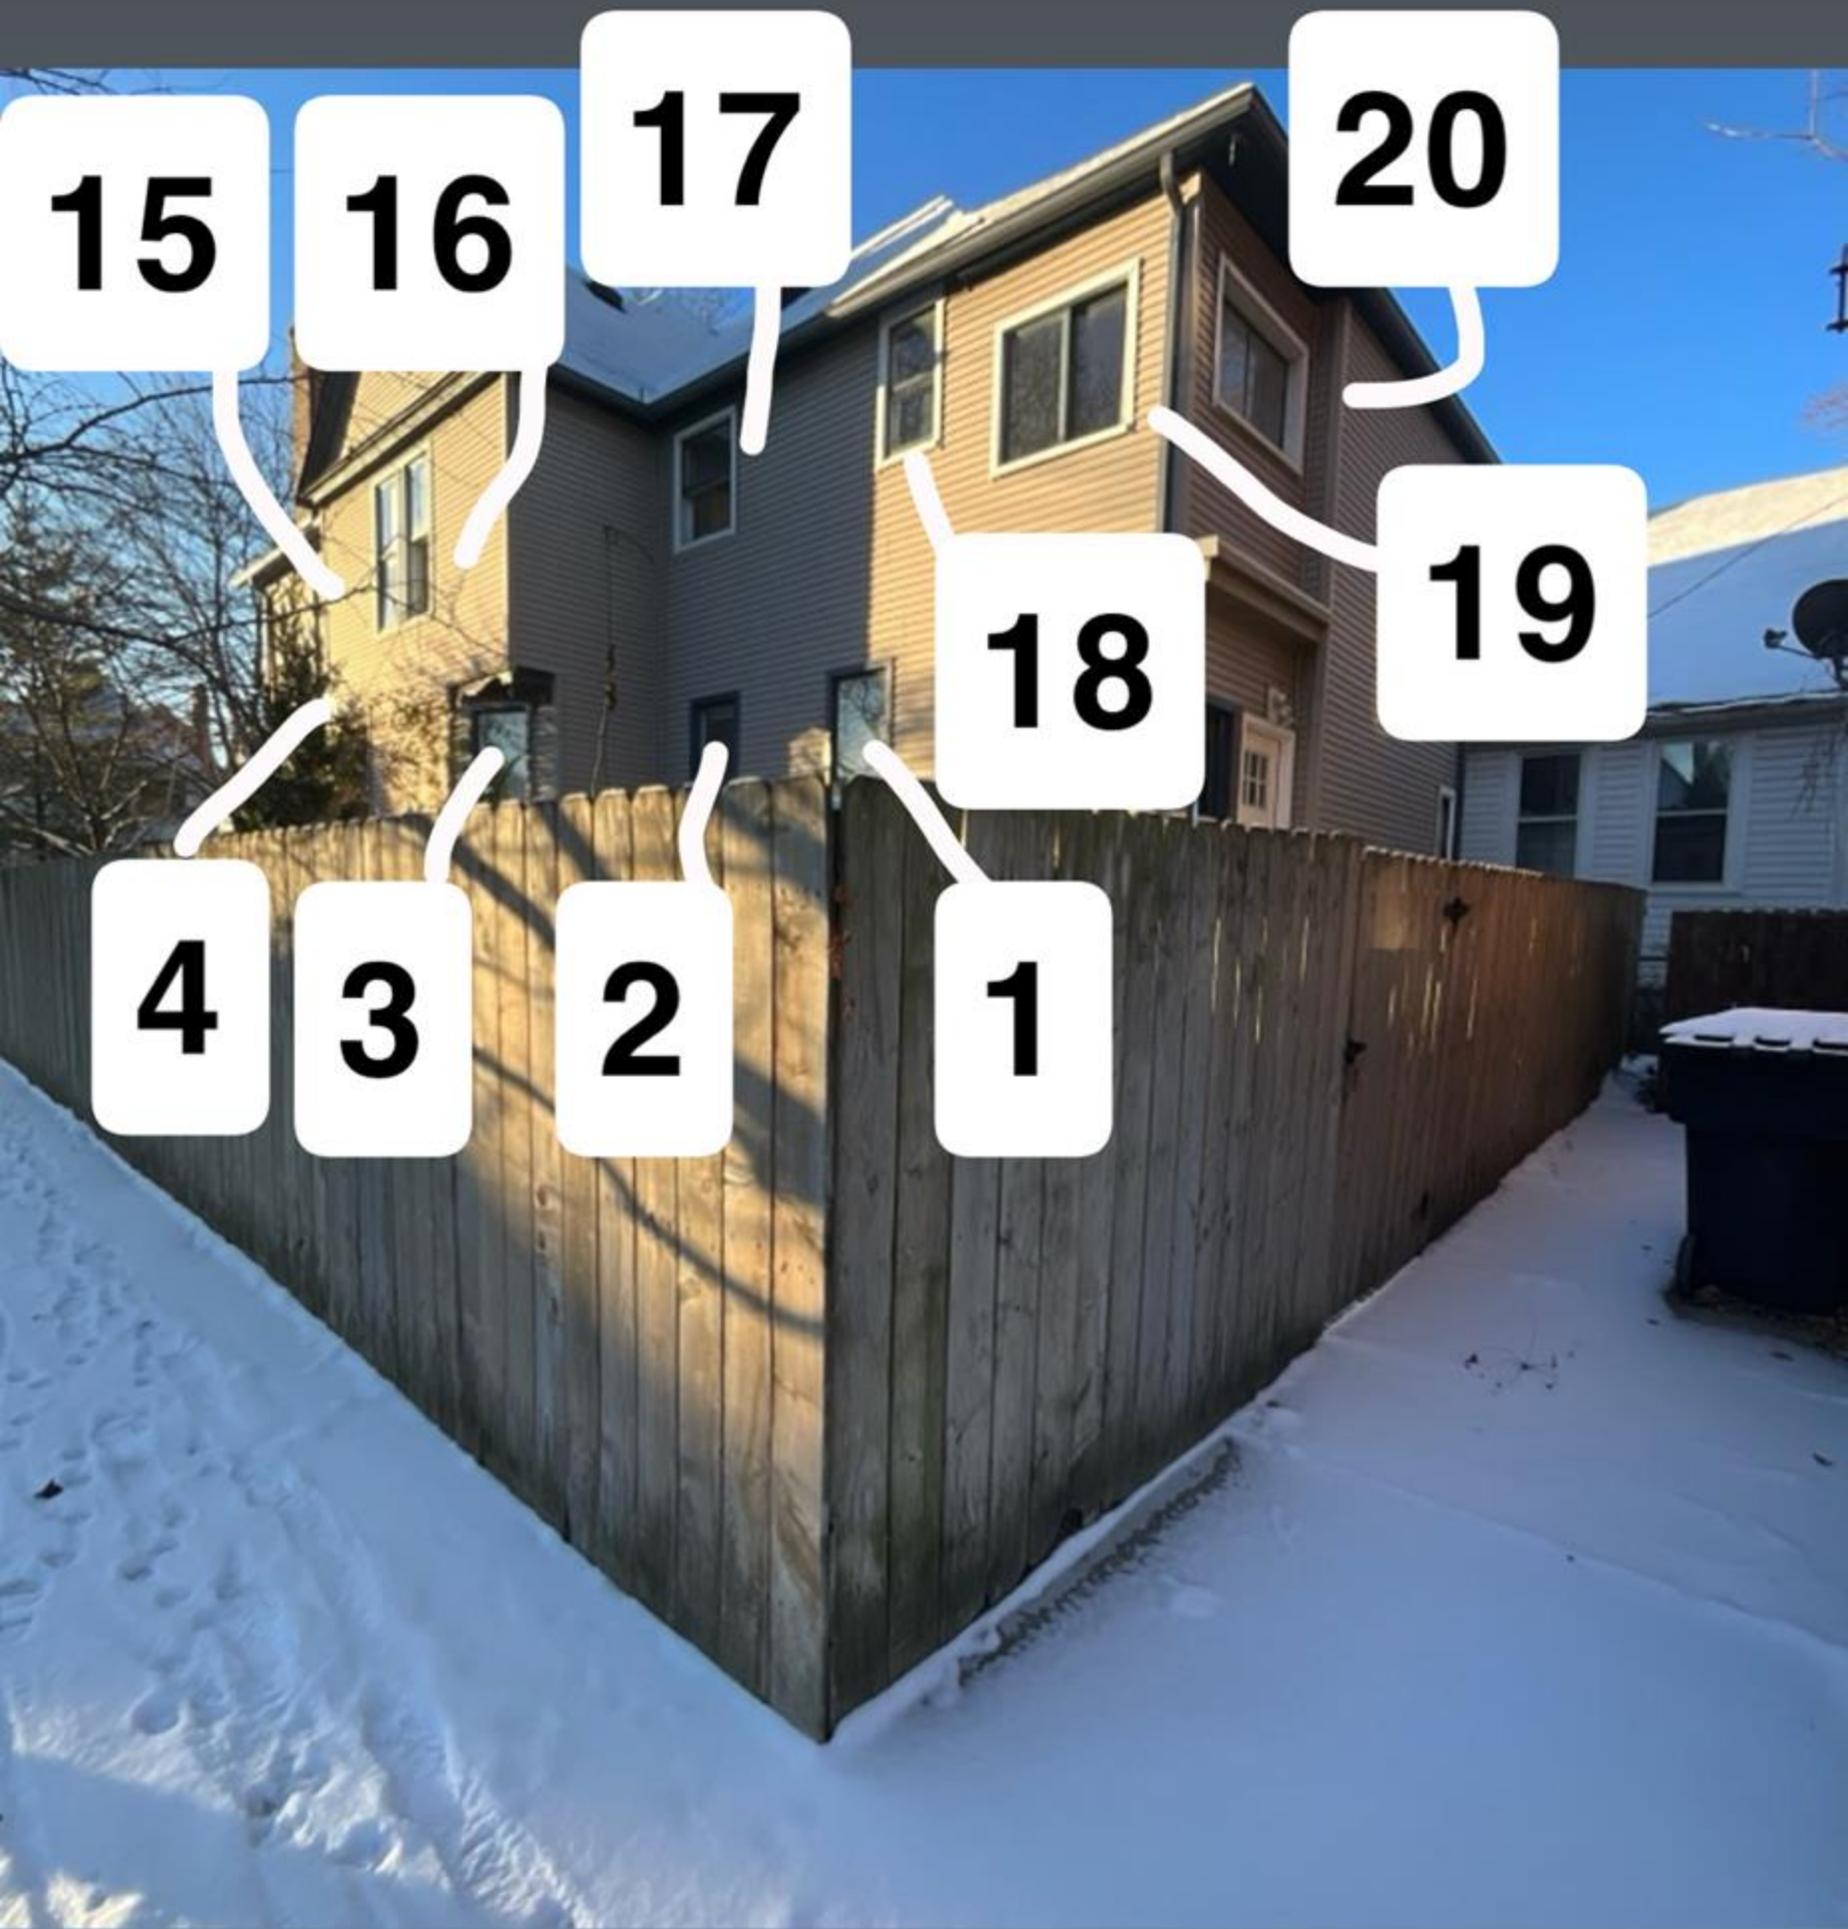
Window 1 – Extensive rot to interior and exterior frames. Severe air infiltration. Pulley system broken. Window is misaligned, preventing proper closure or locking (safety concern).

Window 2 – Similar to Window 1. Rotted interior and exterior framing. Heavy air leakage. Broken pulley system. Misalignment prevents locking (safety concern).

Window 3 – Advanced wood rot throughout. Original pulley system removed or inoperable.

Window 4 – Rotted wood on both interior and exterior frames. Pulley system missing.

Window 5 – Severe rot with visible gaps large enough for small animals to enter between frame sections. Significant air leakage. Lock nonfunctional. Window edges taped to reduce draft. Pulley system missing.

Window 6 – Heavy rot to framing components.

Window 7 – Rotted exterior wood. One side of pulley system broken. Severe air infiltration.

Window 13 – General wood rot present.

Window 14 – Interior wood rot. Heavy air leakage. Lock nonfunctional. Pulley system missing.

Window 15 – Misaligned sash. Rotted framing. Broken pulleys. Lock inoperable. Significant air draft.

Window 16 – Misaligned sash. Rotted framing. Broken pulleys. Lock inoperable. Significant air draft.

Window 17 – Interior wood rot. Severe air leakage. Lock inoperable. No pulley system.

Window 18 – Interior wood rot. Severe air leakage. Lock inoperable. No pulley system.

Window 19 – Heavy rot and overall structural damage.

Window 20 – Interior rot. Significant air infiltration. Lock inoperable. No pulley system.

Due to the extent of rot, misalignment, and mechanical failure, restoration would not restore functionality or energy performance to an acceptable level. Full replacement with historically appropriate windows is recommended to maintain architectural integrity while ensuring safety, efficiency, and durability.

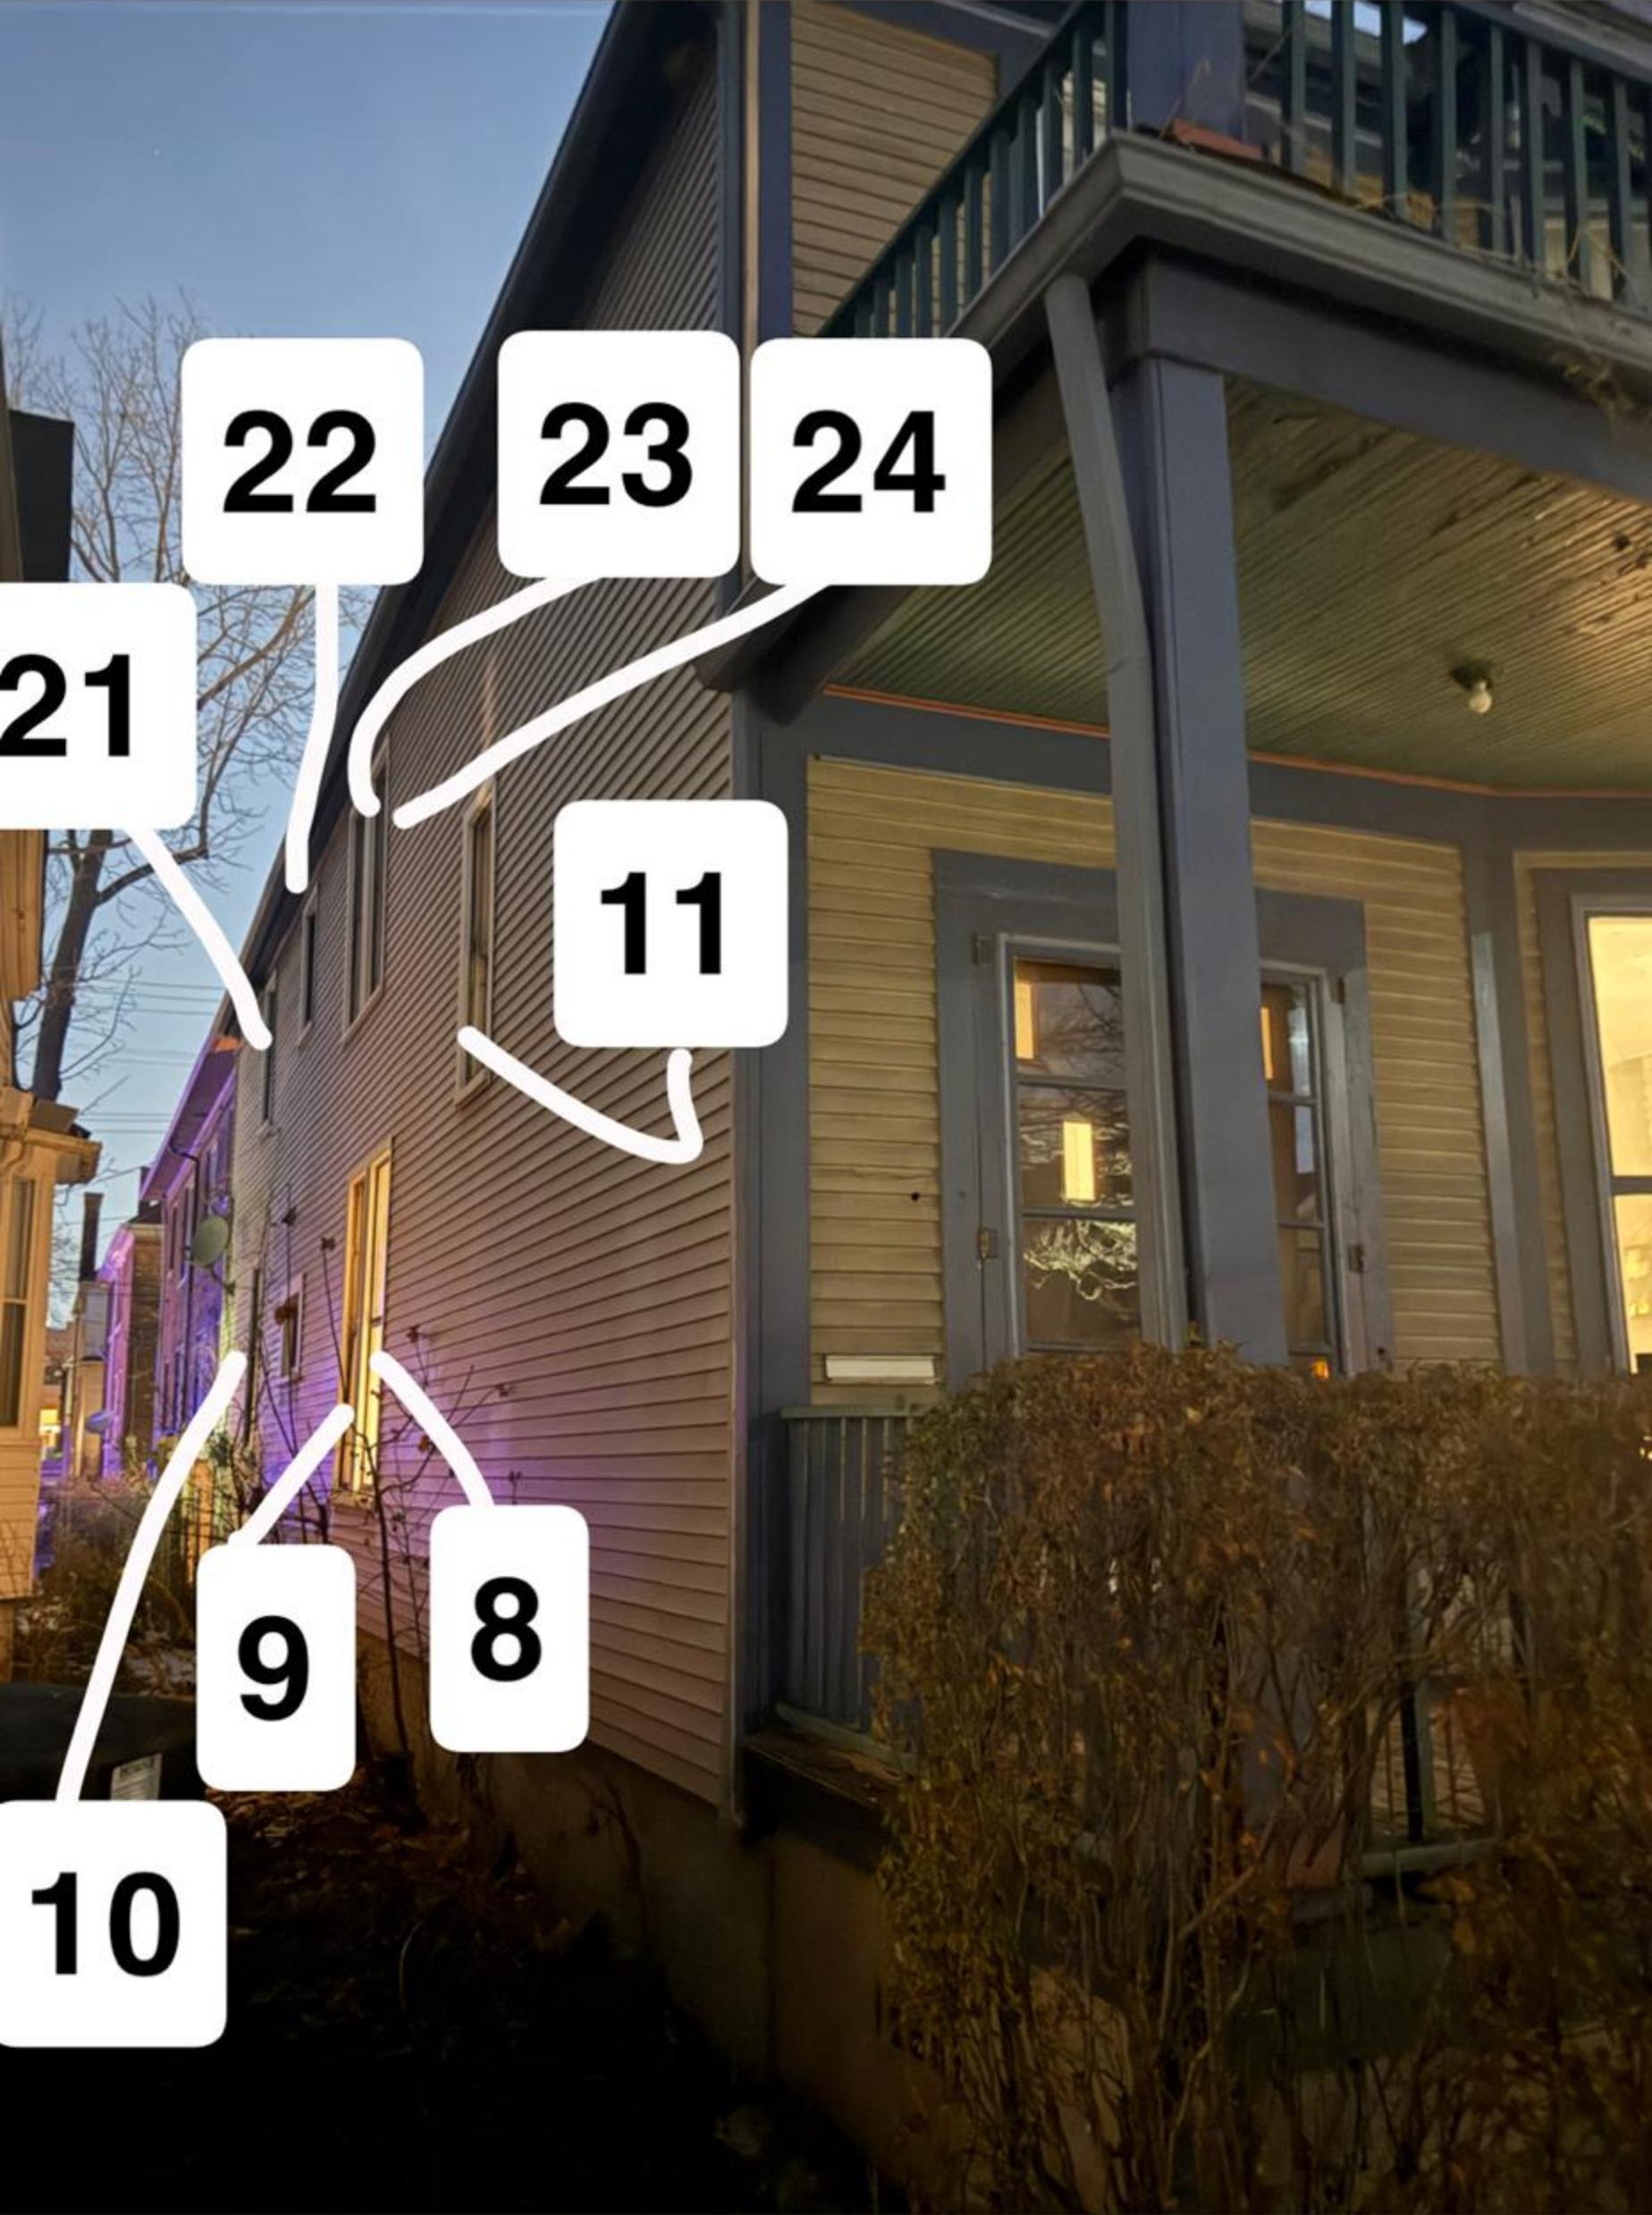
Window 21 – Rotted wood. Pulley system broken.

Window 22 – Rotted framing. Pulley system broken. Window inoperable (won't open).

Window 23 – Rotted wood. Broken pulleys. Misaligned sash. Severe air leakage. Lock inoperable.

Window 24 – Rotted wood. Misaligned sash. Severe air leakage. Lock inoperable.
