HISTORIC DISTRICT COMMISSION APPLICATION FOR WORK APPROVAL

HDC2026-00080

Structural Assessment Report

1436 Edison Street
Detached Garage
Detroit, MI 48206

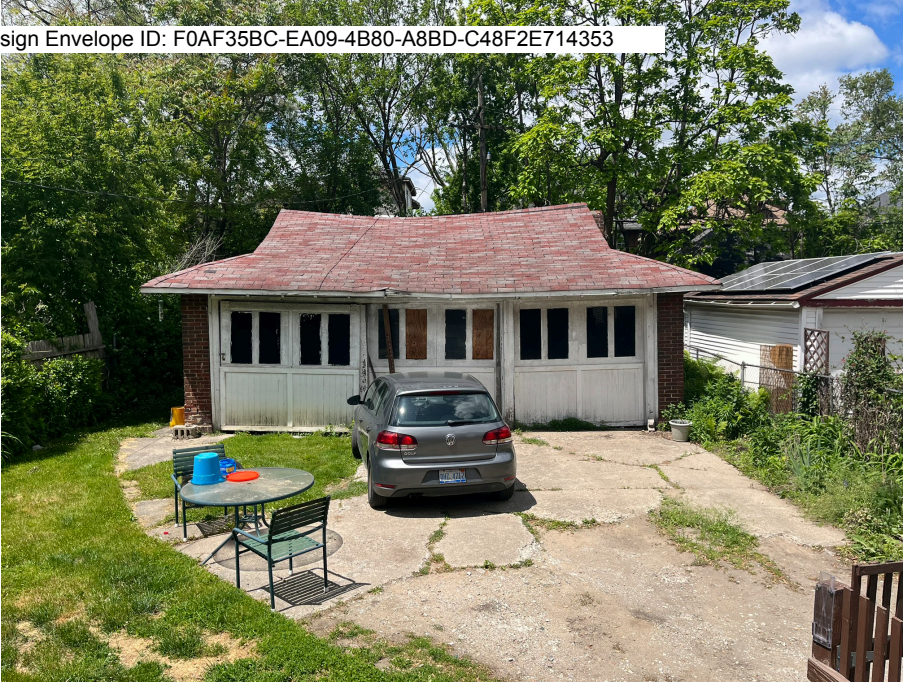
**IMAGE 01:
SOUTH ELEVATION**

South Wall - Wood framing with brick masonry at piers. Mortar is missing and bricks are out of proper location at the base of each pier. Wood columns behind trim, trim has rot at base due to water damage and exposure. Temporary wood column at angle to support sagging of wall at sliding doors. Sliding doors have wood damage, missing pieces, and have multiple repairs applied over top of the existing frame.

South Wall - Severe

Wall is sagging due to weight of roof and deterioration of wood structural elements. Brick piers have masonry damage at the base of both East and West piers.

South Wall - recommend demo and provide new structure as required.

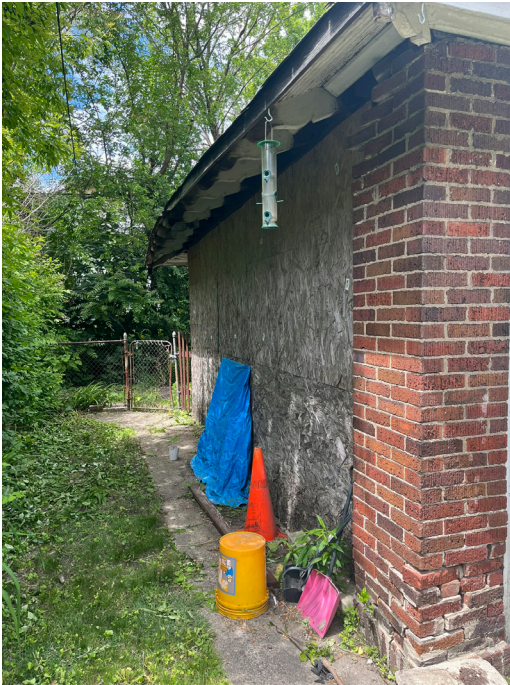
West Wall - Wood framing with plywood substrate, appears to be a temporary securing of the property / structure. Sole plate and framing has deteriorated due to moisture. Limestone threshold behind pier.

West Wall - Severe

Wood framing and plywood sheathing are severely damaged.

**IMAGE 02:
WEST ELEVATION
SOUTH WEST PIER MISSING MORTAR AT
BASE OF PIER
BRICKS AT TOP OF PIER STARTING TO
SHEAR FROM STRUCTURAL FRAMING**

West Wall - recommend demo and provide new structure as required.

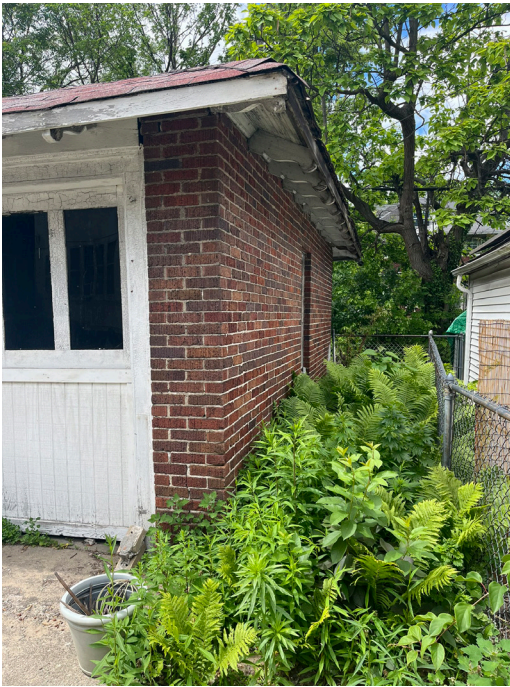
**IMAGE 03:
EAST ELEVATION**

East Wall - Mostly intact. 2x4 wood framing age reflects timing of construction. Substrate visible through framing, masonry on the exterior with mortar to reflect the age of the construction. Wood window has no glass and has been boarded and framed over to secure opening. Limestone sill and lintels reflect the age of construction.

East Wall - Moderate

Wood framing and brick are intact, wall is showing signs of bowing due to structural stresses. Ability to support the wall in its current condition and realign would likely cause further damage to brick masonry.

East Wall - recommend demo and provide new structure as required.

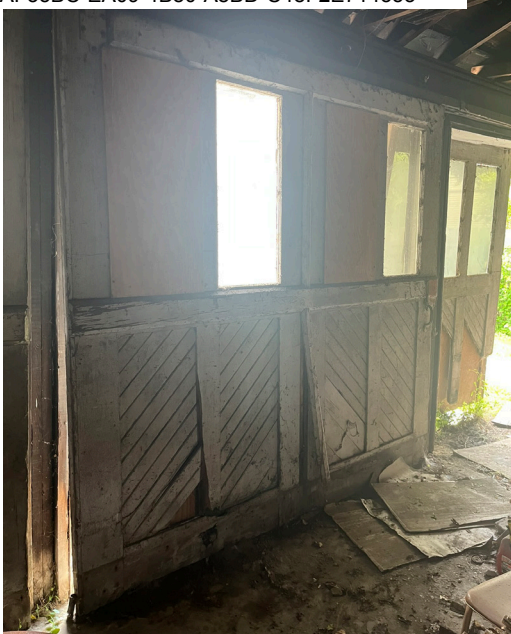
**IMAGE 04:
SLIDING DOORS**

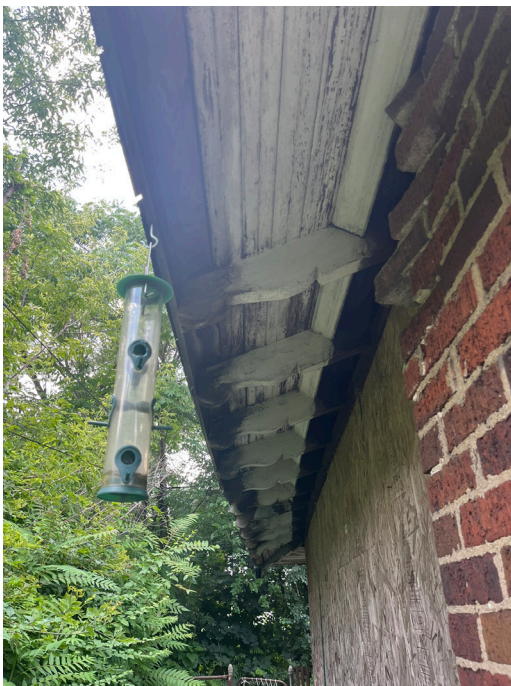
Wood Trim / Eaves - decorative trim detailing exists in some areas, showing deterioration due to age and weather exposure.

**IMAGE 05:
EAVES / BEAD BOARD / RAFTER TAILS**

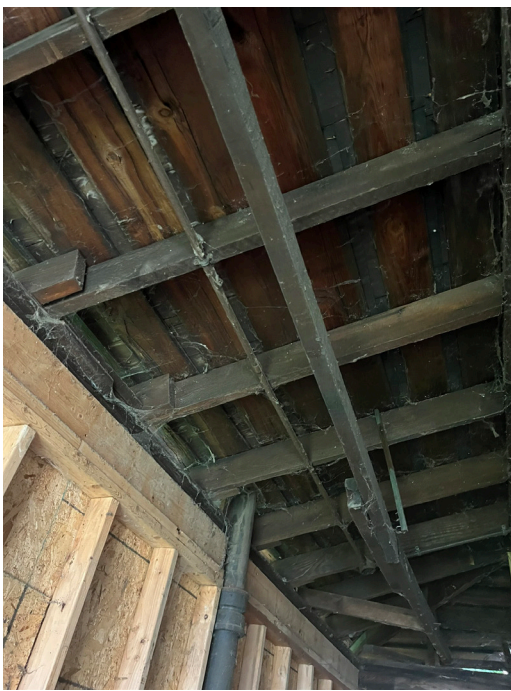
**IMAGE 06:
HIPPED AREA OF WEST ROOF**

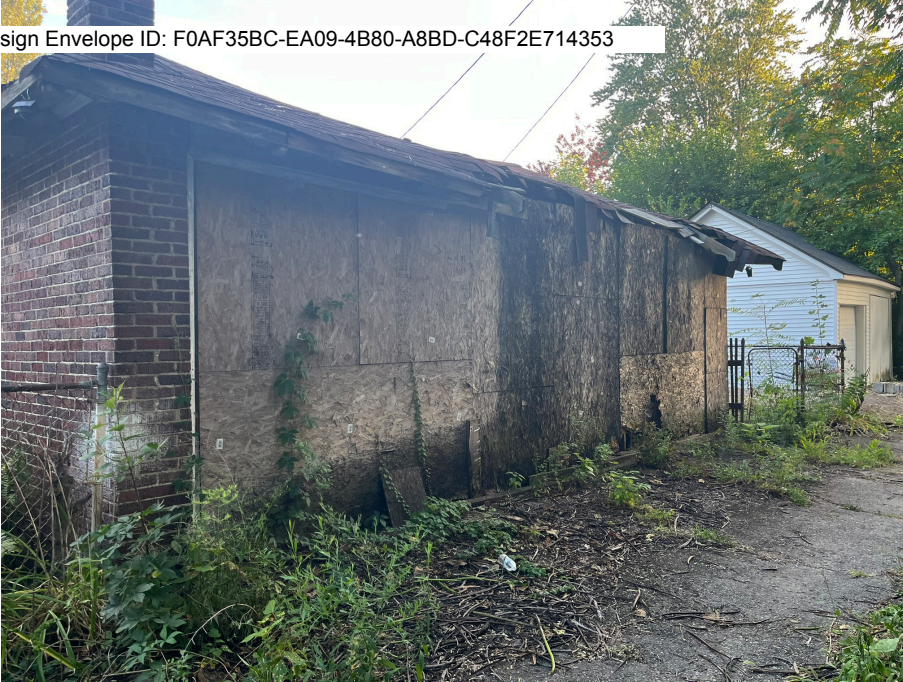
North Wall - Wood framing with plywood substrate, appears to be a temporary securing of the property. Sole plate and framing has deteriorated due to moisture. No masonry on this wall

North Wall - Severe

Wood framing is not complete and severely water damaged. Sheathing is severely water damaged and missing in parts.

**IMAGE 07:
NORTH ELEVATION
EVIDENCE OF DOOR ALONG ALLEY SIDE OF
GARAGE**

North Wall - recommend demo and provide new structure as required.

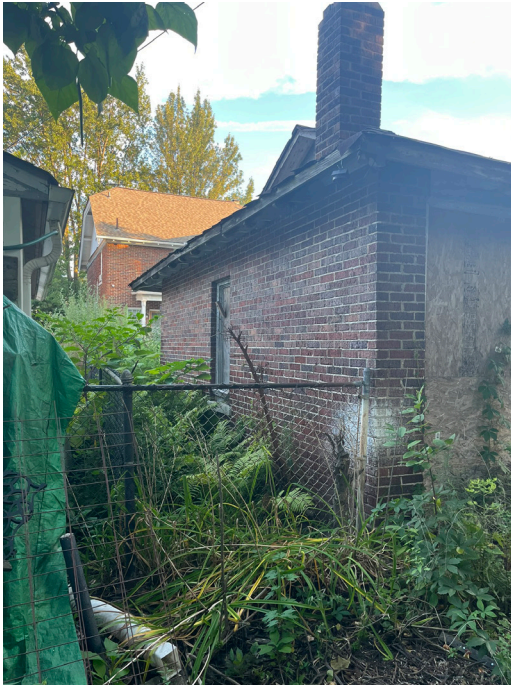
**IMAGE 08:
EAST ELEVATION
EVIDENCE OF DOOR ALONG ALLEY SIDE OF
GARAGE**

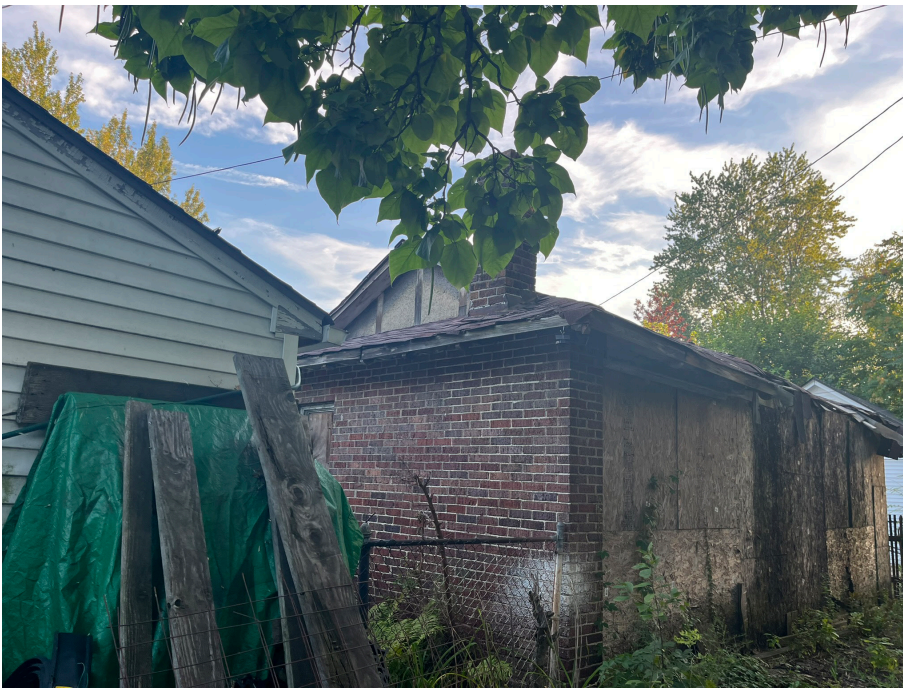
**IMAGE 09:
EAST ELEVATION
SMALL GABLE AT BOTH SIDES WITH
STUCCO AND BEAM DETAILING**

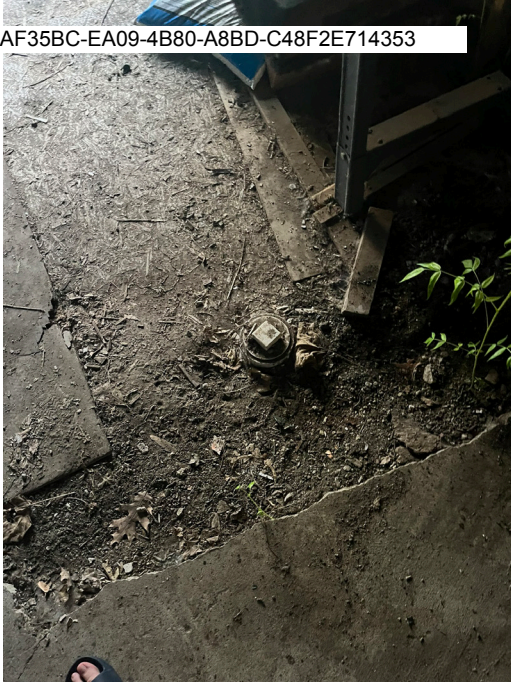
**IMAGE 10:
GARAGE SLAB**

Concrete Slab - Slab on Grade - approximately half of the slab is cracked / crumbling due to damage / exposure to weather

Concrete Slab - Moderate

Approximately 50% of the concrete slab is missing or crumbling. Ability for remaining slab to withstand doweling and adjacent work without further damage is unknown.

Concrete Slab - recommend to demo and pour new to provide proper drainage for the site and underlayment.

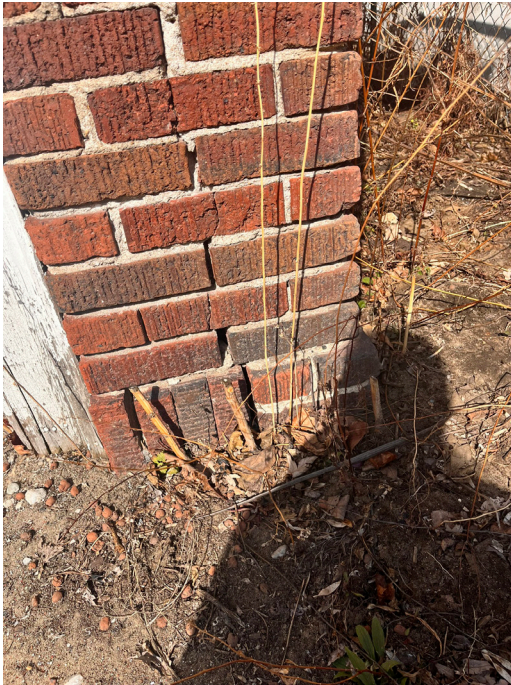
**IMAGE 11:
BASE OF SOUTH EAST MASONRY PIER
MISSING MORTAR AT BASE OF PIER**

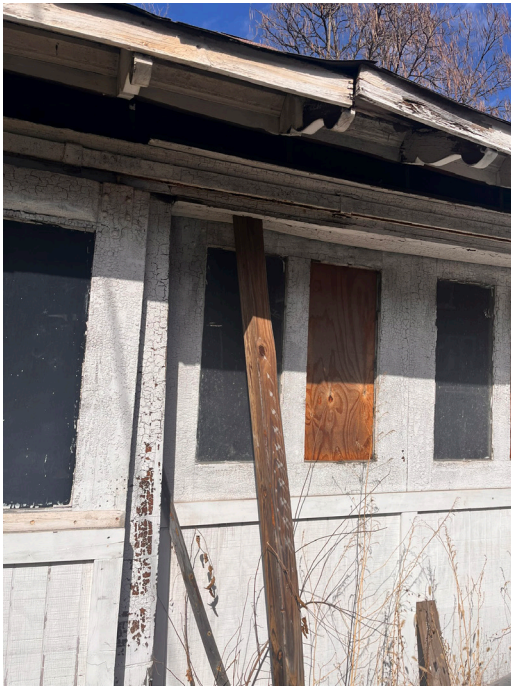
**IMAGE 12:
SUPPORT PROP AT MID SPAN OF SOUTH
WALL
CENTER AND EAST DOORS ARE NOT FUNC-
TIONAL DUE TO SAGGING STRUCTURE +
SLIDING MECHANISM**

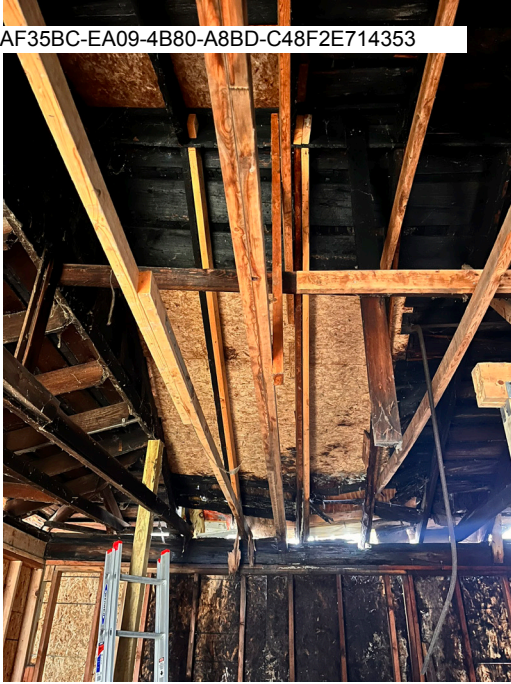
Roof - Asphalt shingles on plywood substrate, shingles missing on approximately 1/4 of the roof. Exposed plywood and patches have significant water damage causing holes in the roof and water infiltration to the structure. Hipped and stucco portions of the roof are somewhat intact.

Roof - Severe

Holes in sheathing allow for further water and weather damage to the structure. Asphalt shingles are over cedar shakes in some locations.

**IMAGE 13:
PLYWOOD PATCH AT HOLE IN ROOF
TEMPORARY FRAMING SUPPORTS TO
KEEP STRUCTURE STABLE**

Roof - recommend demo and provide new structure as required.

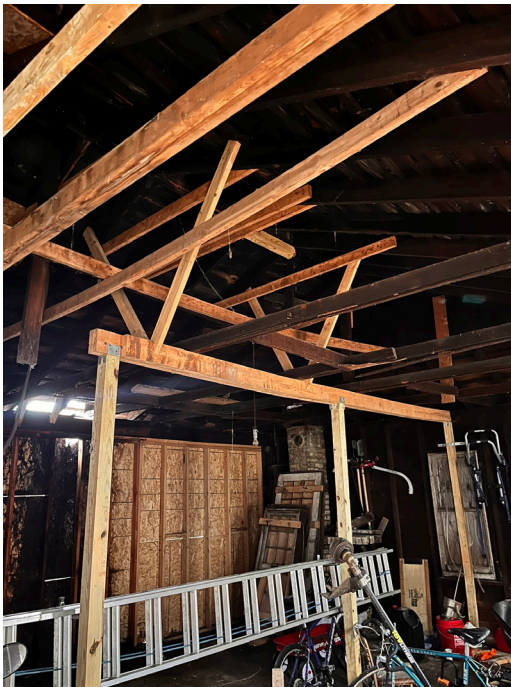
Rafters - Rafters look to be original to the structure, with additional framing and columns across the center of the garage to support the sagging of the roof. Original rafters have been shored up with multiple temporary framing elements and a center support brace. Multiple rafter ties missing or braced with temporary framing. Ridge board and edge beam not supporting the weight of the roof and causing sagging.

**IMAGE 14:
TEMPORARY CENTER SUPPORT AND
RAFTER SUPPORTS**

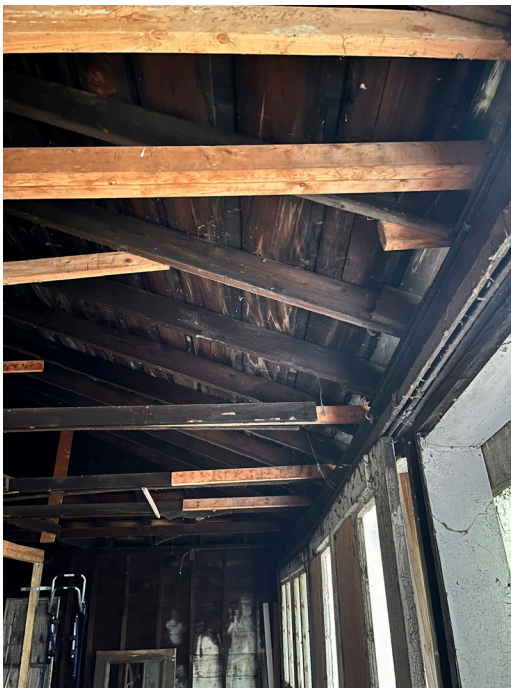
**IMAGE 15:
TEMPORARY CROSS-MEMBER SUPPORTS**

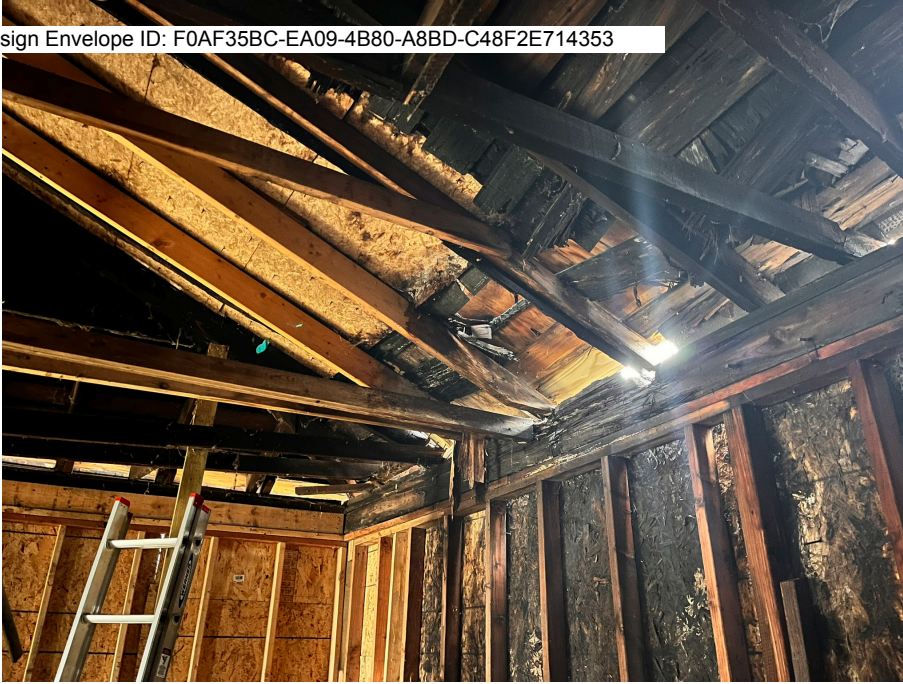
IMAGE 16:
PLYWOOD TO SECURE PROPERTY AND STRUCTURE - WATER DAMAGE ON SOME PLYWOOD ELEMENTS DUE TO HOLE IN ROOF - MULTIPLE UNCONNECTED SUPPORT ELEMENTS

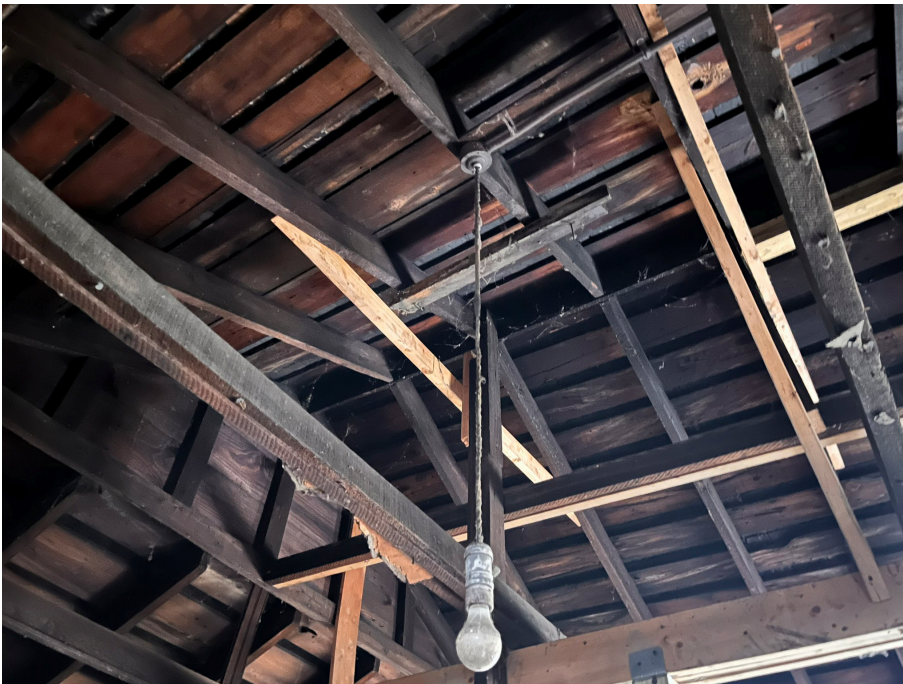
Rafters - Severe

Missing and sagging rafters are not supporting the structure.

IMAGE 17:
RAFTER SHORING IN MULTIPLE LOCATIONS - LIGHT AND CONDUIT ARE NON-FUNCTIONAL

Rafters - recommend demo and provide new structure as required.

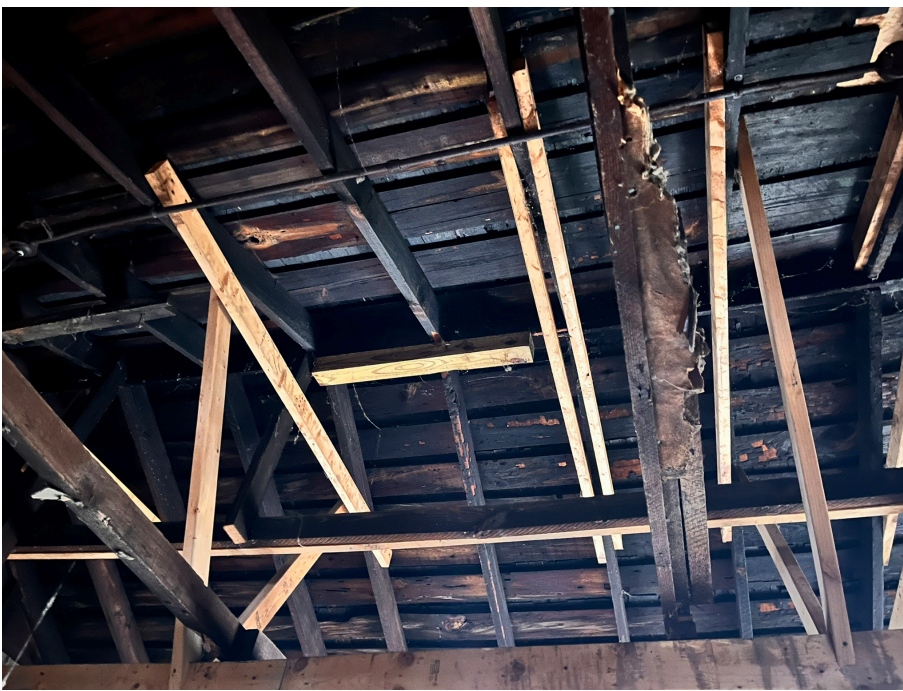
IMAGE 18:
TEMPORARY SISTER SUPPORTS FOR EXISTING RAFTERS - UNKNOWN WOOD CONDITION DUE TO LONGTERM WEATHER EXPOSURE
