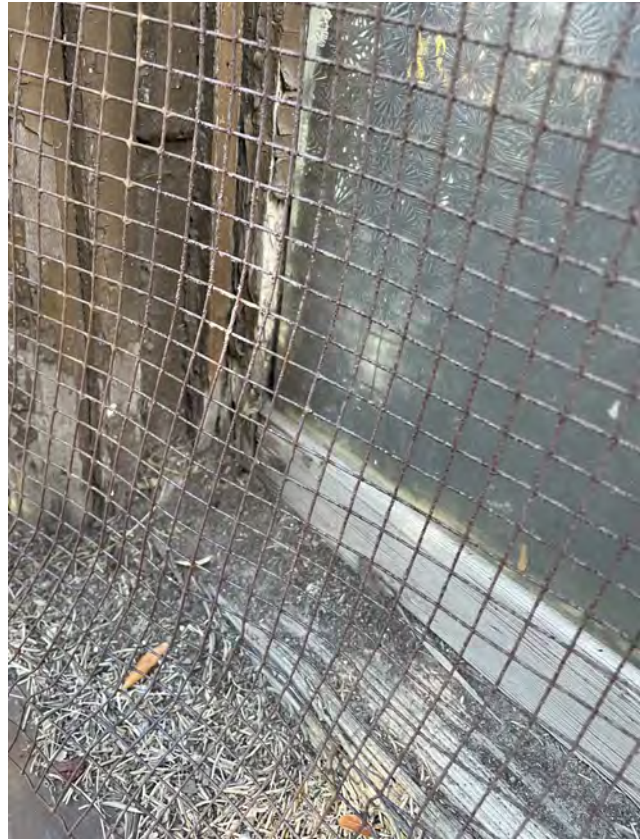
Photo: Window 004, exterior weight pocket detail.  
Typ. inherent flaw condition at historic wood dbl-hung units.

Typical condition at all historic wood double-hung window units throughout the Parish Hall building, including at basement level.

Inherent flaw with historic window construction – the weight pocket access panel is located at exterior vertical jamb track. Many panels observed to be loose, damaged, or missing. This has allowed for water (perhaps insect and other) infiltration causing deterioration. No weight pocket access panels observed at interior.

**Integrity of historic window is compromised.**

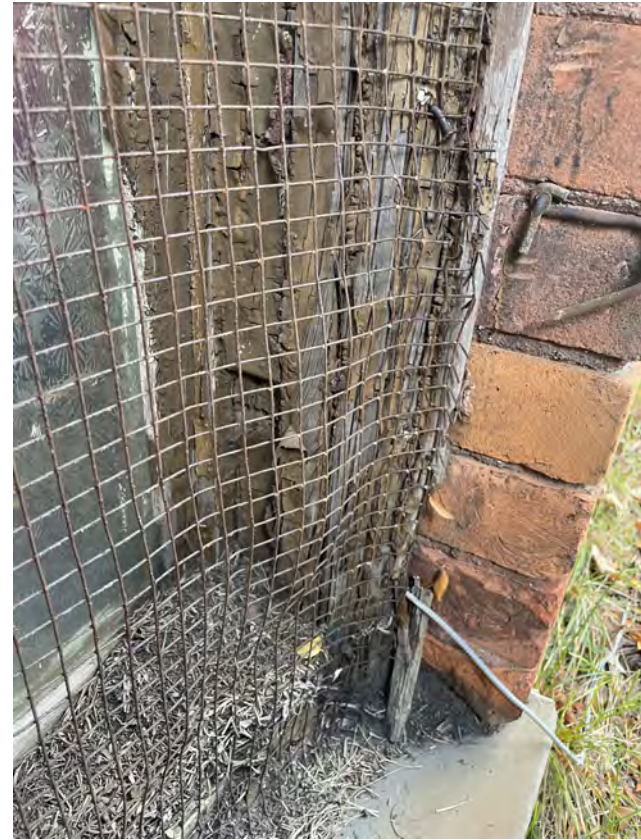
Photo: Window 004, exterior weight pocket detail.  
Typ. inherent flaw condition at historic wood dbl-hung units.

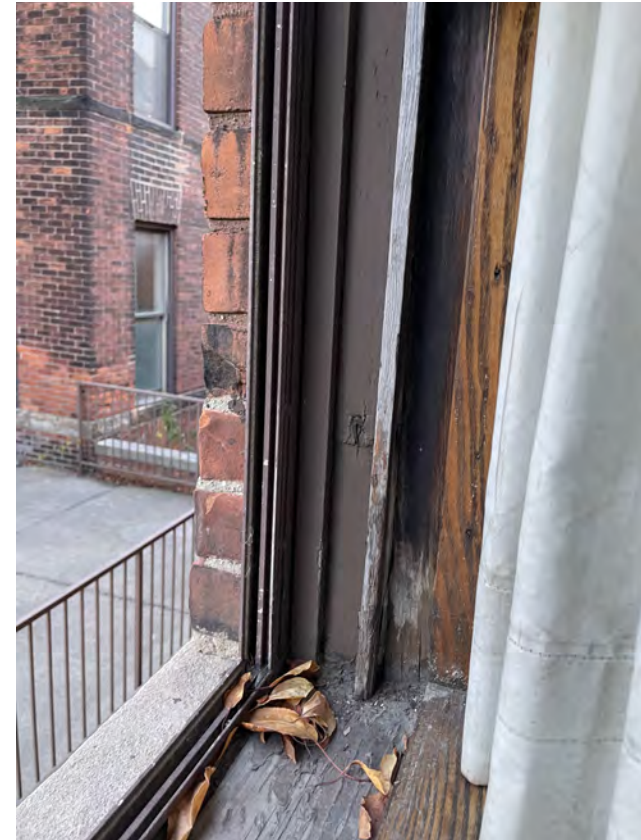
Photo: Window 107 (C), exterior weight pocket detail.  
Typ. inherent flaw condition at historic wood dbl-hung units.

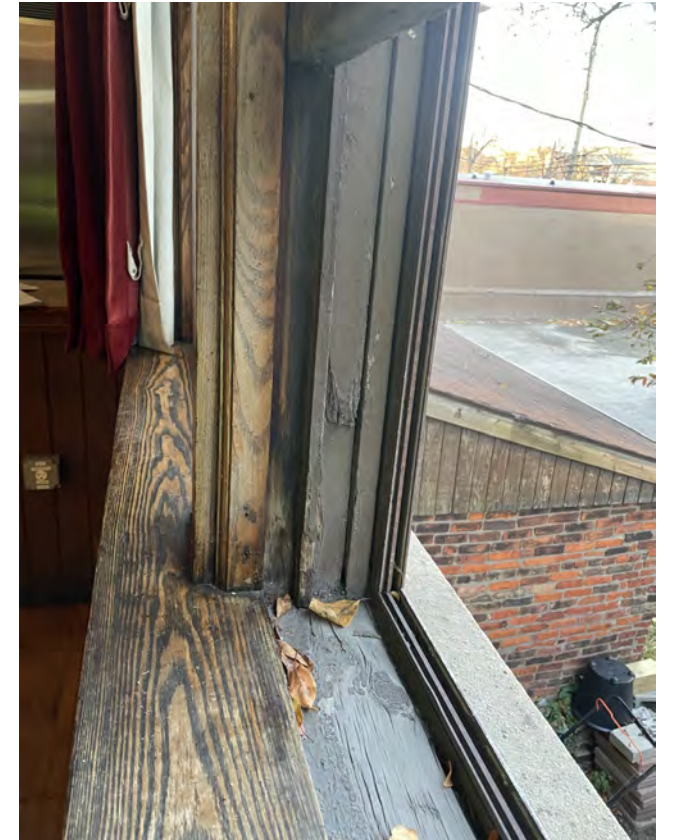
Photo: Window 107 (C), exterior weight pocket detail.  
Typ. inherent flaw condition at historic wood dbl-hung units.

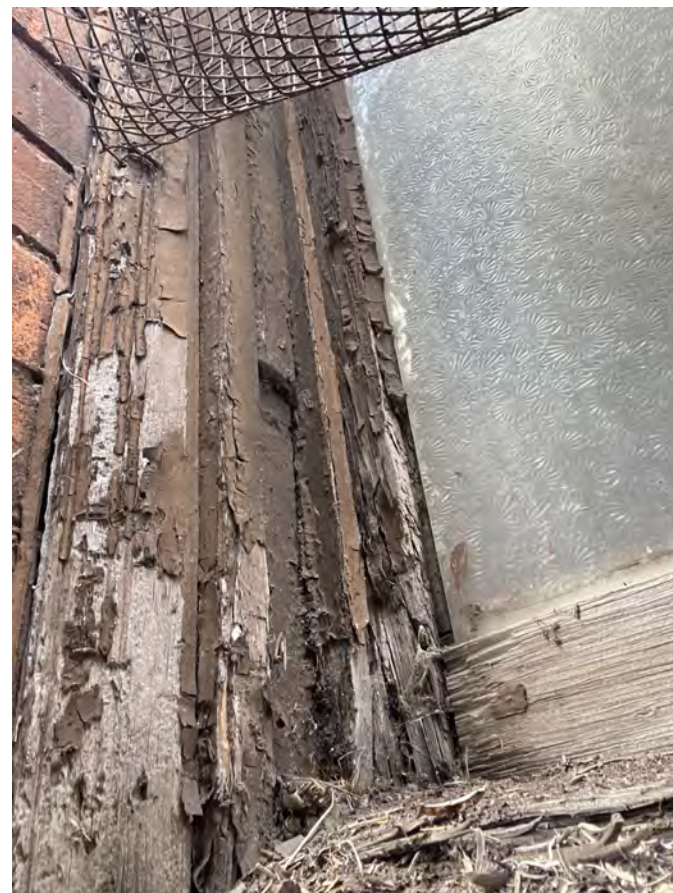
Photo: Window 004, exterior weight pocket detail.  
Typ. inherent flaw condition at historic wood dbl-hung units.

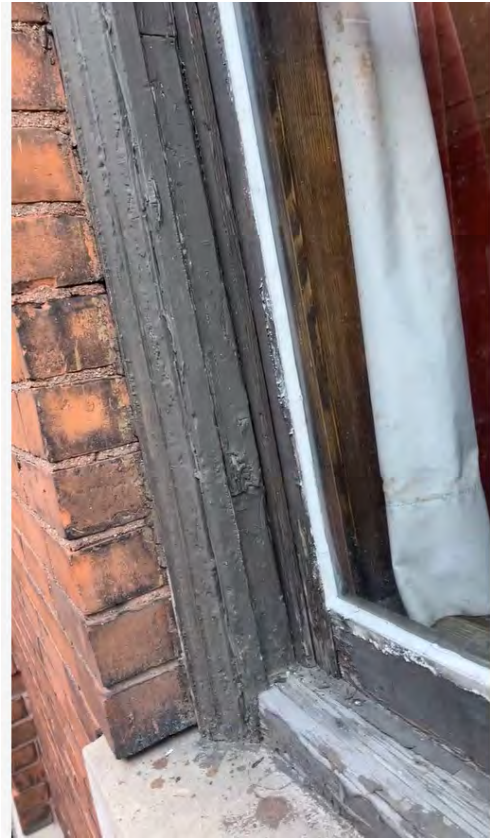
Photo: Window 113 (C), exterior weight pocket detail.  
Typ. inherent flaw condition at historic wood dbl-hung units.

Typical condition at all historic wood double-hung window units throughout the Parish Hall building, including at basement level.

Inherent flaw with historic window construction – the weight pocket access panel is located at exterior vertical jamb track. Many panels observed to be loose, damaged, or missing. This has allowed for water (perhaps insect and other) infiltration causing deterioration. No weight pocket access panels observed at interior.

**Integrity of historic window is compromised.**

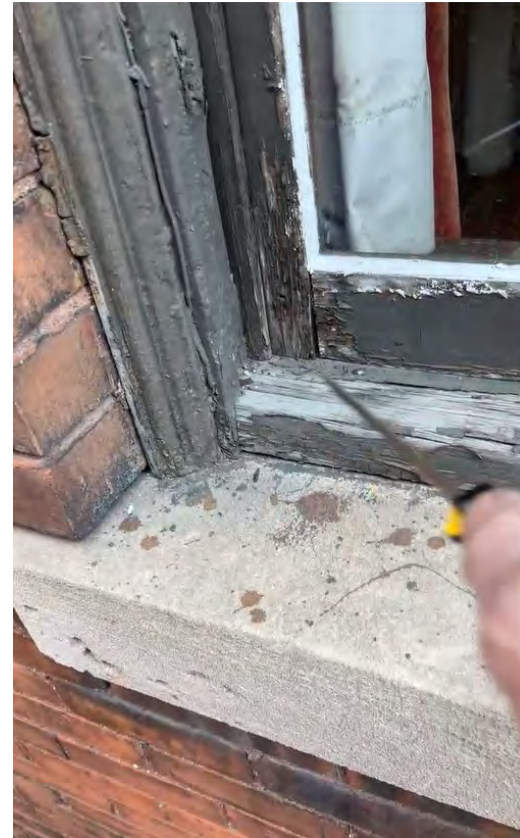
Photo: Window 113 (C), exterior weight pocket detail.  
Typ. inherent flaw condition at historic wood dbl-hung units.

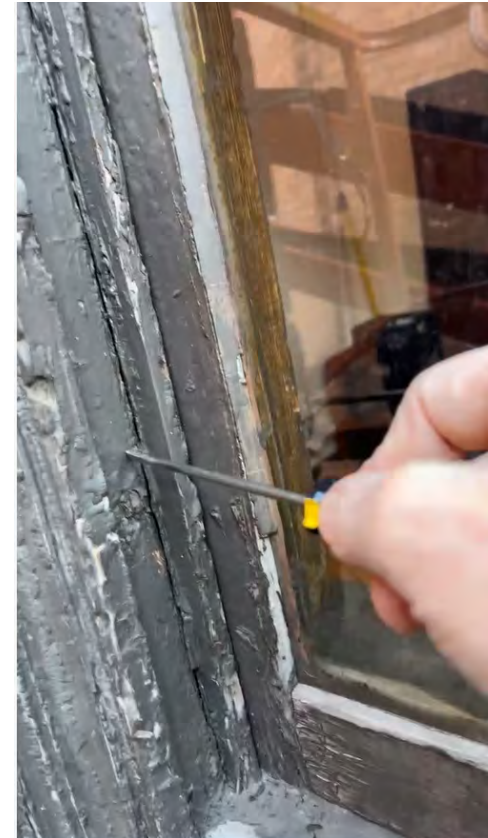
Photo: Window 112 (C), exterior weight pocket detail.  
Typ. inherent flaw condition at historic wood dbl-hung units.

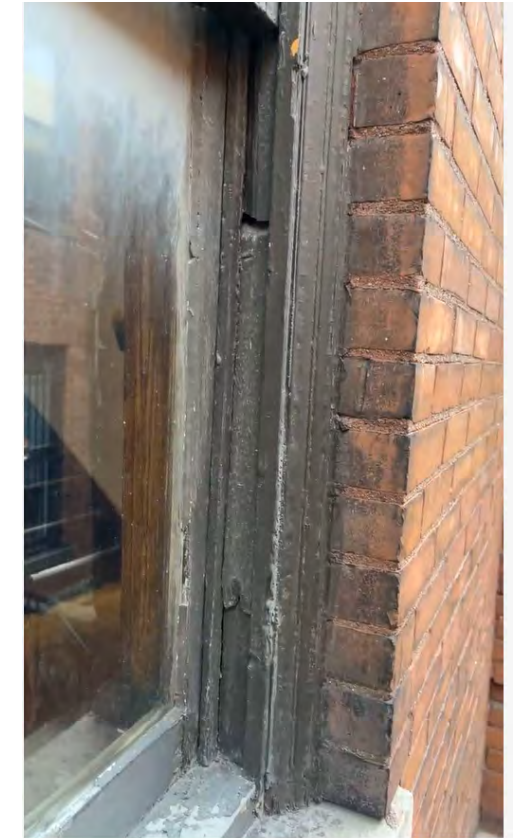
Photo: Window 112 (D), exterior weight pocket detail.  
Typ. inherent flaw condition at historic wood dbl-hung units.
