470 Martin Luther King Jr. Boulevard Historic Hotel Stimson

Rehabilitation & Preservation Compatibility Narrative

Detroit, Michigan
May 2026

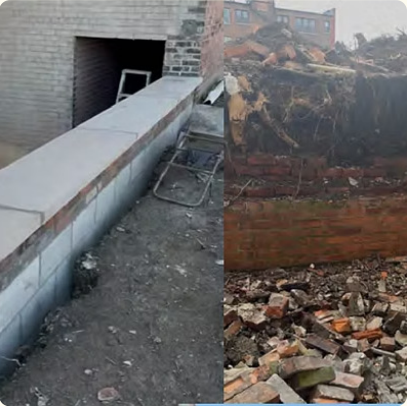
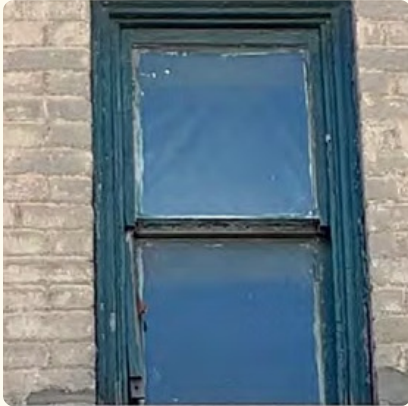
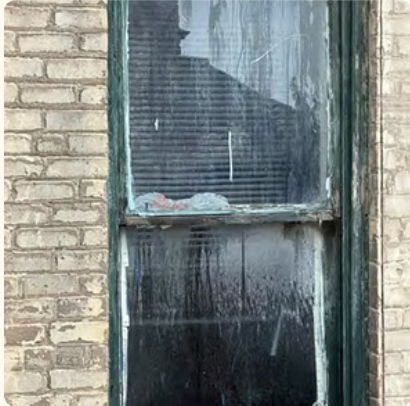
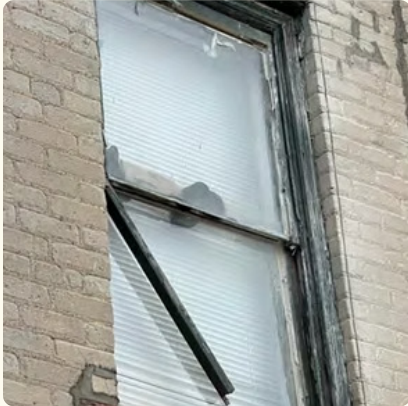
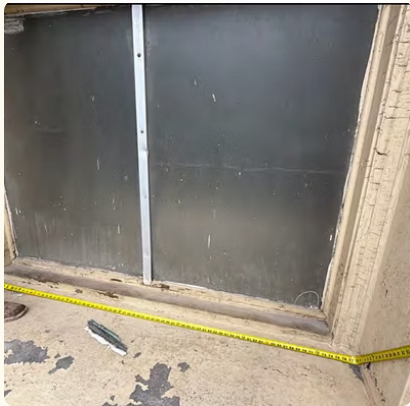
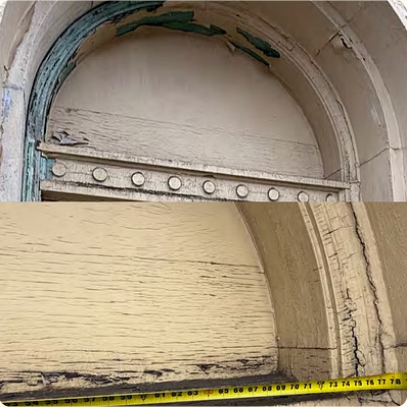
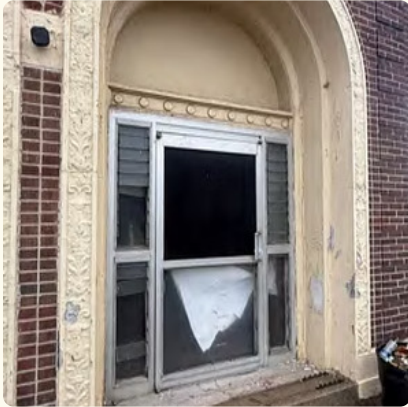
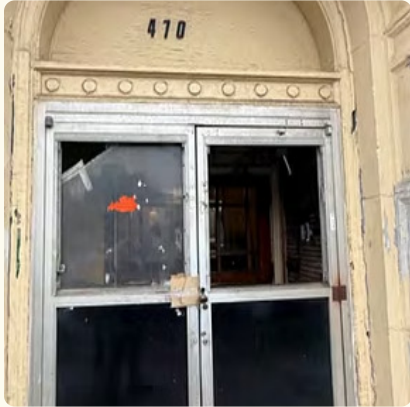
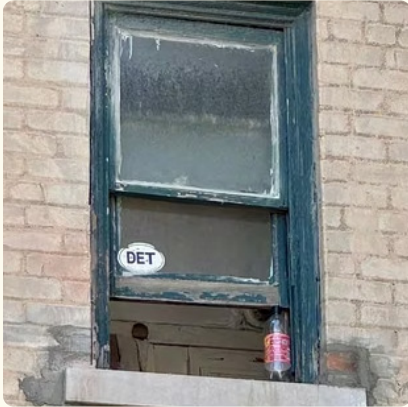
Existing conditions documentation revealed severe deterioration of original wood window assemblies beyond feasible repair.

- Original wood construction
- Extensive structural deterioration
- Rot beyond feasible repair
- Long-term moisture infiltration
- Significant operational failure

The original window systems could not reasonably be restored to provide safe, weather-tight, durable performance within an occupied affordable housing environment.

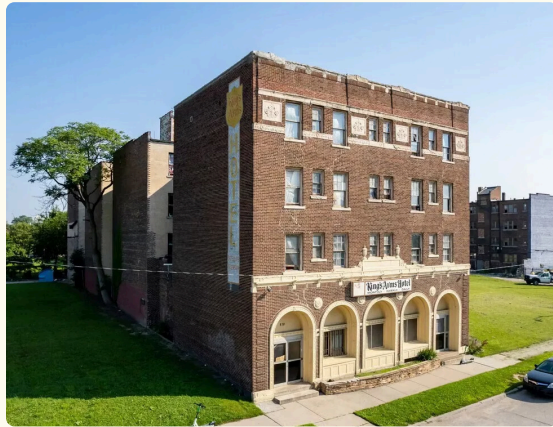
The original windows were deteriorated wood assemblies and were replaced with compatible systems to support safety, habitability, and continued occupancy.

BEFORE — Prior to Rehabilitation
Front elevation, December 2, 2020

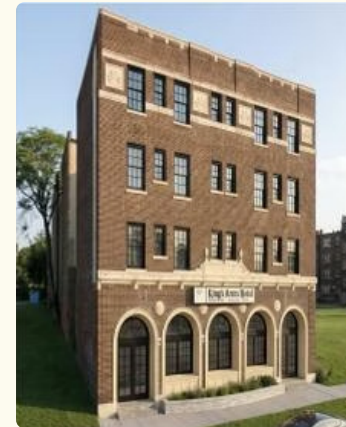
AFTER — Proposed Rehabilitation
Compatible fenestration, retained historic character

The replacement windows reflect a compatible rehabilitation approach that preserves the building's historic character through careful attention to openings, proportions, and grid patterns.

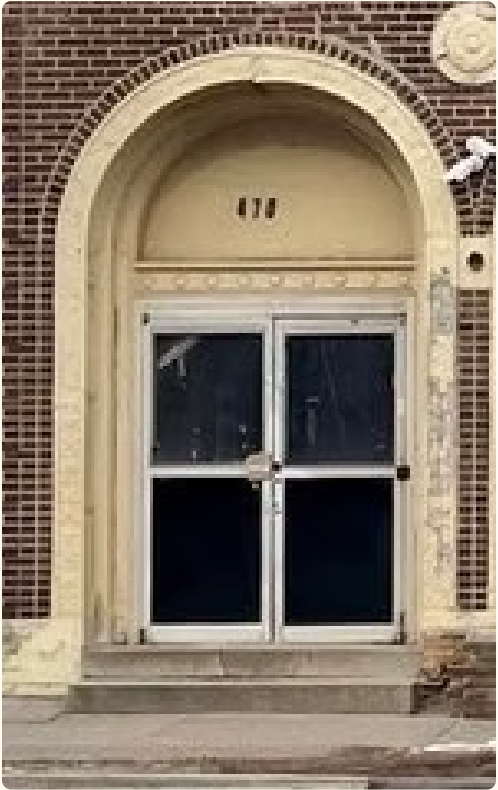
EXISTING CONDITIONS — Original entry doors

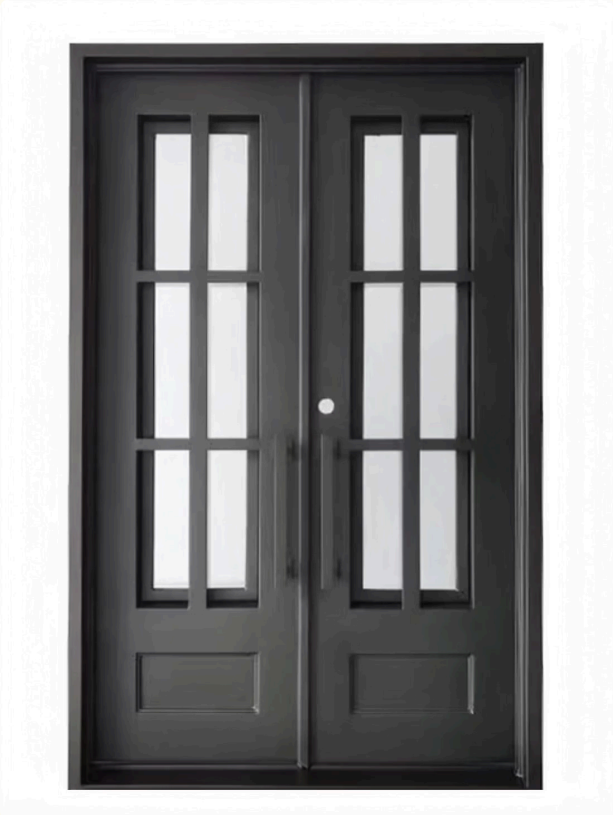
PROPOSED REPLACEMENT — Historically compatible entry systems

Historically compatible replacement entry systems were selected to reinforce the building's historic character while improving durability, security, and long-term operability.

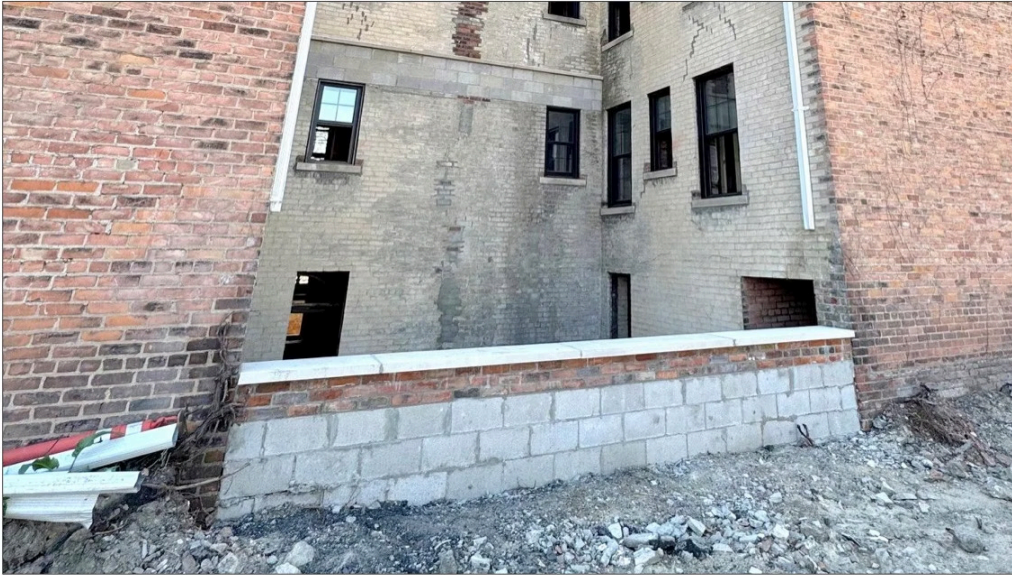
EXISTING CONDITIONS — Exposed retaining wall

Landscape improvements, raised grading, planter integration, and evergreen screening will minimize visibility of stabilization elements while preserving the historic retaining wall relationship to the streetscape.

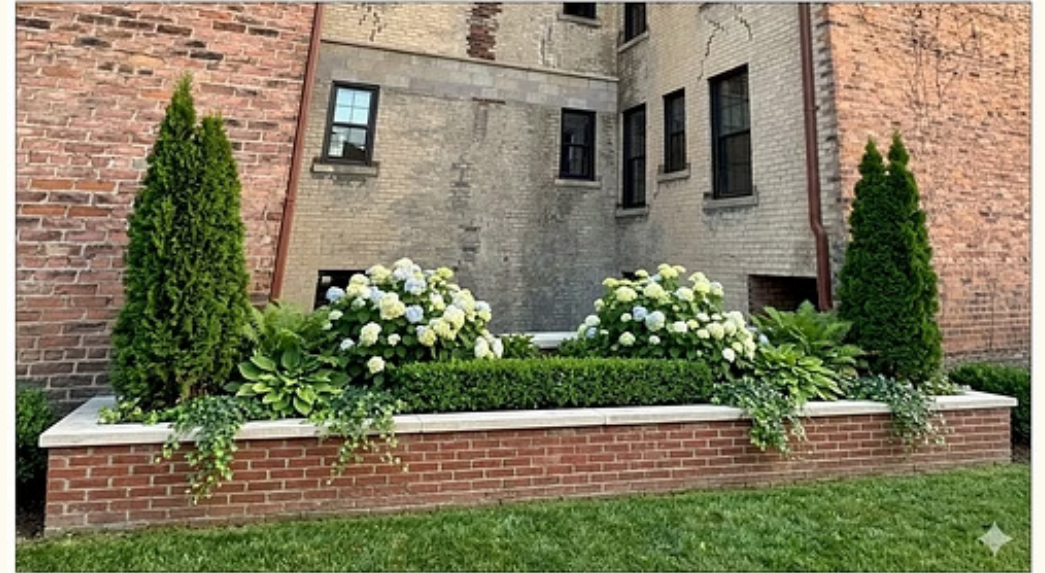
PROPOSED TREATMENT — Landscape screening and integration
