RE: Ste. Anne de Detroit: Exterior Restoration and Rehabilitation  
1000 St Anne St  
Detroit, MI 48216  
Local Historic District: Ste. Anne's Parish Complex

Subject: HDC Application for Ste. Anne de Detroit: Exterior Restoration - Request for COA revision, Historic Wood Windows, Replacement Windows, and Basement Masonry Openings

### EXISTING HISTORIC WINDOWS ASSESSMENT AND PROPOSED TREATMENTS:

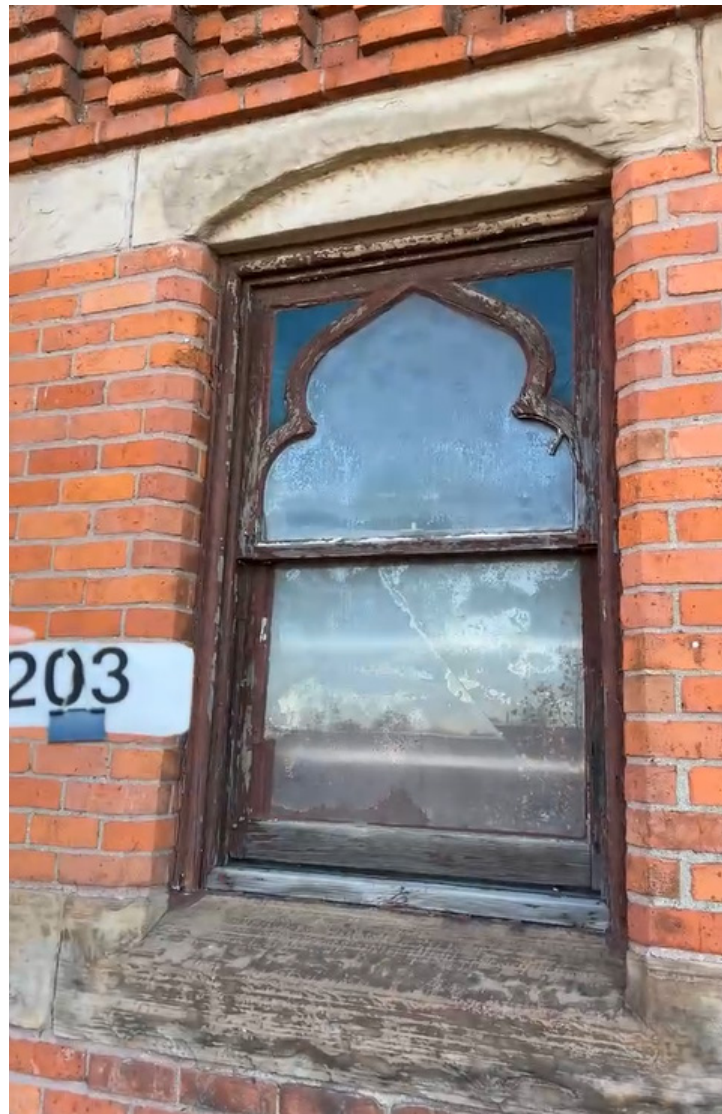
##### Window #203

- Deeply split/checked.

- Bottom 8" at both sides are split, rotted, and twisted from long-term moisture saturation. Dutchman repair is unlikely to result in sound functional frame; likely to impede sash operation.
- Parting stops, overall, are deeply checked, twisted, and have shrunk.
- Bottom 8" of brickmold at both sides are deeply checked and split.

- Meeting rail ends at both sides are deeply checked, rotted, and show evidence of shrinkage at joints which indicates breakdown of internal fiber structure. Structural integrity of joints has been lost.
- Side rail ends at both sides are deeply checked, split at joints with meeting rail, and are vertically displaced, resulting in failure. Structural integrity of joints has been lost.
- All wood tracery is deeply checked and dried out, extensive cracks exist parallel to grain, and the ends of tracery have shrunk away from the right-hand/south side rail. Inadequate previous repairs of tracery "points" evident and failing (glued-on pieces of wood and/or built-up with putty).

Windows #203, #204, and #205 are in very similar condition which is deteriorated beyond repair. The extent, depth and quantity of deterioration at each window is such that the quantity of dutchman and epoxy repairs would be so numerous that they are not likely to result in a sound functional window unit, and not likely to withstand the test of time. Also, while it may be possible to repair individual deteriorated window components, repair of deterioration beyond a certain level/extent - like that exhibited by these three windows - is not practical or reasonable. Replacement in kind, of an entire window that is too deteriorated to repair, using the physical evidence as a model for reproduction complies with the Secretary of the Interior's Standards and Guidelines.

View of existing historic wood window #203 at Basilica (sacristy), 2nd floor, west elevation.

The existing historic wood windows will be retained and documented as a model for the new reproduction replacement windows. Existing historic masonry openings will remain. The proposed custom replacement wood windows will match the historic wood windows in design (size, pane configuration, trim details, planar and reflective qualities), color, and materials. Per the Detroit HDC Guidelines for Historic Wood Windows, the dimensions of the custom replacement wood window components (the rails, stiles, and muntins) will match the dimensions of the original window components.

Where sound/intact, existing historic glass panes will be retained and reused/reinstalled as part of the replacement window unit. Where sound/intact, existing historic brickmold will be retained and reused/reinstalled as part of the replacement window unit. New in-kind brickmold that matches existing historic brickmold in design (size

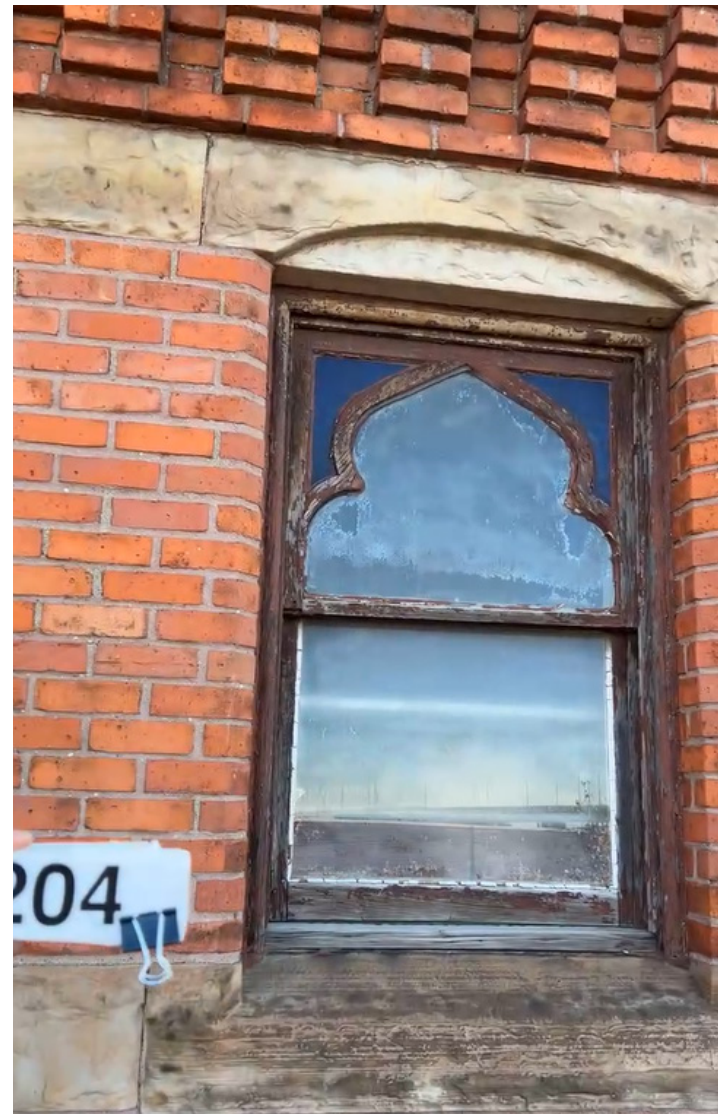
- Deeply split/checked, as well as deep surface deterioration.

- Bottom 6" at both sides are split, rotted, and twisted from long-term moisture saturation. Dutchman repair is unlikely to result in sound functional frame; likely to impede sash operation.
- Parting stops, overall, are deeply checked, twisted, and have shrunk.
- Bottom 8"-12" of brickmold at both sides are deeply checked and split.

- Meeting rail is sagged at center which prevents proper locking.
- Meeting rail ends at both sides are checked and rotted. This checking extends to interior of component.
- Side rail ends at both sides are deeply checked, split at joints with meeting rail, and are vertically displaced, resulting in failure. Structural integrity of joints has been lost.
- All wood tracery is deeply checked and dried out, extensive cracks exist parallel to grain, pieces are missing, and ends of tracery have shrunk away from the side rails at both sides. Inadequate previous repairs of tracery "points" evident and failing (glued-on pieces of wood and/or built-up with putty).

View of existing historic wood window #204 at Basilica (sacristy), 2nd floor, west elevation.

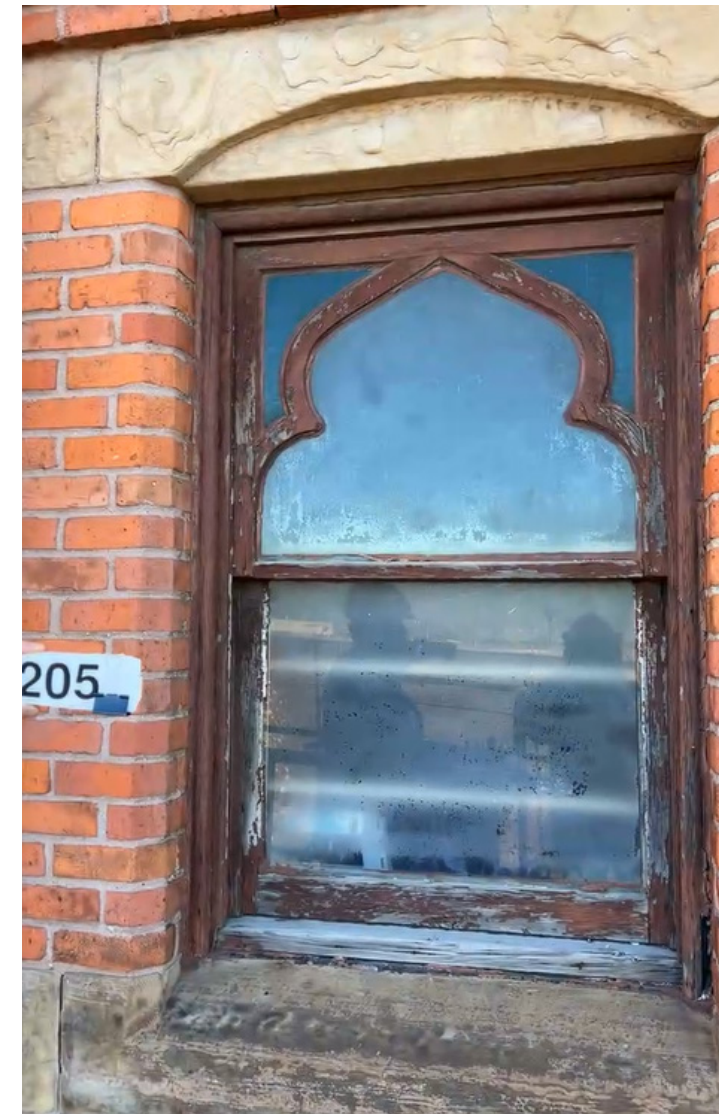
- Deeply split/checked, as well as deep surface deterioration.

- Bottom 8" at both sides are split and rotted. Dutchman repair is unlikely to result in sound functional frame; likely to impede sash operation.
- Parting stops, overall, are deeply checked, twisted, and have shrunk.
- Bottom 2"-8" of brickmold at both sides are deeply checked and split.

- Meeting rail is sagged at center which prevents proper locking.
- Meeting rail ends at both sides are deeply checked, rotted, and show evidence of shrinkage at joints which indicates breakdown of internal fiber structure. Structural integrity of joints has been lost.
- Side rail ends at both sides are deeply checked, split at joints with meeting rail, and are vertically displaced, resulting in failure. Structural integrity of joints has been lost.
- All wood tracery is deeply checked and dried out, many cracks exist parallel to grain, and the ends of tracery have shrunk away from side rails on both sides. Inadequate previous repairs of tracery "points" evident and failing (glued-on pieces of wood and/or built-up with putty).

View of existing historic wood window #205 at Basilica (sacristy), 2nd floor, west elevation.

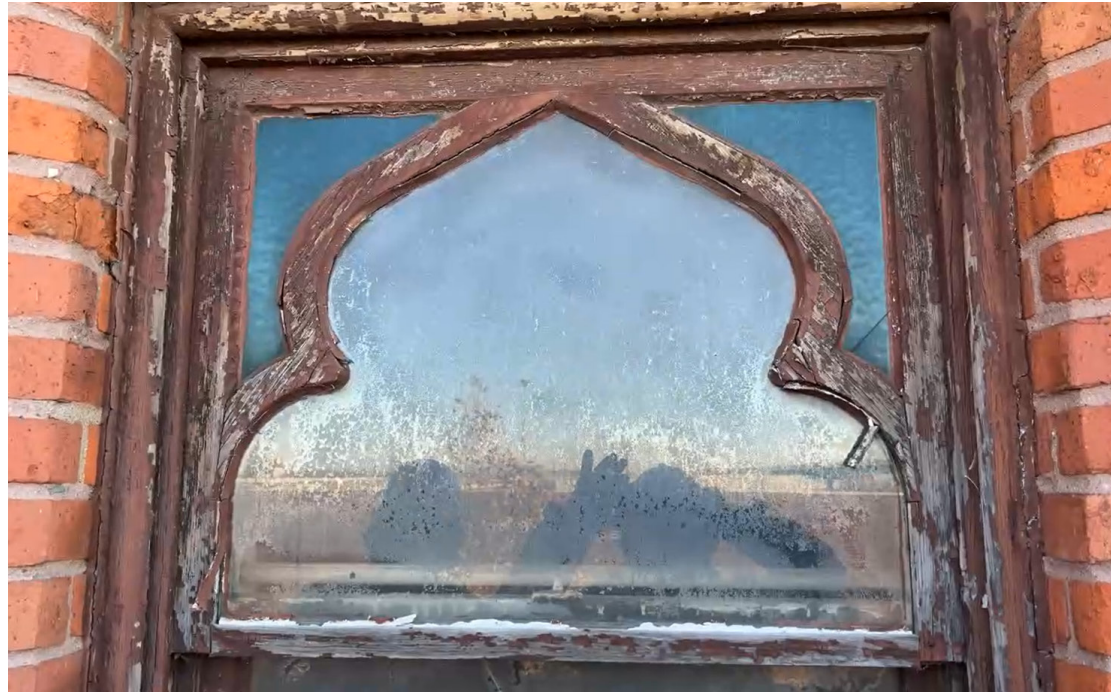
Detail view of existing historic wood upper sash and frame, typical condition.

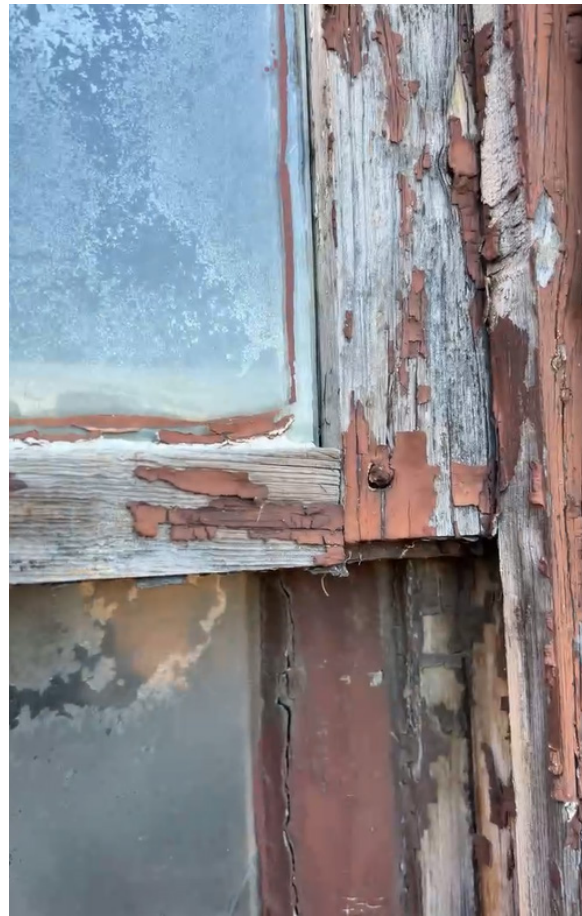
Detail view of existing historic wood upper sash components and frame, typical condition.

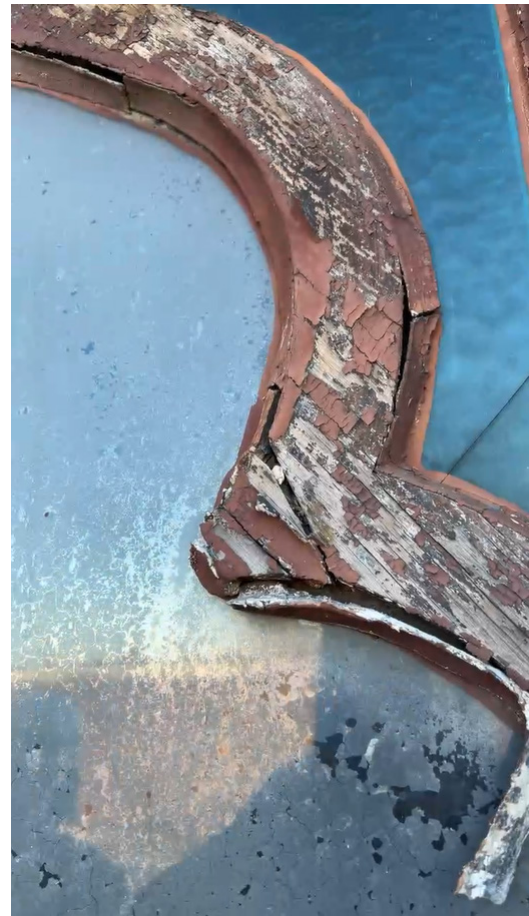
Detail view of existing historic wood tracery, typical condition.

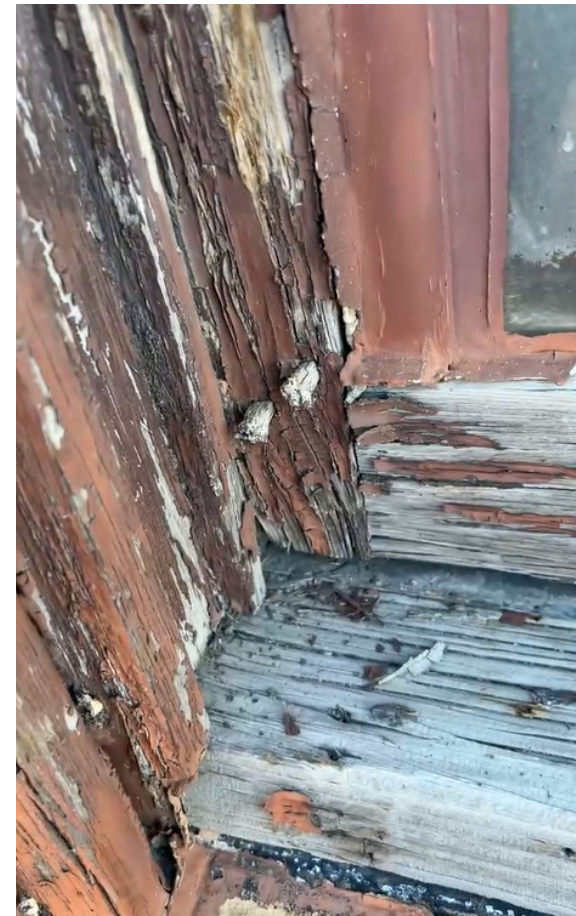
Detail view of existing historic wood sill, frame, and lower sash components, typical condition.

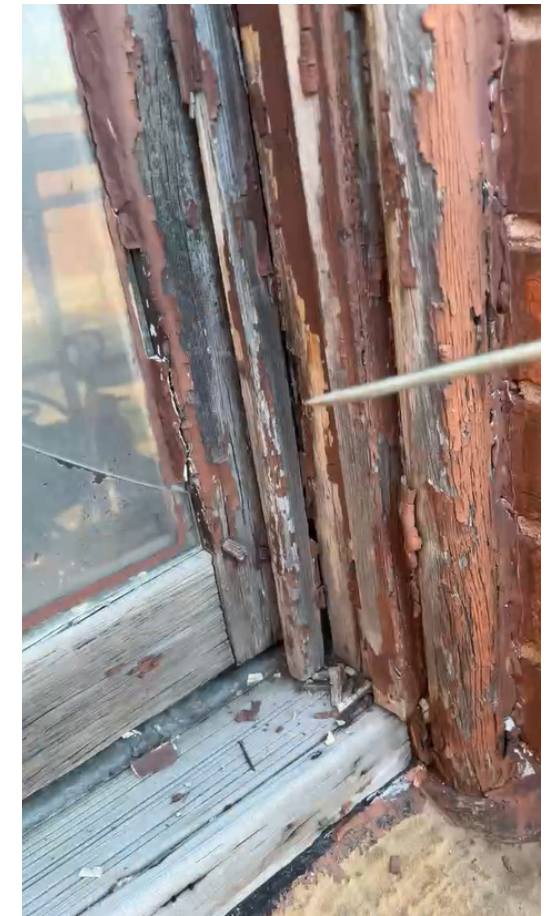
Detail view of existing historic wood sill, frame, and lower sash components, typical condition.

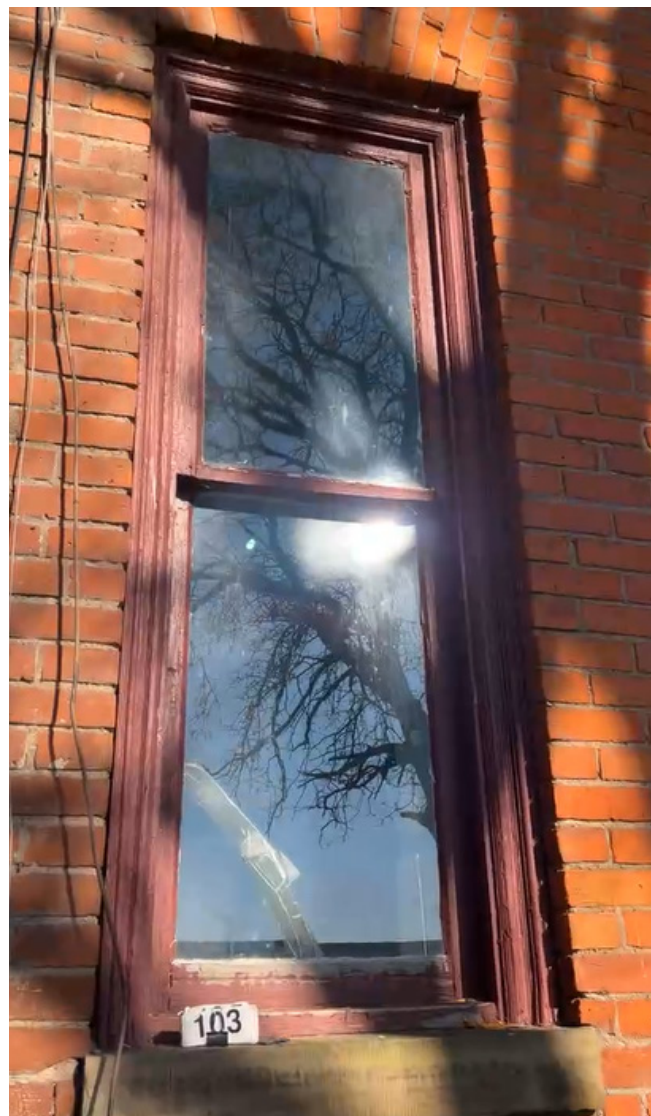
- Bottom 6" at both sides are checked.
- Parting stops, overall, are loose and have shrunk.
- Bottom 1" of brickmold at both sides are checked and split.

- Meeting rail bottom ends at both sides are deeply checked/split, rotted, and show evidence of shrinkage at joints which indicates breakdown of internal fiber structure. Structural integrity of joints has been lost. Glazing rabbets are deeply oxidized with some rot.
- Side rail ends at both sides are deeply checked and split at joints with meeting rail. Areas of missing wood have compromised the structural integrity of the pegged mortise and tenon joints. Checking continues several inches above the meeting rail. Glazing rabbets deeply oxidized with some rot.
- Joints between meeting rail and side rails at both sides have split, failed, and are vertically displaced. Structural integrity of joints has been lost.

- Bottom rail exterior has deep horizontal split along the full length of the rail, is deeply and extensively checked, and the wood is deeply dried out and oxidized. A corresponding horizontal split is visible on the interior of the component. Bottom rail ends on both sides are deeply checked and show evidence of shrinkage at joints which indicates breakdown of internal fiber structure. Structural integrity of joints has been lost. Rotting is evident at exterior and interior. Glazing rabbets are deeply oxidized with some rot.
- Side rail ends at both sides are deeply checked at joints with bottom rail. Structural integrity of joints has been lost. Rotting is evident at exterior and interior. Glazing rabbets are deeply oxidized with some rot.

Windows #103 and #104 are deteriorated beyond repair. The extent, depth and quantity of deterioration at each window is such that the quantity and extent of repairs would be so numerous that they are not likely to result in a sound functional window unit, and not likely to withstand the test of time. Also, while it may be possible to repair individual deteriorated window components, repair of deterioration beyond a certain level/extent - like that exhibited by these three windows - is not practical or reasonable. Replacement of an entire window that is too deteriorated to repair with a new window that is compatible with the historic character of the building complies with the Secretary of the Interior's Standards and Guidelines.

View of existing historic wood window #103 at Rectory, 1st floor, south elevation.

Existing historic masonry openings will remain. The proposed replacement wood windows will match the historic wood windows in design (size, pane configuration, trim details, planar and reflective qualities), color, and materials.

Per the Detroit HDC Guidelines for Historic Wood Windows, the dimensions of the replacement wood window components (the rails, stiles, and muntins) will very closely match the dimensions of the original window components.

Where sound/intact, existing historic brickmold will be retained and reused/reinstalled as part of the replacement window unit. New in-kind brickmold that matches existing historic brickmold in design (size and profile), color, and material will be used where additional material is needed.

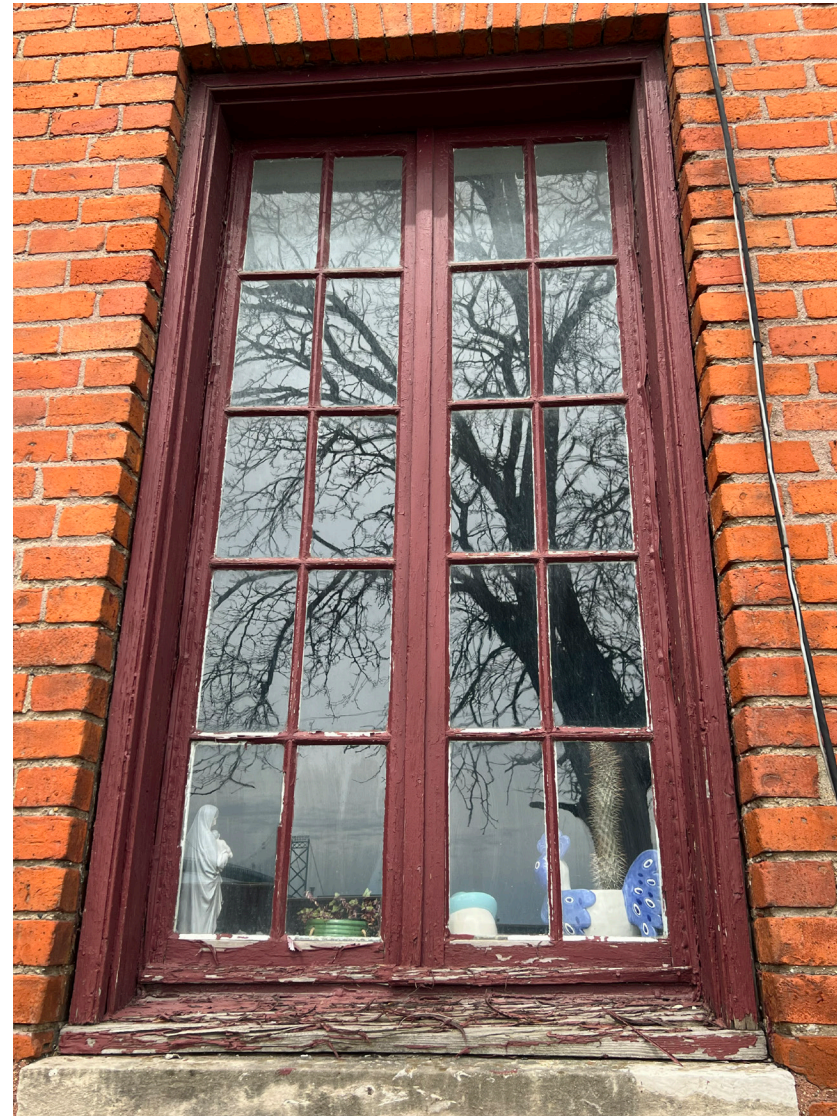
- Deeply split/checked, with deep surface deterioration. Splits are 1" deep or more, with loss of material deep into each split. Material integrity of sill is severely compromised, and splinters of wood are easily displaced.

- Bottom 12" at both sides are deeply split with rot at the bottom. Some checking continues up to 24" above the sill.
- Bottom 2" of brickmold at both sides are deeply checked and split. At both sides, brickmold is also twisted and pulled away from frame at bottom.

- All side rails area deeply checked at joints with bottom rail, with loss of structural integrity, extending several inches up. Rails are warped at bottom, preventing full closure, with a gap of approximately 3/4" at the bottom. Glazing rabbets are checked with areas of missing wood and pockets of rot.

- Bottom rails are deeply and extensively checked, and wood is significantly dried out over their whole length, with splits at joints with side rails. Structural integrity of joints has been lost. Glazing rabbets are deteriorated and deeply oxidized. Rails are rotted at bottom edges at intersection with wood drips. Sealant has been smeared over some damage. Bottom rail is warped away at the center closure.

- Bottom wood drips at bottom rails are partially detached, deeply spit and oxidized, and have lost almost all material integrity. Splinters of wood break away at the slightest touch. Some deterioration is evident at interior, which is heavily covered with paint.

- Retrofit ad-hoc exterior weatherstripping has been applied at jambs, which appears to cover up deteriorated wood. This has contributed to deterioration of side rails at jambs by trapping water.

View of existing historic wood window #104 at Rectory, 1st floor, south elevation.

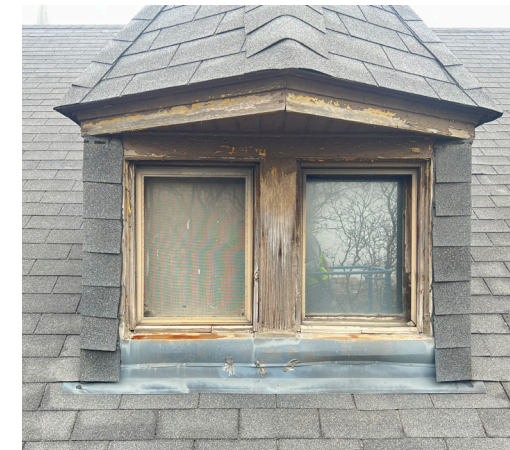
- Sill is covered with galvanized steel panning. Condition of sill is concealed.
- What previously appeared to be Dutchman repaired sills is actually some wood stops that have been installed to hold the previously installed aluminum screen in place. There are wood stops around the perimeter to hold in the screen frame.

- The lip of the aluminum sill cover has a gap at the sash which is not sealed, and has admitted water under the panning to the sill.
- The joints between the bottom rail and the side rails are covered with sealant on the surface; however, a probe showed that it is covering rotted material. A probe was able to be inserted approximately 1.5" into the deteriorated joint beneath the sealant.

- The glazing compound has been replaced with sealant all around the perimeter of the sash.

- Similar conditions to right/east window; however, less sealant on the bottom rail. Deep rot was present on the left end of the bottom rail and bottom of the side rail. Sealant covers this location on the right end, but a probe was able to be inserted to confirm that concealed conditions are similar. A probe easily penetrated approximately 1.5" into the joints on each end.
- Glazing rabbets are significantly oxidized. Sash is held in with nails at the bottom.

The overall condition of these windows and frames is extremely poor/deteriorated beyond reasonable repair. The depth and extent of deterioration would require replacement of so many components, that little of the original window would remain. Replacement of an entire window that is too deteriorated to repair with a new window that is compatible with the historic character of the building complies with the Secretary of the Interior's Standards and Guidelines.

View of existing historic wood window #400A/B at Rectory, roof dormer, south elevation.

Existing historic masonry openings will remain. The proposed replacement wood windows will match the historic wood windows in design (size, pane configuration, trim details, planar and reflective qualities), color, and materials.

Per the Detroit HDC Guidelines for Historic Wood Windows, the dimensions of the replacement wood window components (the rails, and stiles) will very closely match the dimensions of the original window components.

Where sound/intact, existing historic brickmold will be retained and reused/reinstalled as part of the replacement window unit. New in-kind brickmold that matches existing historic brickmold in design (size and profile), color, and material will be used where additional material is needed.

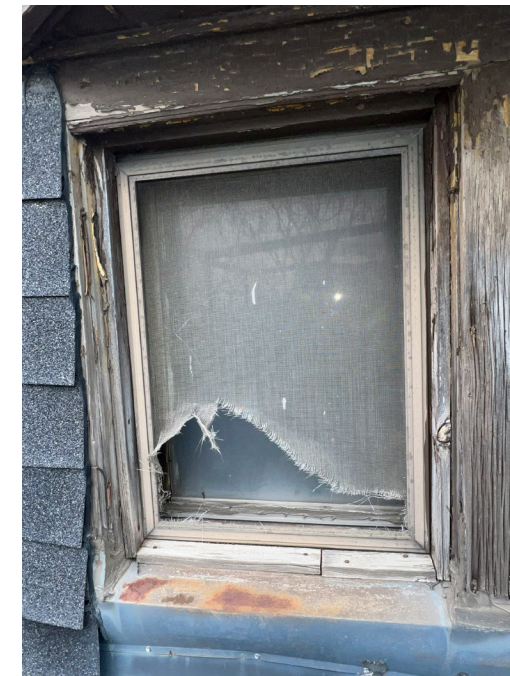
Detail view of existing historic wood window #400A.

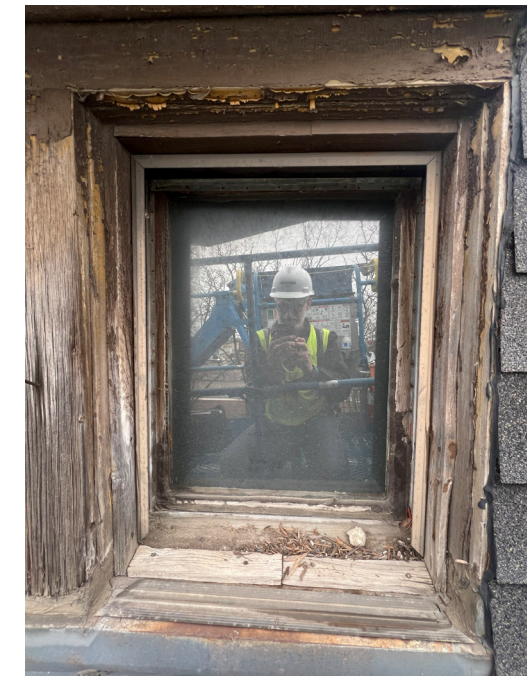
Detail view of existing historic wood window #400B.

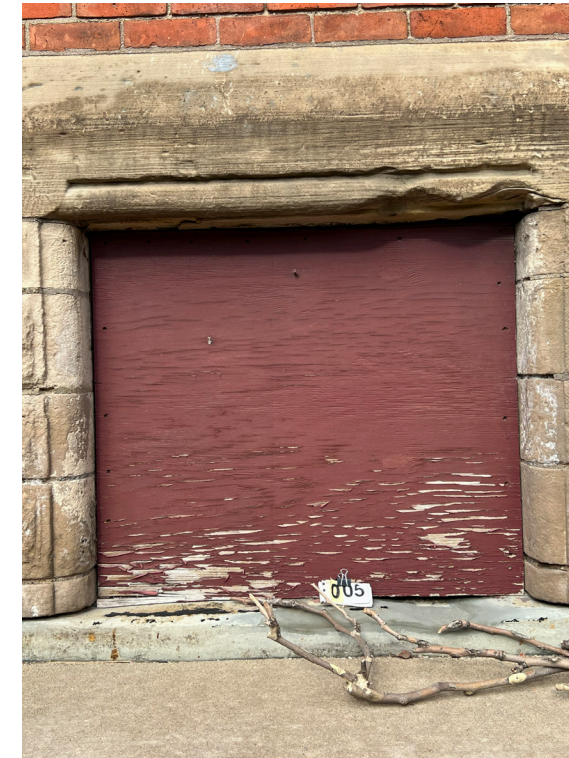
- a. Historic bsmt window unknown, previously concealed.
- i. Visible from public sidewalk/street.
- ii. Plywood infill exists. Condition of frame and sash is unknown.

View of existing historic masonry opening #005 at Basilica/chapel, west elevation.

Proposed infill of one basement masonry opening at west elevation (#005). Masonry infill will be recessed to face of existing/former window frame (2" rusticated face stone w/ CMU backup); integrity and visual reading of original M.O. will be maintained.

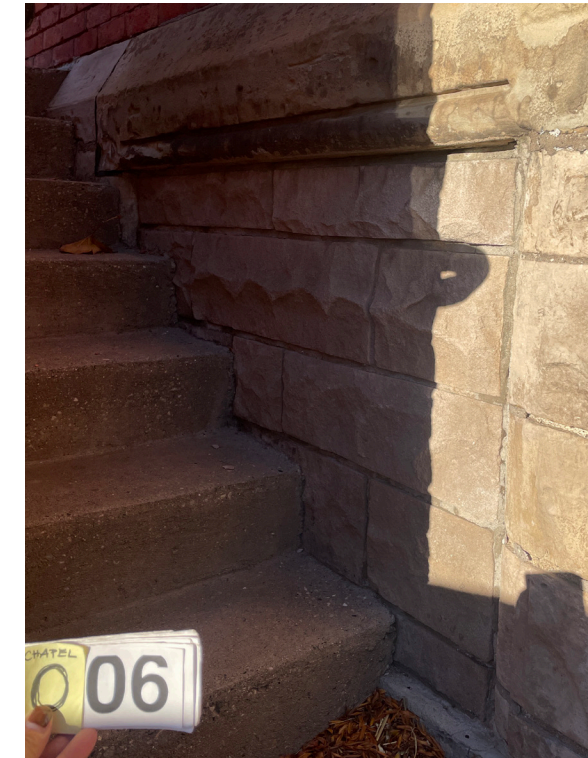
FOR REFERENCE: View of existing historic masonry opening #006 at Basilica/chapel. Previously infilled with stone; north of #005 at west elevation.

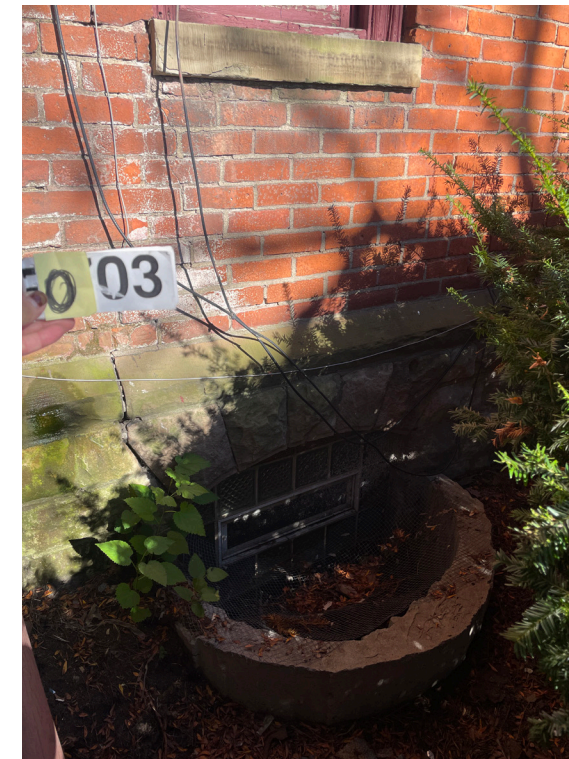
View of existing historic masonry opening #003 at Rectory, south elevation.

Proposed infill of six basement masonry openings (listed below). Masonry infill will be recessed to face of existing/former window frame (2" rusticated face stone w/ CMU backup); integrity and visual reading of original M.O. will be maintained.

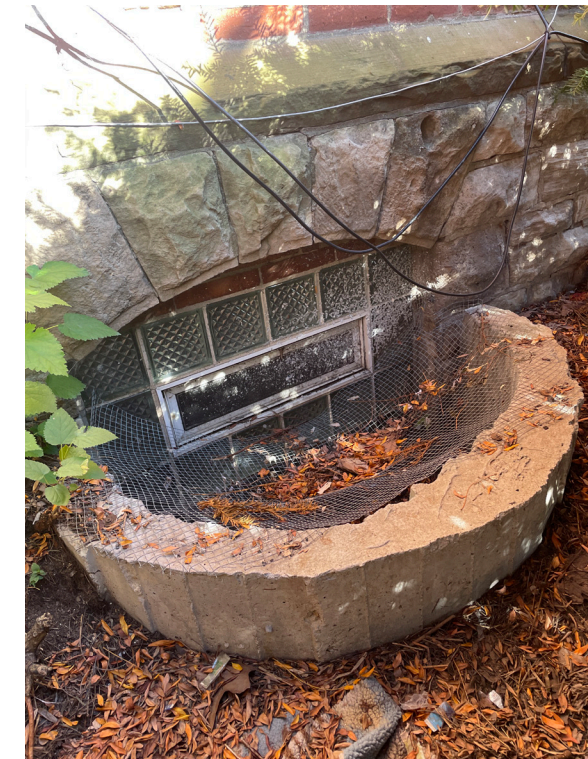
View of existing historic masonry opening #003 at Rectory, south elevation.

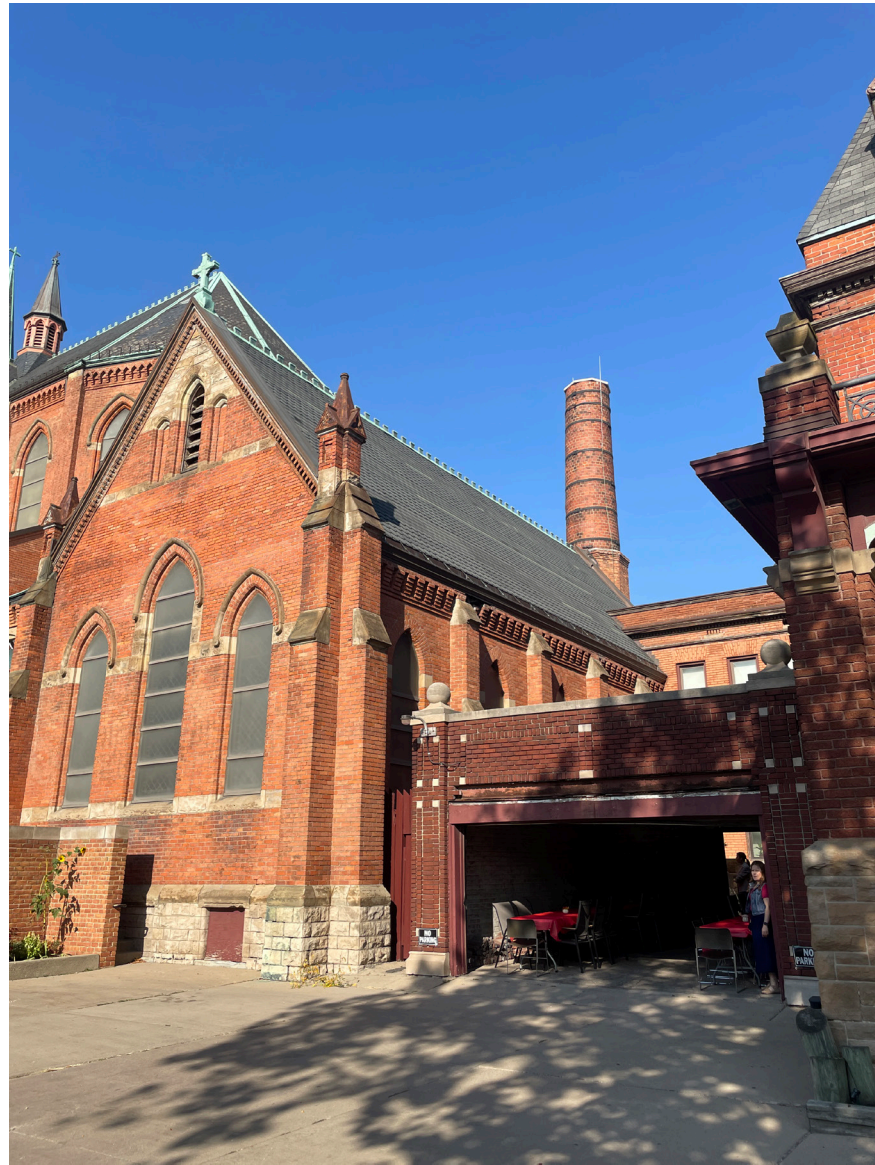
**EXISTING CONDITION - MASONRY OPENING #005 @ BASILICA/CHAPEL**

View of existing historic masonry opening #005 at Basilica/chapel, west elevation. Existing painted (red) plywood infill panel visible. Detracts from visual qualities of the historic stone foundation wall; distracting and incompatible material.

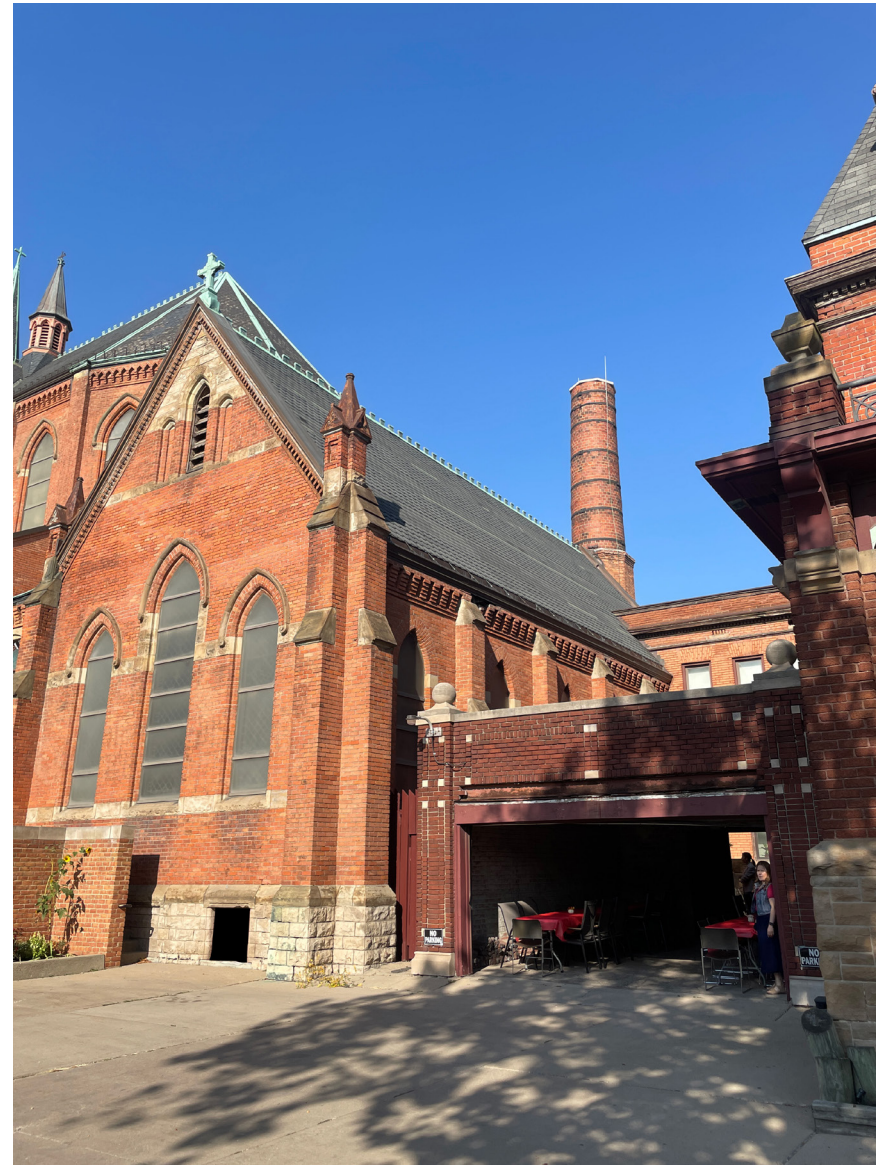
**SUGGESTED TREATMENT - MASONRY OPENING #005 @ BASILICA/CHAPEL**

View of existing historic masonry opening #005 at Basilica/chapel, west elevation. Unspecified opaque/solid infill painted black, as suggested by a Commissioner during the 04/08/26 HDC meeting. Detracts from visual qualities of the historic stone foundation wall; distracting and incompatible material.

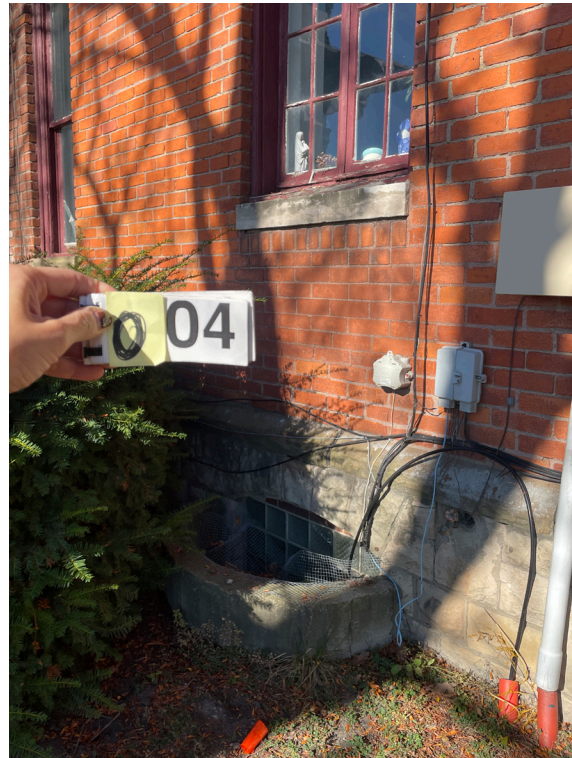
View of existing historic masonry opening #004 at Rectory, south elevation.

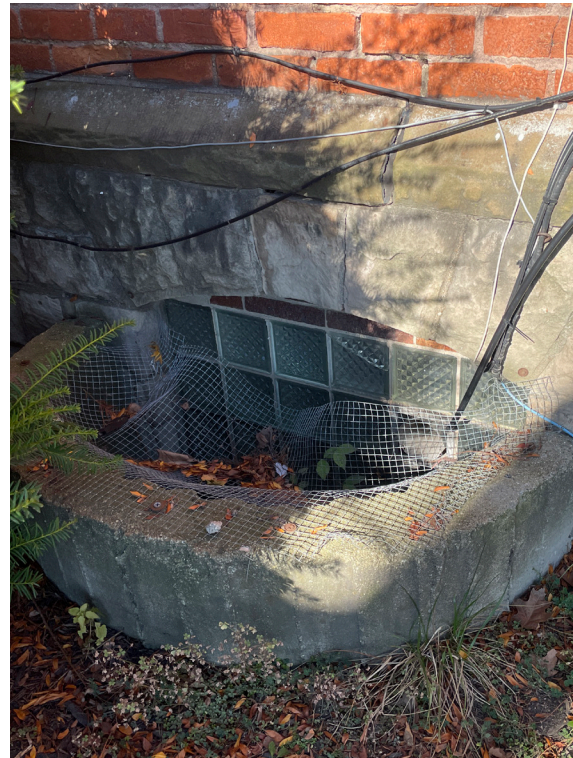
View of existing historic masonry opening #004 at Rectory, south elevation.

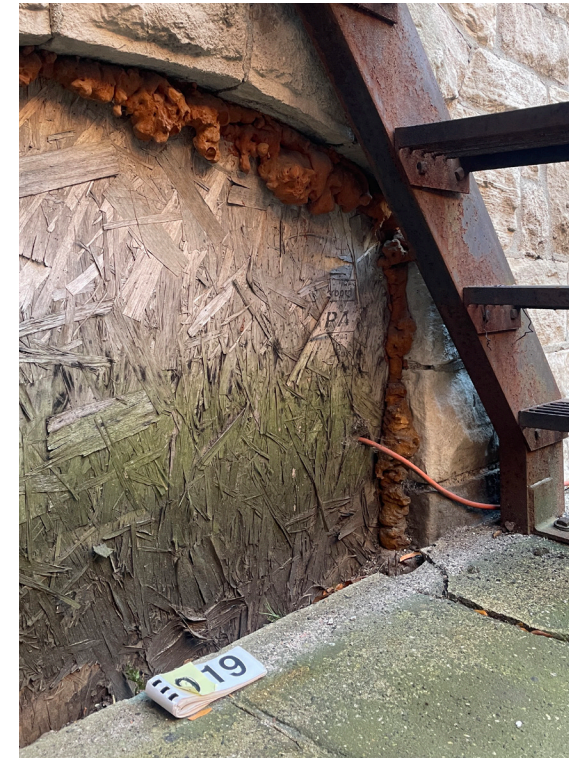
View of existing historic masonry opening #019 at Rectory, north elevation.

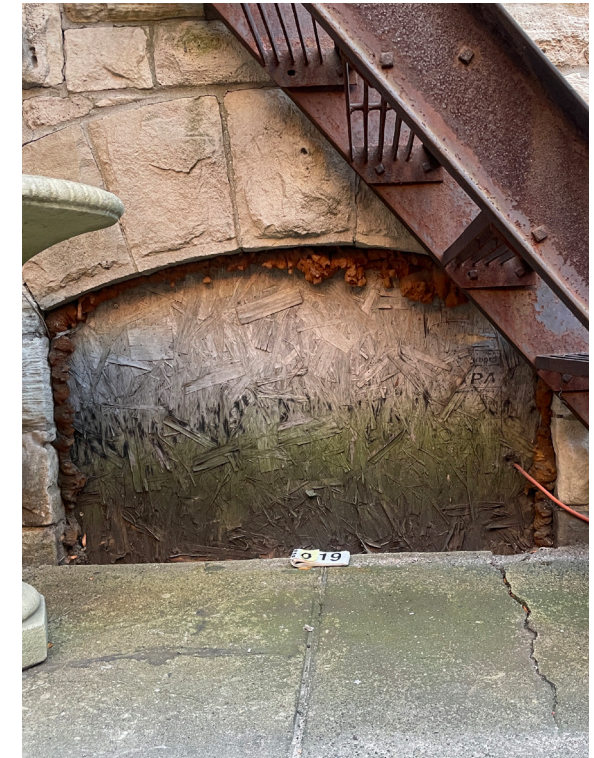
View of existing historic masonry opening #019 at Rectory, north elevation.

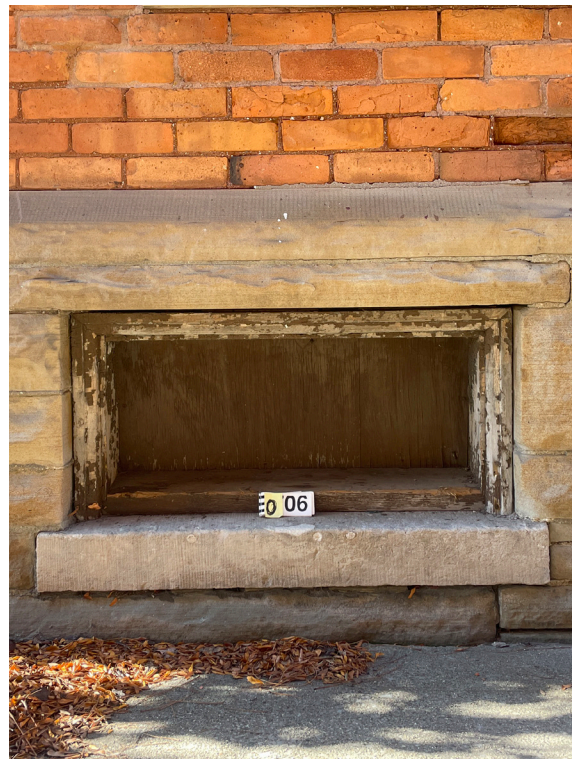
View of existing historic masonry opening #006 at Rectory, south elevation.

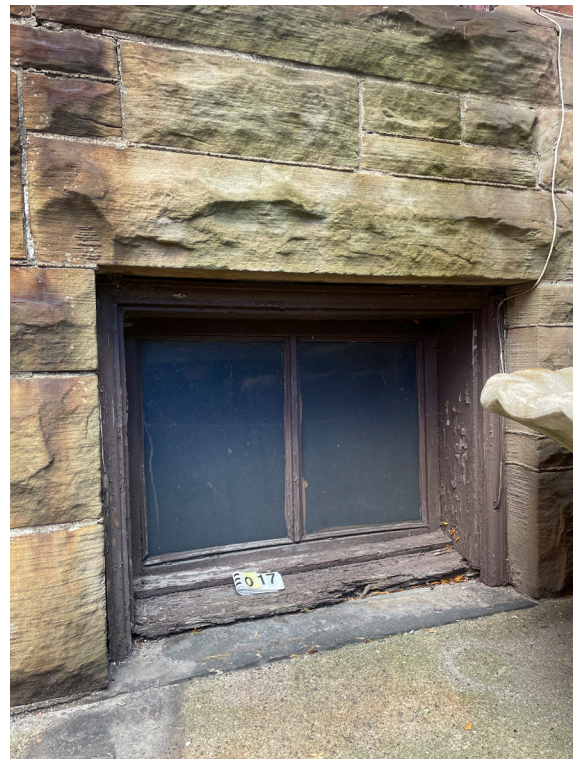
View of existing historic masonry opening #017 at Rectory/connector, west elevation.

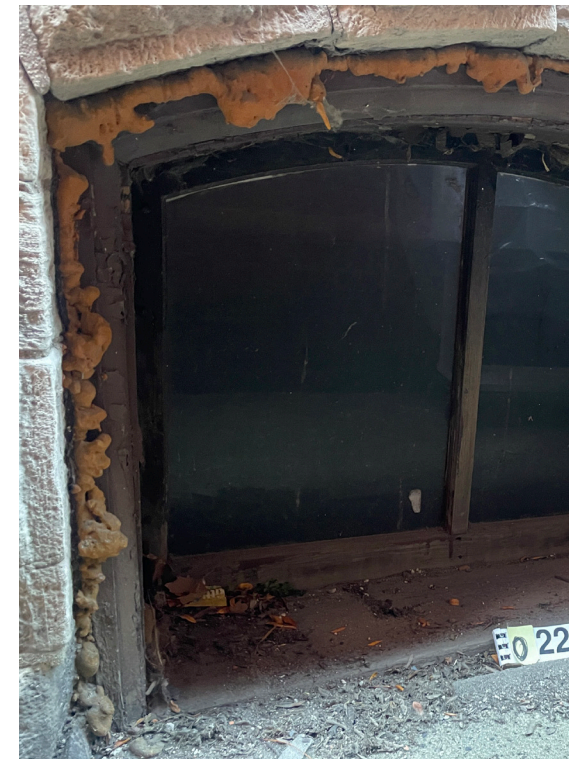
**Opening #022:**

- a. Historic bsmt window previously modified.
- i. At crawlspace. Inaccessible from interior during assessment.
- ii. Visible from public sidewalk/street.
- iii. Frame and sash components exist. Spray foam insulation visible at exterior. Condition is non-repairable.

View of existing historic masonry opening #022 at Rectory, north elevation.

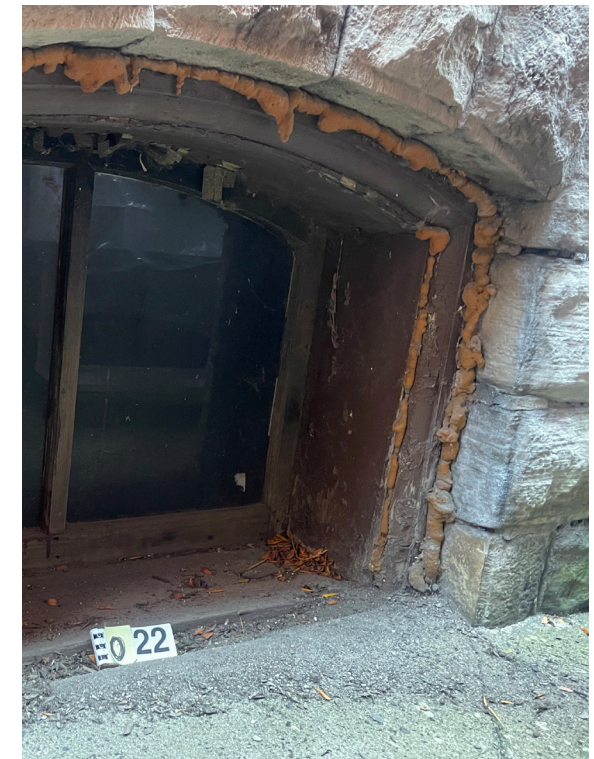
View of existing historic masonry opening #022 at Rectory, south elevation.

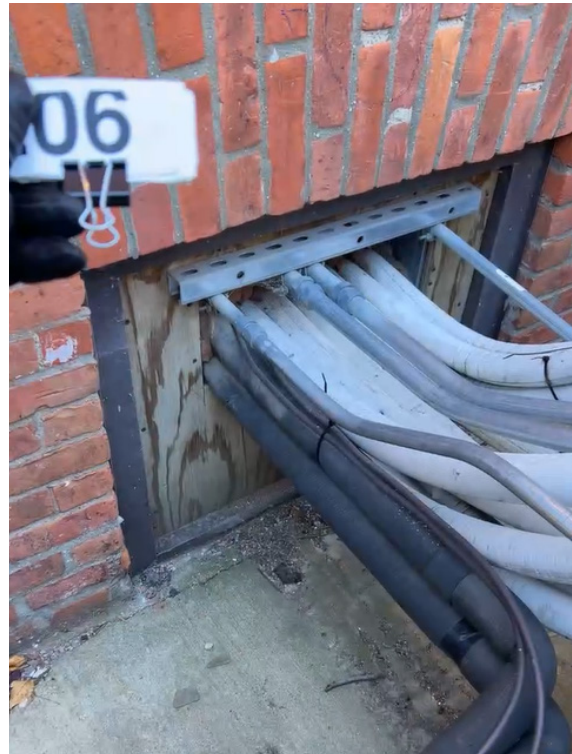
View of existing historic masonry opening #006 at Wellness Center/Convent, north elevation.

Revised scope of work: Previously proposed for infill at all basement masonry openings (04/08/26 HDC meeting). Revised as proposed for only one basement masonry opening (#006 at rear/north elevation) to receive new treatment, while all others remain as is (no work). (05/13/26 HDC meeting).

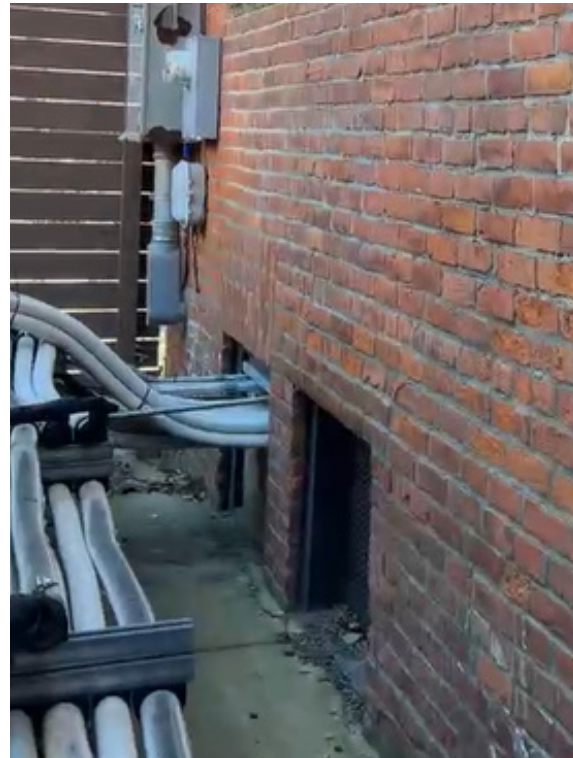
*FOR REFERENCE:* View of masonry openings #006 and #007 at Wellness Center/Convent, north elevation. Concealed from view by existing screen/fence.
