HISTORIC DISTRICT COMMISSION ADDITIONAL INFORMATION REQUEST

Application Number: HDC2026-00121

PROJECT ADDRESS: 2900 Cass Avenue.

2900 Cass Façade Review

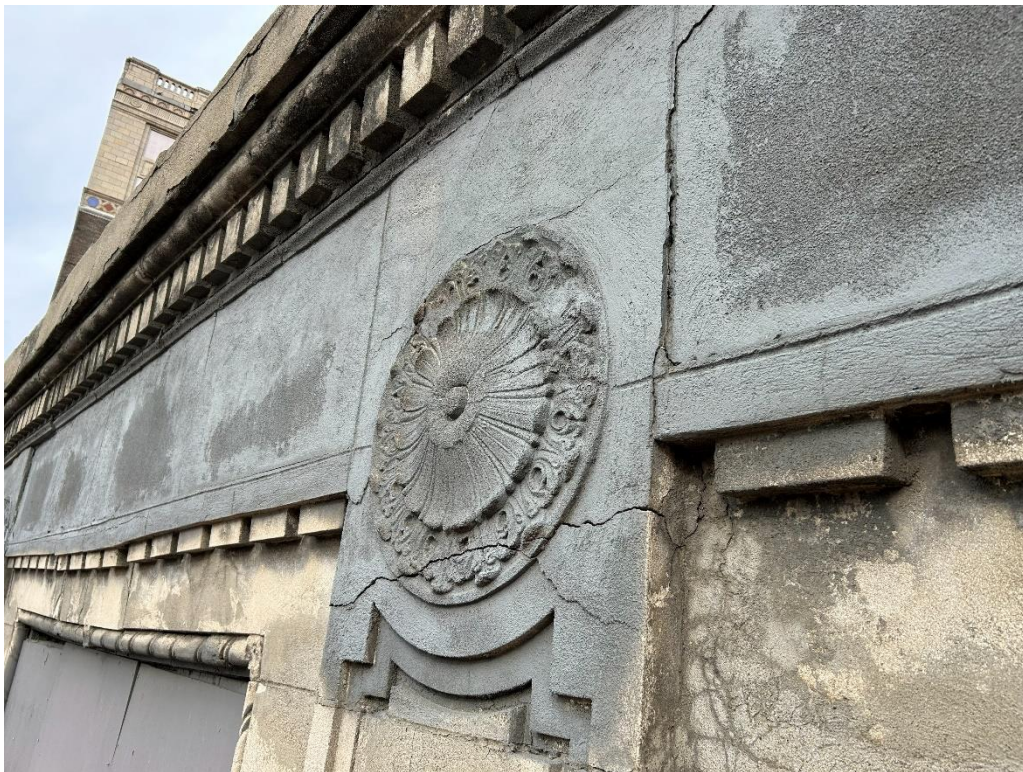
Photo 1: Unbonded/damaged decorative panel

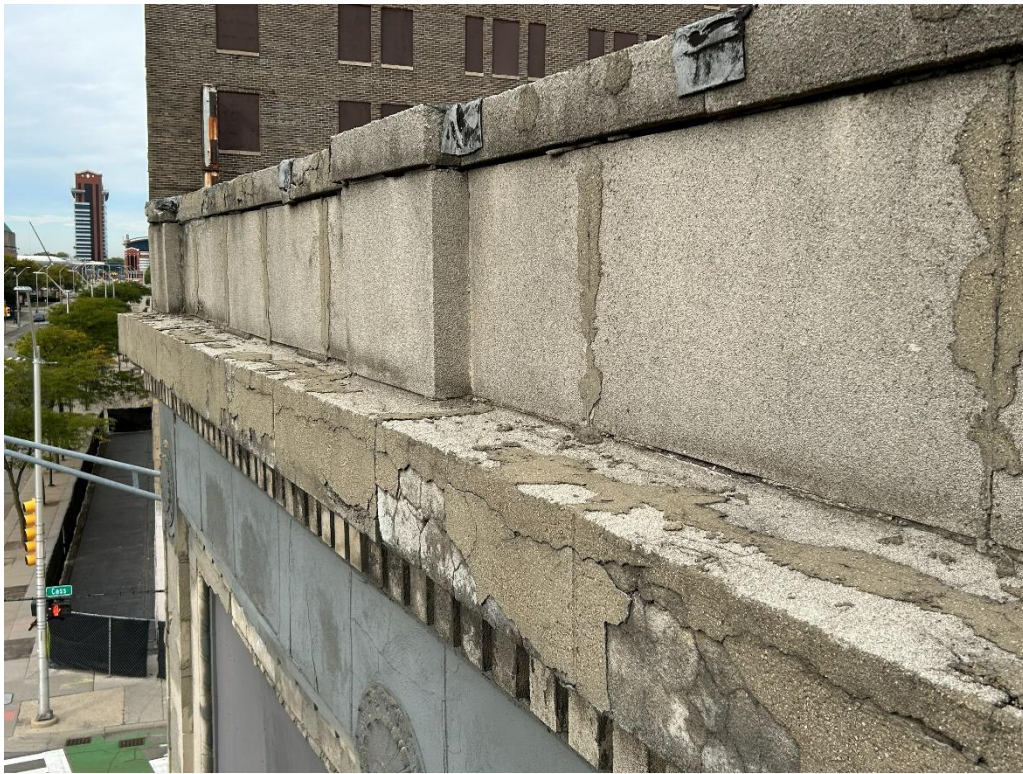
Photo 2: Damaged Cornice component

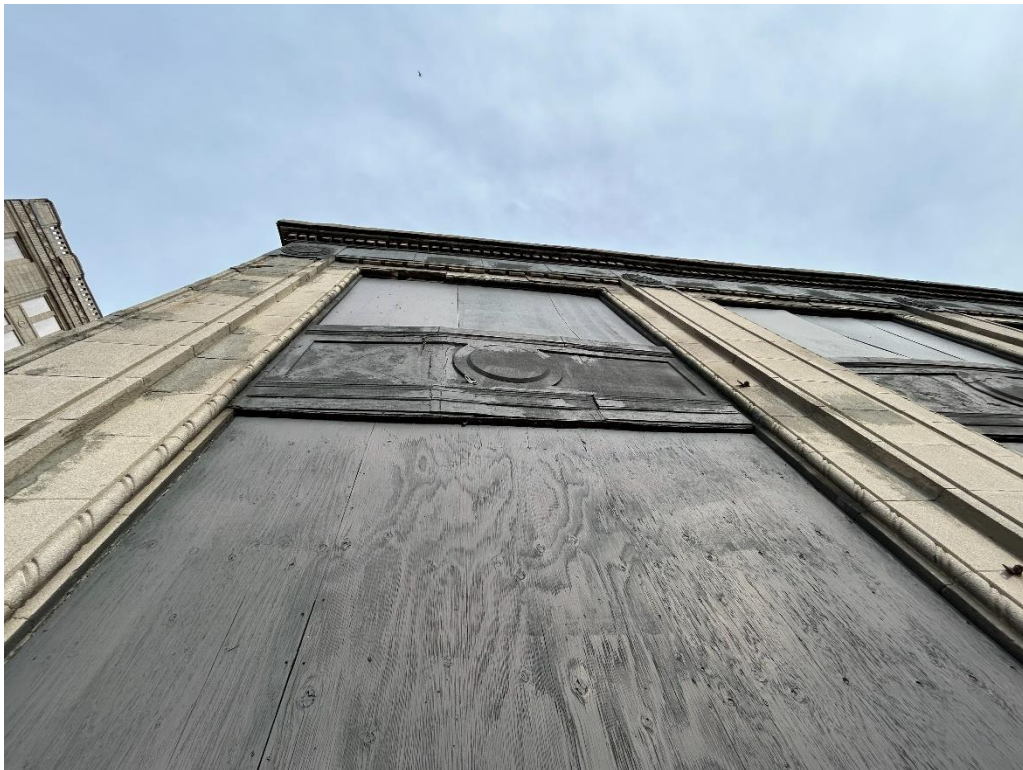
Photo 3: Debonded decorative spandrel component

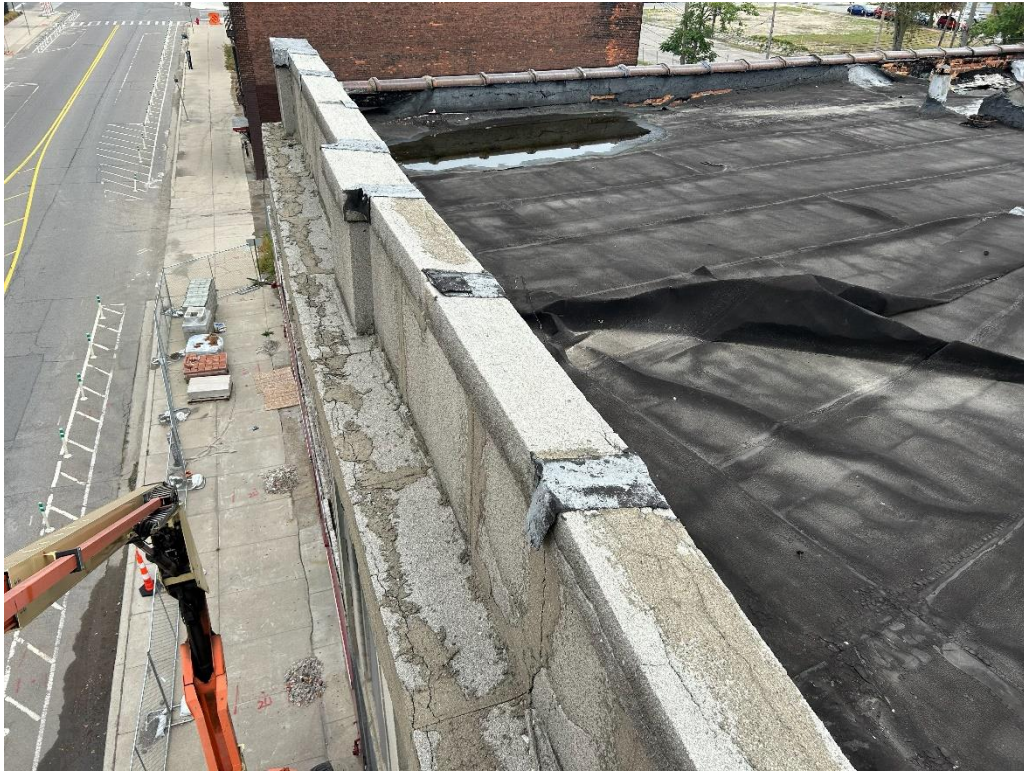
Photo 4: Out of plumb parapet wall

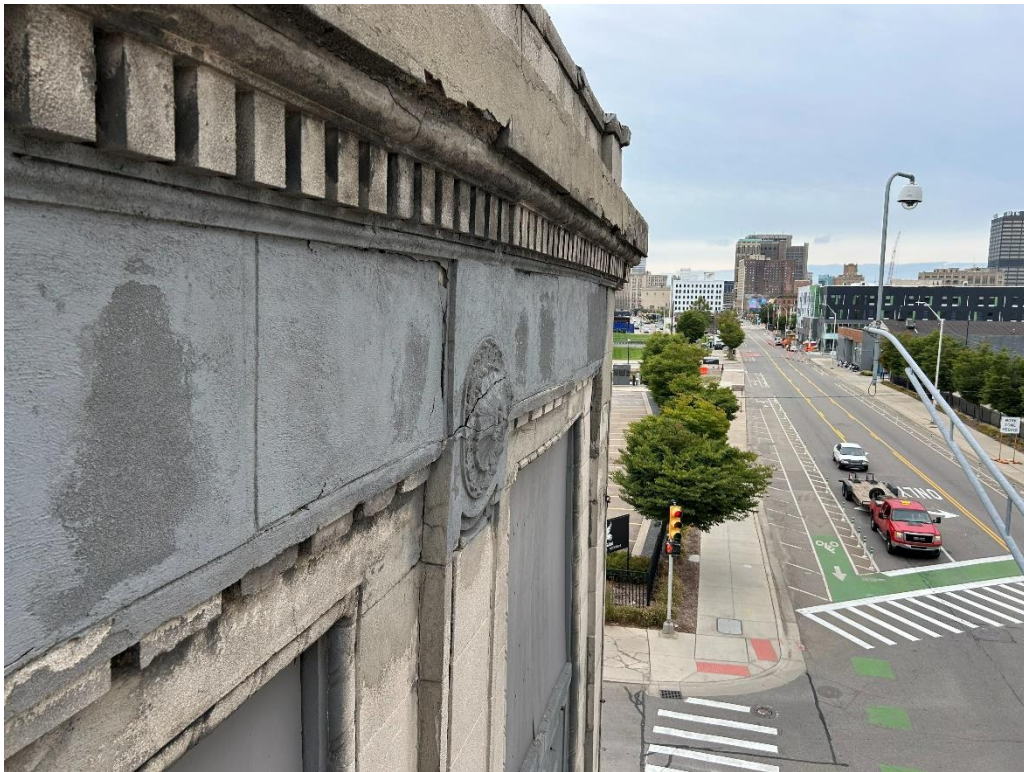
Photo 5: Damaged concrete panels and cornice components

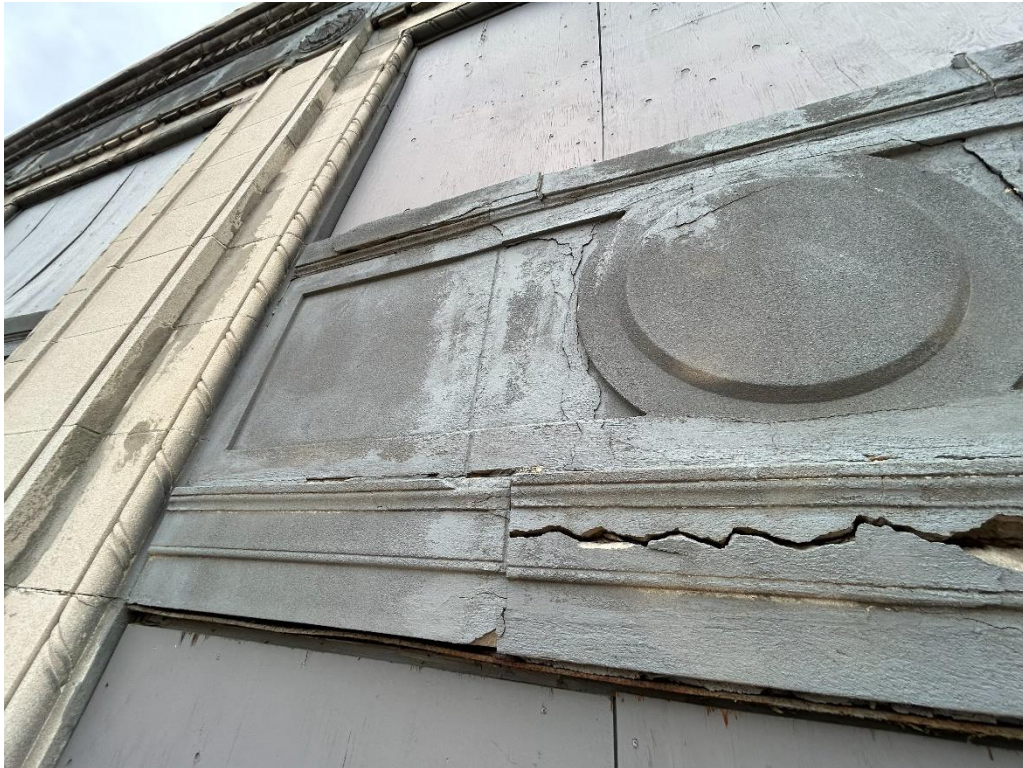
Photo 7: Damaged spandrel and header components
