HISTORIC DISTRICT COMMISSION ADDITIONAL INFORMATION REQUEST

Application Number: HDC2026-00121

PROJECT ADDRESS: 2900 Cass Avenue.

2900 Cass Façade Review

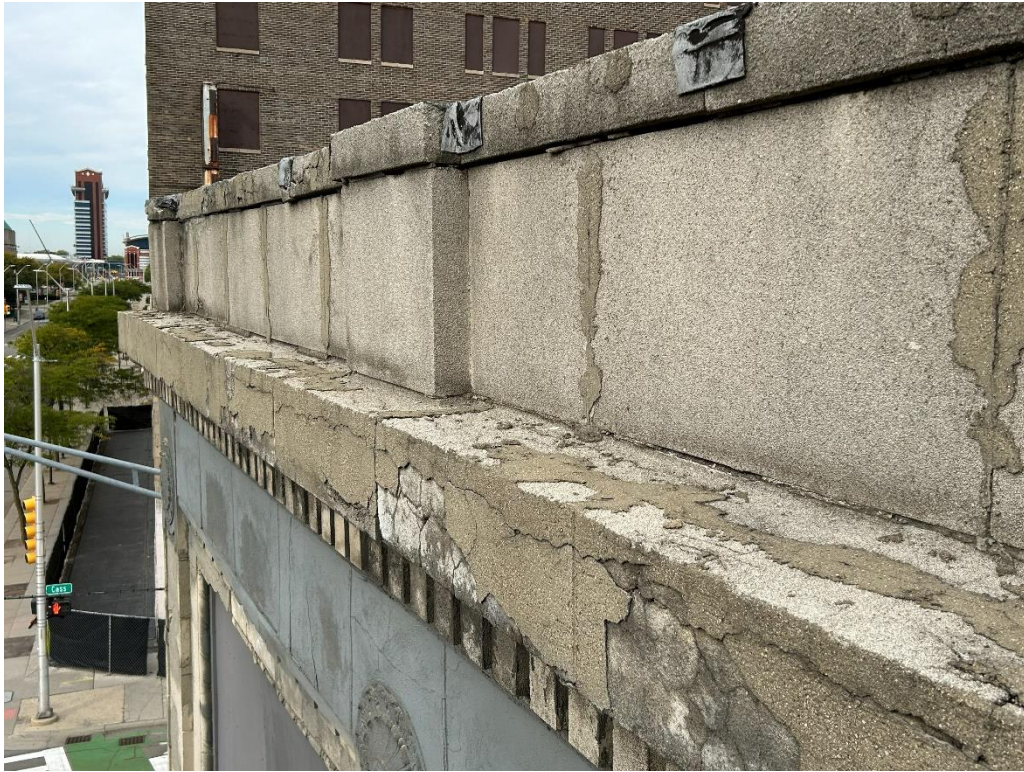
Photo 2: Damaged Cornice component

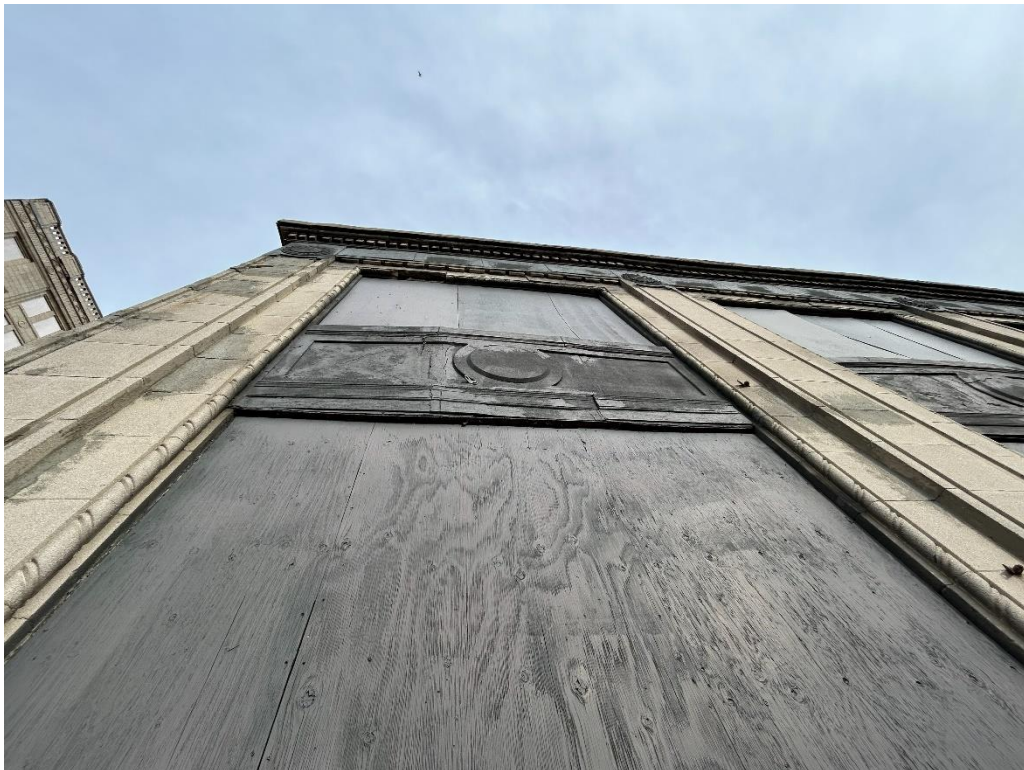
Photo 3: Debonded decorative spandrel component

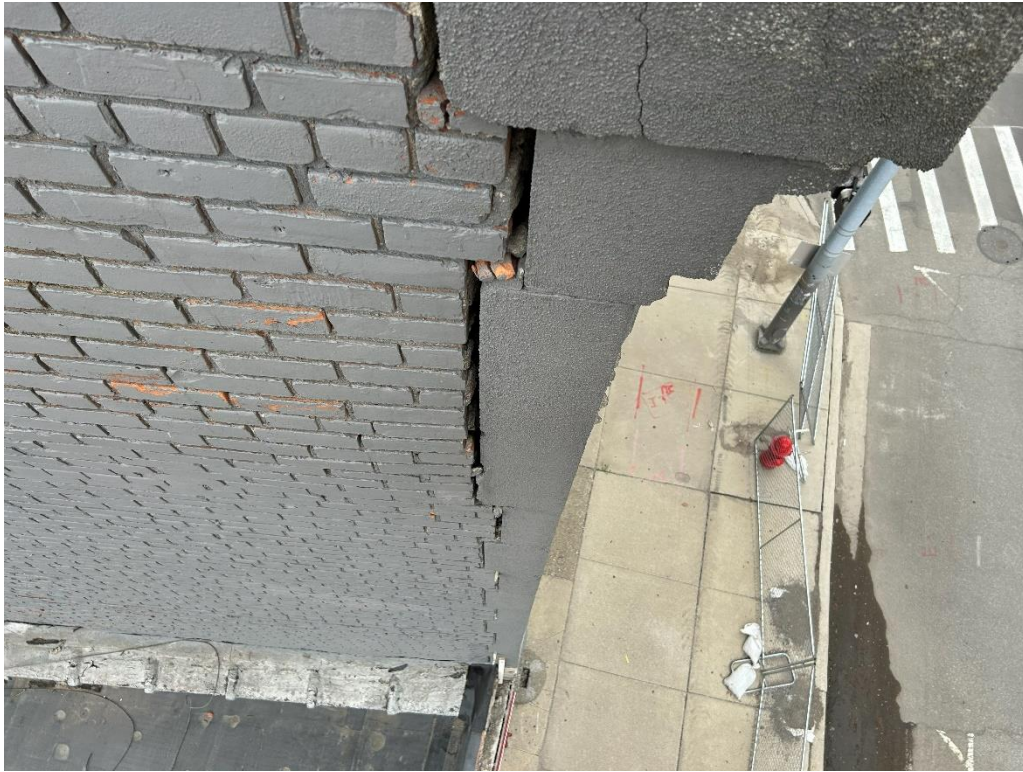
Photo 6: Unbonded brick façade at building corner
