# HISTORIC DISTRICT COMMISSION APPLICATION FOR WORK APPROVAL

HDC2026-00448

**ADDRESS(ES):** 105 Delaware Street

**HISTORIC DISTRICT:** New Center Area

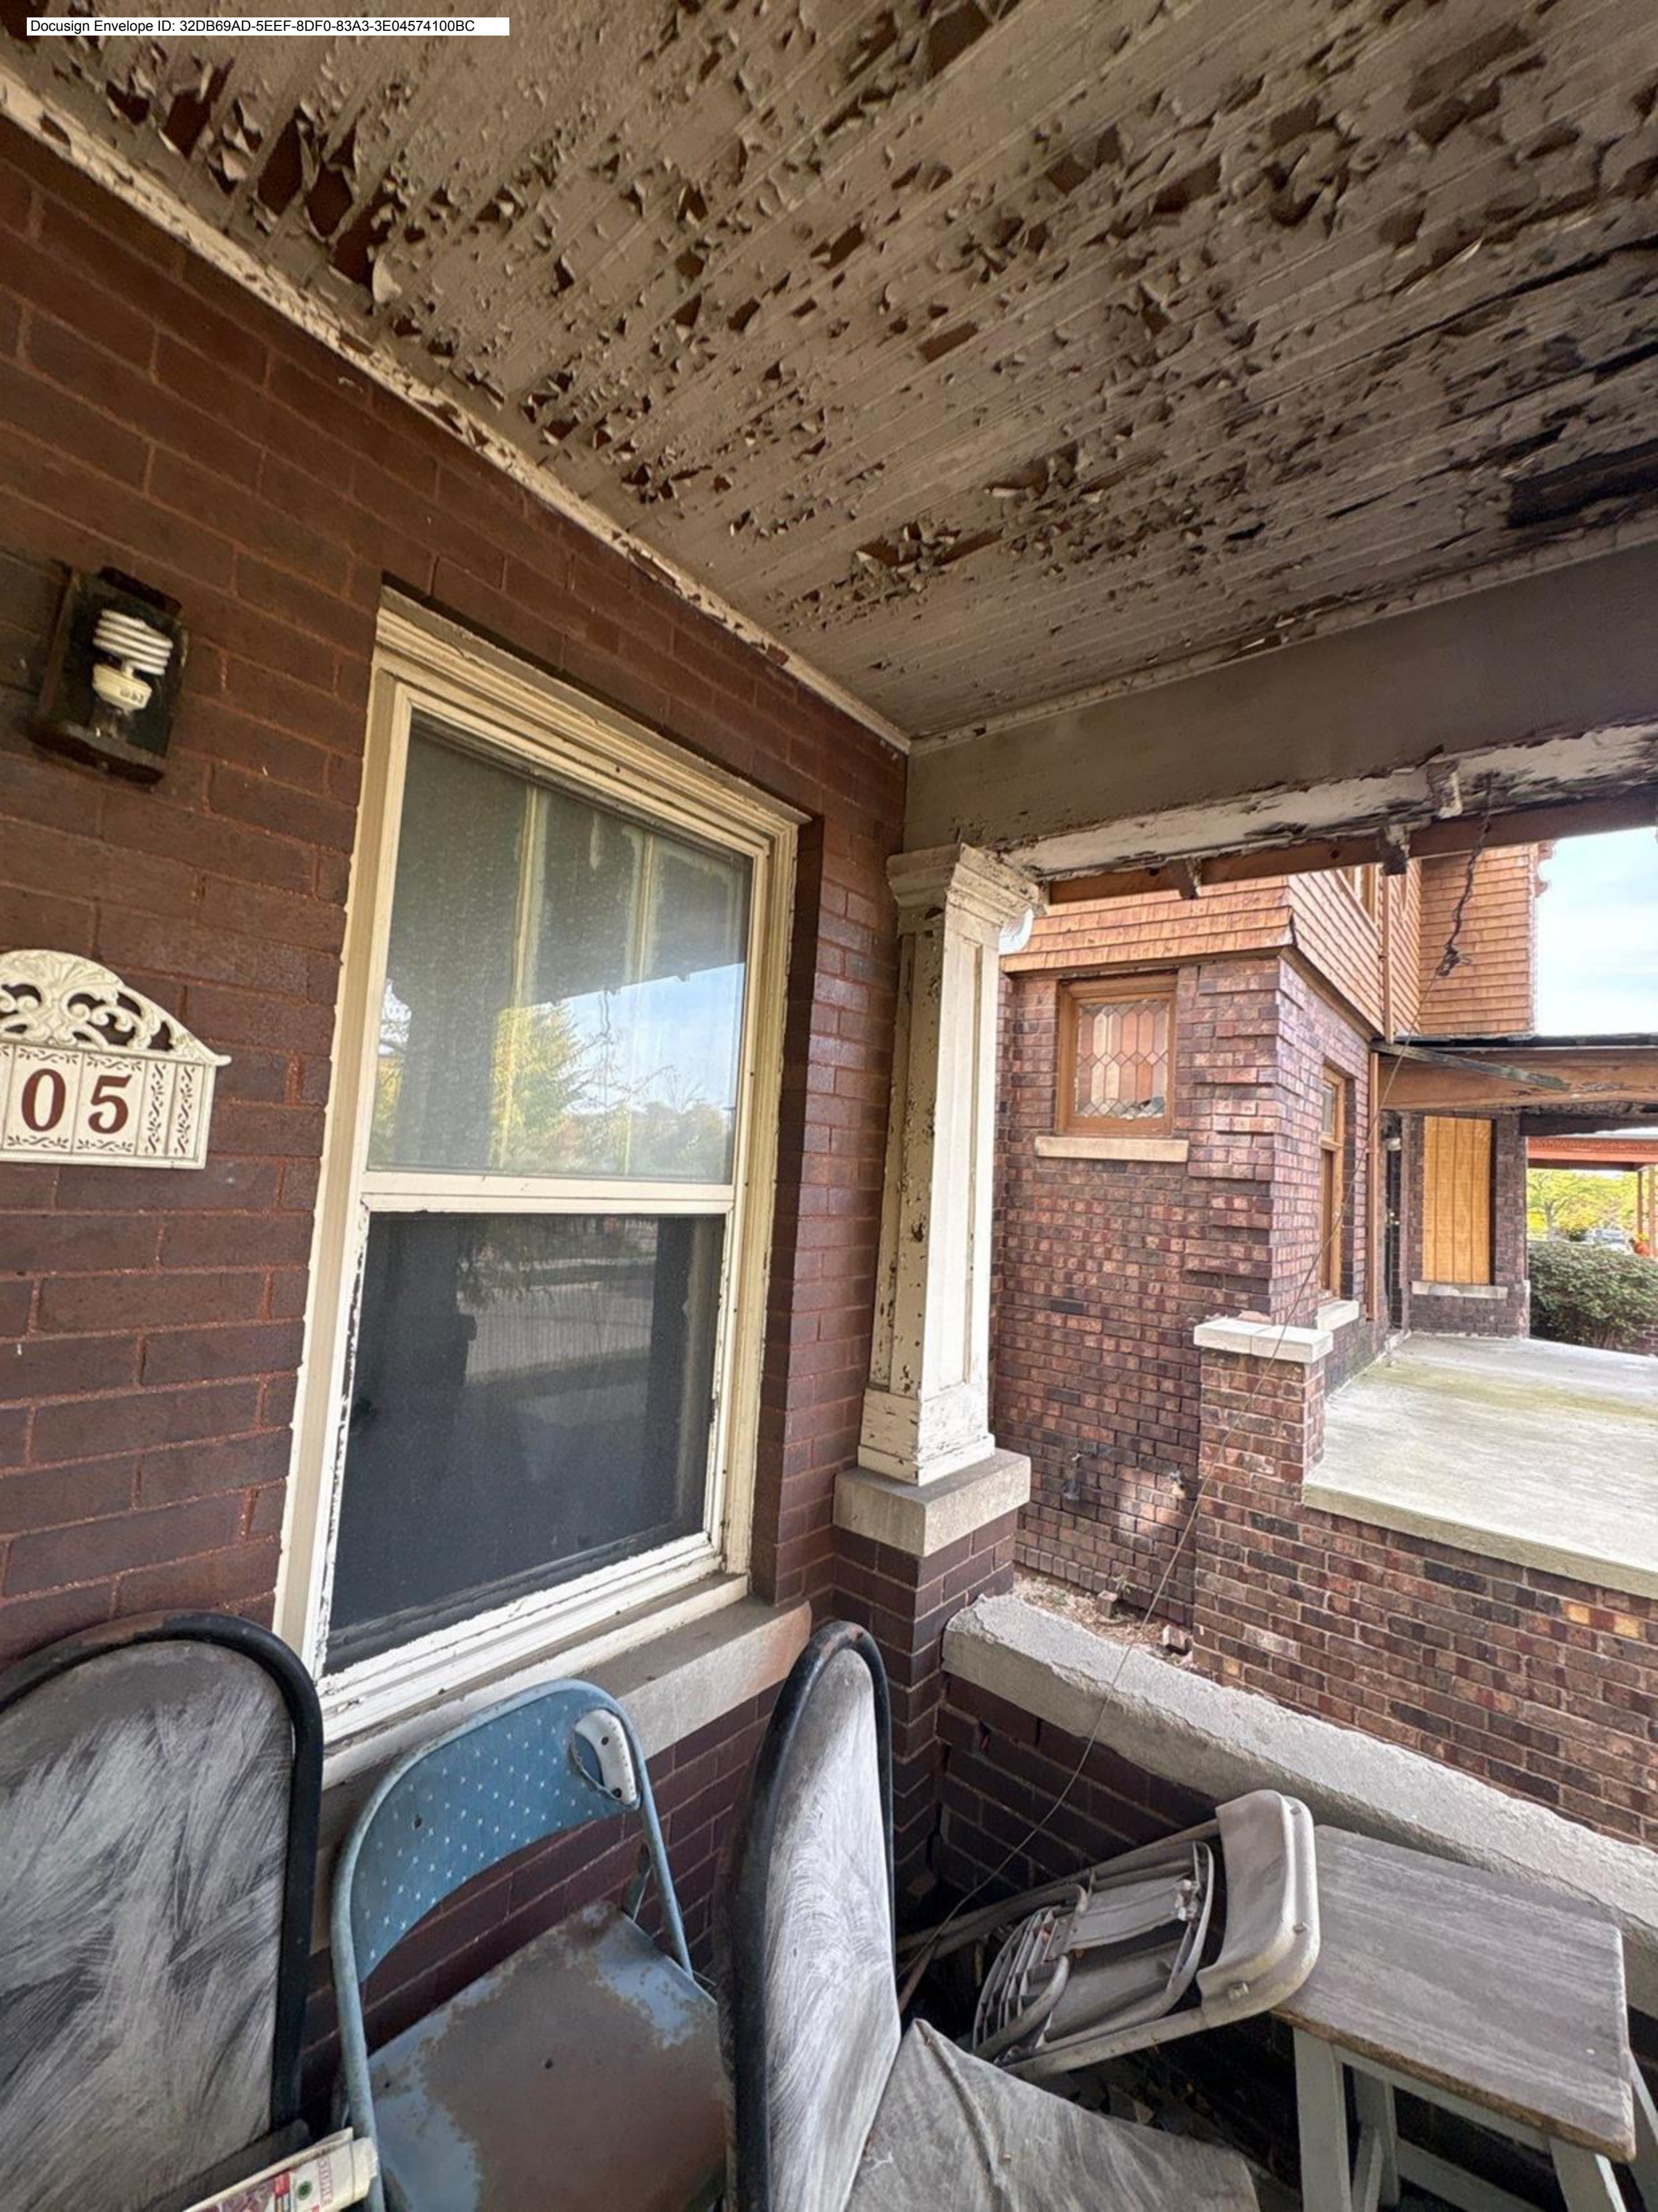
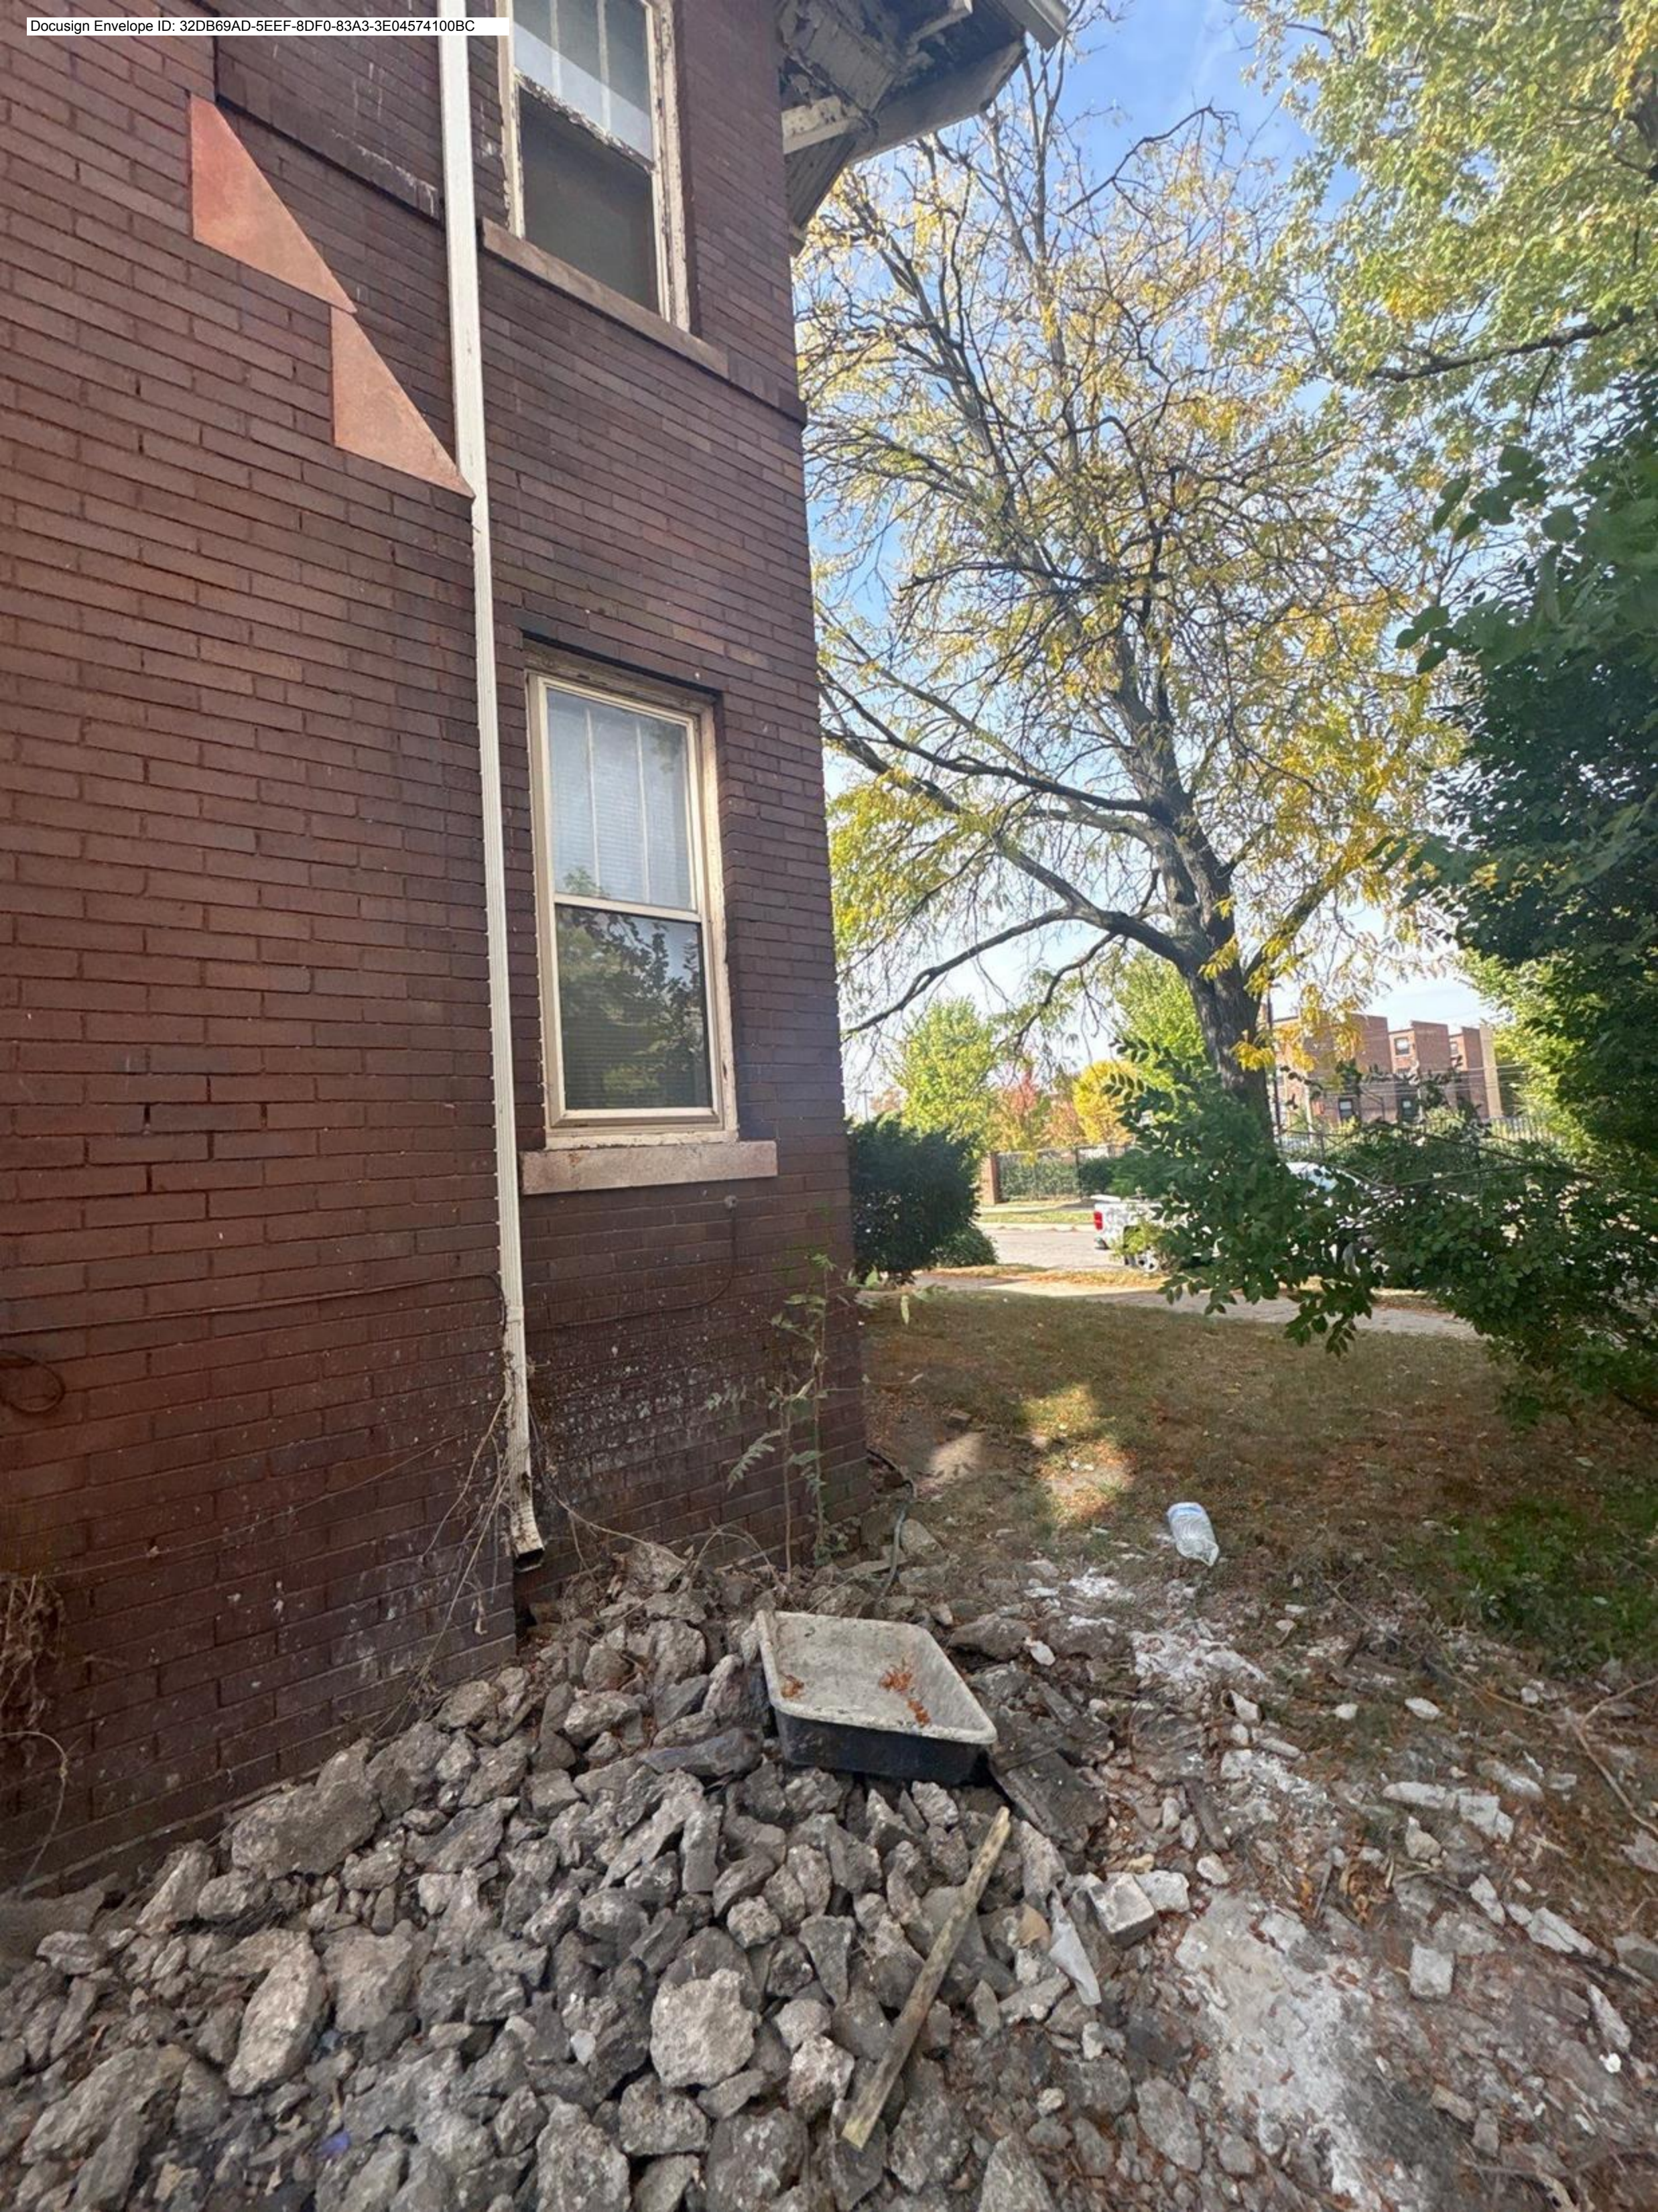
*Photos 13 and 14 in the attached photo gallery show existing window conditions.*

- Retain all existing window frames and sashes
- Repair broken glazing with single-strength glass in-kind
- Re-glaze all sashes with traditional oil-based glazing compound
- Repair rotted sill ends with Dutchman repairs using matching wood species in-kind
- Strip and repaint all sash, frame, and sill elements
- No window unit removal or replacement
