STAFF REPORT 05-08-2024 REGULAR MEETING

APPLICATION NUMBER: HDC2024-00183

ADDRESS: 64 EDMUND PLACE

SCOPE: ERECT REAR ADDITION AND ROOF DECKS, RESTORE FULL-WIDTH FRONT PORCH, INSTALL WINDOWS

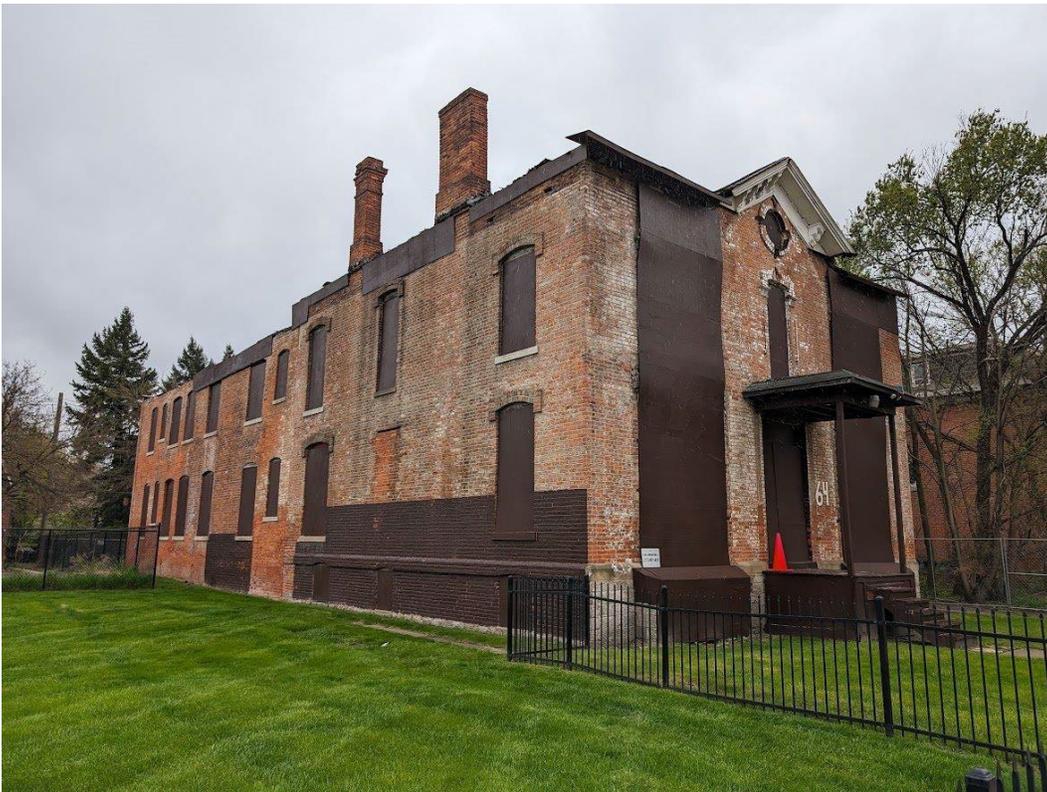
View of 64 Edmund Place, looking southwest from the sidewalk. Staff photo, April 23, 2024.

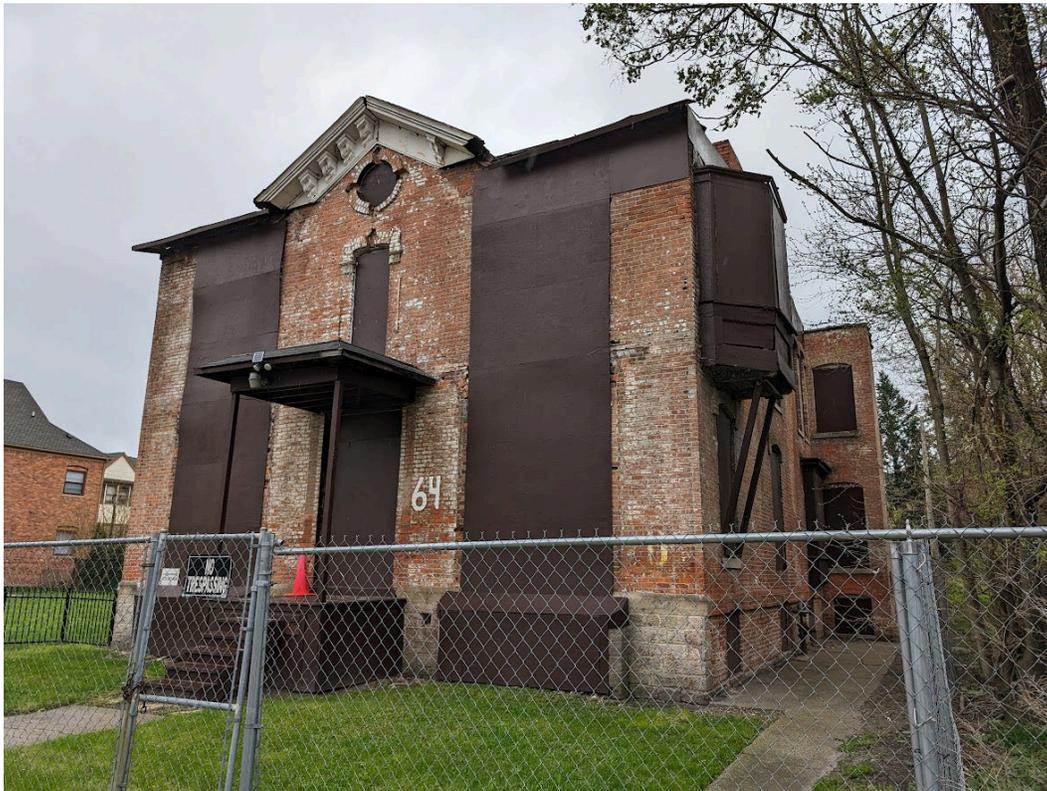
Another view of front elevation, with right (west) side visible. Staff photo, April 23, 2024.

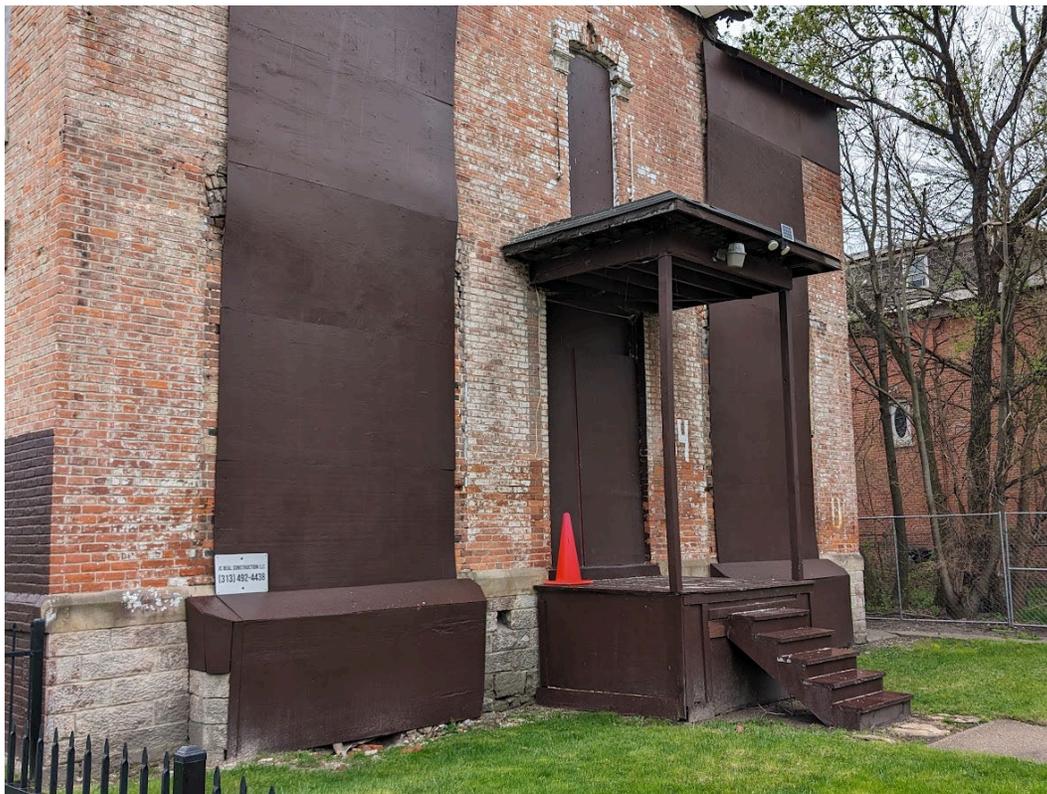
Detail view of front foundation and existing non-approved porch. Staff photo, April 23, 2024.

- The front porch of this house has existed in at least four different iterations over the last 150 years. The original Victorian era porch, as rendered speculatively on page 2 of this report, was removed early in the historic period. The second porch, shown below, was a grandly stylized Colonial Revival full-width porch with six columns and a balustrade, centered by a curved projection over the main entrance. It was likely added at the same time as the “rooming” addition, and would have served as a welcome exterior social space for the various working residents of the building. In 1978, just prior to the district’s designation, the Colonial Revival porch was simplified by removing the curved portion. While likely done for maintenance purposes, this alteration of the porch’s rooflines returned more balance to the juxtaposition between the 19th and 20th century expressions of the house, in staff’s opinion. Finally, the remainder of the historic 20th century porch was removed in the late 20th century and replaced with a small utility porch of no historic character, which survives today.

The applicant proposes to reconstruct a close facsimile of the early 20th century Colonial Revival porch that existed *at the time of designation* (without the curved projection), in compatible and authentic wood materials, based on surviving photographs from the 1960s through the 1980s. There is no record of Commission approval for removal of the Colonial Revival porch which was present in 1980. Staff recommends this treatment as historically appropriate, and also as a remedy for this apparent violation, as it returns the porch to its appearance at the time that regulatory controls commenced.

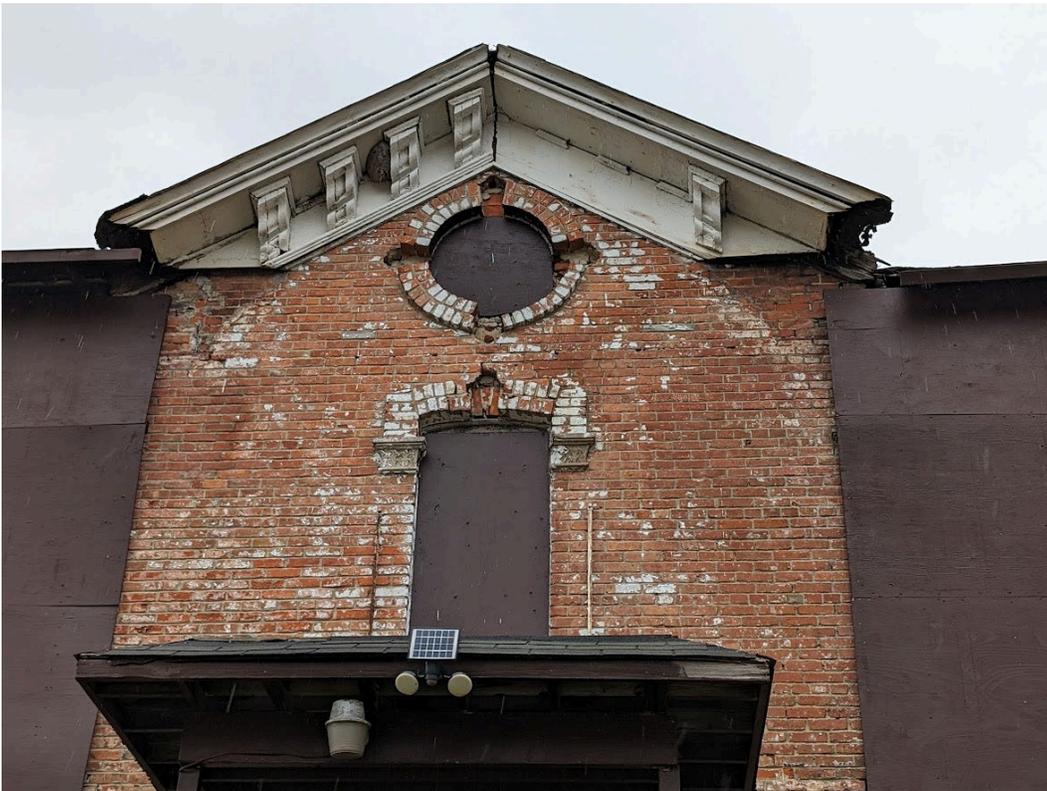
Central gable, with some remaining historic elements. Staff photo, April 23, 2024.

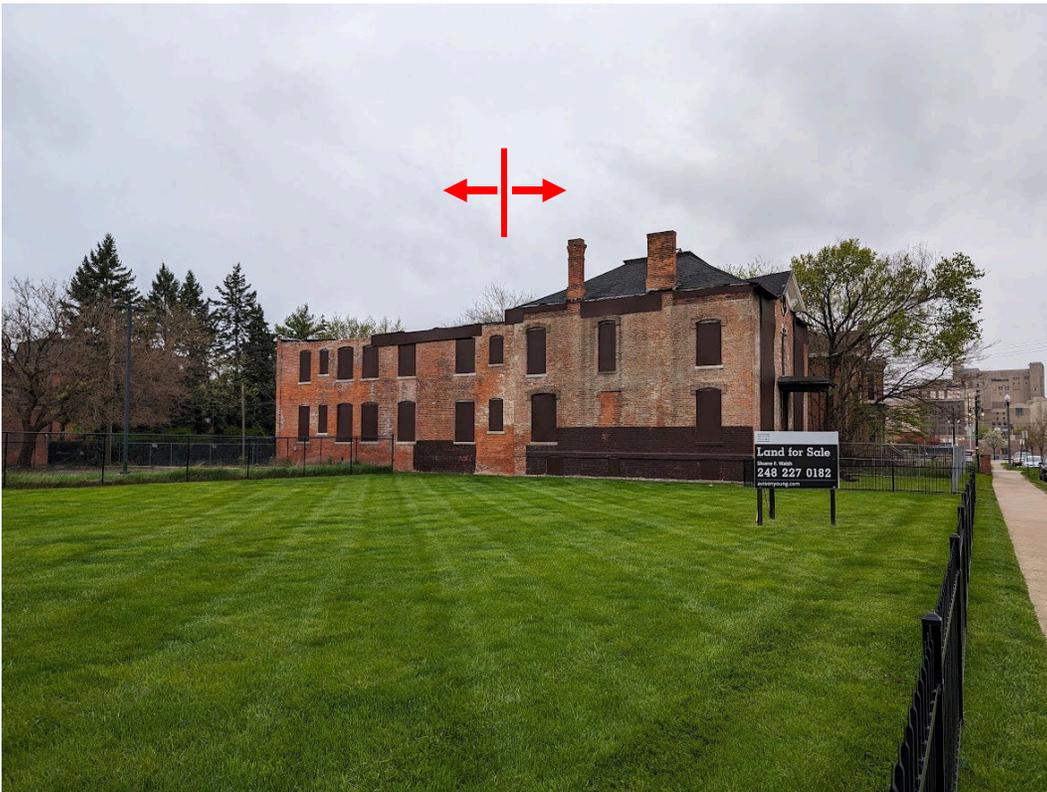
Distant view of left side (east) elevation, looking towards the west. The two construction phases (original mansion and 1920s addition) are easily read here, divided by the vertical red line. Staff photo, April 23, 2024.

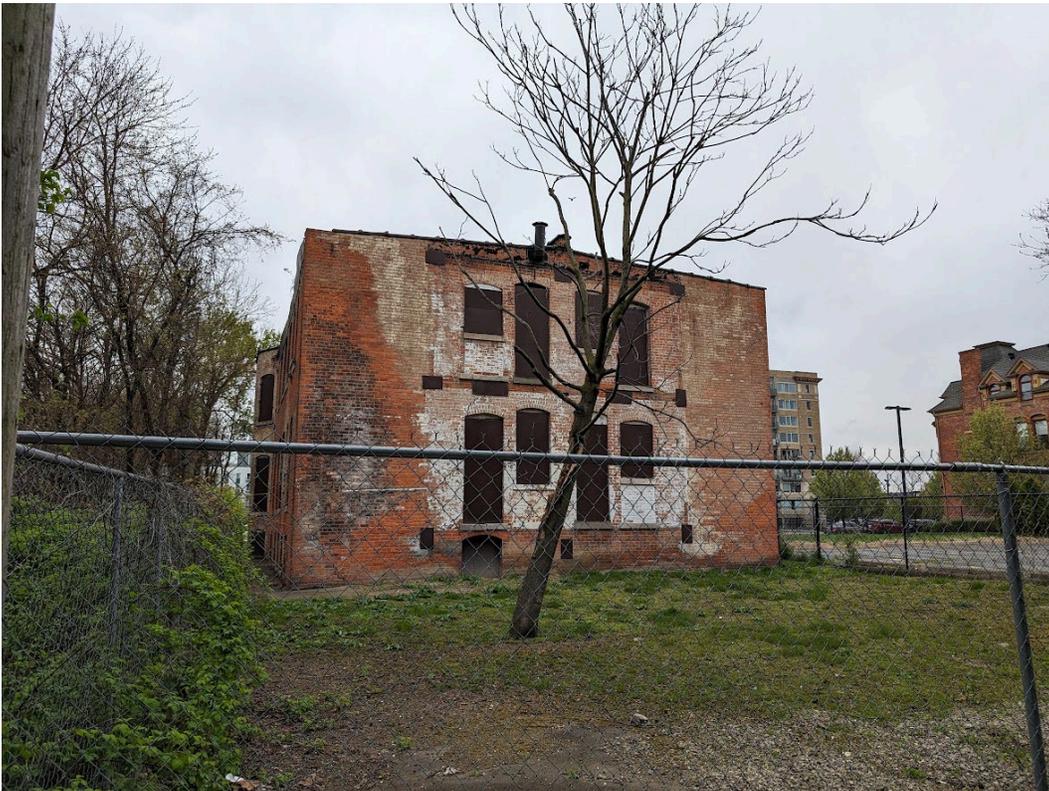
Rear elevation of existing building (rear of the rooming house), showing present condition. This wall and the damaged tree growing in the yard would be removed to erect the new rear addition. Until the 1920s, a 2-story garage or "barn" blocked this view and was situated at the very rear of this parcel. later reduced to 1-story. Staff photo, April 23, 2024.

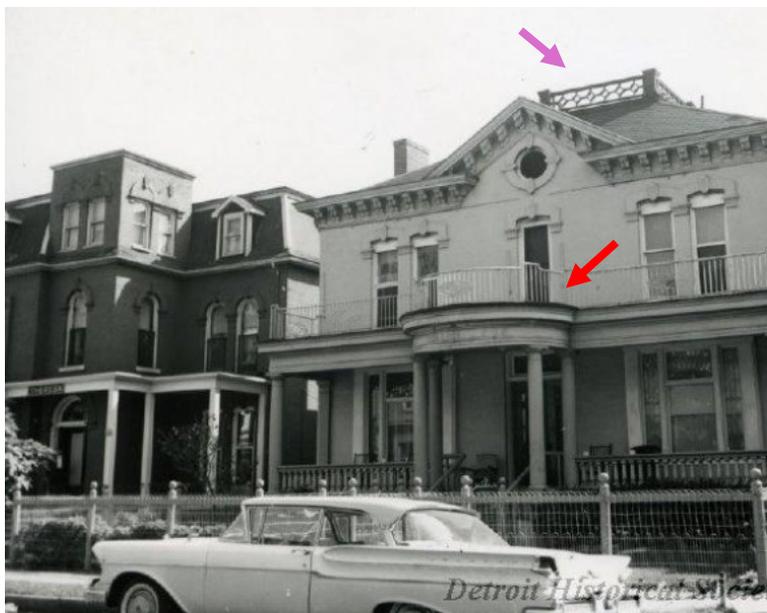
1963 view of the property. Note curved porch entablature supported by two additional outboard columns at center (red arrow), which was removed prior to historic district designation in 1980. Also visible is a rooftop balustrade surrounding the flat top of the roof, now gone (purple arrow), discussed further below.

- Restoring the long lost rooftop balustrade (also visible in the 1963 photo above), which would restore another authentic historic element to the roof (along with retaining the chimneys) that might reduce the impact of the “doghouse” elements.
