TAFF REPORT: 05/08/2024 MEETING

APPLICATION NUMBER: HDC20204-00182

ADDRESS: 1485 LONGFELLOW

SCOPE OF WORK: ERECT REAR ADDITION

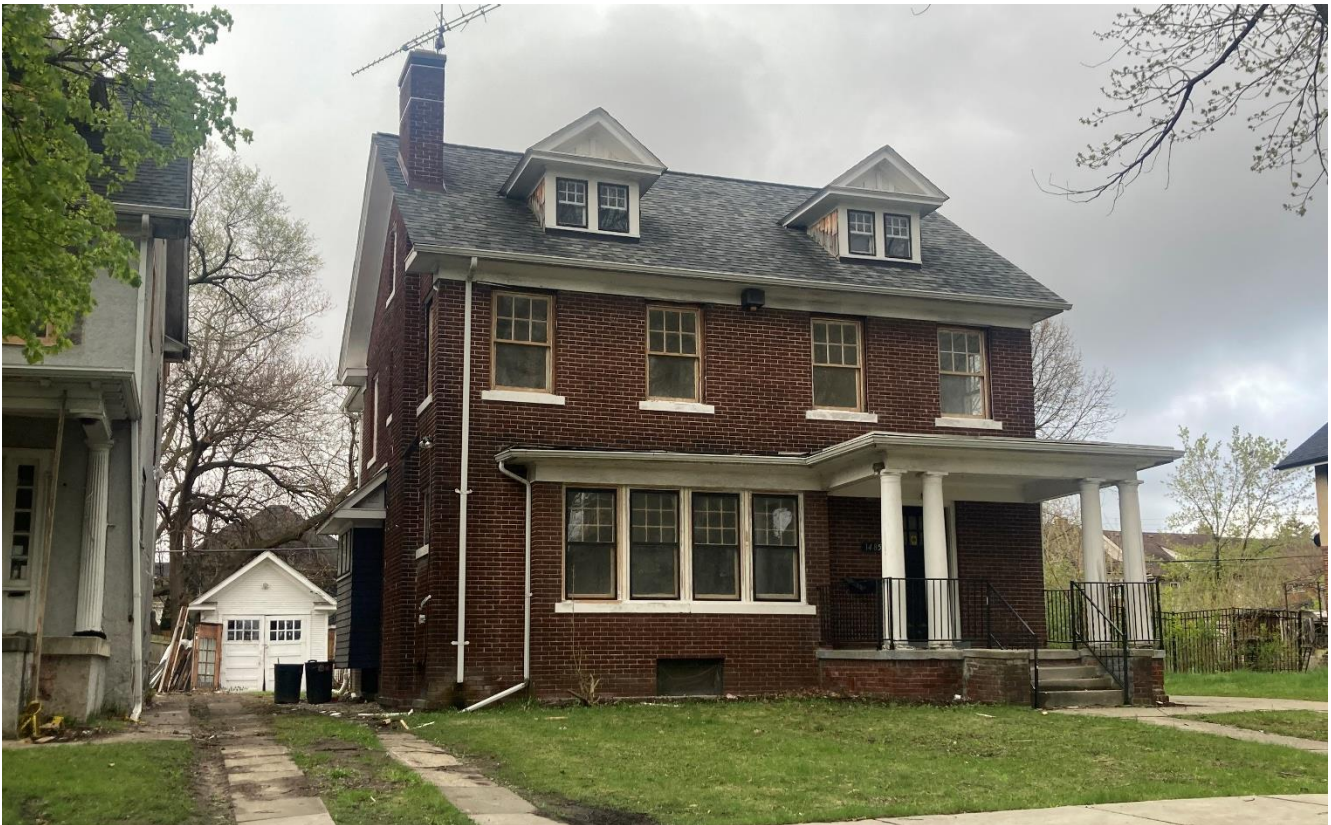
1485 Longfellow, current conditions. Facing southwest. Staff photo taken on 4/22/2024

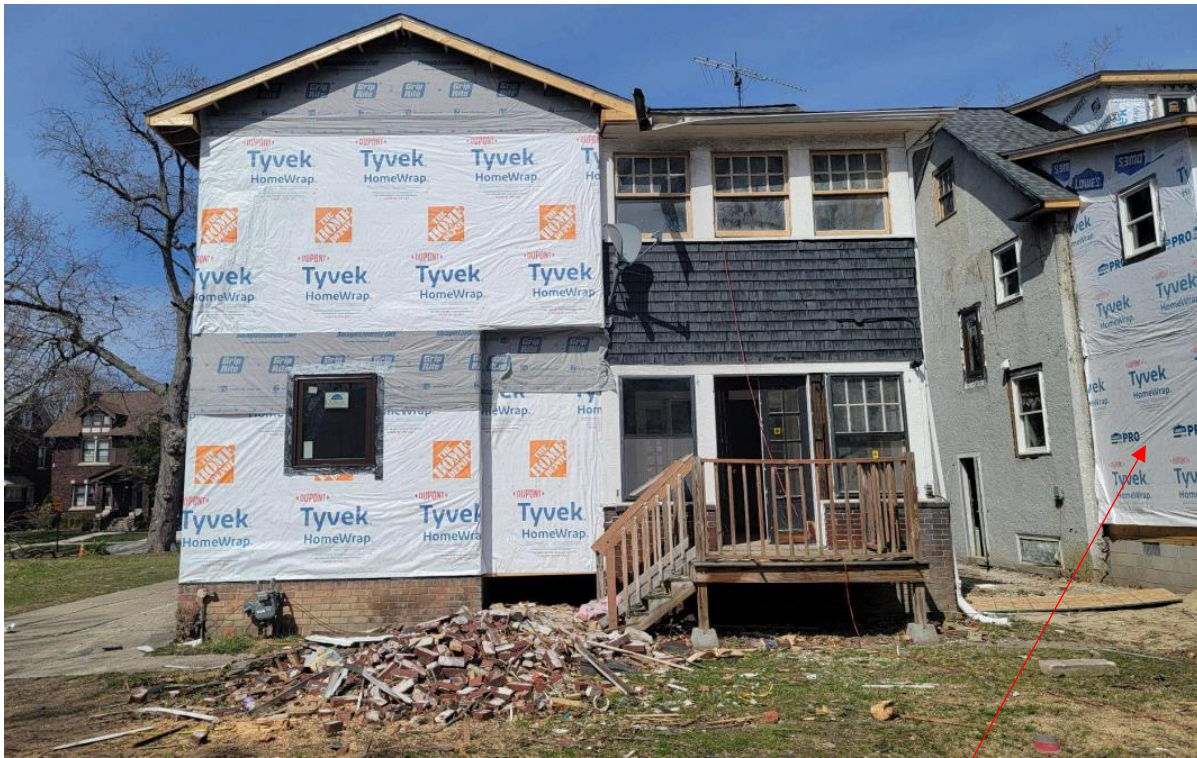
1485 Longfellow, current conditions. Facing north towards rear elevation. Note new two-story addition which was erected without HDC approval. Photo provided by applicant. Also, note that a new addition has been added to the rear of the house next door/1475 Longfellow without HDC review/approval. 1475 and 1485 Longfellow are owned by the same person

- It is staff's opinion that the newly erected rear wing does not meet the Standards because it has been directly appended to the character-defining, two-story, rear wing resulting in the removal of its entire west wall and completely changing its overall form. Also, the large scale of the addition overpowers/is not subordinate to the significant rear wing.

Recommendation # 1 - Section 21-2-73, DENIAL – Erect a rear wing and replace existing French doors at rear elevation with salvaged window

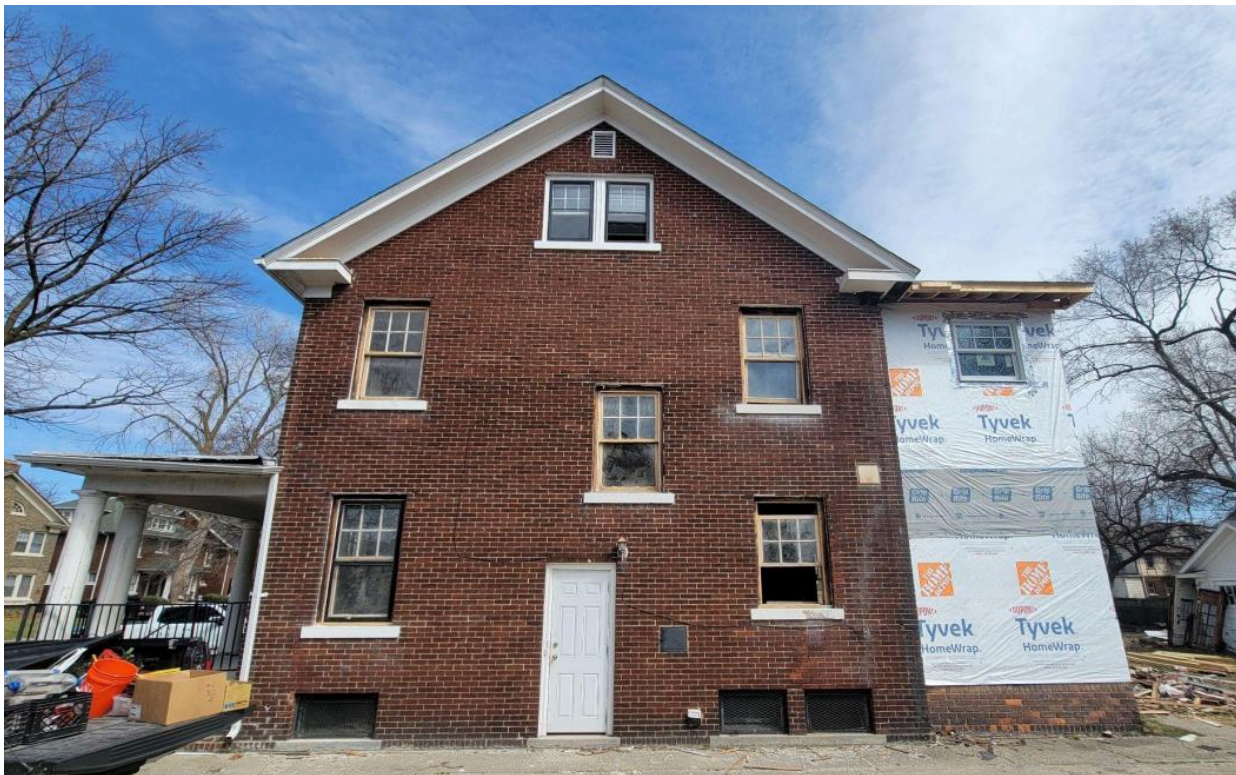
1485 Longfellow, current conditions. Facing south. Note new two-story addition which was erected without HDC approval. Photo provided by applicant

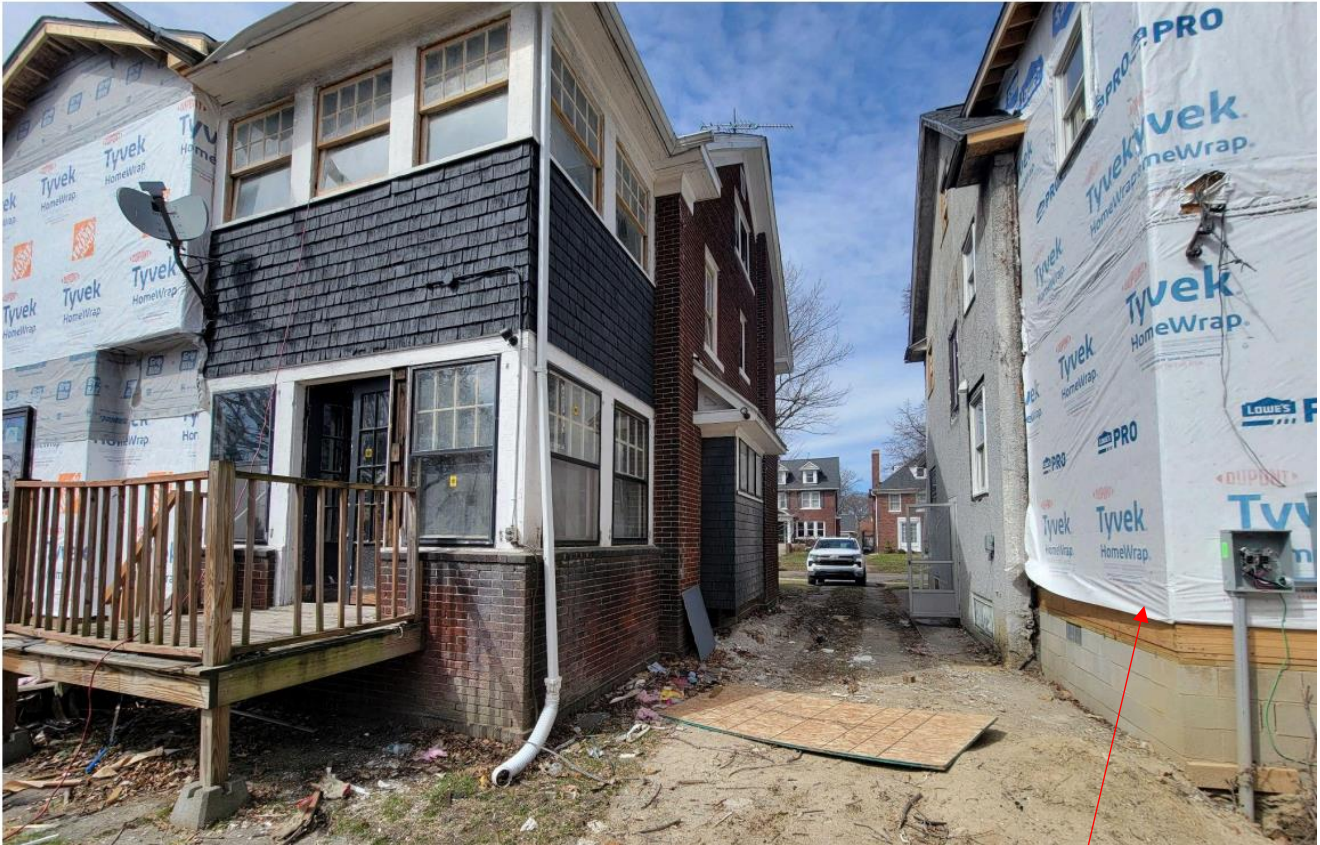
1485 Longfellow, current conditions. Facing northwest. Note that new two-story addition which was erected without HDC approval is directly adjacent to the original, character-defining flat-roof, 2-story wing. Photo provided by applicant. Also note historic wood French doors proposed for replacement. Also, note that a new addition has been added to the rear of the home next door/1475 Longfellow without HDC review/approval. 1475 and 1485 Longfellow are owned by the same person

- It is staff's opinion that the historic-age, paired wood French doors proposed for removal are distinctive character-defining features of the home which should be retained as it is not clear that they are deteriorated beyond repair (see photo on page 6).

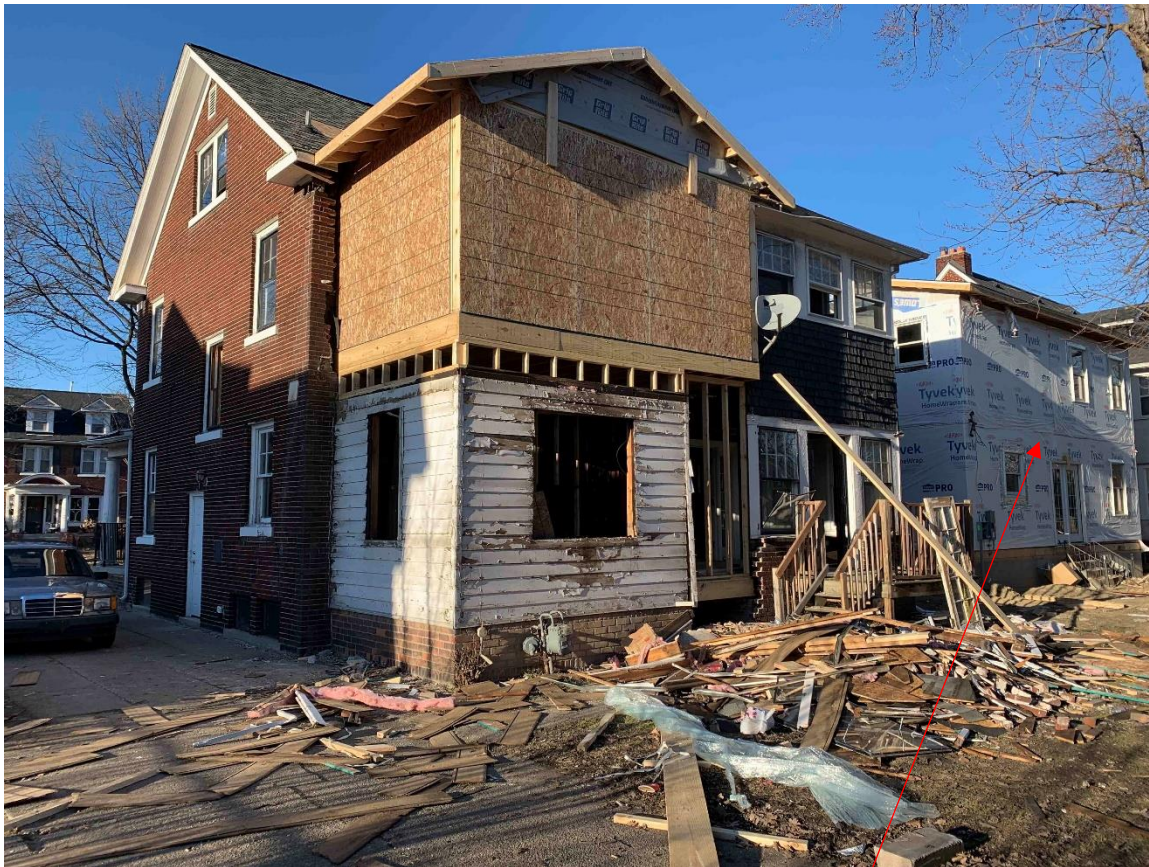
Photo showing home on 2/14/2024. Submitted by resident. Facing northwest, showing unapproved work at rear (outlined in yellow). Also, note that a new addition had been added to the rear of the home next door/1475 Longfellow without HDC review/approval. 1475 Longfellow is also owned by owner of 1485 Longfellow

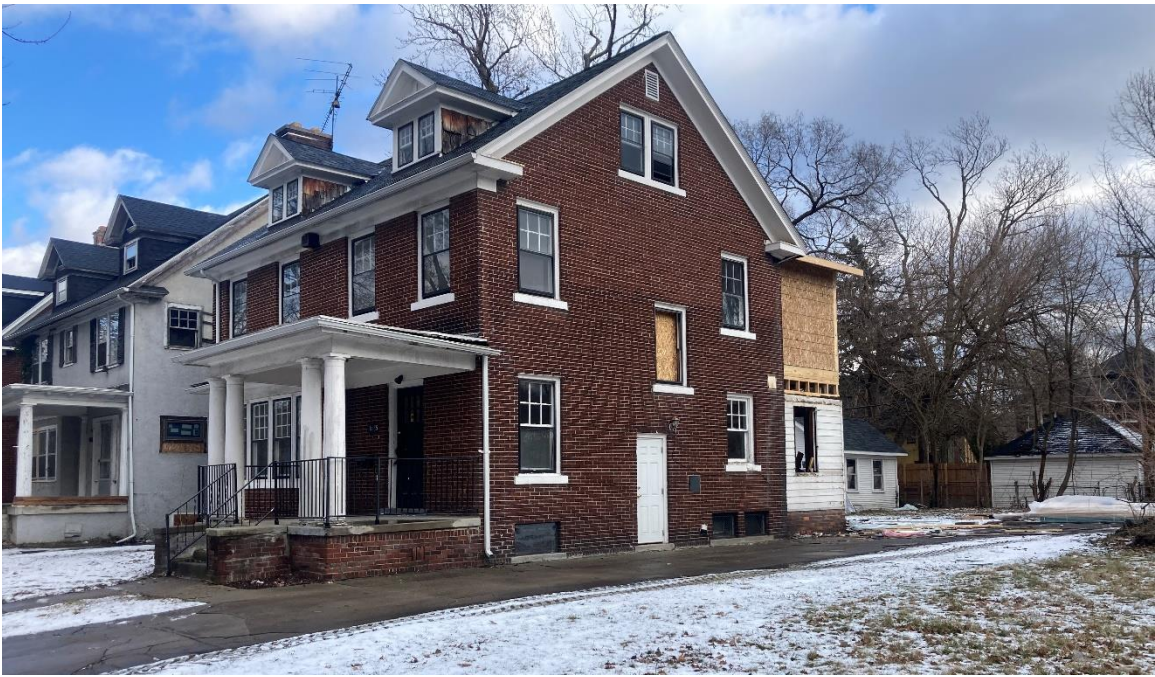
Photo showing home on 2/14/2024. Photo by staff. Facing southeast, showing unapproved work at rear

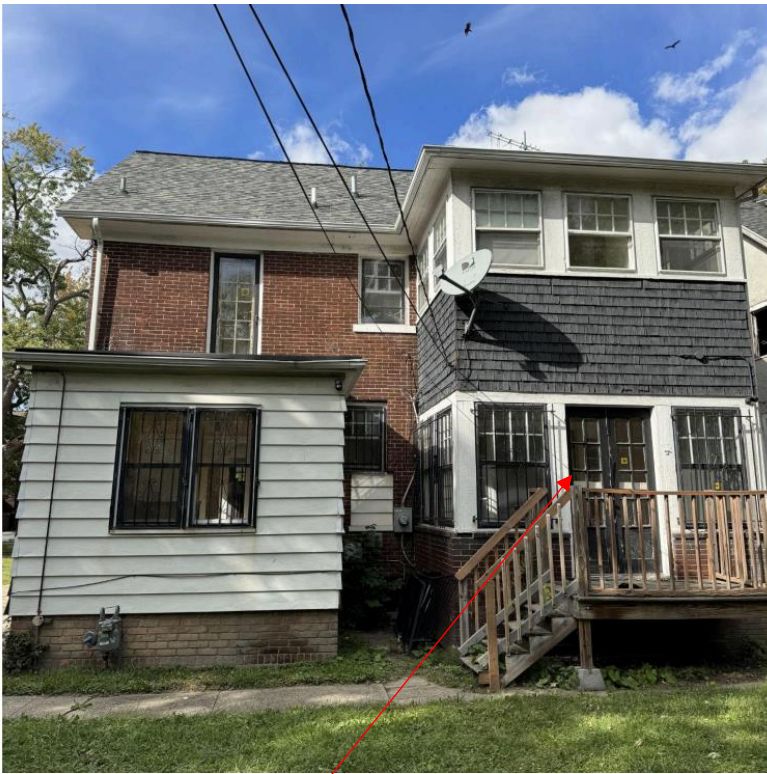
Rear of home, prior to unapproved work, facing north. Photo provided by applicant. Note the condition of the French doors proposed for removal
