# DHDC 22-7665

### CERTIFICATE OF APPROPRIATENESS

**RE: Application Number 22-7665; 715 Van Dyke; West Village Historic District  
Project Scope: Demolish and Rebuild Front Porch**

## Front Porch Project 715 Van Dyke:

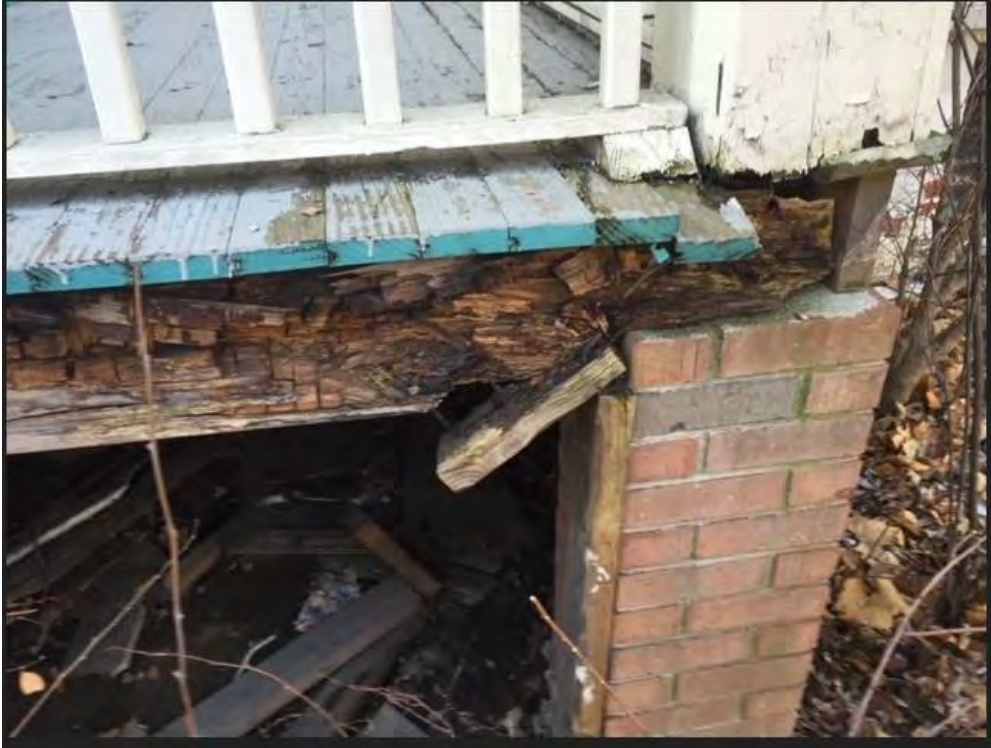
Condition of original porch: Rotten Wood / Missing Footing

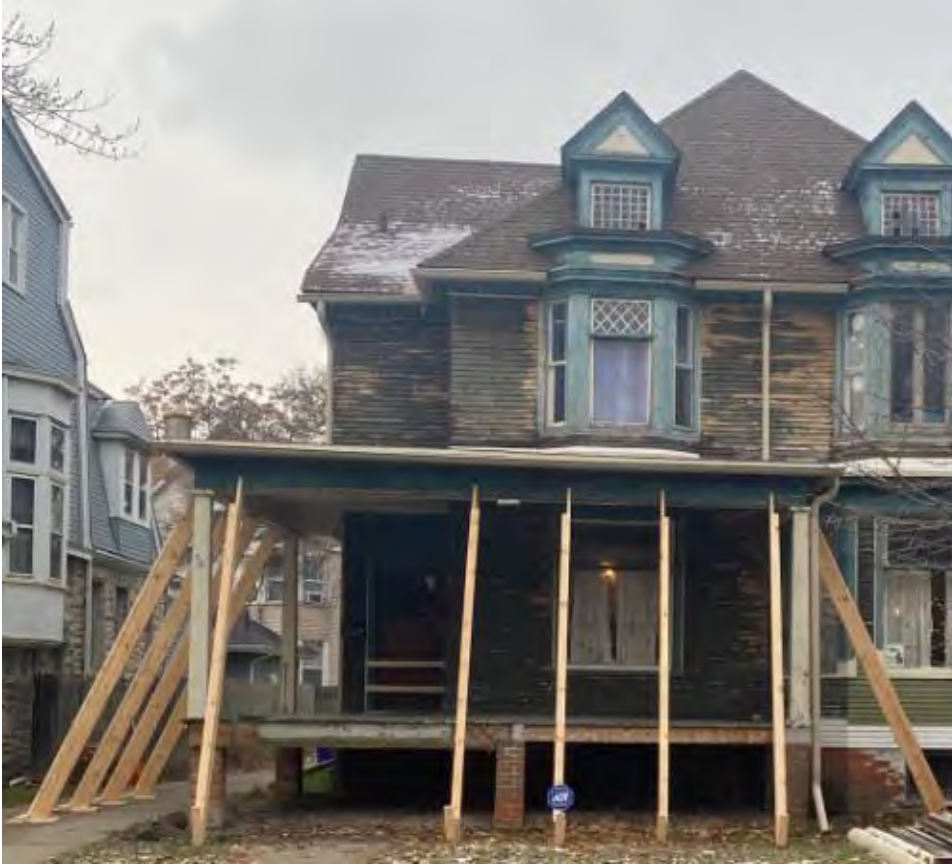
Before we purchased the house the porch was rebuilt (we think in the 90's)– it was not to code, not historically accurate, and structurally unsound. The lumber they used was untreated and built the columns using 1" x 4" wood without supports inside the columns. Due to the deterioration for the wood and the weight of the ceiling we braced the porch in case of a heavy snow / wind.

Porch braces:

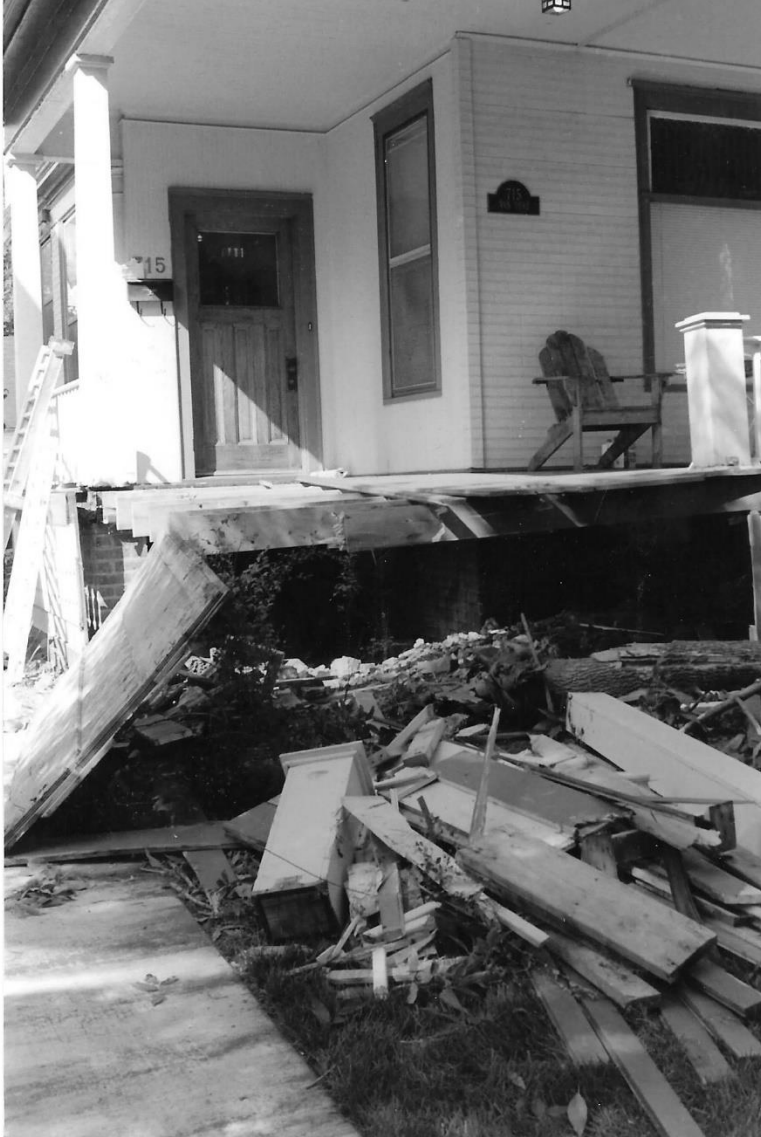
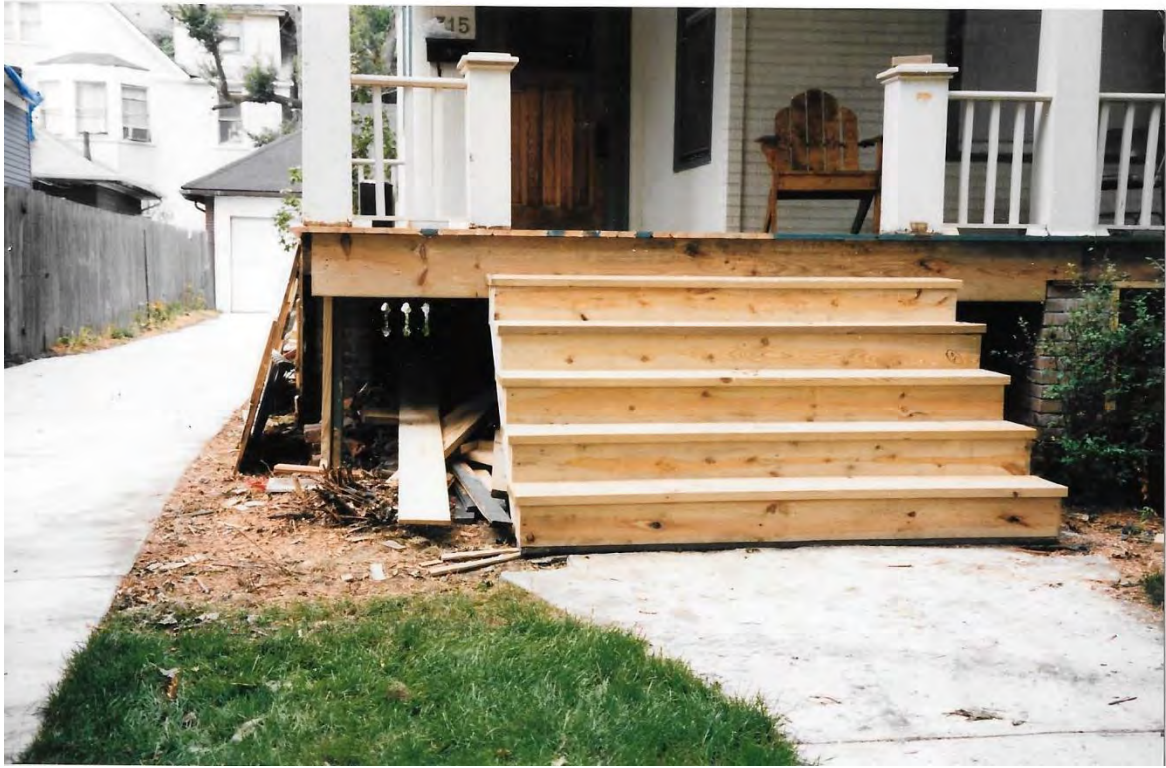
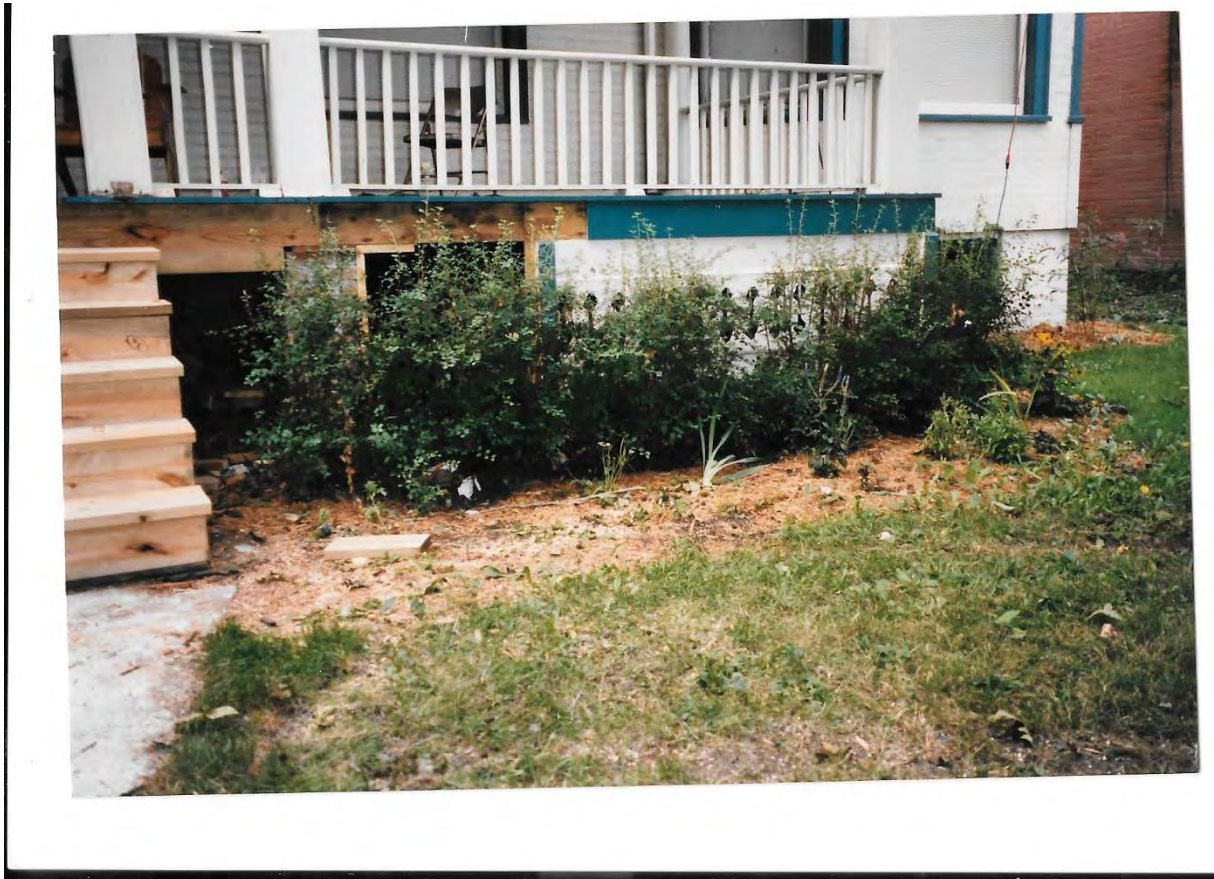
I received these pictures from the previous owner (Cheryl Huff). She rebuilt a large section of this porch in the 1990s. There are some scanned images of the rebuilding of the porch. As you can see – nothing is up to historical accuracy, or code.

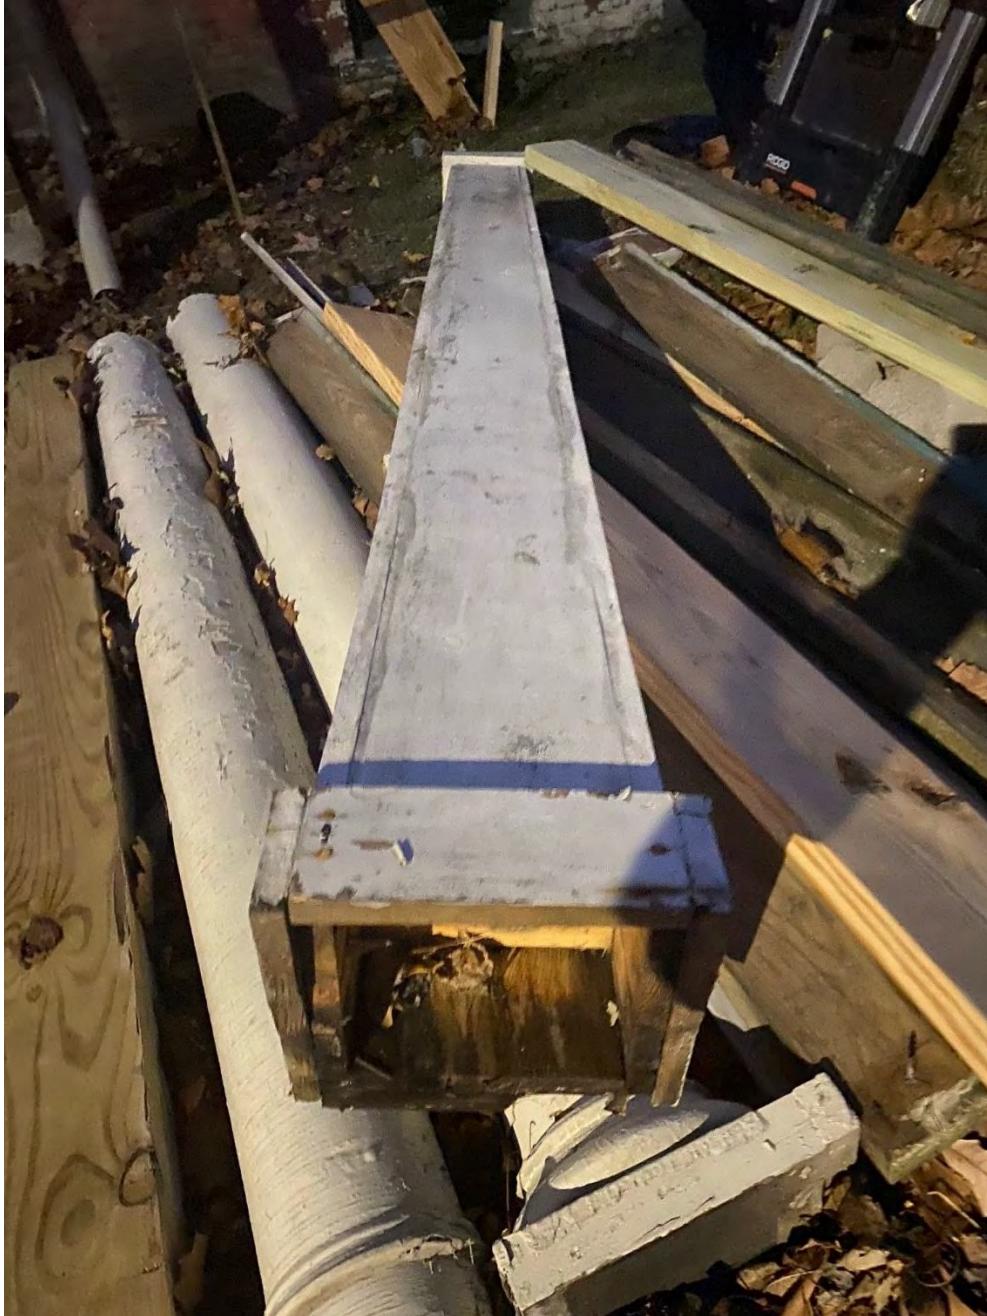
Here is one of the square columns that is currently sitting in my front yard. You can see that it is only made of 1x4 boards and is starting to rot at the base.

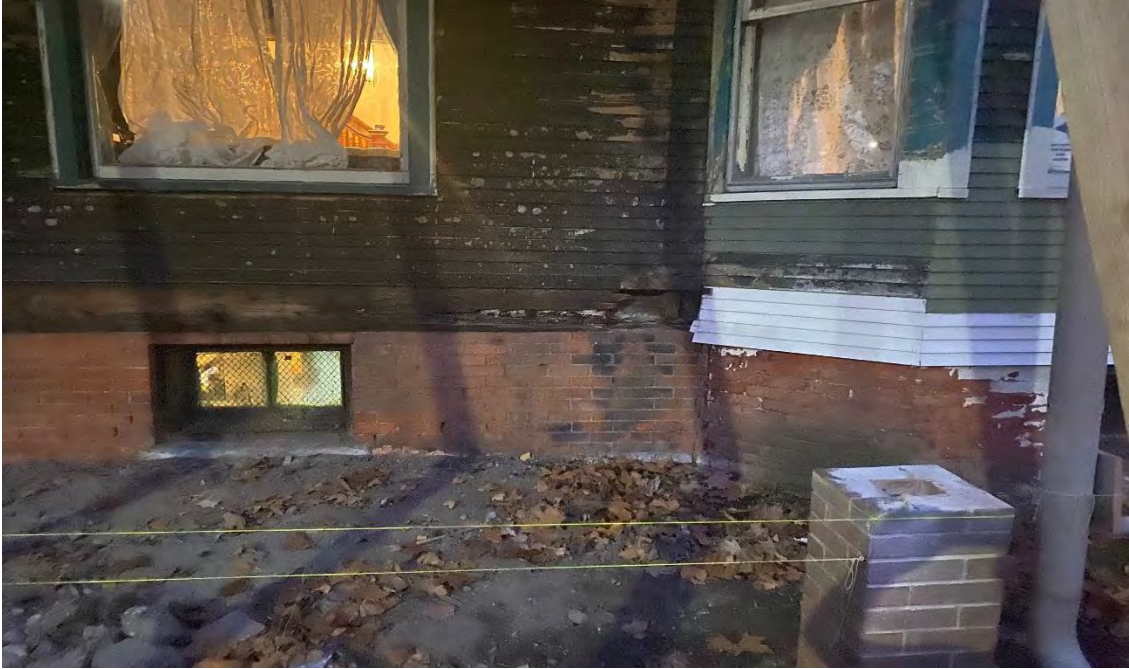
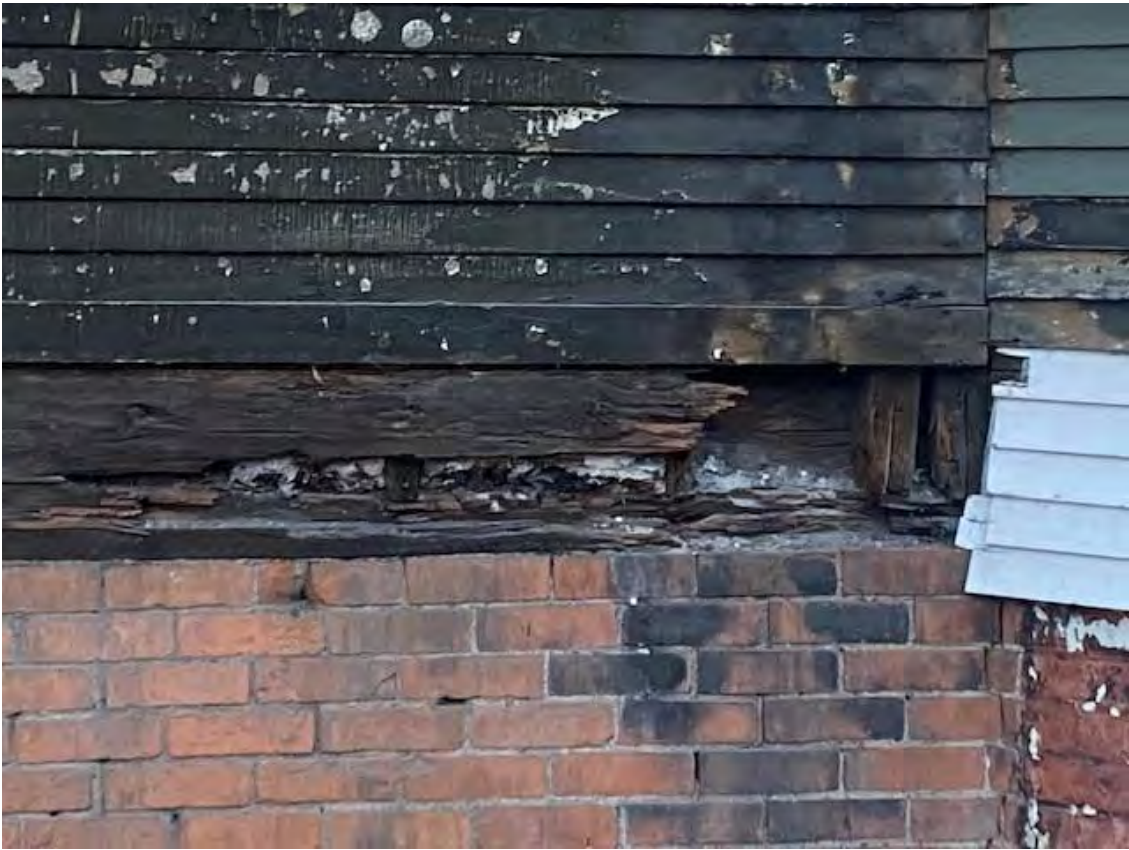
Rotting of the porch. As you can see that is actually part of the house so with out taking a significant part of the porch to begin with, I am not sure how we could fix this.

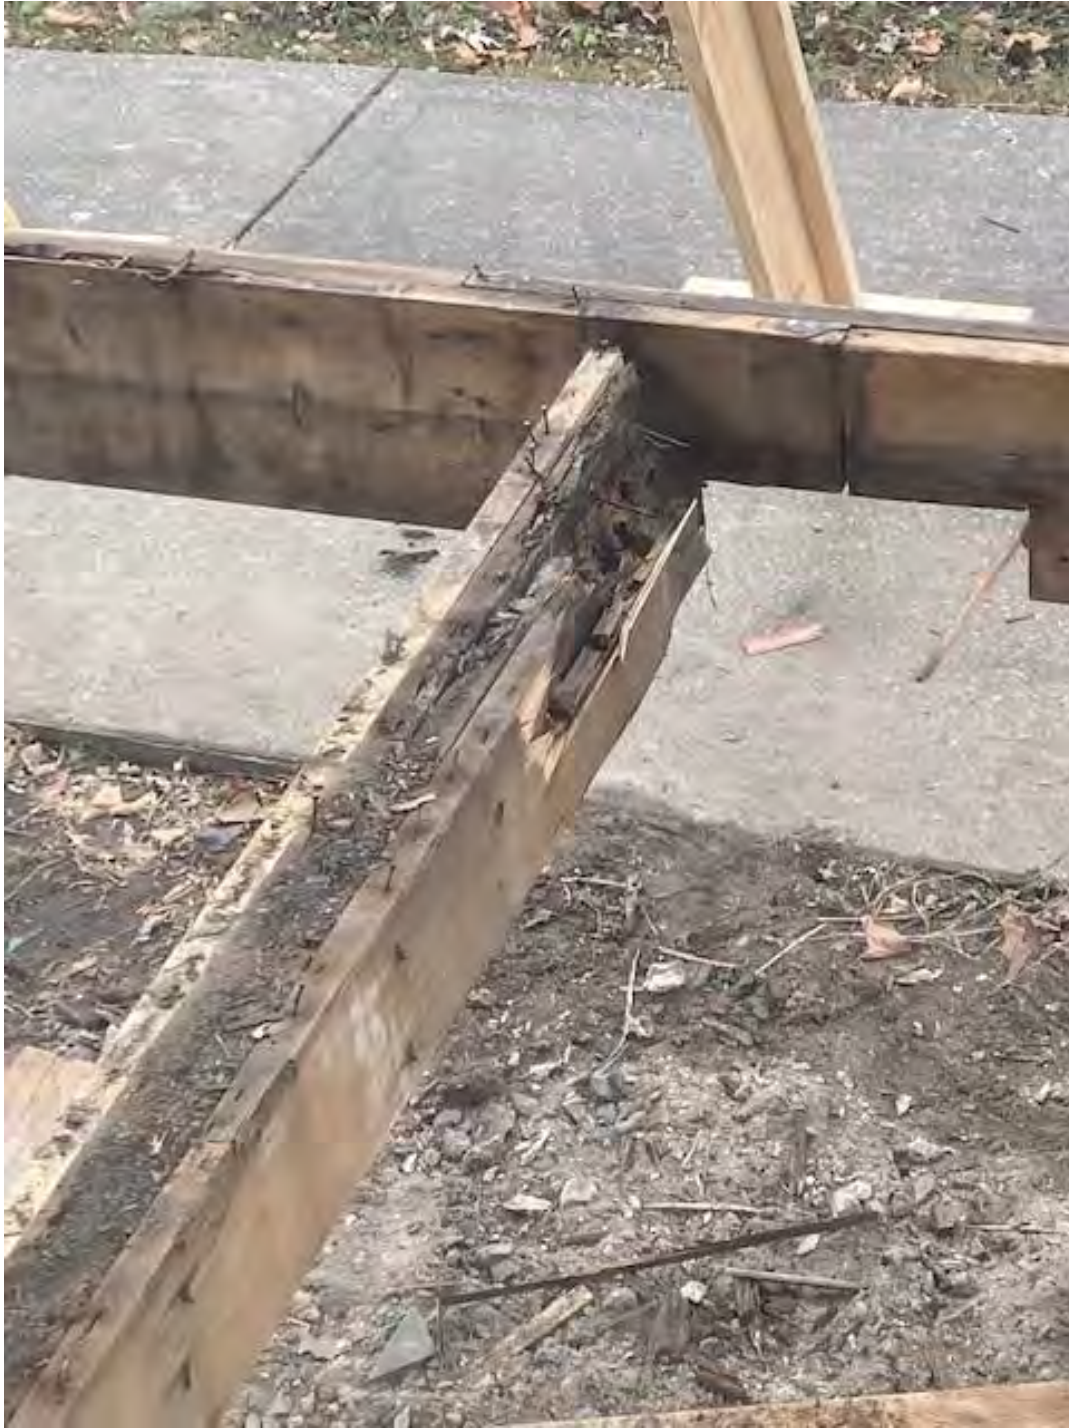
You can see from this picture the framing was done incorrectly in the (1990s). Instead of replacing they just added boards onto each other.

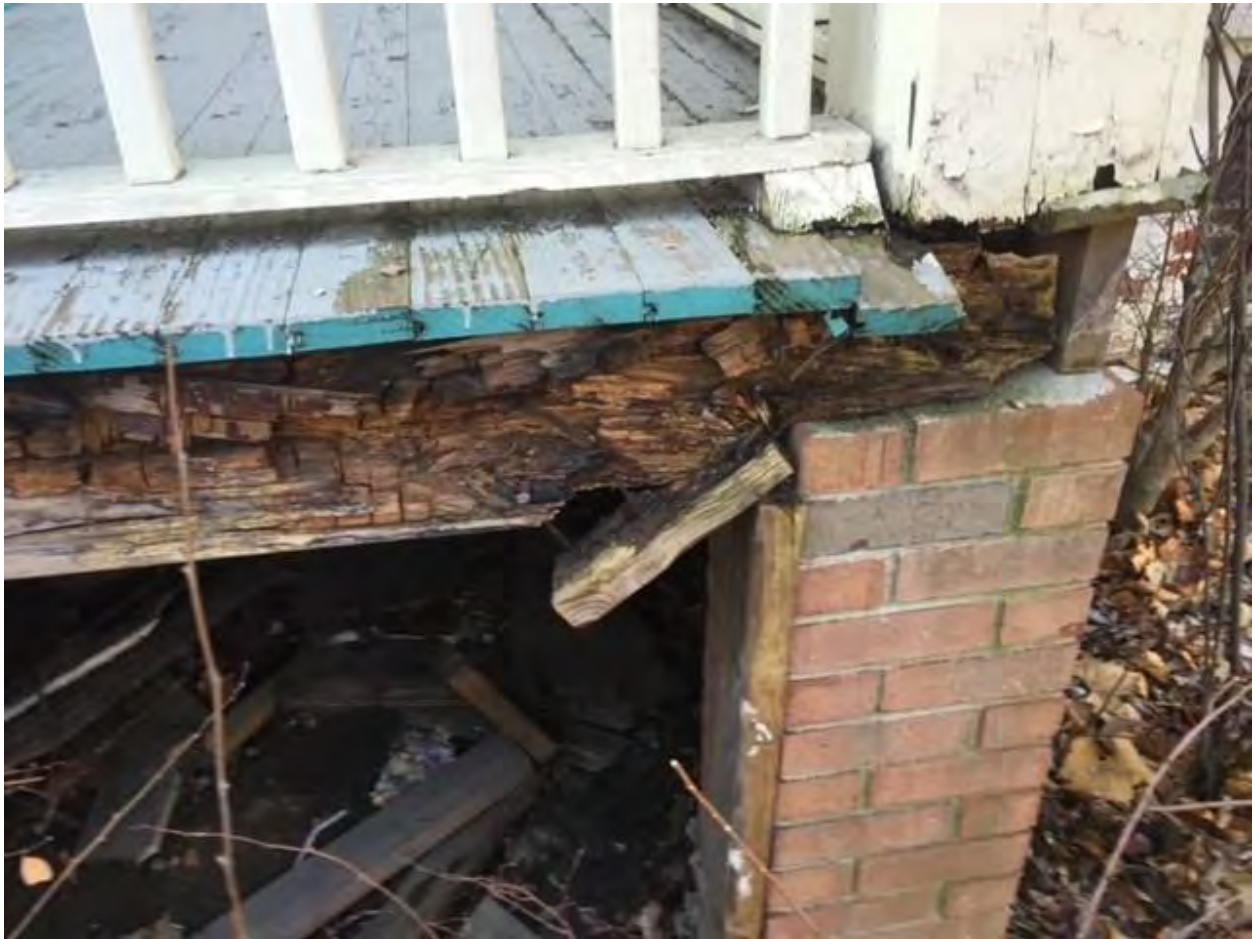
This was from earlier this year where I had to do temporary fix because the wood had gotten so rotted.

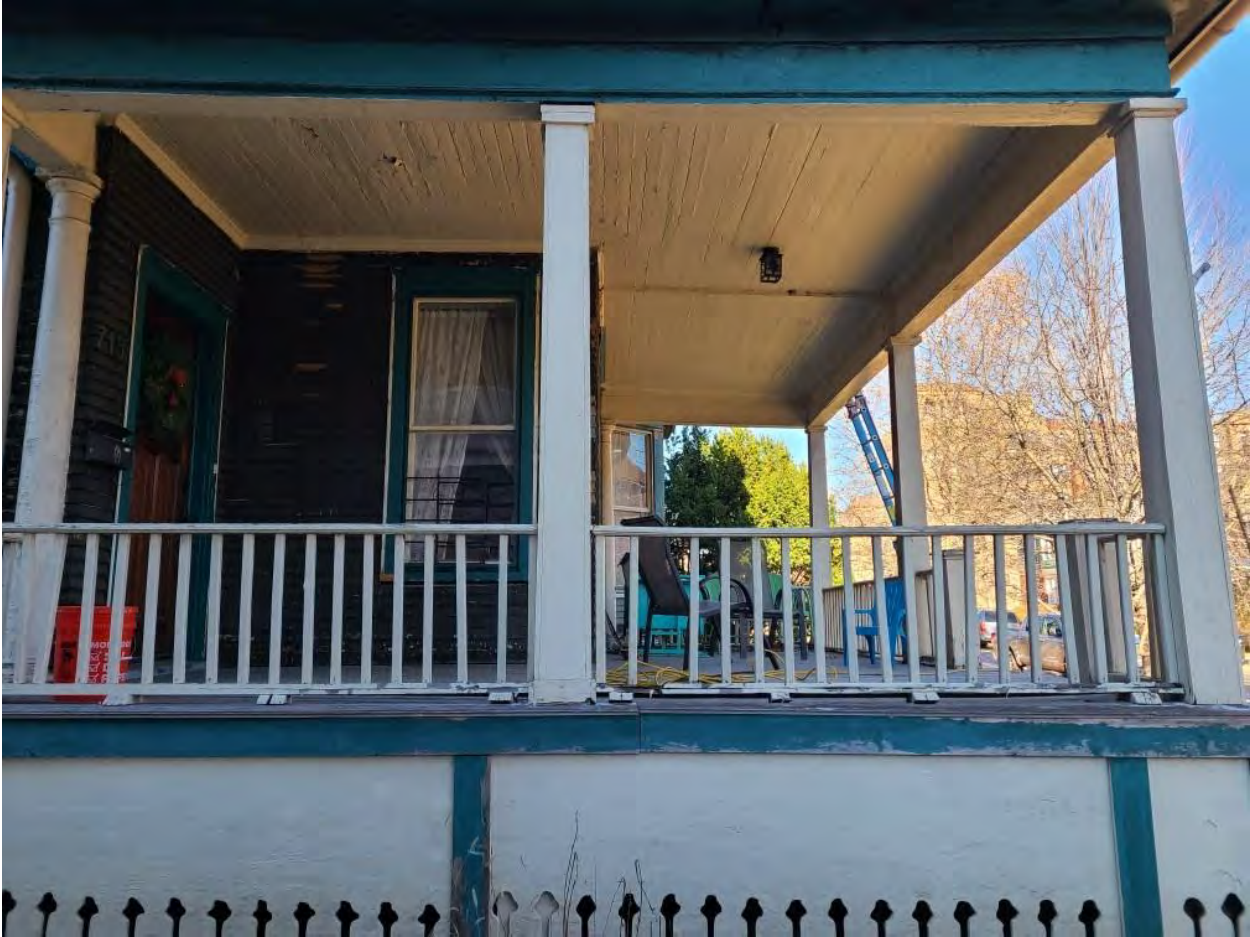
Not that I am that worried about the skirting at this point but as you can see the “decorative” Victorian that was added.

- ***The skirting design will be revised to include framing and vertical boards at column/pier locations and will be submitted for staff review.***
- ***The paint color/finish for each porch component (including decking) will be submitted for staff review.***
- ***The porch elements won’t be painted until the wood members have dried out.***

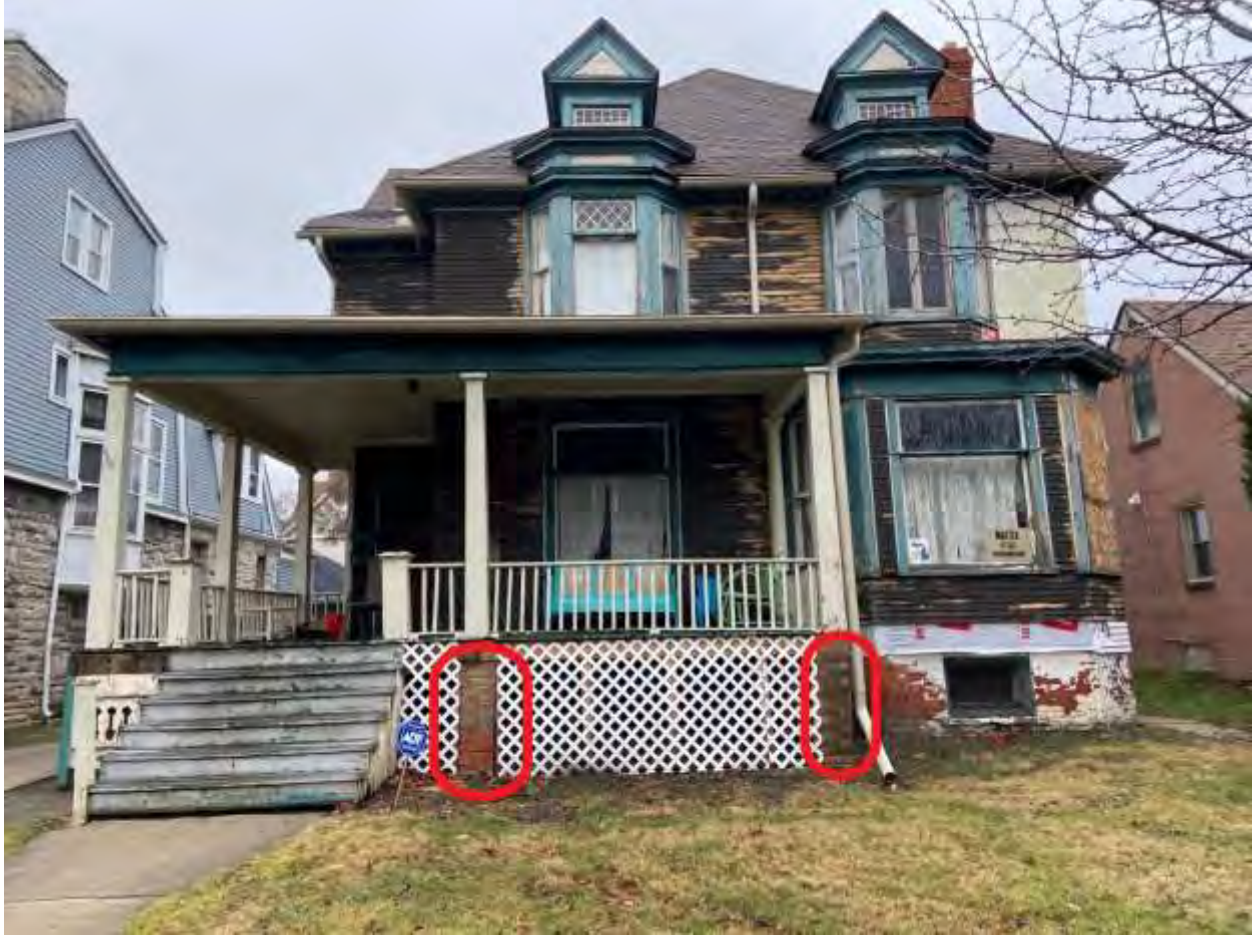
Original brick piers: you can see from this pic that they are angled and are off centered

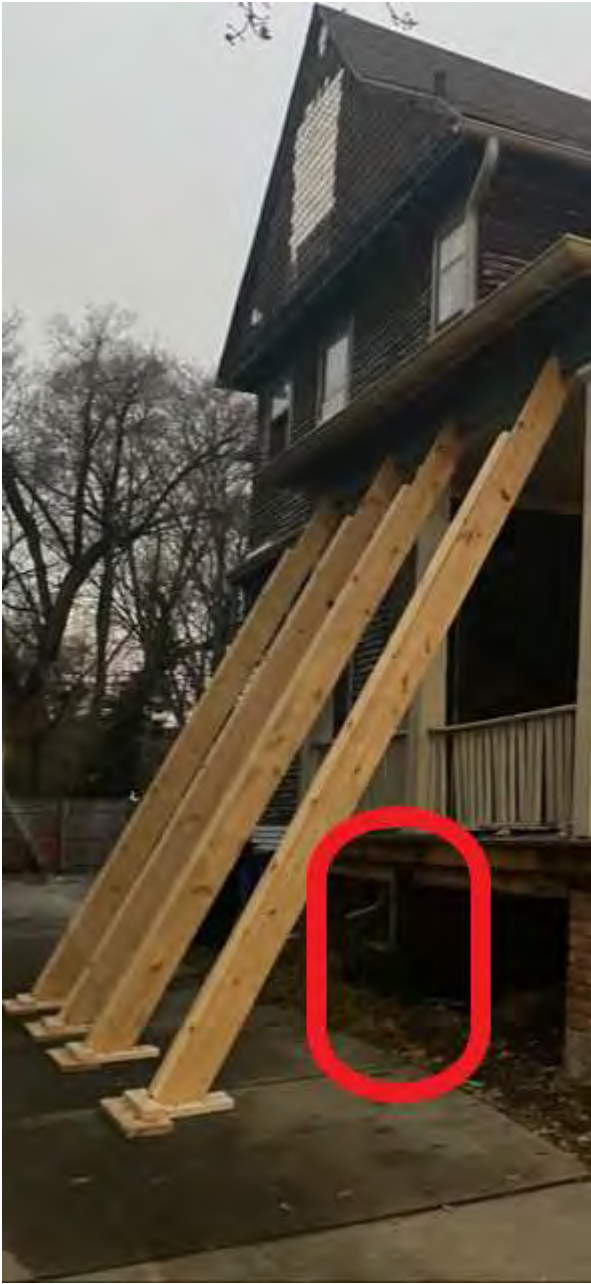
Here the pier is missing.

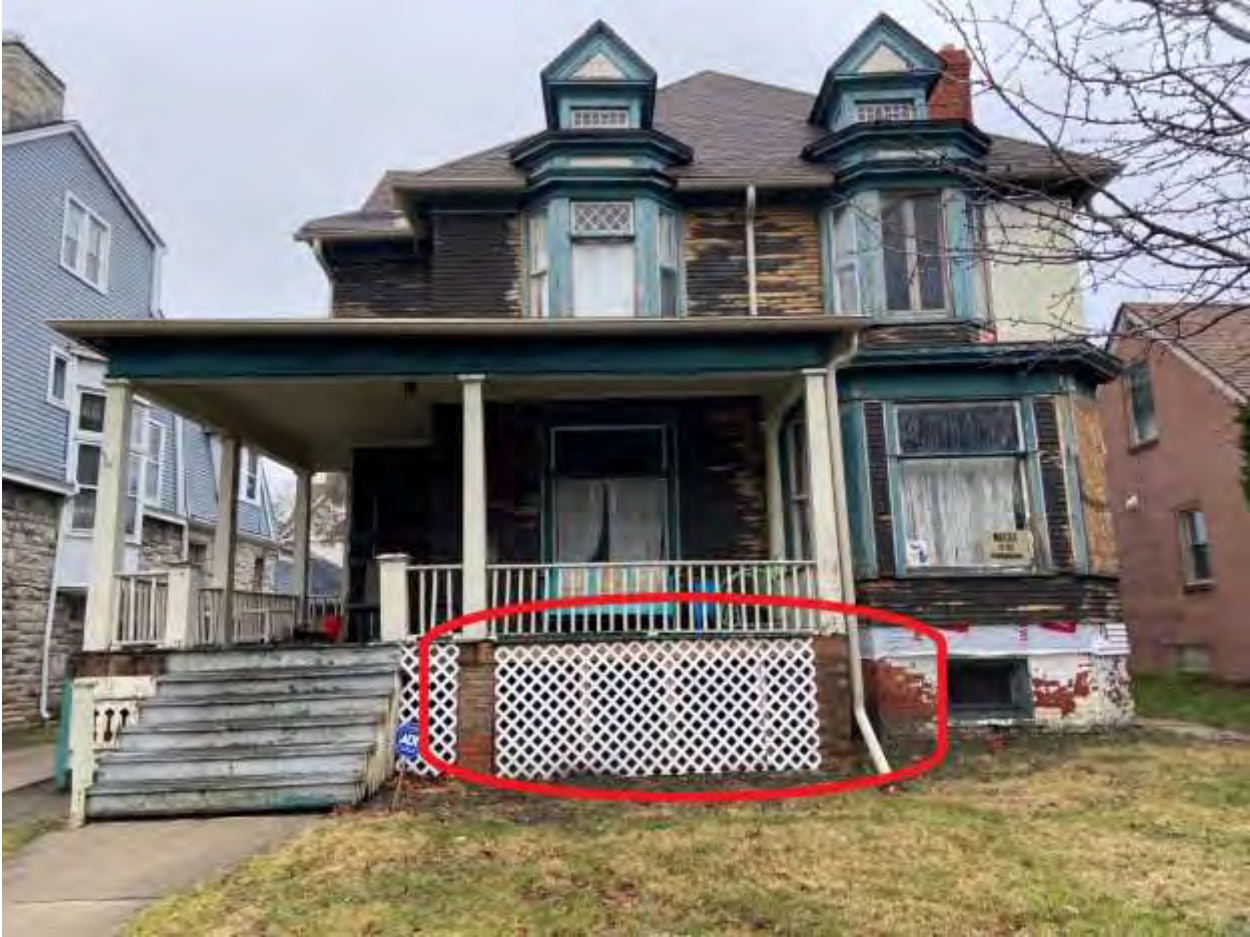
Here you can how bad the right side of the porch is off from the rest of the porch. We have estimated that is it 8" lower than the other part of the porch

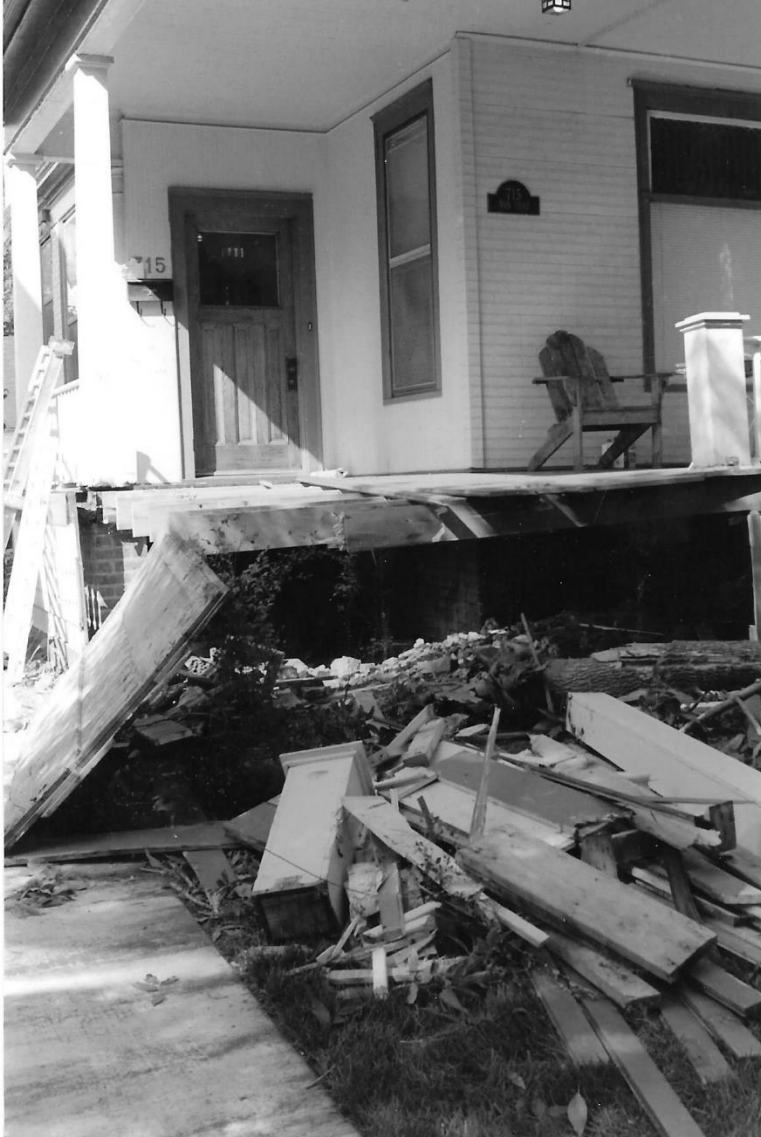
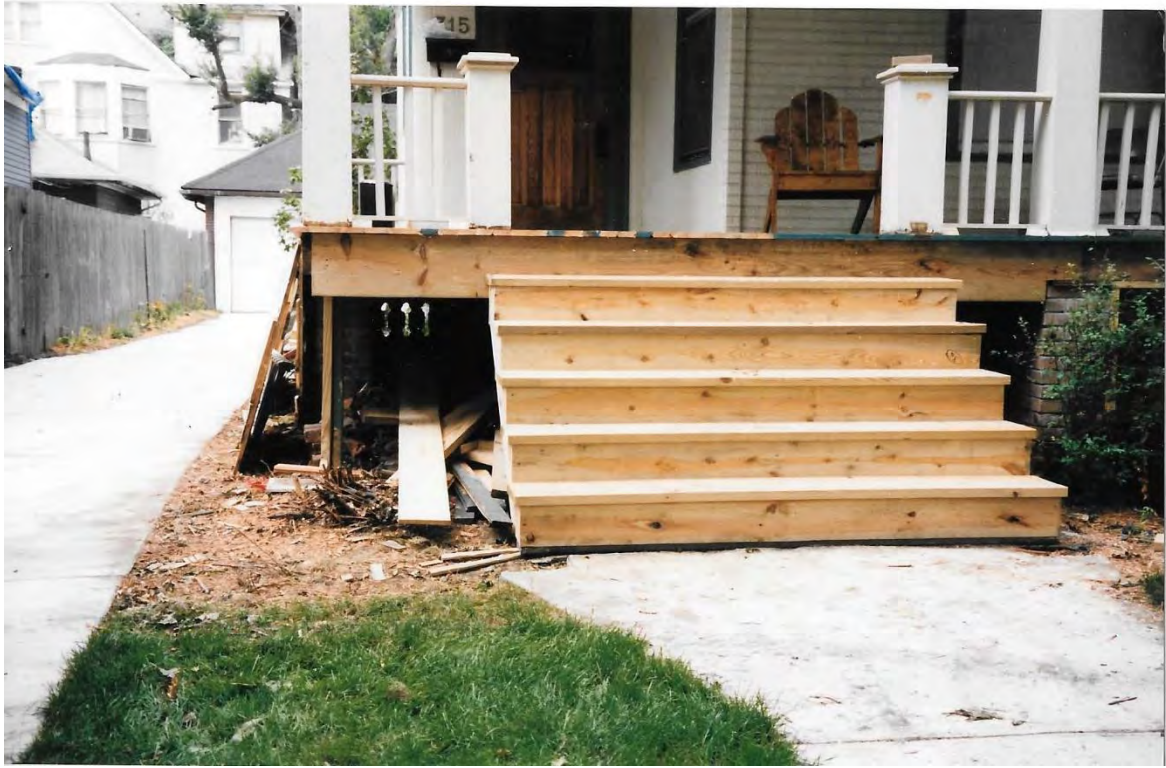
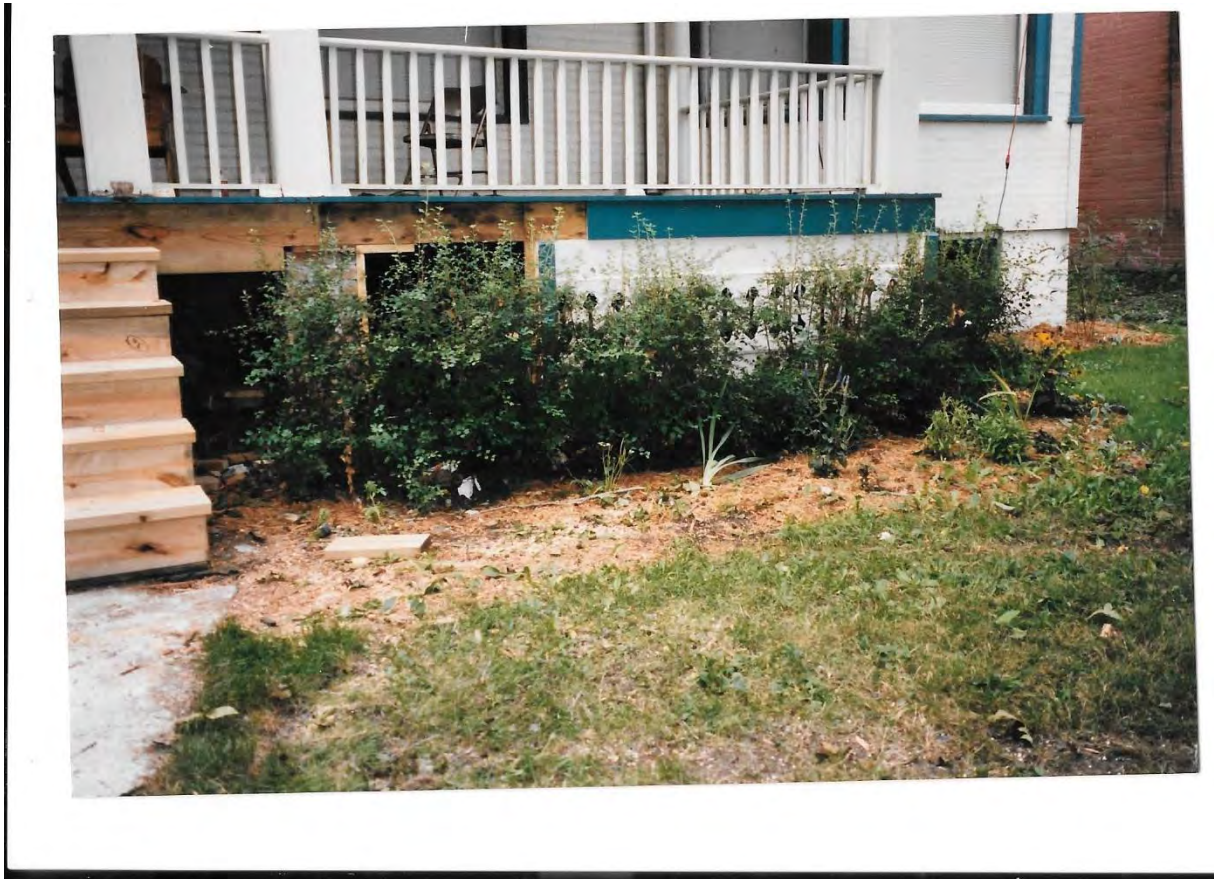
I received these pictures from the previous owner (Cheryl Huff). She rebuilt a large section of this porch in the 1990s. There are some scanned images of the rebuilding of the porch. As you can see – nothing is up to historical accuracy, or code.

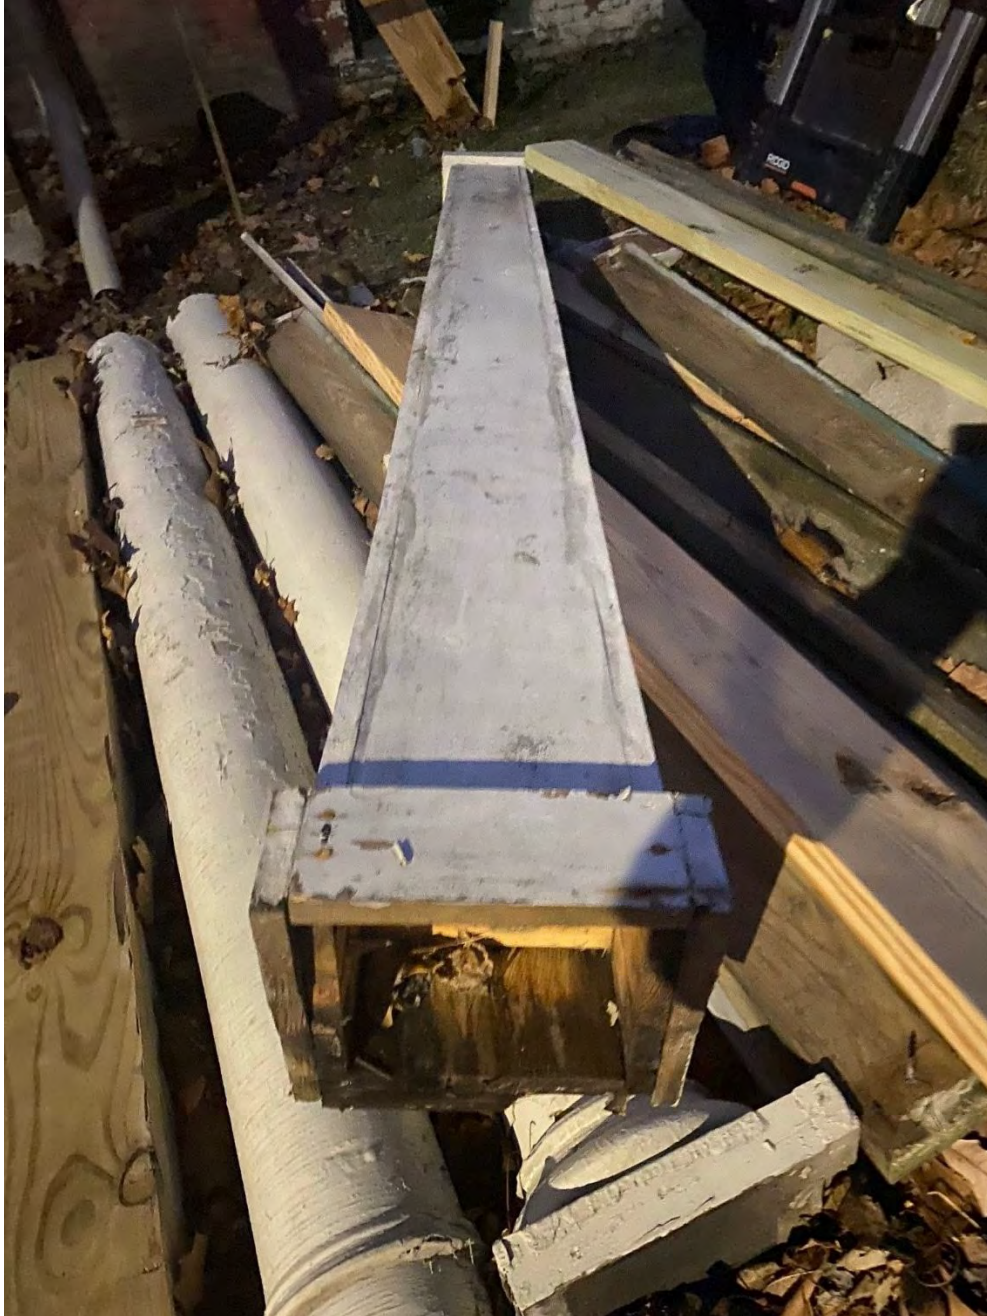
Here is one of the square columns that is currently sitting in my font yard. You can see that is only made of 1x4 boards and is starting to rot at the base.

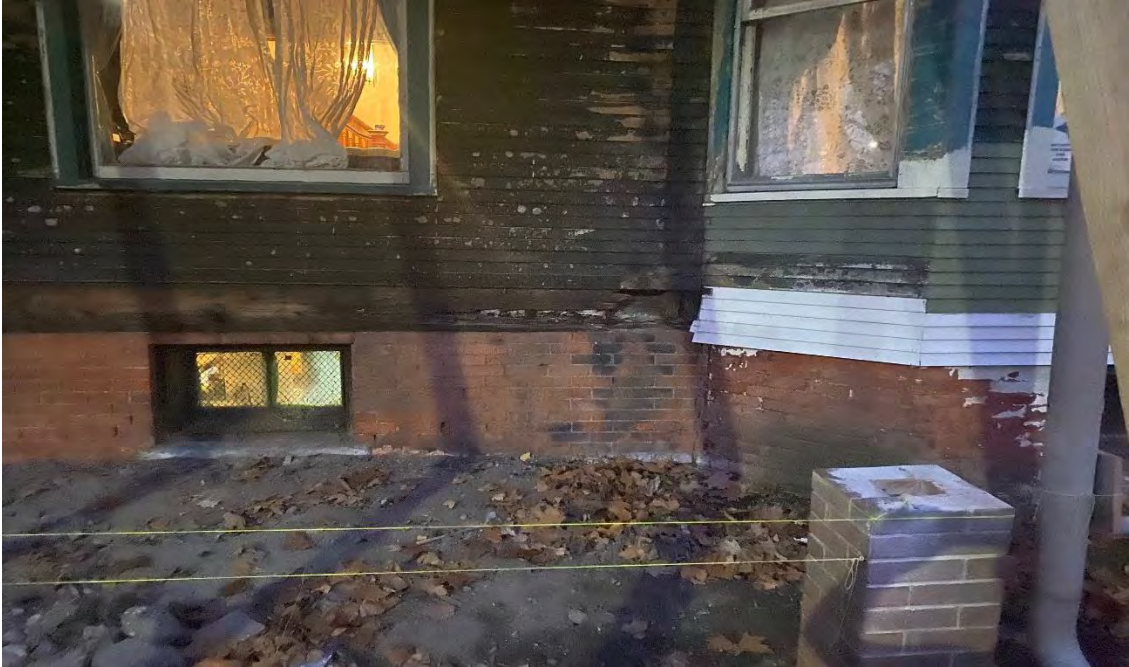
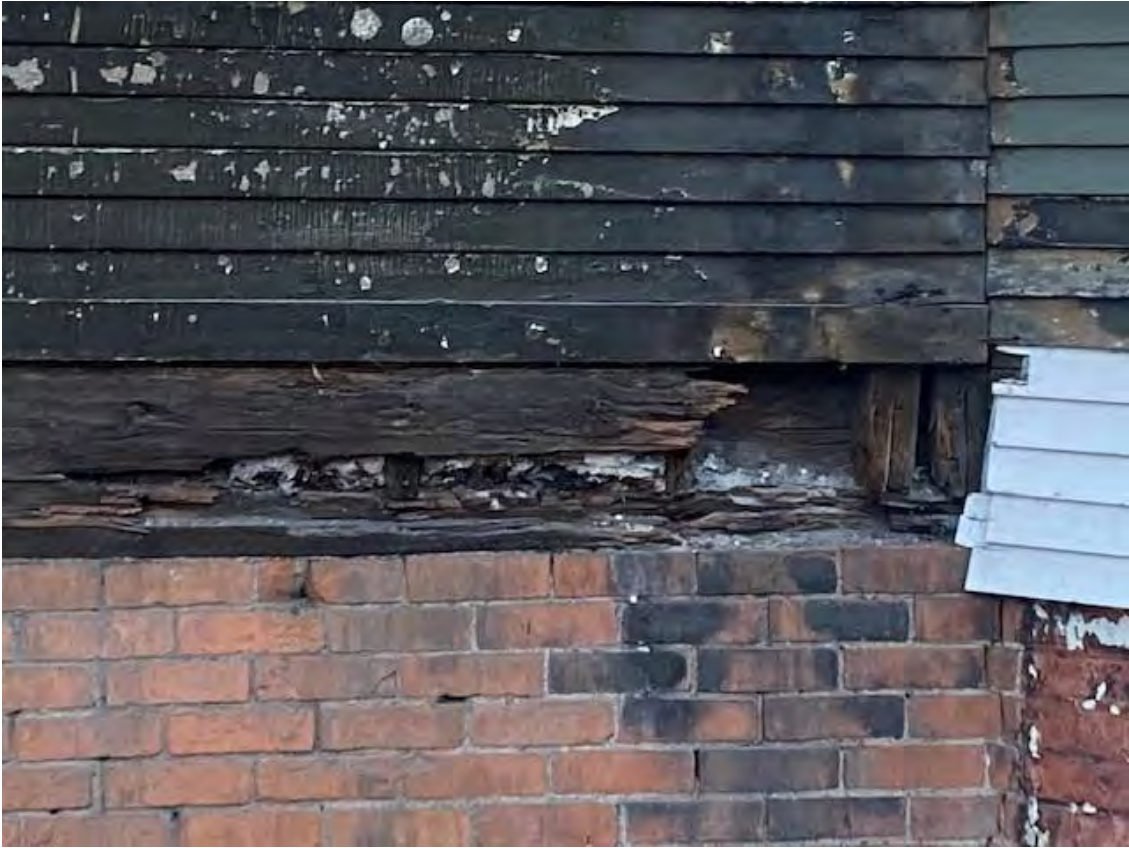
Rotting of the porch. As you can see that is actually part of the house so with out taking a significant part of the porch to begin with, I am not sure how we could fix this.

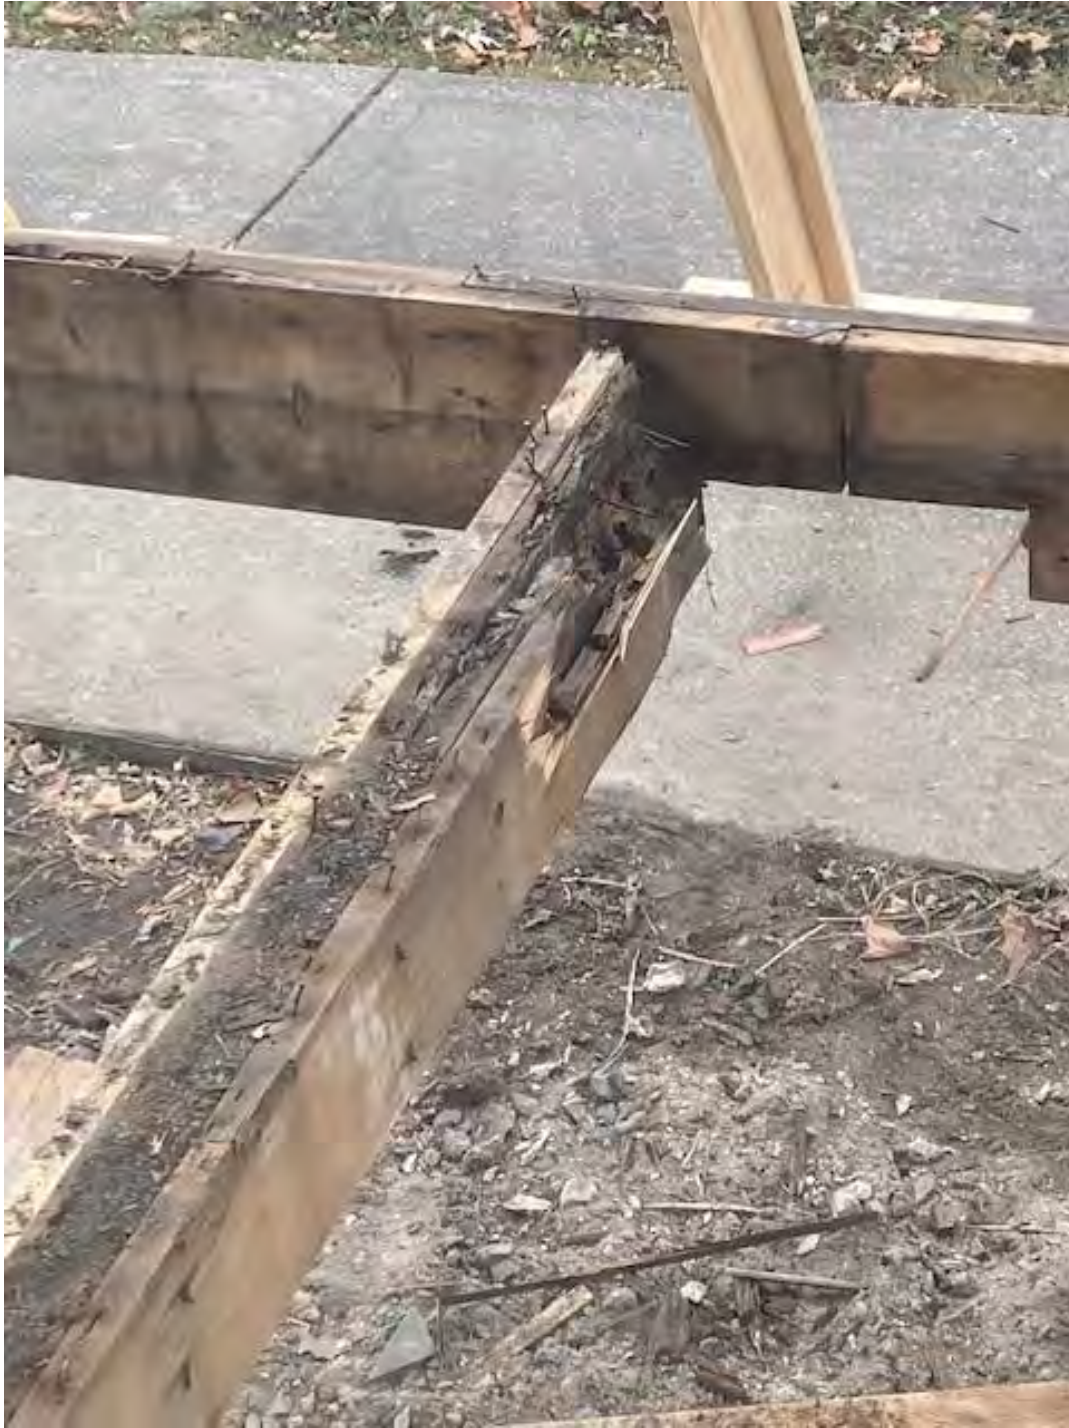
You can see from this picture the framing was done incorrectly in the (1990s). Instead of replacing they just added boards onto each other.
