# DHDC 22-7665

### CERTIFICATE OF APPROPRIATENESS

**RE: Application Number 22-7665; 715 Van Dyke; West Village Historic District  
Project Scope: Demolish and Rebuild Front Porch**

## Front Porch Project 715 Van Dyke:

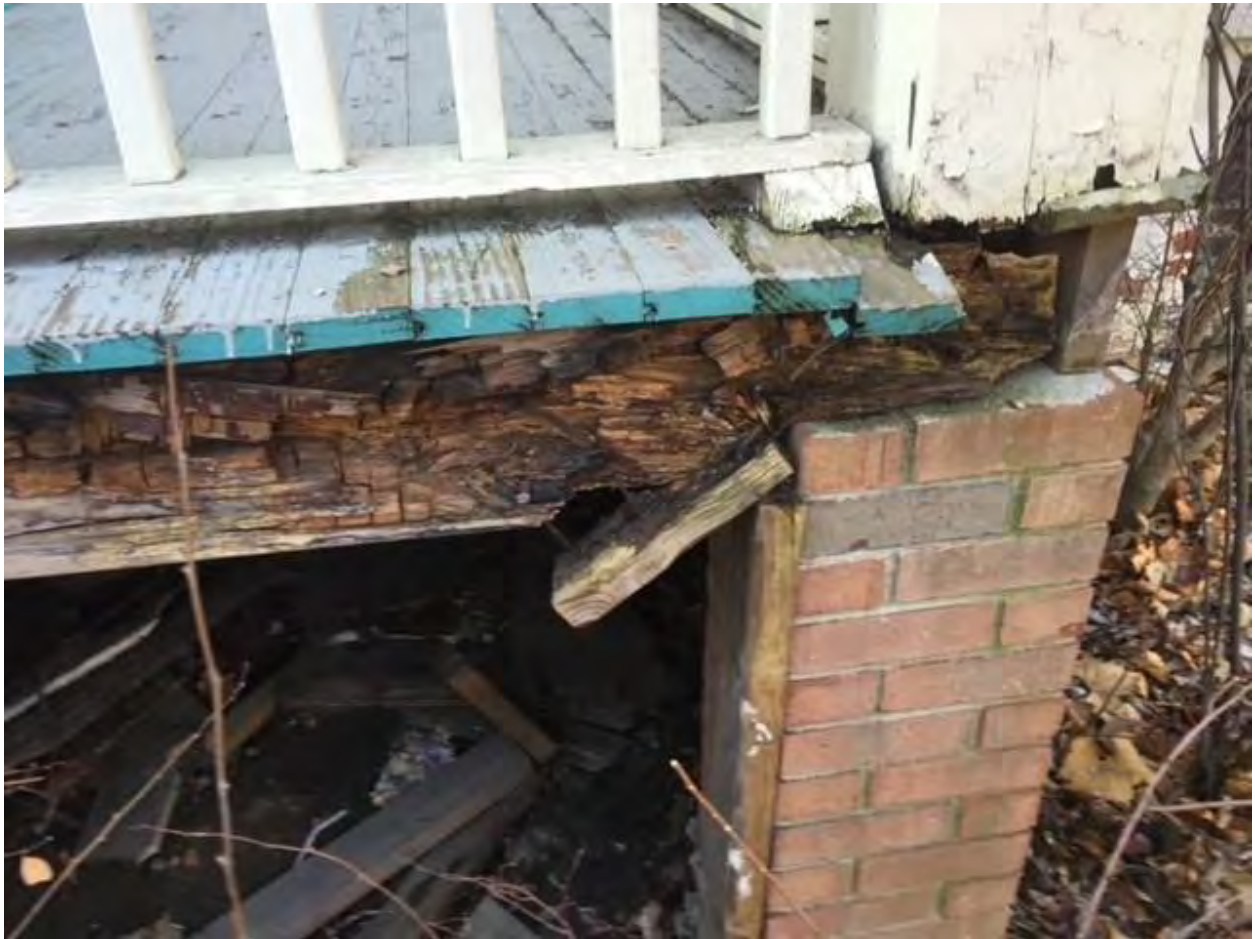
This was from earlier this year where I had to do temporary fix because the wood had gotten so rotted.

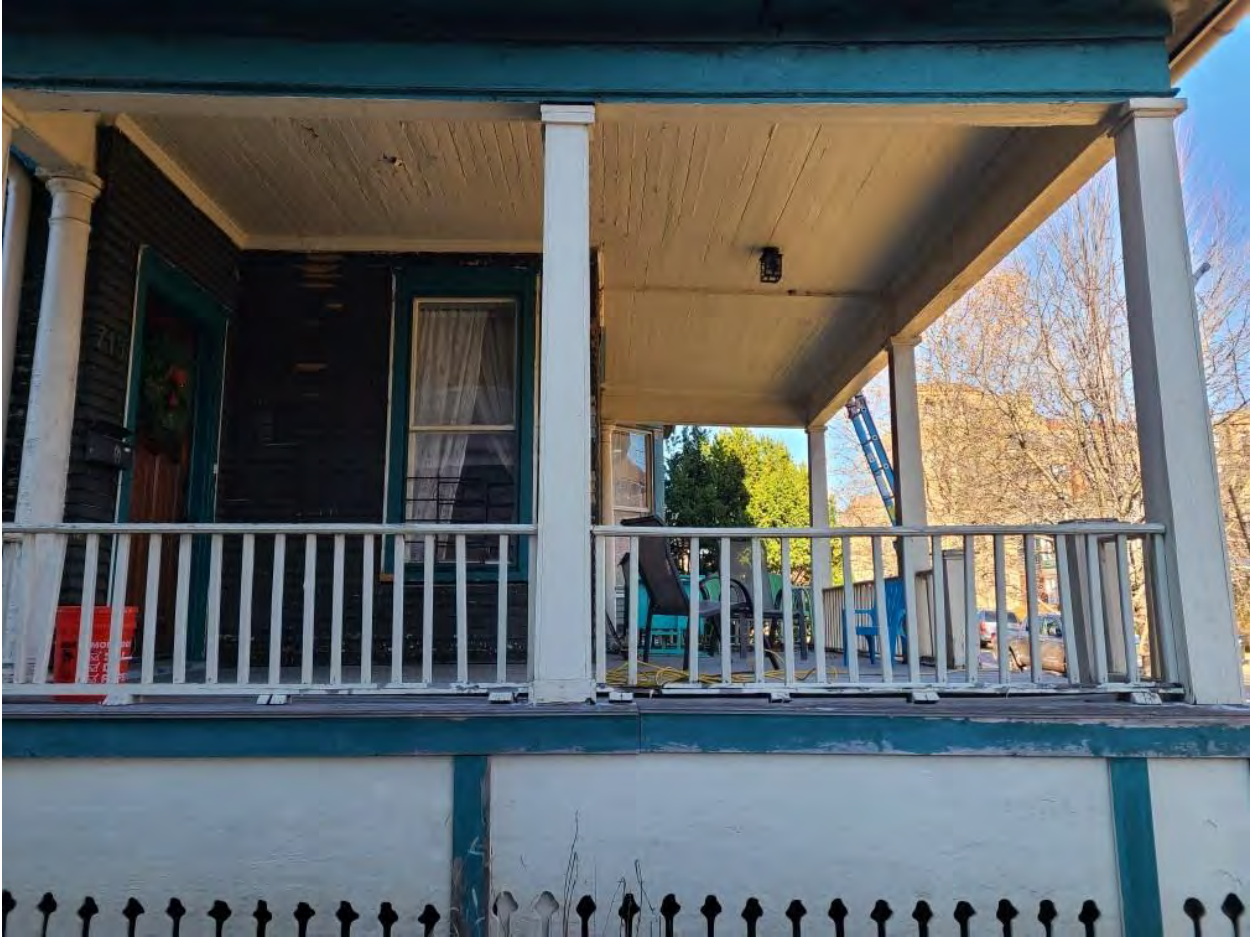
Not that I am that worried about the skirting at this point but as you can see the “decorative” Victorian that was added.

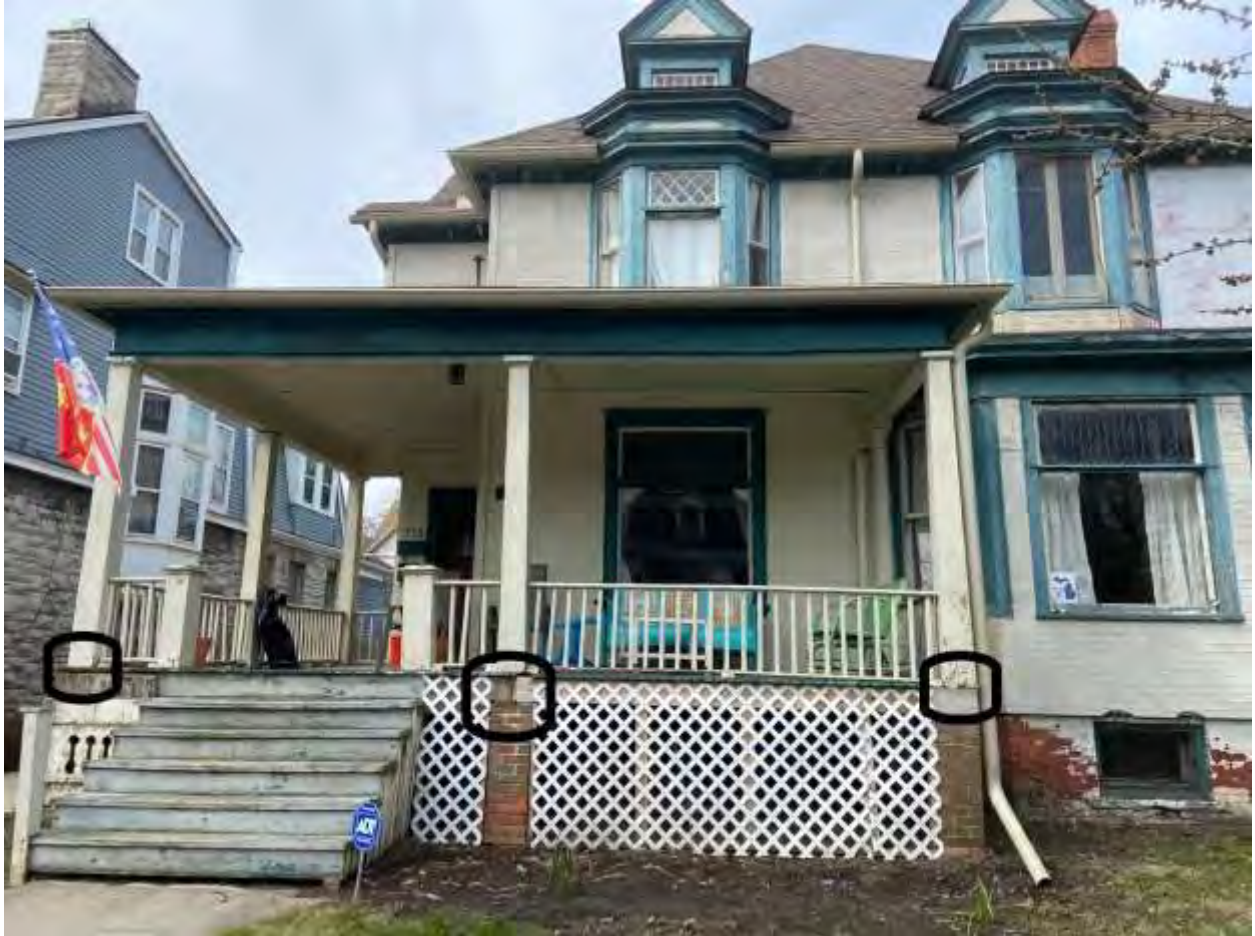
In this picture you can see the pillars have no bases, are not connect to porch and are rotting at the base

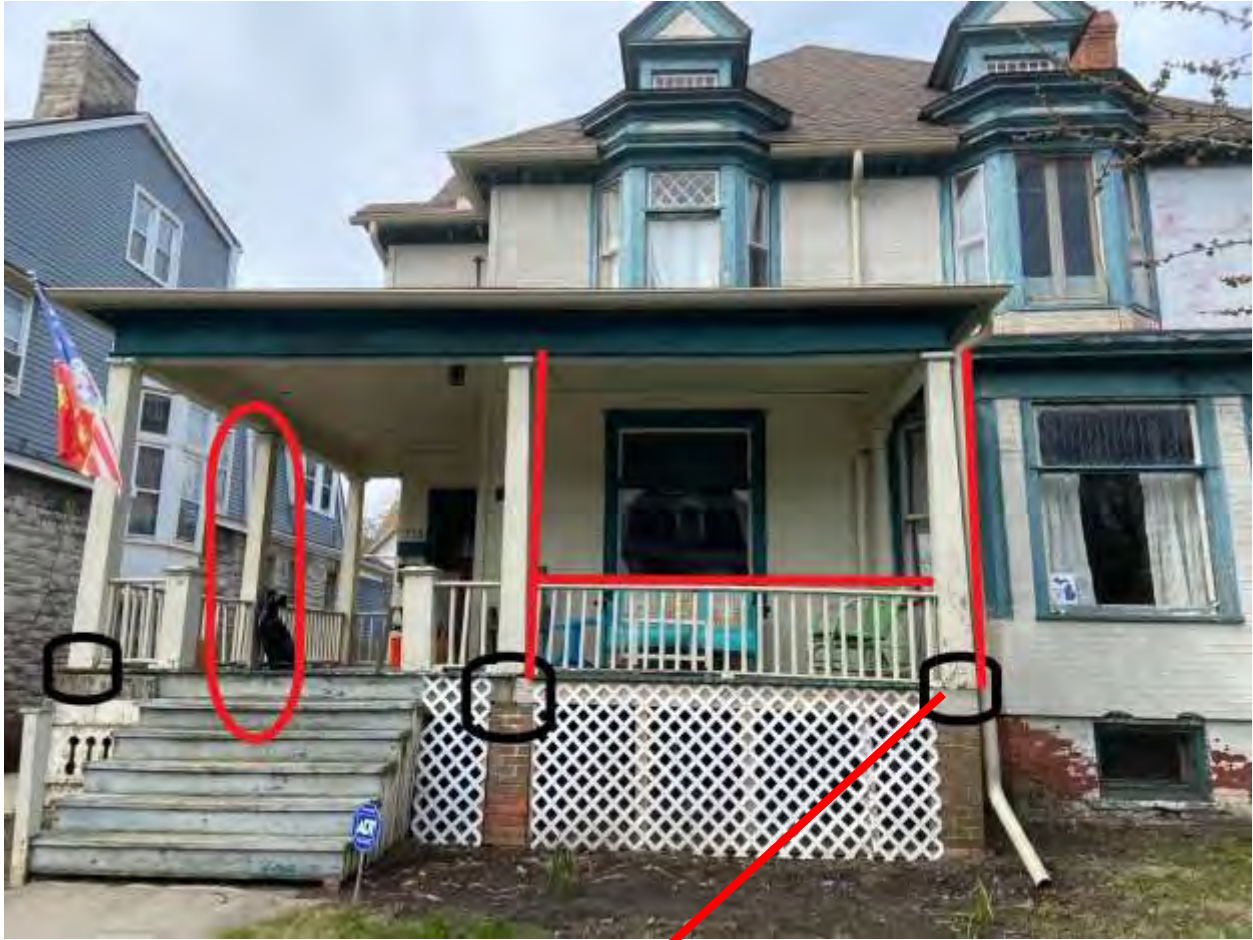
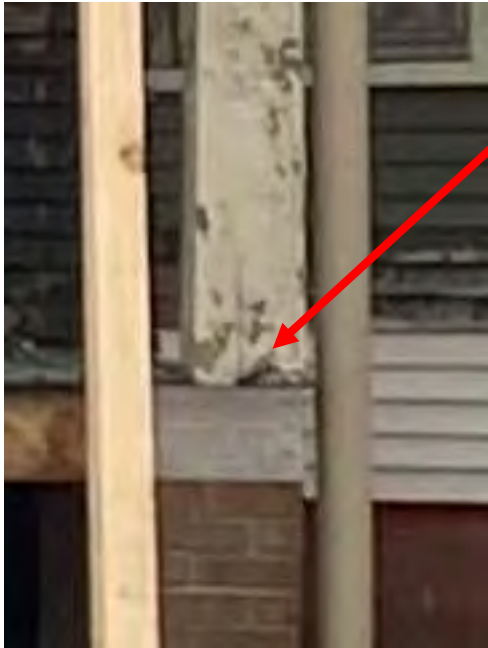
Here you can see the columns are leaning and rotting. There are no base for the columns, so they are not attached to the porch. The center column on the south elevation is not connected to the roof .

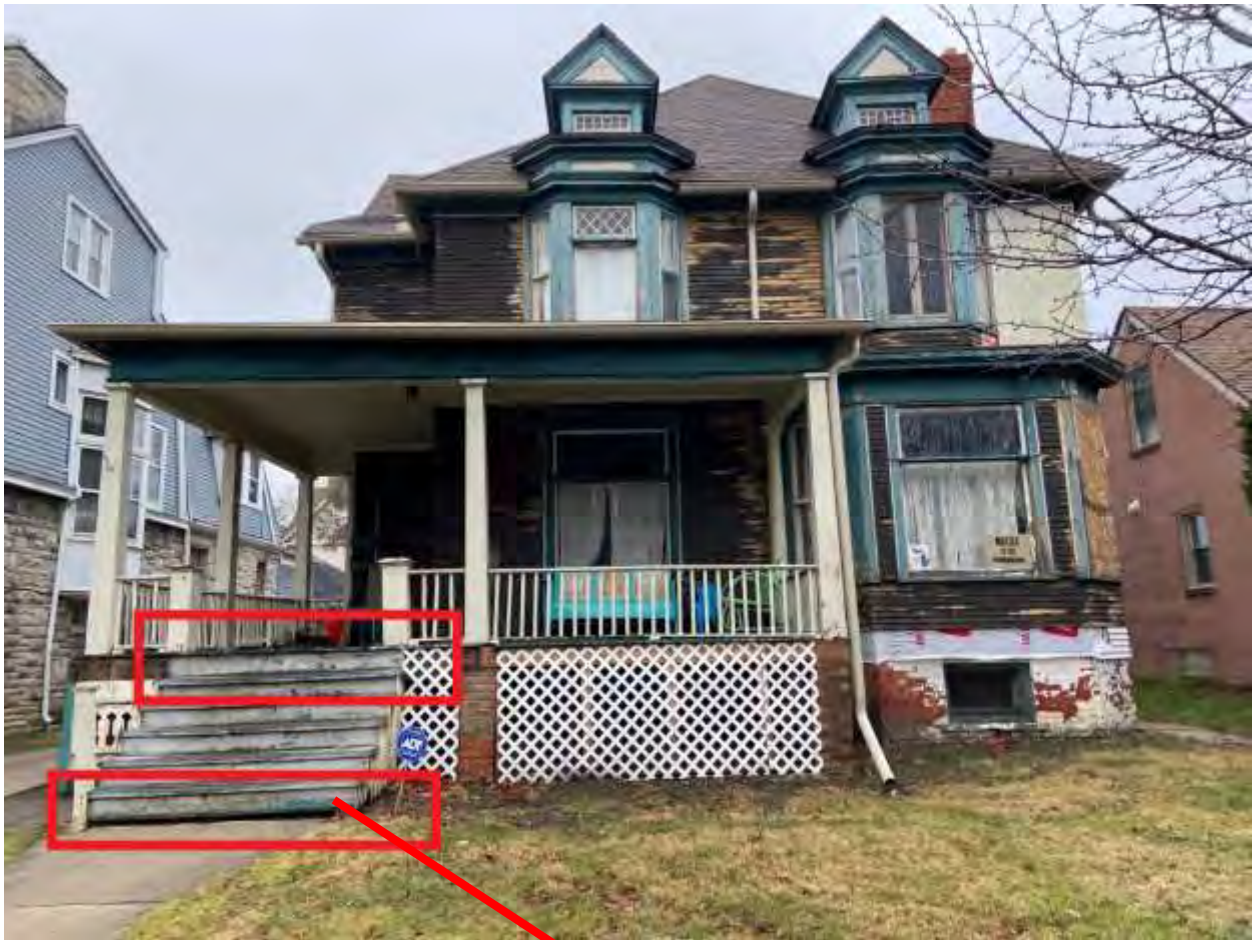
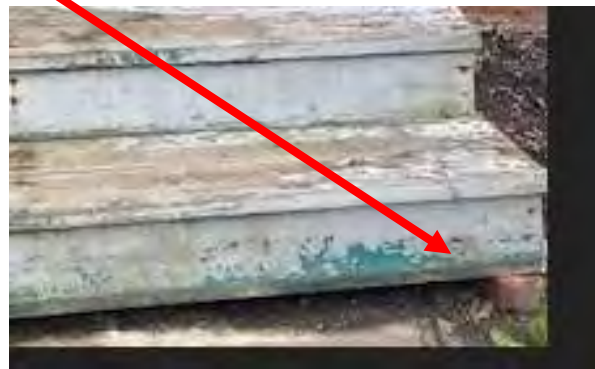
Stairs:

You can see from the pictures the stairs are not to code missing handrails, risers at different heights, bricks use to level the stairs.
