04/19/2022

NOTICE OF DENIAL

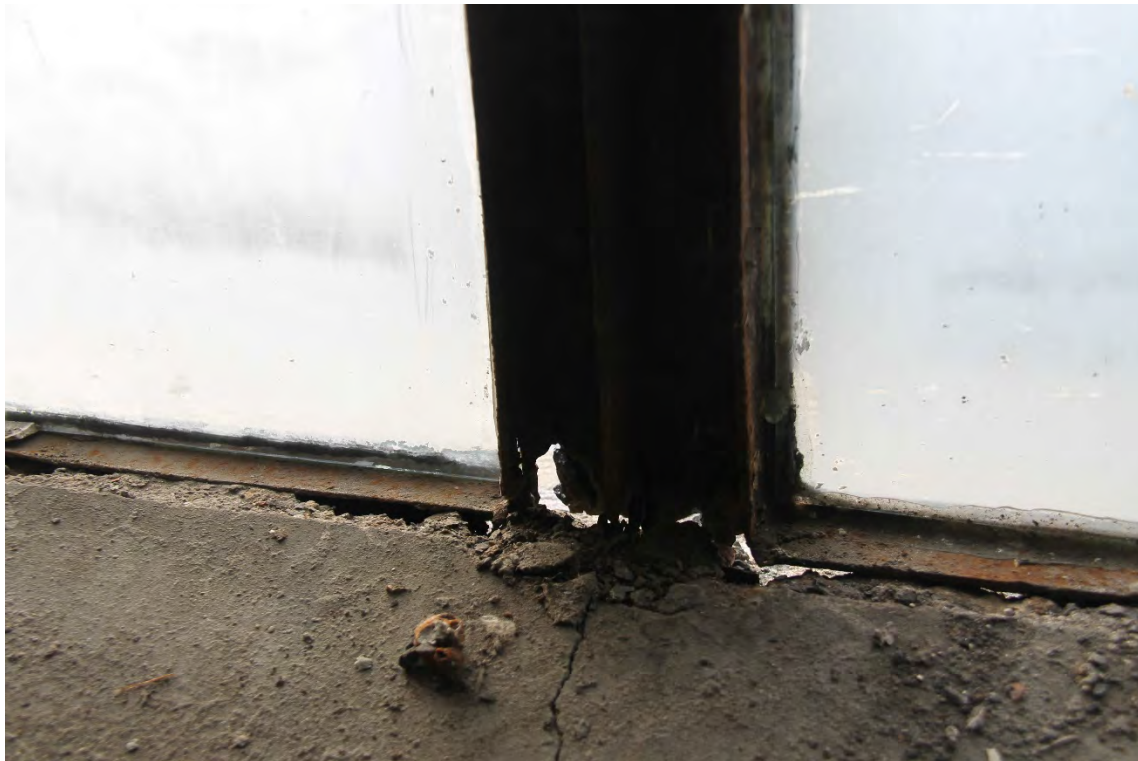
Mullion Condition of Existing Steel Window, Interior View

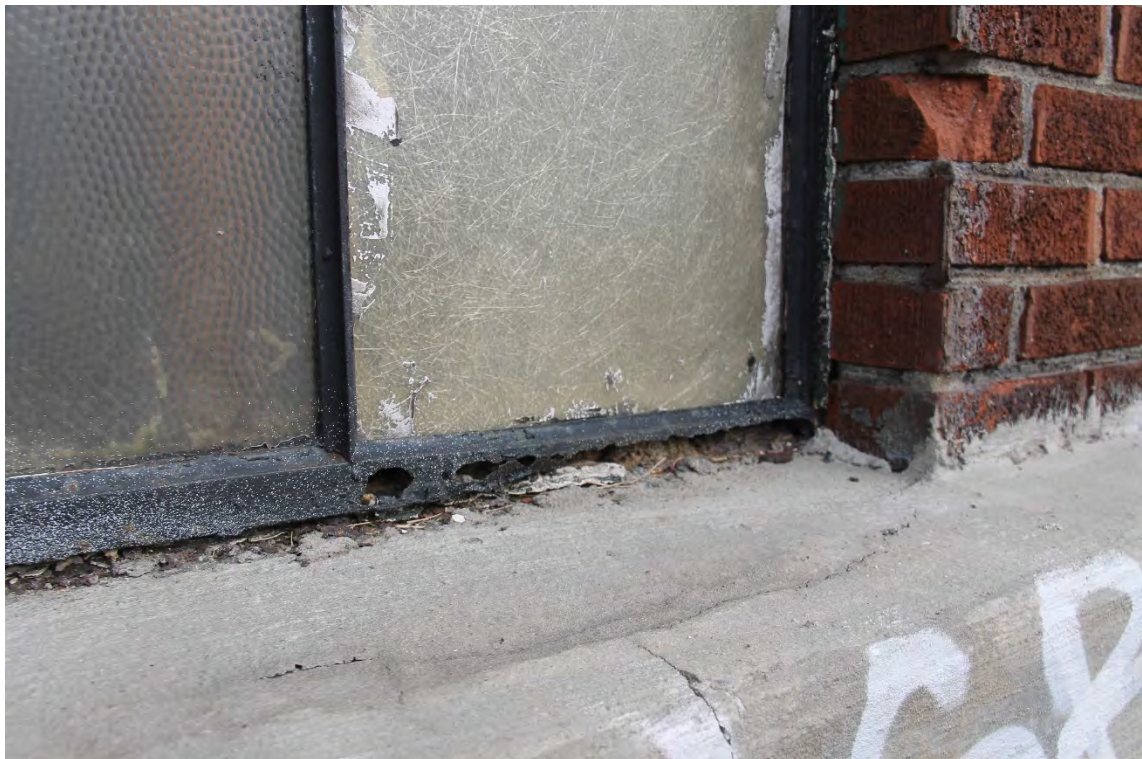
Typical Bottom Rail Condition, Exterior View

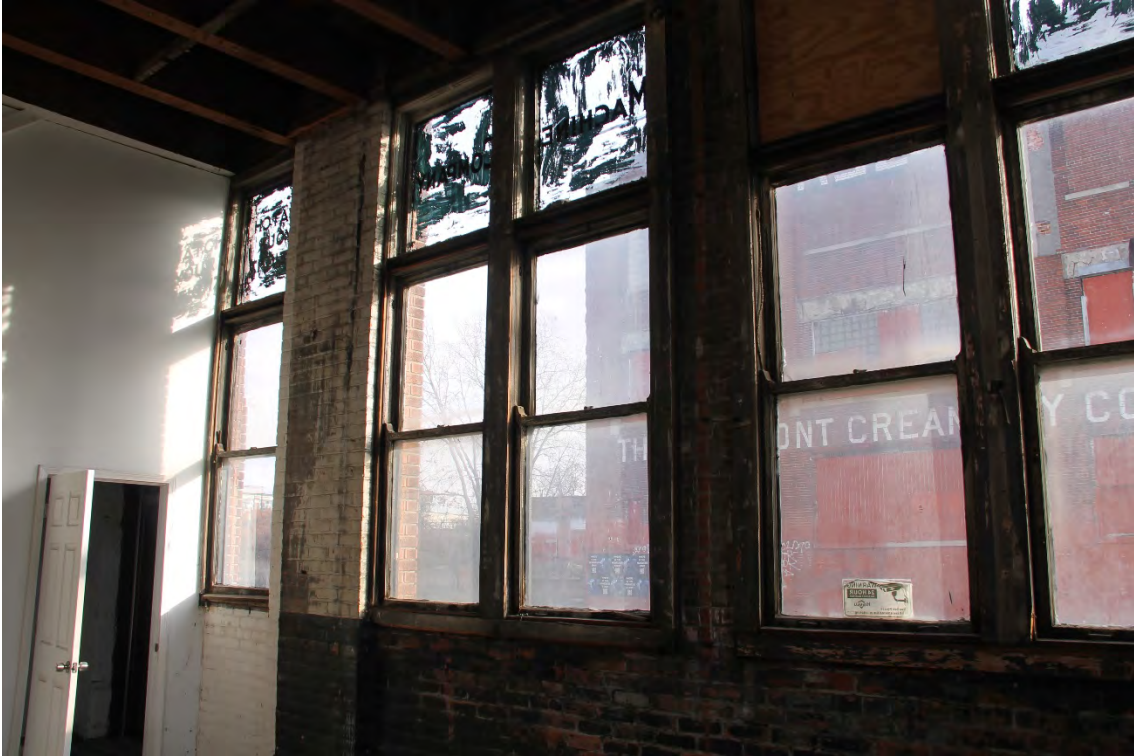
Interior View of Wood Double Hungs

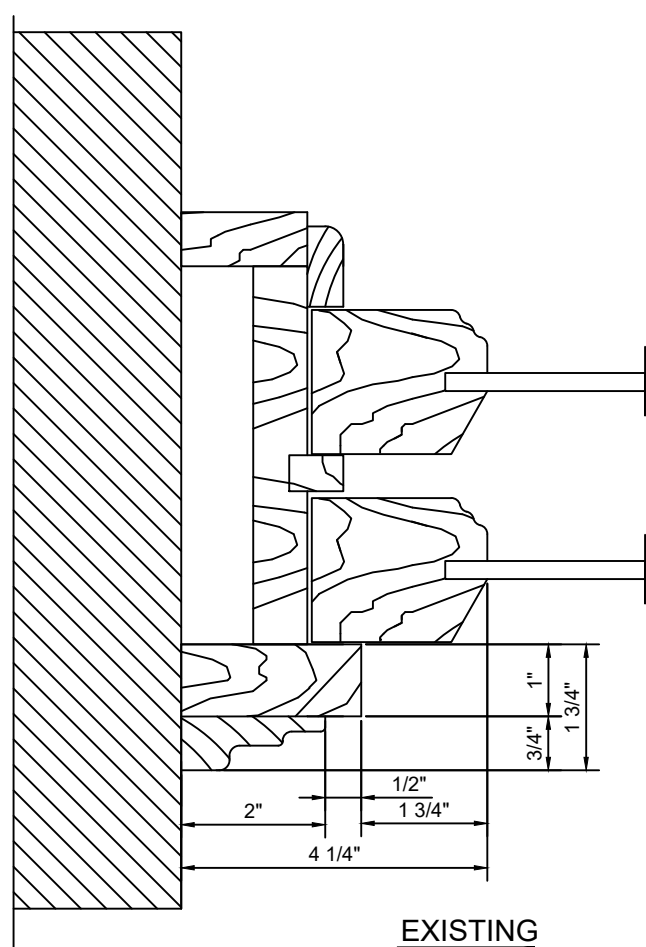
**EXISTING
EXTERIOR**

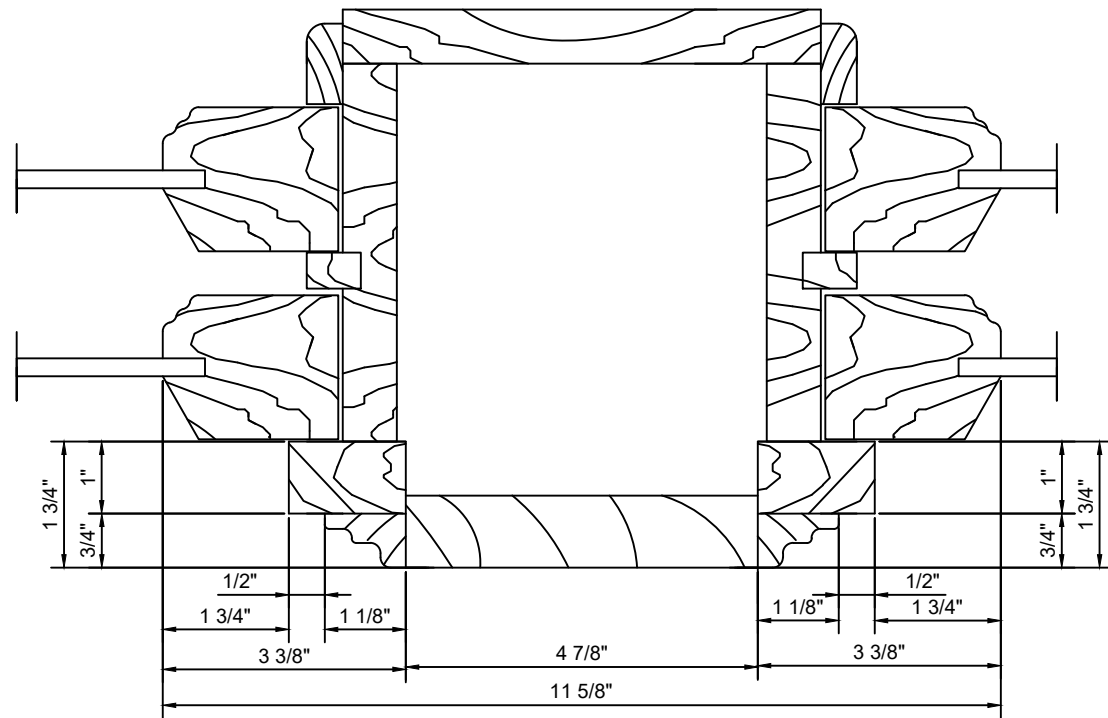
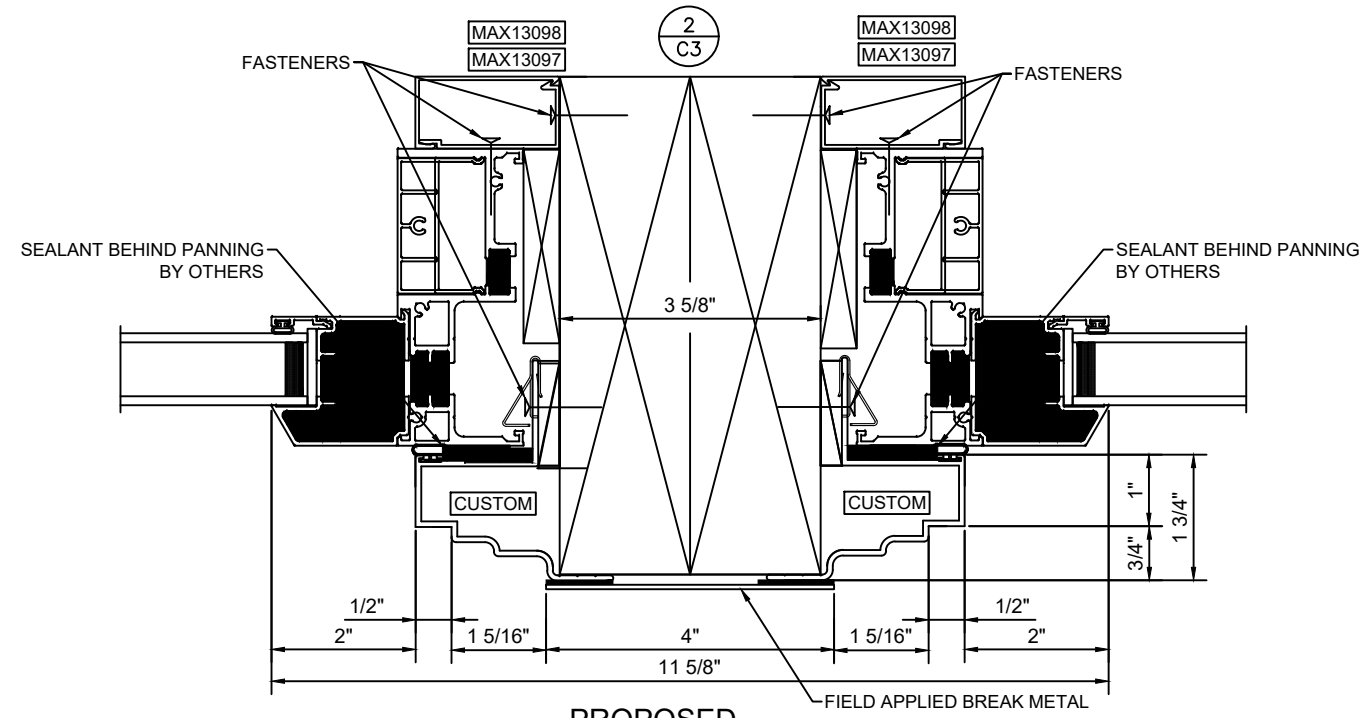
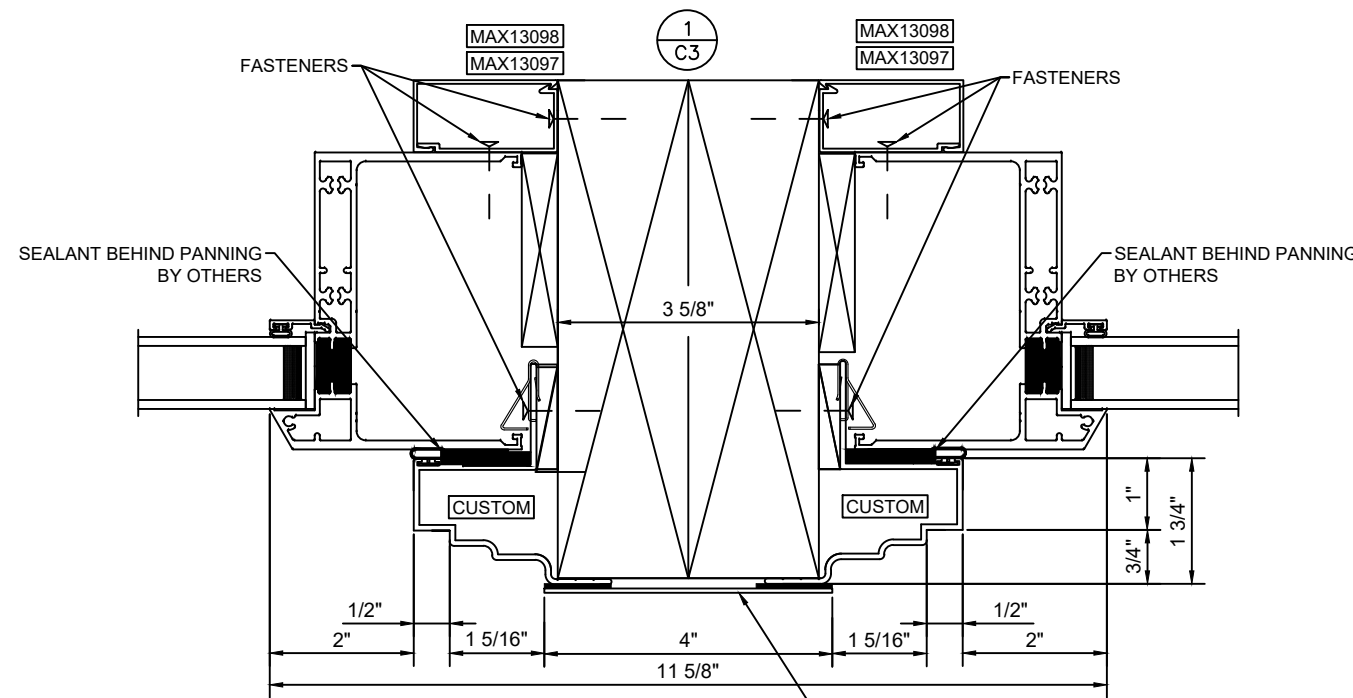
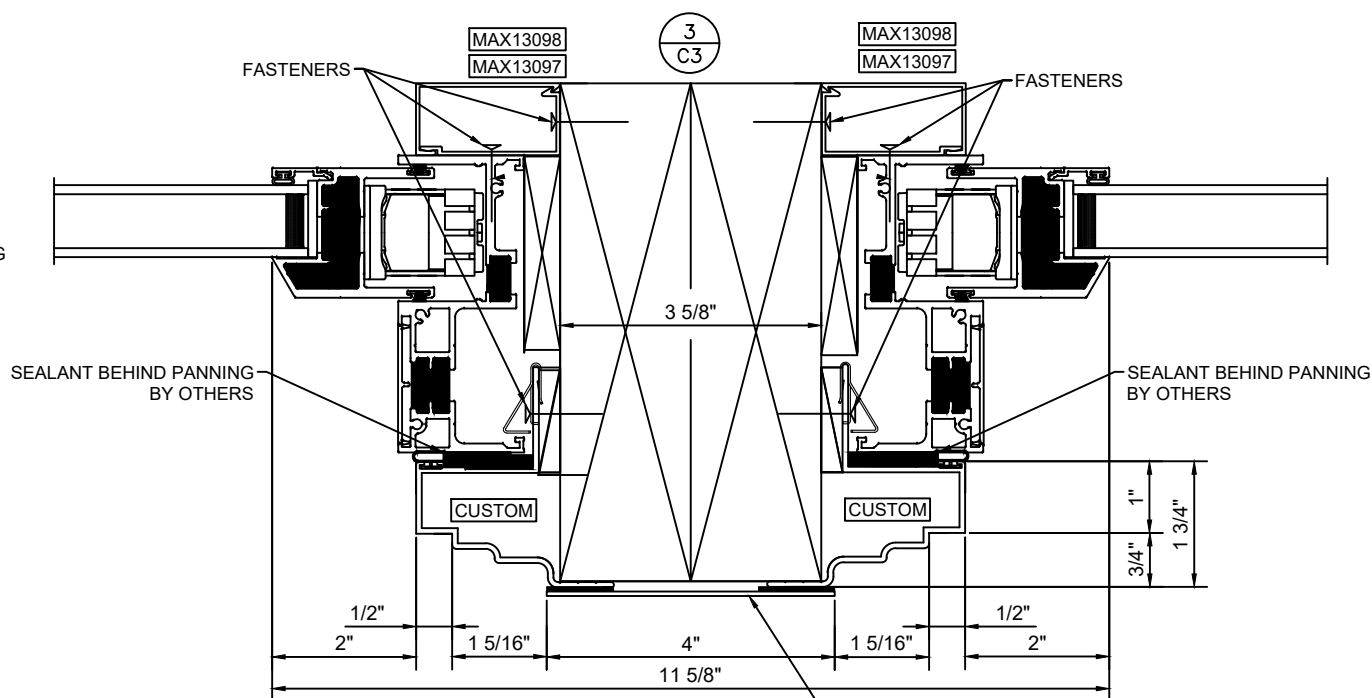
Project Name:
PEERLESS
603 E. MILWAUKEE ST.
DETROIT, MI 48202
