**RE: Application Number 23-8232, 4440 E. Canfield/4444 Russell; Atkinson Avenue Historic District
Project Scope: Alter front porch of rectory building**

Request to Demolish the Existing front Porch Roof and Columns and Construct a New Front Porch Roof and Support Structures for the Mother of Divine Mercy Rectory / Parish Office Located Adjacent to Sweetest Heart of Mary Church

SWEETEST HEART OF MARY RECTORY PORCH RENOVATION

EXISTING CONDITIONS

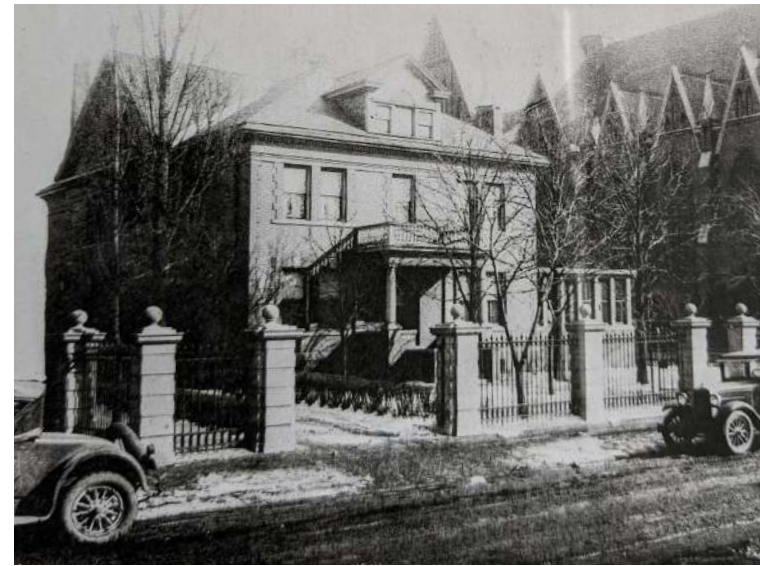
HISTORIC REFERENCE IMAGE

Close examination of an available historic photo revealed that the flat roof of the porch was originally adorned with a low balustrade and that the original columns were round Tuscan type. The balustrade no longer exists. According to on parish member, the original columns degraded and were replaced with “temporary” square craftsman-type columns many years ago. The existing rectangular pilasters appear to be original and

(SHOWING ORIGINAL BALUSTRADE AND ROUND COLUMNS)

The sizes and style of pilasters and columns were chosen to match, as closely as possible, those in the referenced historic photo.

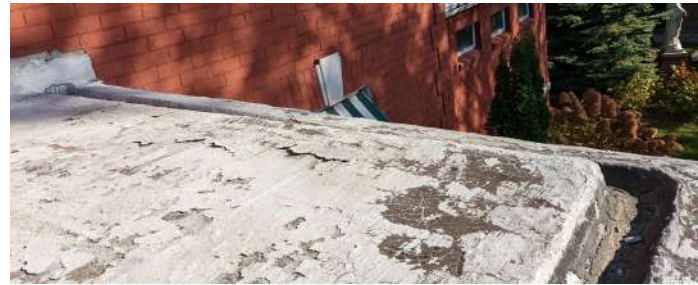
The existing flat roof slopes downward slightly away from the rectory building and contains a shallow integral gutter that is supposed to drain to a downspout mounted on the rectory front façade adjacent to the south pilaster. The existing downspout is a 3" diameter painted pvc sewer pipe. It is unclear whether the roof slope was an original design feature or if it was created by decay of the original support columns and replacement of those columns with temporary columns that were too short. The current counteracting roof slope prevents water flow toward the downspout drain resulting in it spilling over roof edges. The poor condition of the integral gutter inverts allows water in the gutter to soak into the roof structure. The seepage of water into the roof structure and edge spillover has contributed to decay of the wood soffits, fascia and roof joist ends and it likely contributed to decay of the original columns that ultimately necessitated their removal.

MULTIPLE LAYERS OF DECAYED ROOFING, LEAKING INTEGRAL GUTTER, INADEQUATE GUTTER DEPTH, DECAYED WALL COUNTERFLASH

Professional roofing contractors have indicated that redesign of the roof drainage strategy is necessary for successful installation of a new roof on the porch.

In this project, we propose to remove and reconstruct the decayed wood porch roof and support pilasters / columns. All masonry portions of the existing porch will remain. Existing brick and limestone will be cleaned of spalling paint. The wood portion of the porch will be reconstructed with a new level curb at all exposed roof edges. The curb will conceal a new sloped roof surface that drains to two scuppers that divide the roof runoff and eliminate the need for a gutter and downspout. The relatively small amount of water that will drain into each scupper will be absorbed by the existing landscape adjacent to the porch. Scuppers are strategically located to avoid saturating the ground immediately adjacent to the rectory basement while avoiding direct discharge onto concrete paths where winter icing could occur. The detachment of stormwater discharge systems from the existing combined sewer is in keeping with current Detroit Water and Sewerage Department recommendations.

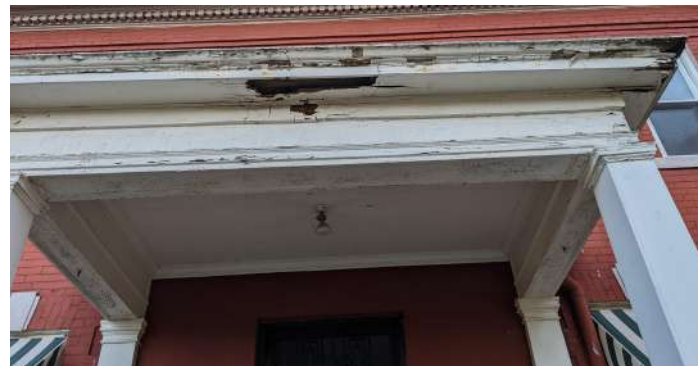
The existing porch light consists of a bare floodlamp in a lampholder. It is unknown if a porch light was installed when the rectory was built. A pendant fixture is not possible due to the lack of clearance between the top of the outswinging security door and the ceiling. The existing security door is to remain in place.

MODIFIED OVERHANGS WITH DECAYED SOFFITS AND FASCIA, EXISTING PORCH CEILING AND LIGHT

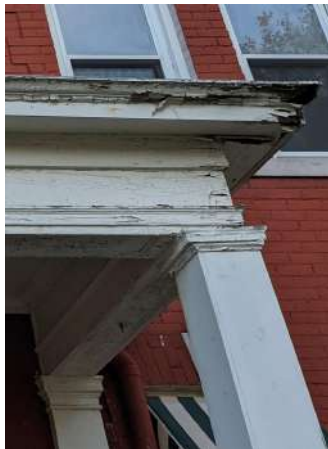
are Tuscan type. The centerlines of pilasters that support the porch adjacent to the building do not align with the centerlines of columns that support the porch distally.

**TEMPORARY COLUMNS
COLUMN/PILASTER OFFSET,
EXPOSED COLUMN CAPITALS**

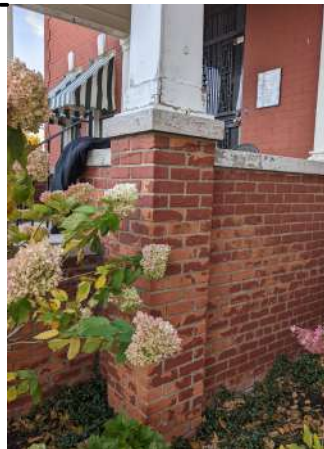
**EXISTING COLUMN BASE
SPALLING MASONRY PAINT**

- Demolish existing wood components of front porch. Masonry portion of porch to remain along with existing steel handrails.
- Clean and remove spalling paint from porch brick and limestone masonry per HDC masonry cleaning guidelines.
- Construct new porch roof framing system to support gravity and lateral loads
- Install roof decking and tapered insulation to provide sloped surface
- Install finish trim and millwork.
- Install EPDM roof membrane, copper counterflashing, coping and scuppers
- Install new decorative balustrade
- Prime and paint all wood components
- Install new porch light. Connect to existing switched branch circuit.
- Repair any damage to the adjacent landscape areas that might arise from construction activities.

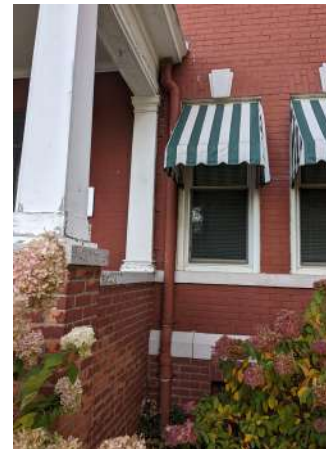
**EXISTING PILASTER
EXISTING DOWNSPOUT**
