CERTIFICATE OF APPROPRIATENESS

RE: Application Number 21-7222; 1920 Atkinson, Atkinson Avenue Historic District

DHDC NARRATIVE

1920 ATKINSON ST. Detroit, Michigan 48206

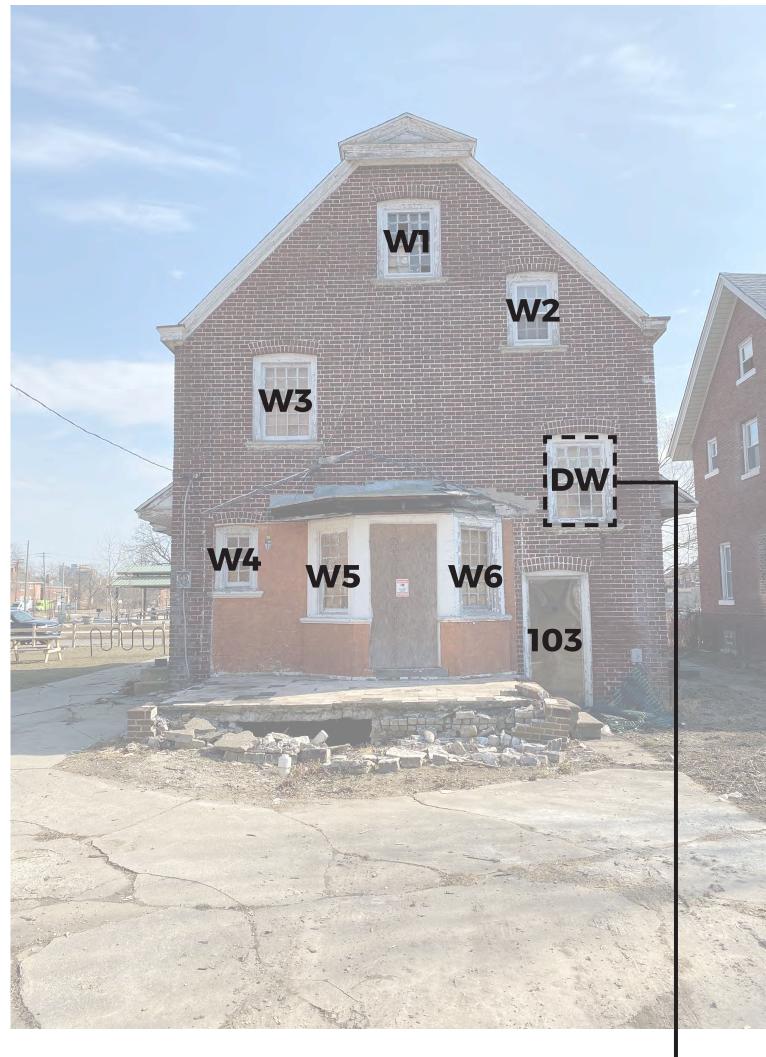
NORTH ELEVATION

REMOVING WINDOW TO
MOVE DOOR 103 UP FOR
NEW PATIO - SEE
ELEVATIONS AND PLANS

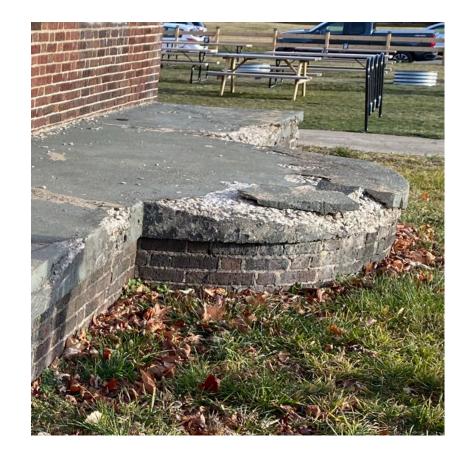
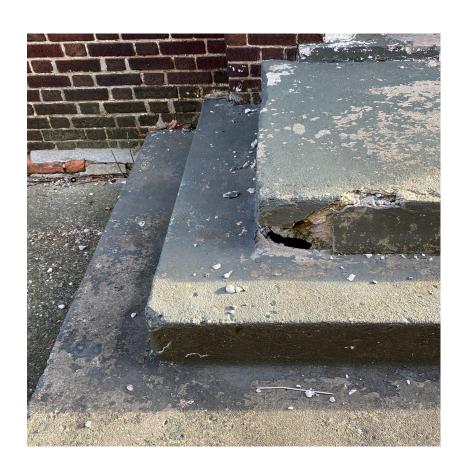
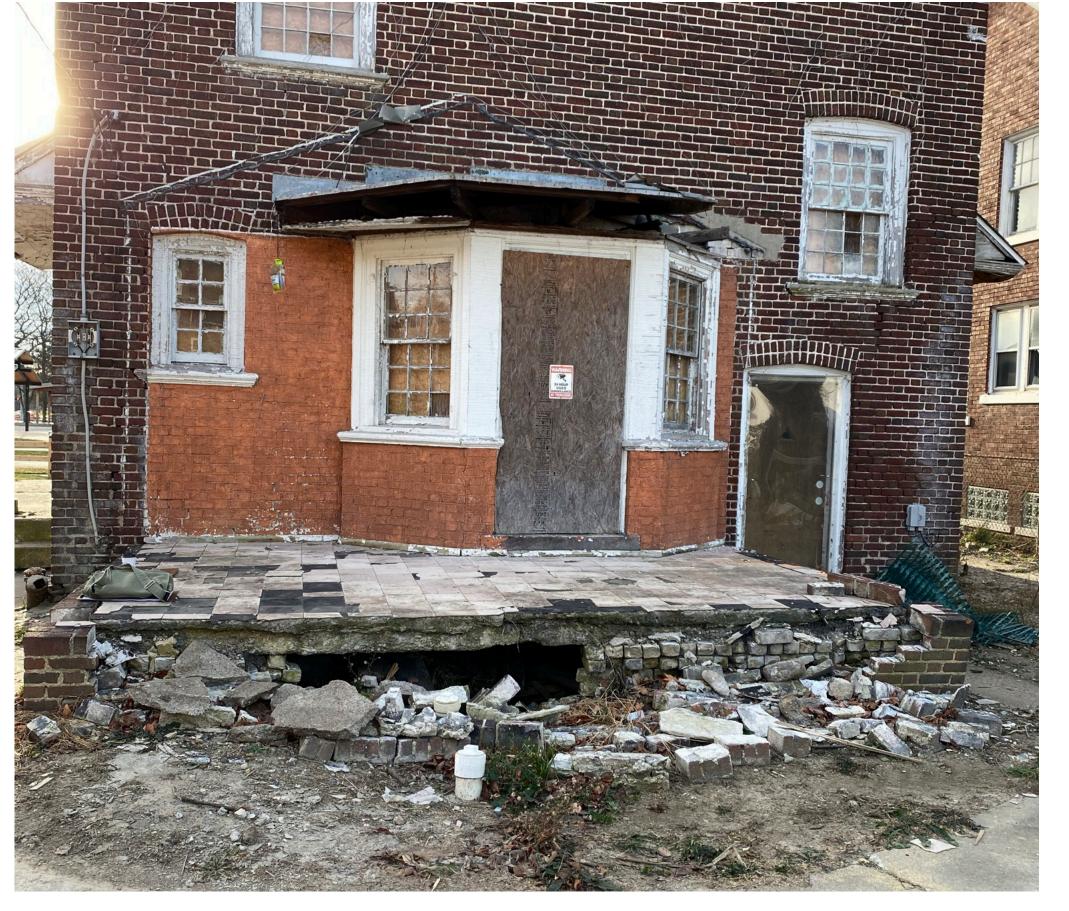
PORCHES

SALVAGE BRICK FROM CRUMBLED BACK PORCH TO USE IN FRONT PORCH AND OR WINDOW CLOSURE (D108)

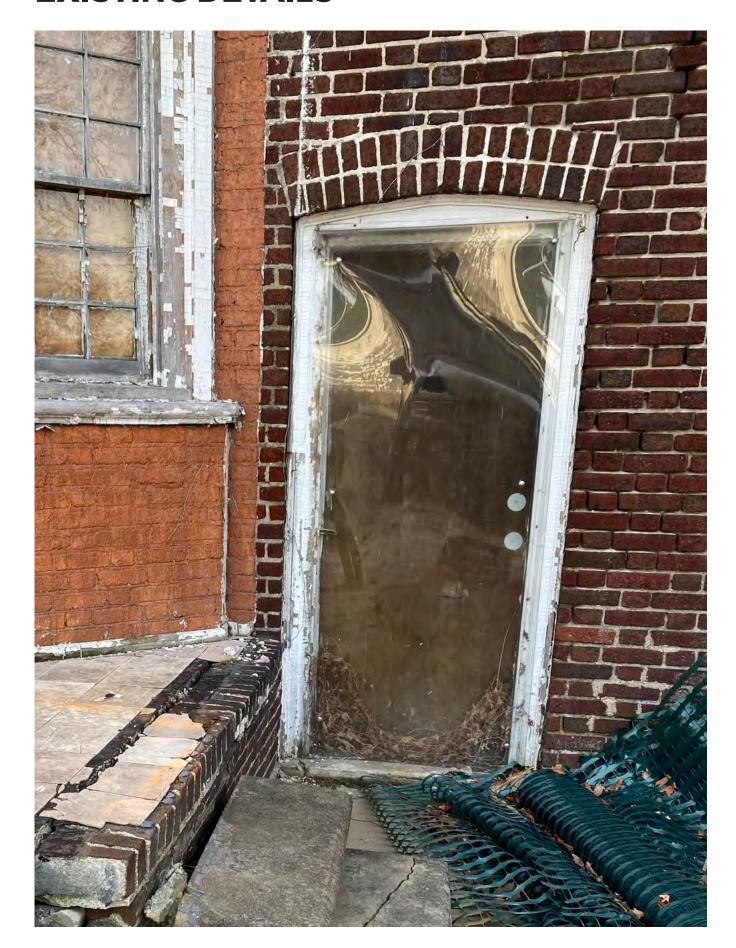
DOOR A - NEW DOOR SILL HEIGHT AND DOOR (103) FOR RESIDENTIAL TENANTS - SEE DOOR SCHEDULE FOR DETAILS

EXISTING MATERIAL: WOOD

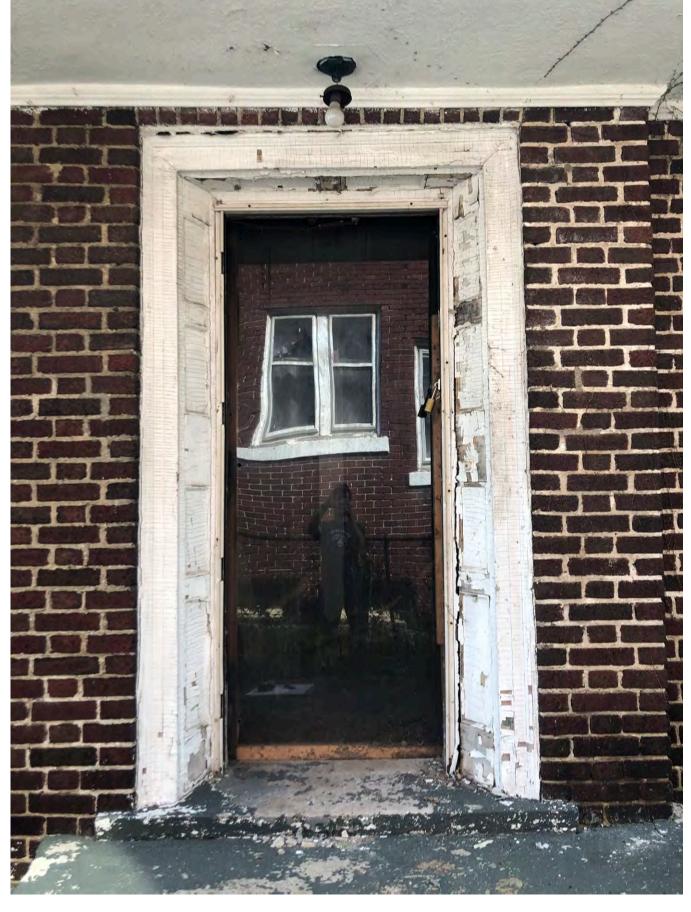
DOOR B - NEW DOOR (102) FOR SECONDARY ENTRANCE TO RESTAURANT - SEE DOOR SCHEDULE FOR DETAILS

EXISTING MATERIAL: WOOD; CURRENT DOOR IS MISSING AND IS HELD BY AN ACRYLIC PIECE

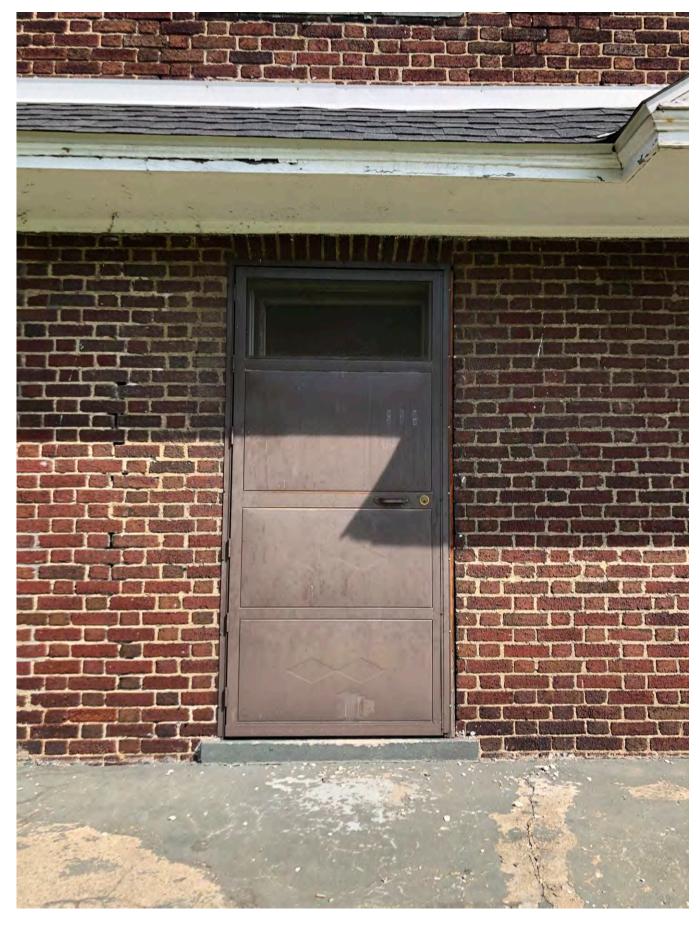
DOOR C - NEW DOOR (104) - SEE DOOR SCHEDULE FOR DETAILS

EXISTING MATERIAL: METAL

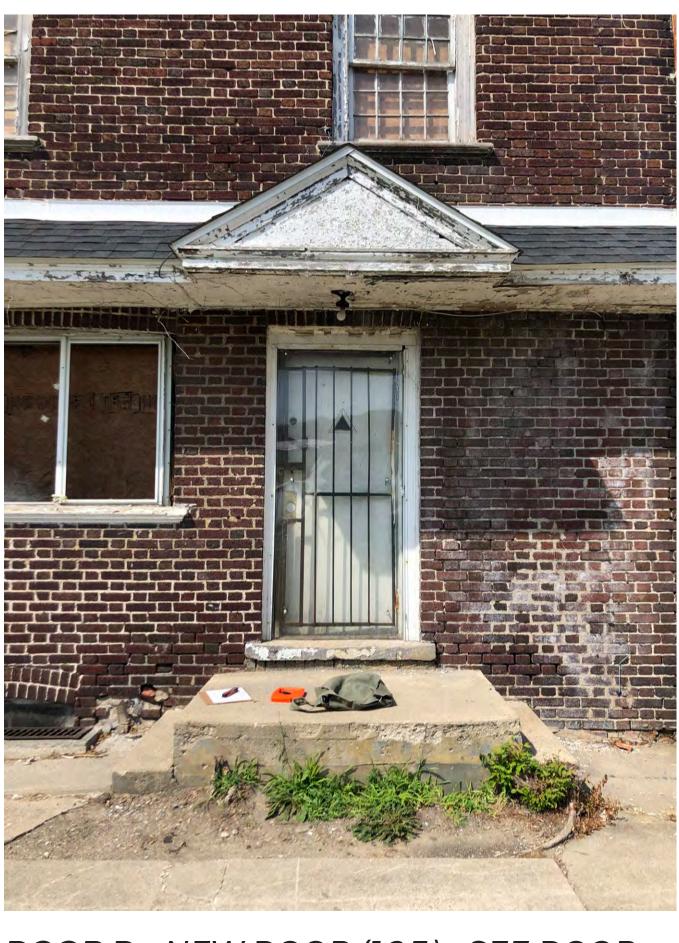
DOOR D - NEW DOOR (105) - SEE DOOR SCHEDULE FOR DETAILS

EXISTING MATERIAL: WOOD

THE DOOR WOOD TRIMS ARE ROTTED AND NEED TO BE REPLACED AS WELL. BECAUSE THE FIRST FLOOR WILL BE A COMMERCIAL SPACE, ALL EXISTING DOORS ARE NOT TO CODE AND MUST SWING OUT. NEW DOORS WILL MIMIC ADJACENT WINDOW DESIGN.
