NOTICE OF DENIAL

RE: Application Number 23-8396; 2405 Burns St.; Indian Village Historic District

CERTIFICATE OF APPROPRIATENESS

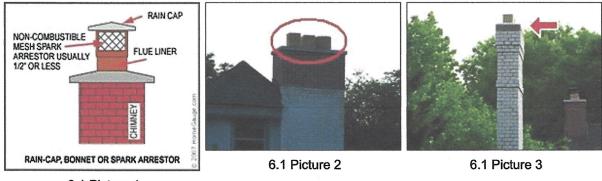
6.1 Picture 1

(2) The chimney at the rear left of the house has a slight lean to it, but it could have been this condition for an extended period of time. We did not see any issues at the time of inspection and recommend to monitor the area as needed.

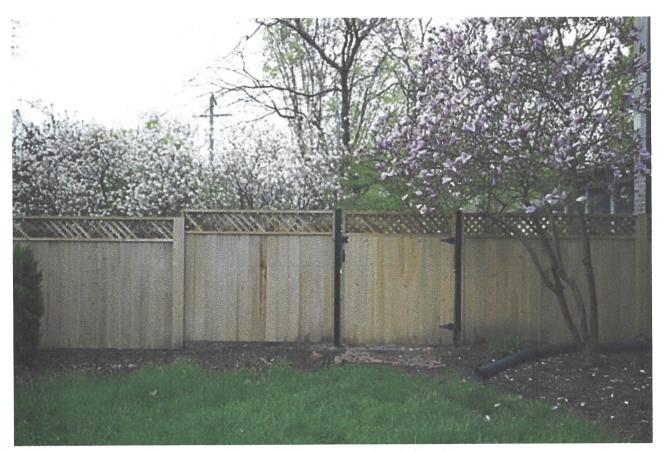
Picture 1: Backyard fence facing Burns on Vernor Side of Mouse

The first 4 pictures (captioned Picture 1 through Picture 4) are of the backyard privacy fence. It has been completely removed and replaced exactly as it was with new cedar construction. The previous fence was falling down and rotting in many areas. The contractor was Kimberly Fence in Warren. They did exemplarily work and I would recommend even though they were not the lowest bid. This work was completed in January.

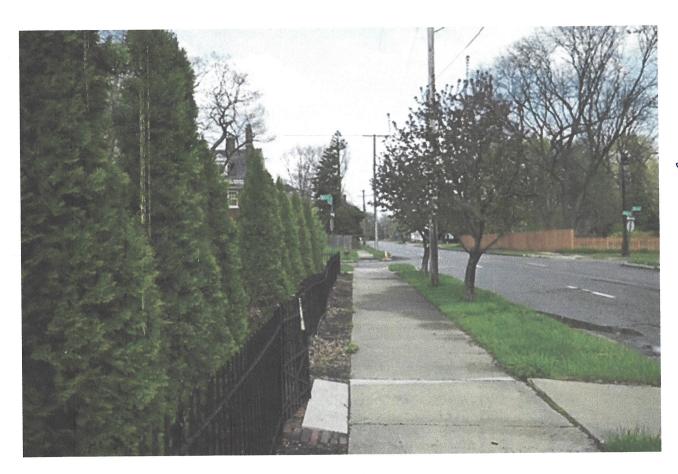
Ve 6006 Picture 5 1500

Pictures 5 through 8 are of the current iron fence on the front of the house. This is to be replaced as in Picture 7 and 8 which is an identical construction as originally put it. This work has not been started to date

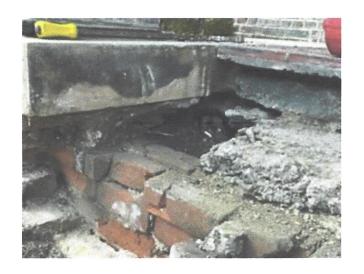
Picture 12

The front steps were falling backwards causing water to flow towards the house. This was due to the foundations had deteriorated. I hired a restoration concrete and brick contractor (Grunwell-Cashero) to do this work. The limestone steps were temporarily removed and the foundations were rebuilt. The limestone steps were placed back on the new foundations. This portion is complete. (Pictures 9 through 12)
