CERTIFICATE OF APPROPRIATENESS

RE: Application Number 20-6662; 677 W. Canfield; West Canfield Historic District

677 W. Canfield – Historical Restoration

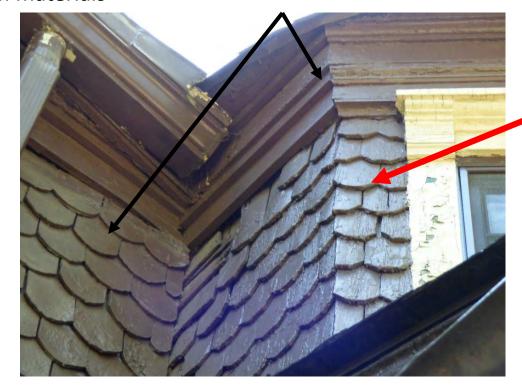
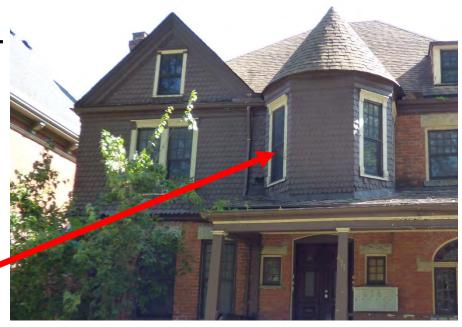
Front Elevation (7 of 16) – Siding:

A mismatched repair made with wider scallops between corner and downspout (this will be fixed with new siding) as well as this mismatched trim (about 3ft) to be repaired with salvaged trim materials

Scallop siding at front bay is different then rest of home. It is a straight bottom with angle cut corners with the same exposure and dimensions as the rest of the shingles. We are proposing to us the same scallop siding on the front bay to keep all the siding consistent.

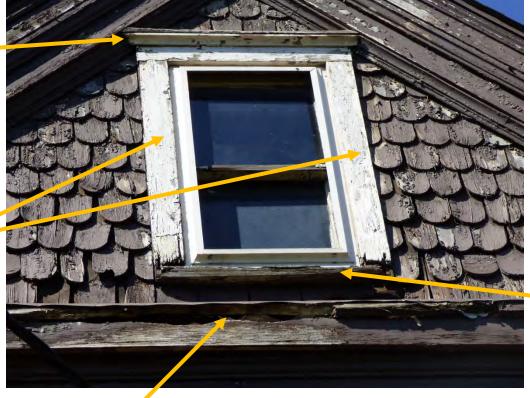
Rear Gable

Rotten Fascia Boards

Existing 2" cove crown to be replaced with matching 2" smooth wood cove molding

Existing 5/4x4 casing and header to be replaced with new 5/4x4 flat stock smooth wood painted B:19 Black.

Remove and replace siding with new siding consistent with rest of home replacements

Existing 1.5" thick sill to be replaced with new 1.5" thick beveled washed cedar sill (cut to same profile)
