STAFF REPORT: 07-08-2020 MEETING

APPLICATION NUMBER: 20-6691

ADDRESS: 14909 GREENVIEW

SCOPE: REPLACE REAR FRENCH DOOR WITH SLIDING DOOR

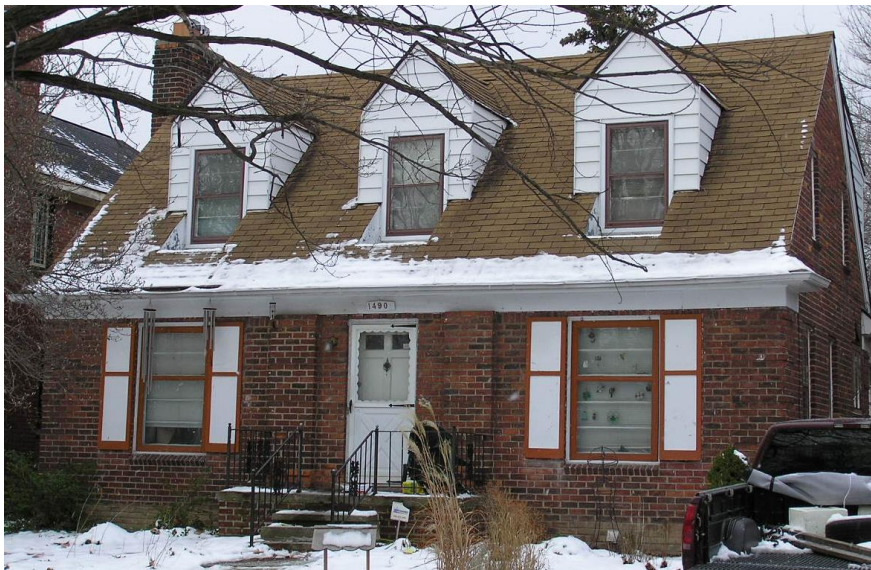
Designation Photo: January 2003, Historic Designation Advisory Board Photo

- Looking closely at the designation photo, it is staff's opinion aluminum siding covered the front dormers due to the thin strips that serve as rakeboards, window casings and corner trim.

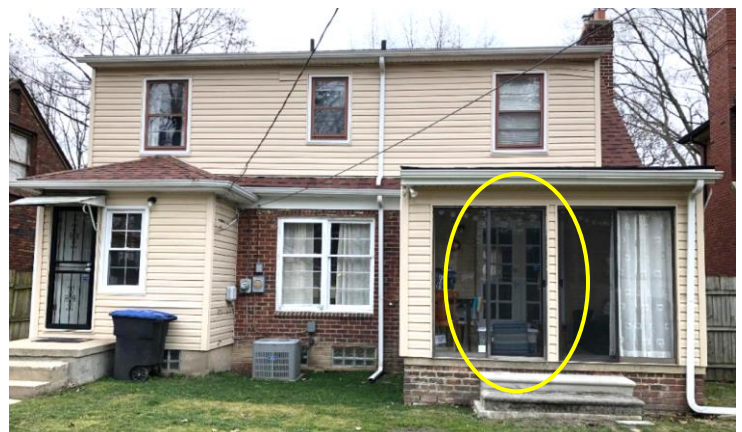
Applicant supplied photo – French Door as seen from backyard

The work proposed by the applicant is located on the rear elevation of the house. They are requesting to remove a set of painted, true-divided light, wood French patio doors and install an Anderson (400 series) wood with vinyl exterior, clear glass, gliding door.

- *The current French doors are literally about to rip out of the wall any minute by the hinges. Because of that, we aren't able to use the doors.*
- *We've removed the hinges before and used a few methods of reinforcing the wood. For example, inserting the skinny portion of golf tees with wood glue to create new "meat" for the hinge screws to bite in to. And it hasn't worked. The weight of these extremely old doors is pulling on them more and more every day. You can also see from some of the close ups, the level of rotting and deterioration on the molding and "weather stripping", if you can call it that.*

- *Each door has 10 panes of glass. It is very old, non-tempered glass. It's very unsafe for anyone let alone having two small children in the house.*
- *We opted to go with a sliding door as opposed to French doors because of the energy efficiency that the sliding door will offer. And again, less moving pieces and parts with kids running around.*

As the proposed patio door replacement will remove historic materials which will alter features or spaces that characterize the property, HDC staff recommends the Commission deny a Certificate of Appropriateness for this project as proposed as it does not meet the Secretary of Interior Standards for Rehabilitation, specifically Standards:
