**STAFF REPORT:** 08-12-2020 MEETING

**APPLICATION NUMBER:** 20-6760

**ADDRESS:** 1980 EDISON

**HISTORIC DISTRICT:** BOSTON-EDISON

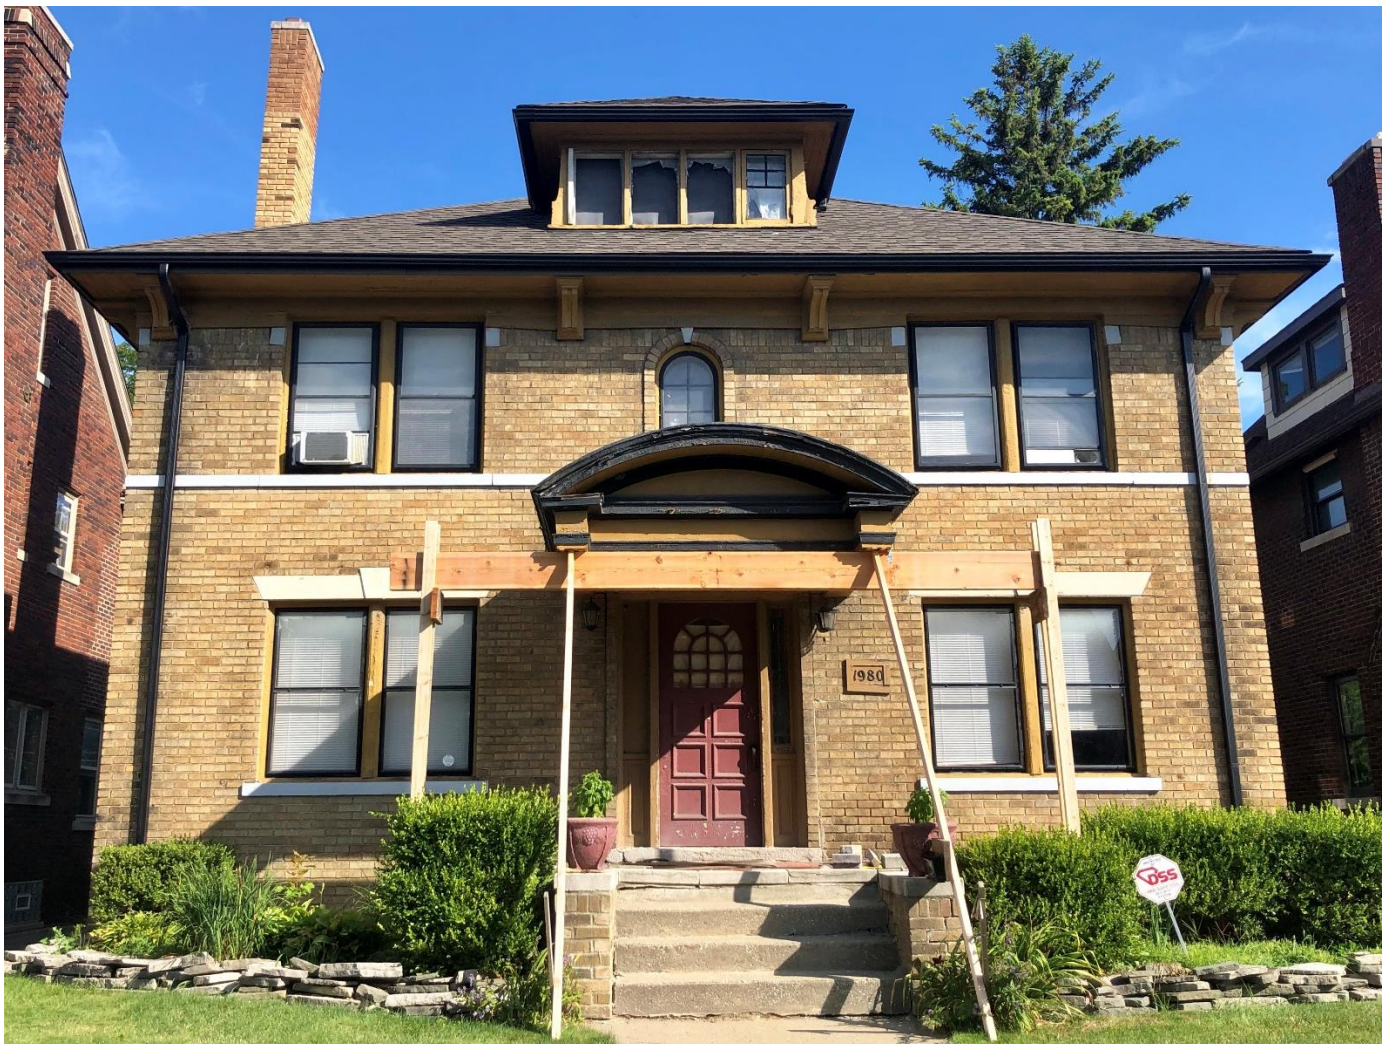
HDC Staff Photo, July 31, 2020.

Prior to the district's designation, as evidenced in the above photo, the wood columns that would have supporting the portico had already been replaced with metal columns. The iron columns were still present until their recent removal by the applicant, as shown in the photo on the right. The matching metal ironwork obscuring the keystone lintels of the first floor windows is no longer present.

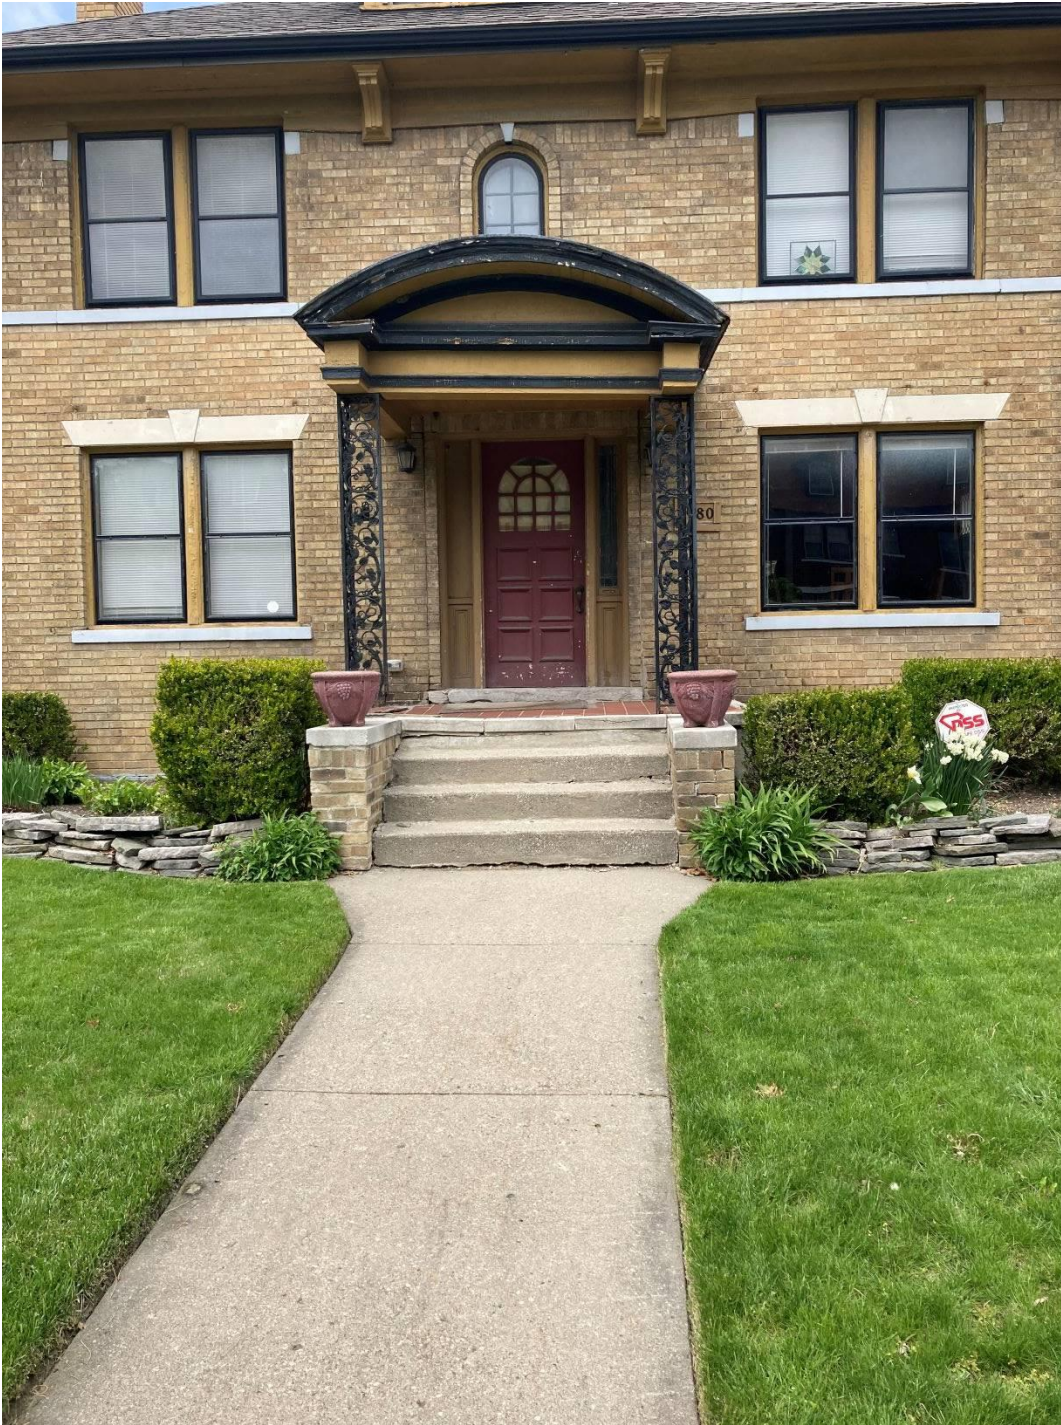
Applicant Photo – Shows porch before columns were removed and temporary supports put in place

The rebuilding of the front porch and pouring of a new concrete sidewalk, which will retain its existing footprints, as well as the height and design of the stairs and porch platforms, while reusing existing brick and stone where possible, and installing wood columns in place of the metal filigree columns, will overall be an improvement because the existing metal columns detract from the historic and architectural character of the house.

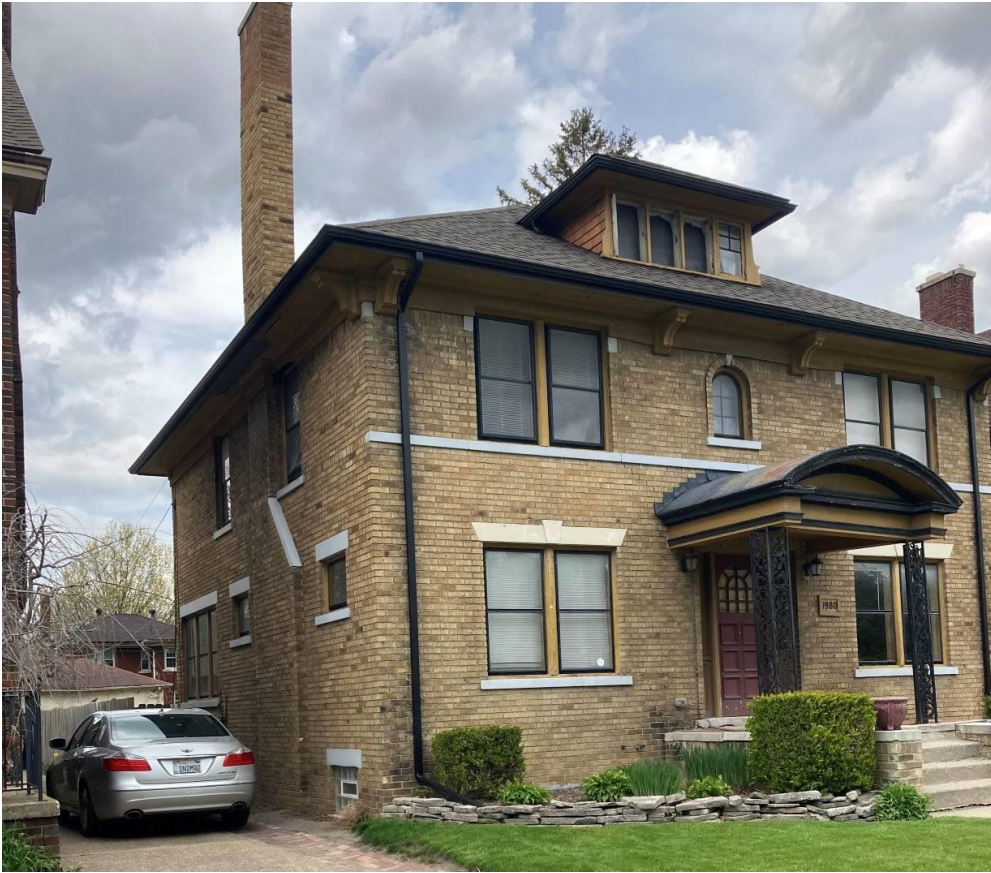
Applicant Photos

- The photographs submitted by the applicant of the current condition of the porch front entry and stairs show sinking platforms, the separation of the support walls from the platforms, and insensitive platform repairs (pouring of concrete where tiles had once been installed).

- Should new face brick be needed, it shall match the historic brick in dimension, color, composition, pattern and profile. A historic mortar mix, matching that of the existing mortar, shall also be used. The existing stone caps, shall be reused, or new stone caps will be specified (no concrete caps).
- The existing front door shall be retained or, if the applicant can substantiate the existing door and surround are beyond repair, all components will be replaced in-kind. The paint color for the front door will be submitted for staff review.

- Square clay tiles or a manufactured product, matching the design, dimension, color and placement of the existing tile platform, will be installed as the walking surface on the entry porch and side extension. A catalog cut confirming the tile details will be submitted to staff for review.

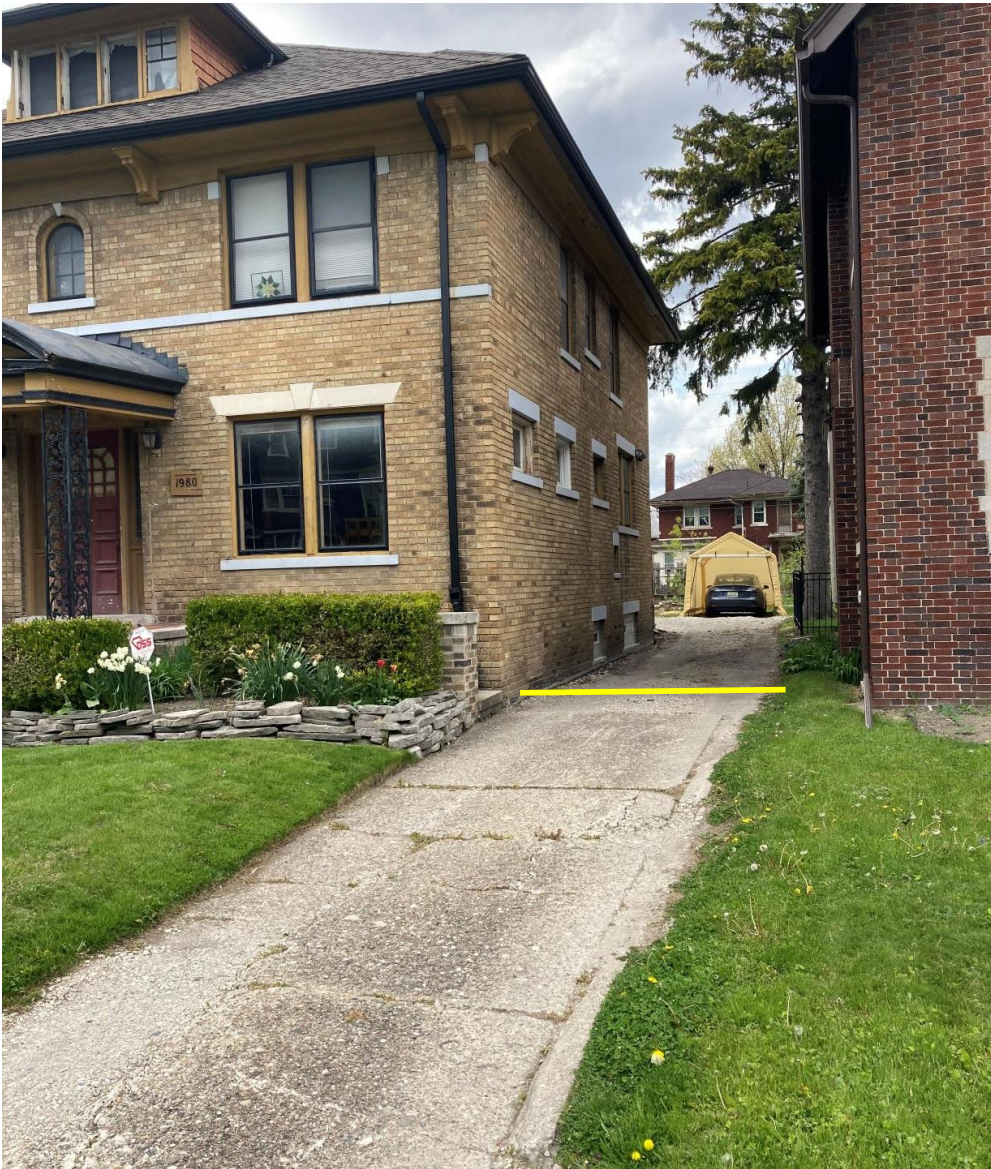
- According to the site plan, the footprint of the traditional concrete, new pour, will remain as-is and will extend from the street/apron to the front corner of the house. The new product to be installed from the corner of the house to the garage is a commercial-grade permeable paver. The open areas of the paving system will be filled with gravel, so the altered appearance of the driveway from the street will be minimal.

Applicant supplied photo - - yellow line indicates where the permeable system would start
