**STAFF REPORT:** 08-12-2020 MEETING

**APPLICATION NUMBER:** 20-6783

**ADDRESS:** 1225-1227 HUBBARD

**SCOPE:** ERECT NEW FENCES, REMOVE FRONT TWO-STORY PORCH AND CONSTRUCT NEW TWO-STORY PORCH, NEW ENTRY DOORS AND LIGHTING, NEW REAR PORCH

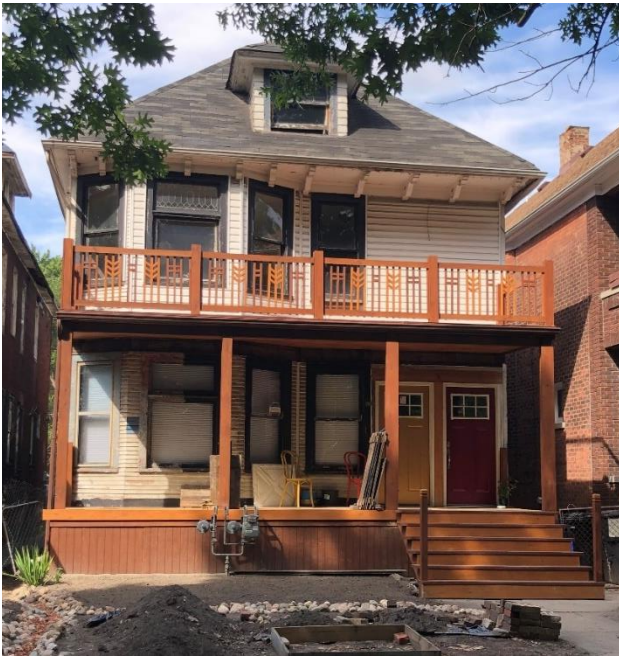
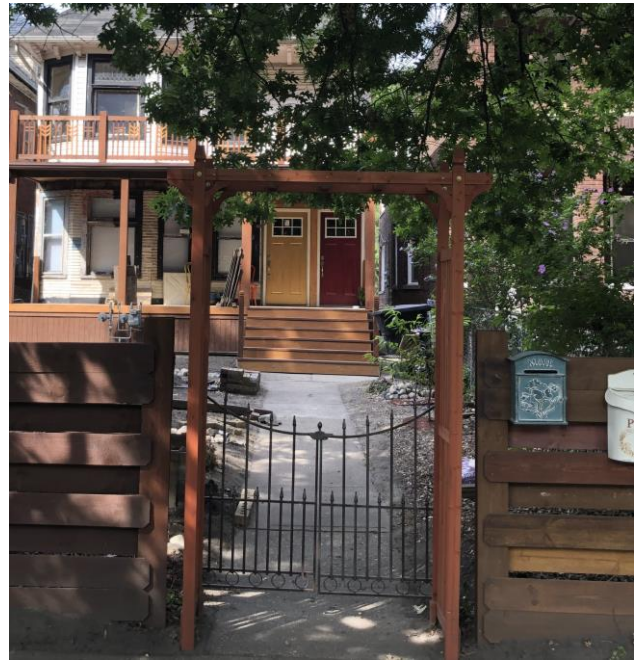
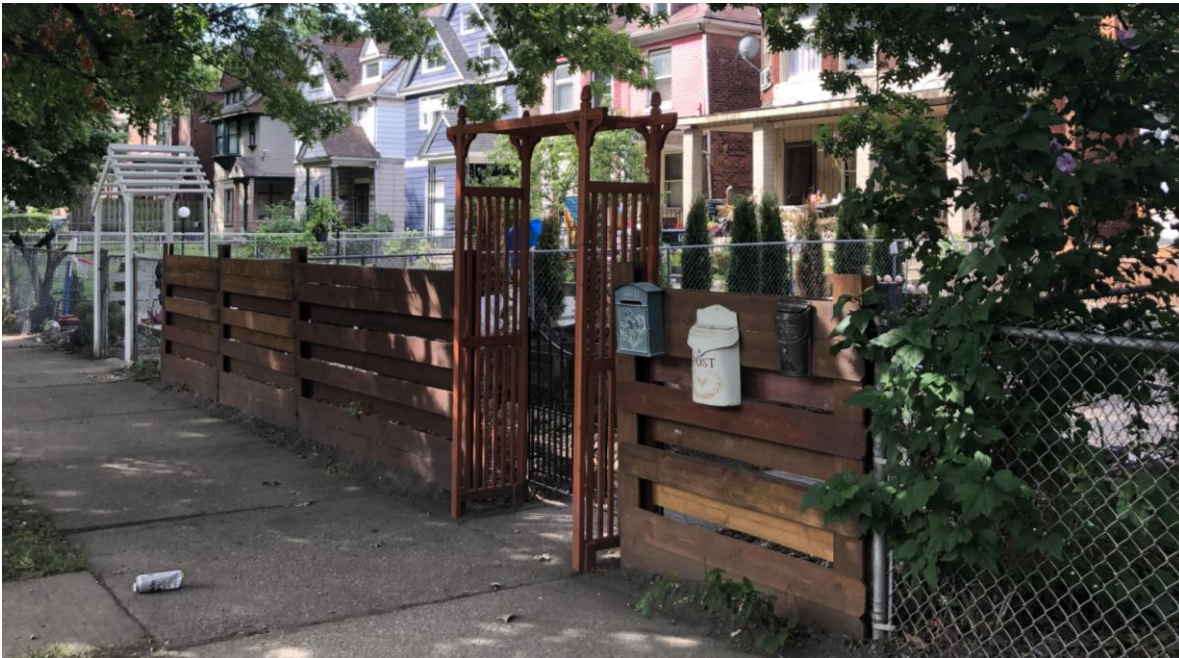
Current conditions show the house and lot in transition: grass has been removed from the front yard; the two-story porch was removed and rebuilt with square columns; a decorative perimeter railing with square posts has been installed at the second floor; the full glass entry doors were replaced with paneled entrance doors with rectangular windows at the top; and a horizontal wood panel perimeter fence, decorative arbor, and metal gate were installed at the sidewalk. None of this work was approved by the HDC.

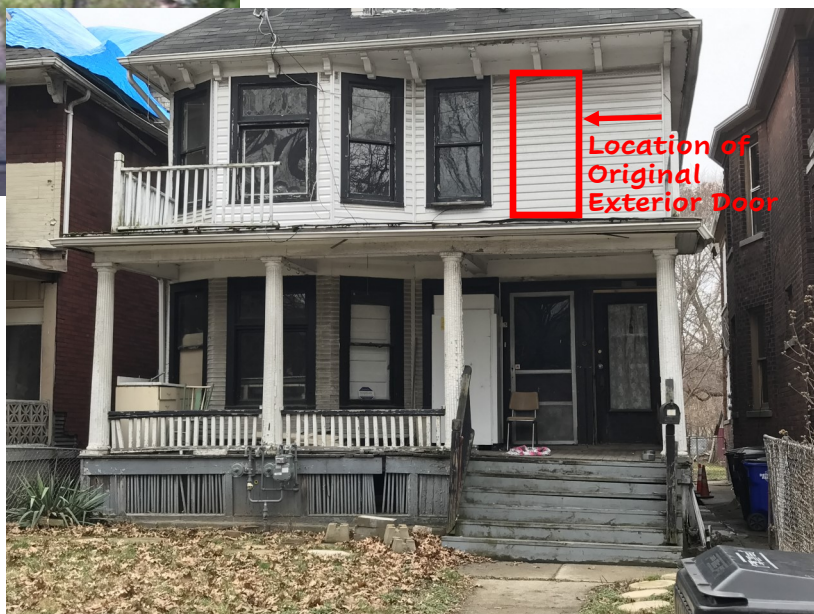
**2016, Right.**

Some 2nd story railing still in place. Significant deterioration visible in woodwork, including cracked fascia, broken stiles, water damage, notable water damage, etc. NE stair sag. Vinyl siding patch on upper level, covering door.

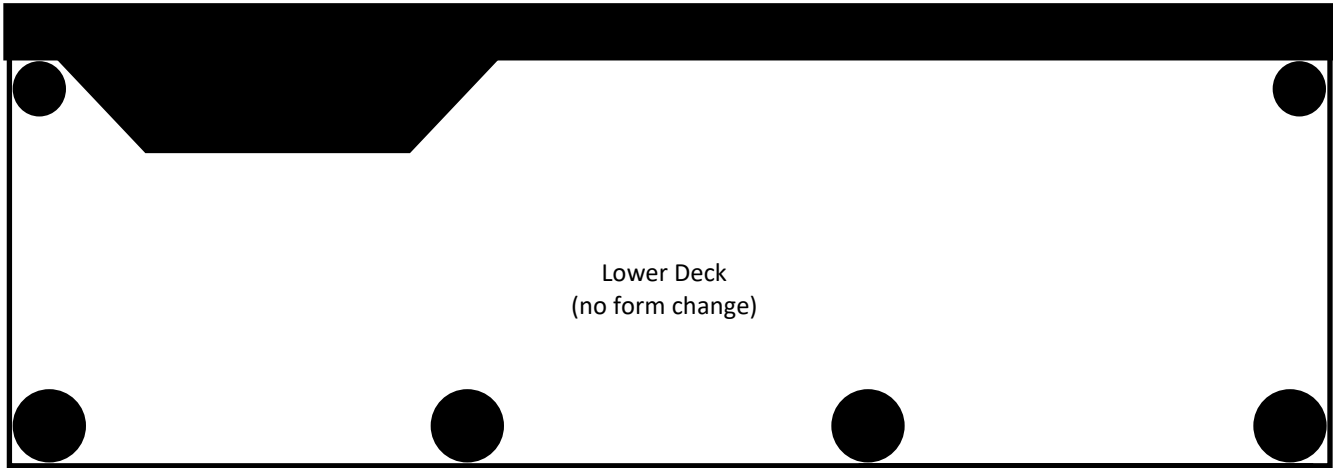
**Footprint.** Original and current, unchanged footprint of the porch. There are four 6" support posts at approximately 8' intervals. The lower deck floor is 40" above grade. An 8' stairway has 6 steps, with 12" treads and 6.75" closed risers.

The upper deck retains five posts on the front, with four 6' railing sections.

The footprint and profile are congruent with all original woodwork. The current railing height and baluster spacing conform with building codes for safety.

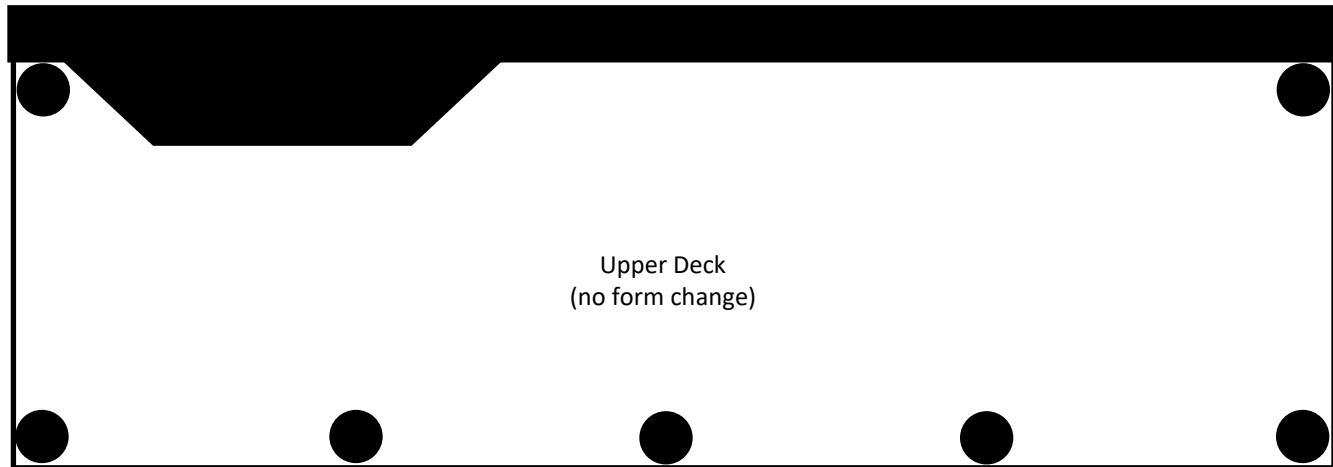
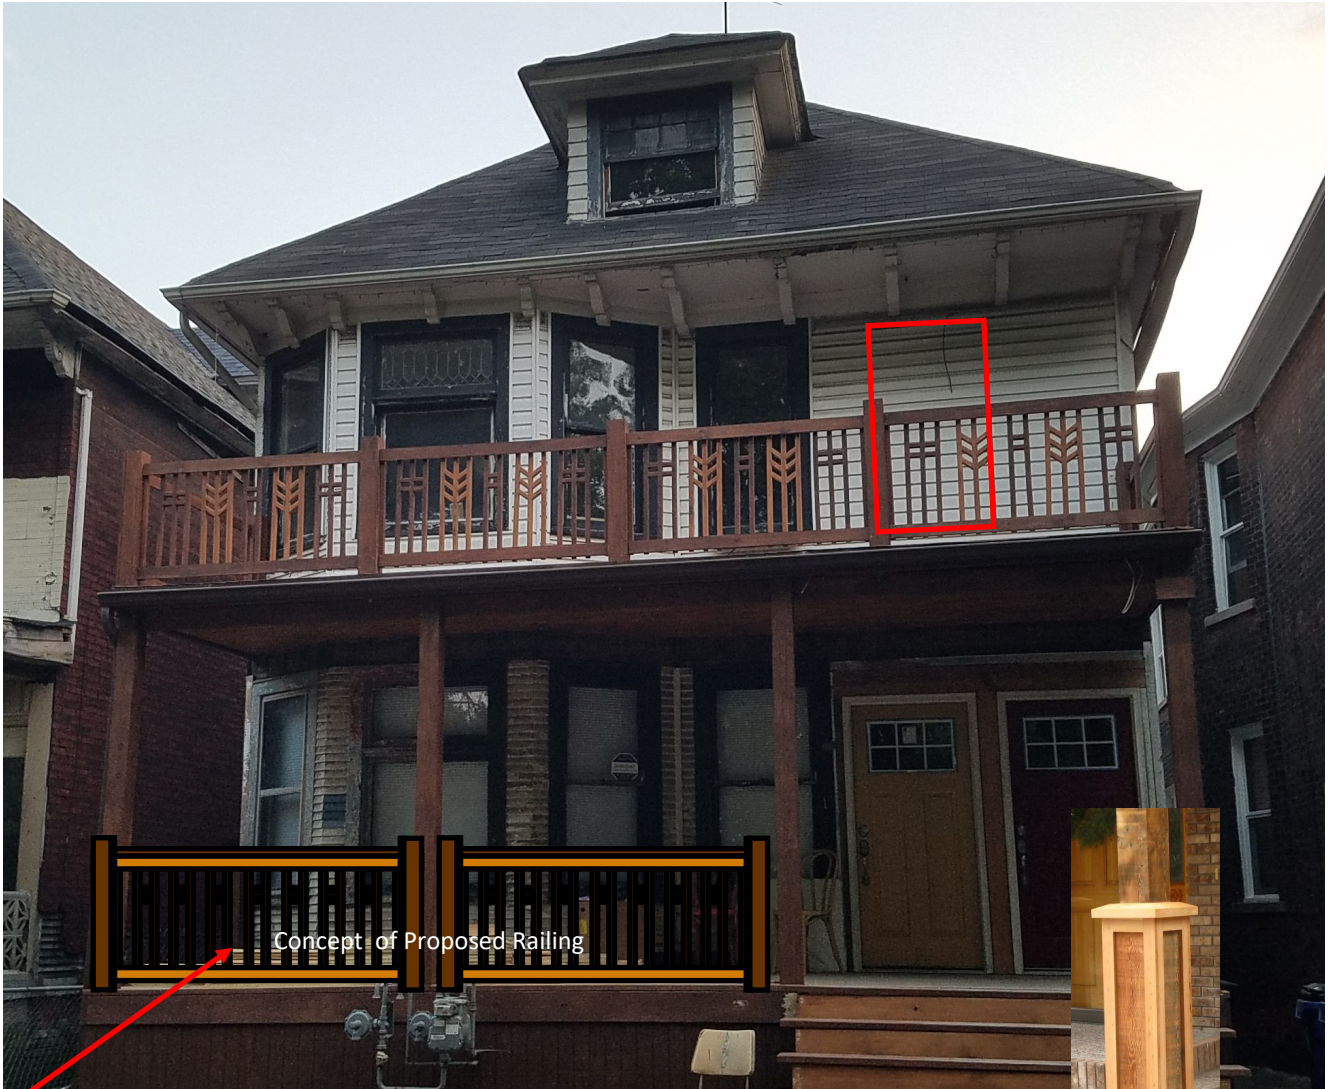
**Porch with Current Repairs, Replaced Railing**  
(existing and proposed)

Proposed railing, modified to palette trim color, with Mission hatch as the above railing to pair with upper deck and create design continuity.

**Notes.** Dangerous and rotten wood has been repaired or replaced. Wood stained in palette as curing allows. Railing between posts and on stair edge added with approval of trimmed post concept, since the rails must be fastened to the final support post treatment. Please see work description attachment for full discussion.

- The porch railing (regardless of the approved design) will be painted, not stained, to match the trim (B:18, Dark Reddish Brown). This will allow the railing to play a more neutral role against the house.
- A catalog cut of the proposed second story porch door will be submitted for staff review.
- Drawings showing how the rear porch will be re-constructed will be submitted for staff review. The porch will also be painted to match the house trim.

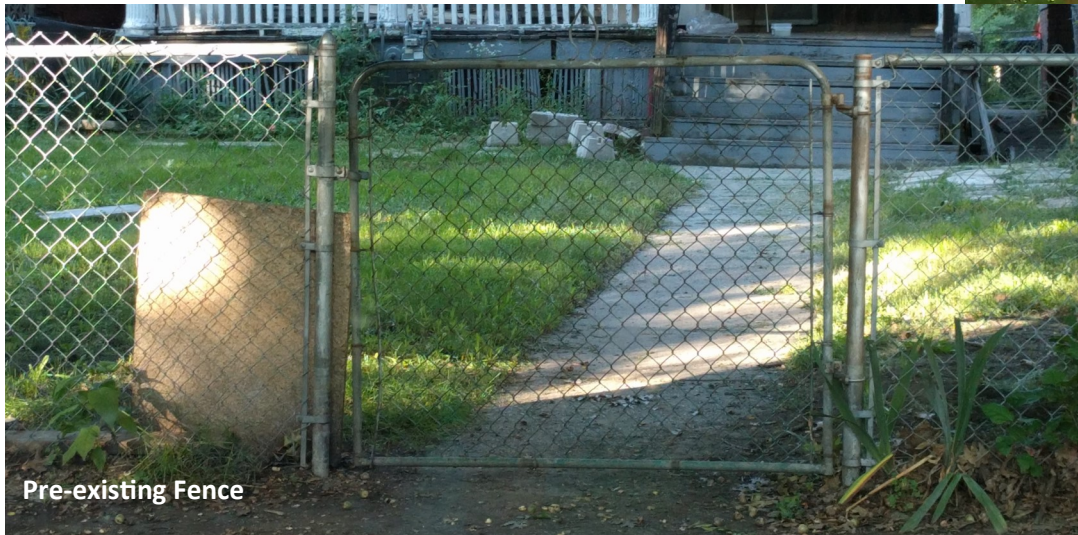
Pre-existing Fence

**Notes.** View of pre-existing chain link fence (*top right*). View of current wood pickets which replaced chain link material, using same posts and frame (*bottom left*).
