**STAFF REPORT:** 08-12-2020 MEETING

**APPLICATION NUMBER:** 20-6791

**ADDRESS:** 869 LONGFELLOW

**SCOPE:** REPLACE 10 WOOD 1/1 DOUBLE-HUNG WINDOWS WITH PELLA ARCHITECT SERIES 1/1 DOUBLE-HUNG WINDOWS

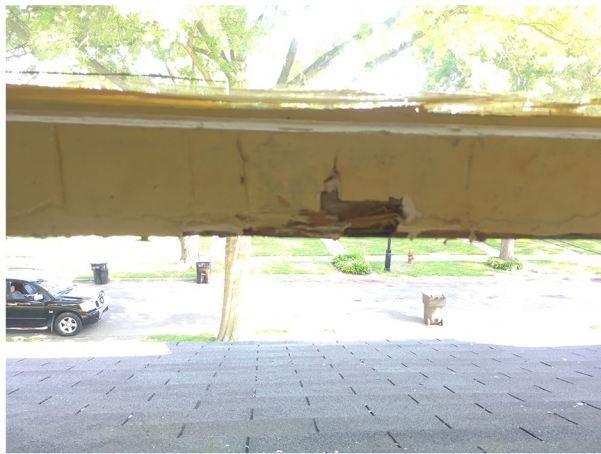
**ROTTED WOOD**

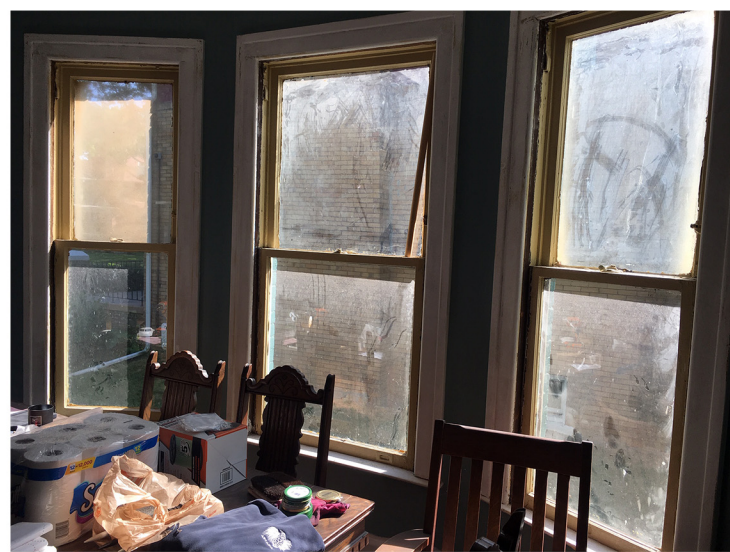
**INTERIOR VIEW: PLEXI GLASS**
