**STAFF REPORT: 09-09-2020 MEETING**

**APPLICATION NUMBER: 20-6829**

**ADDRESS: 3333 CAMBRIDGE**

**SCOPE: REAR PORCH ALTERATION**

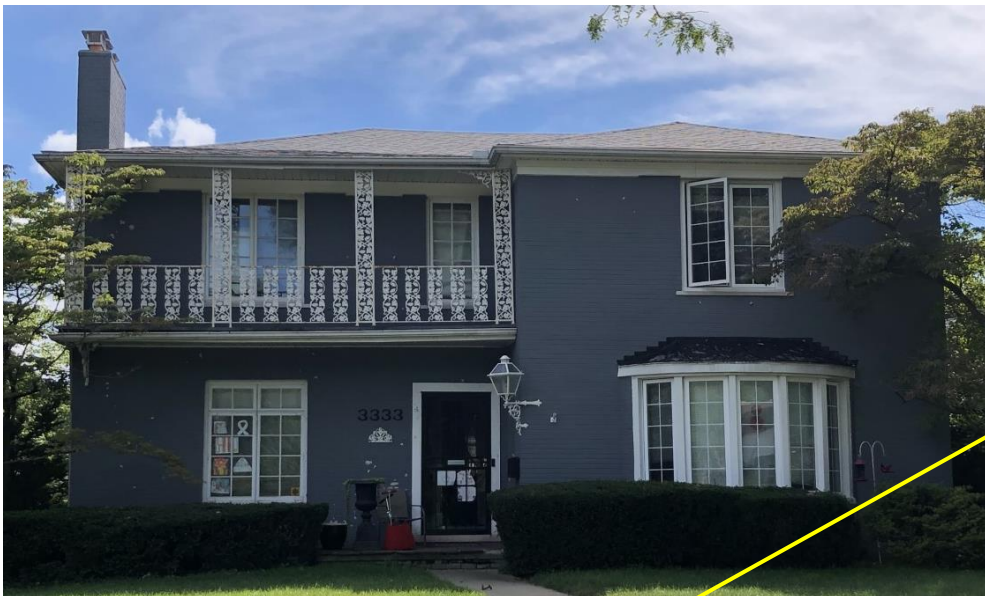
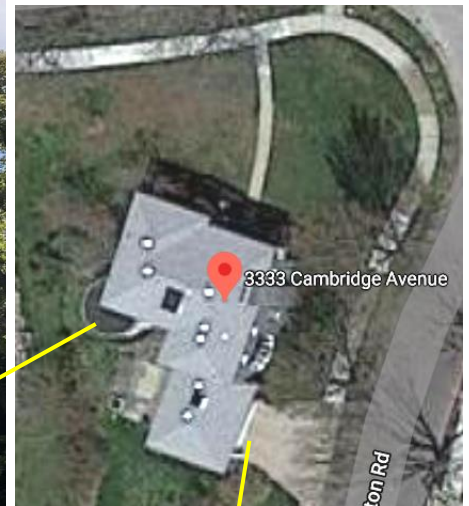
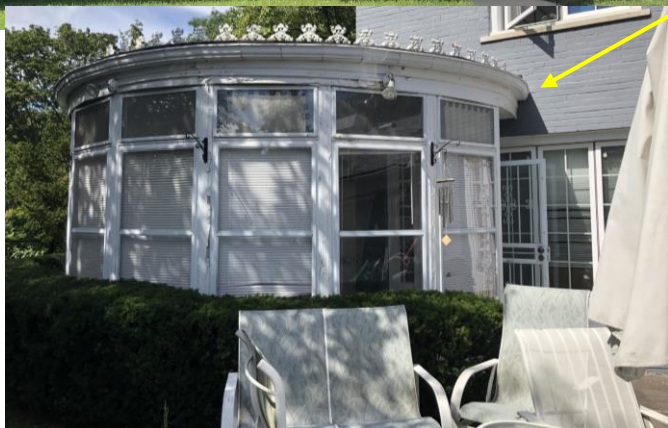
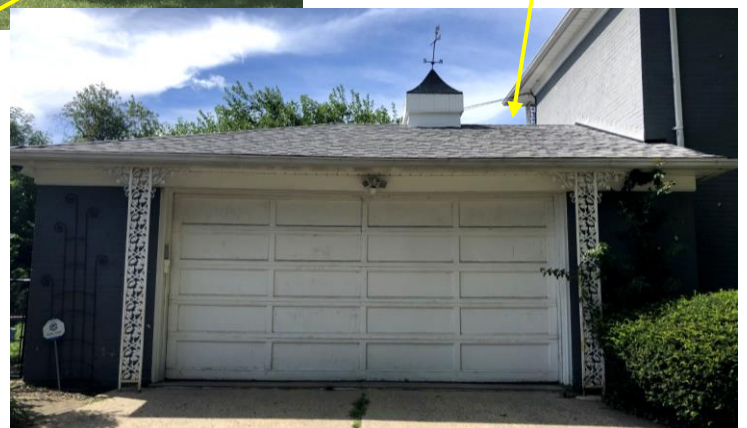
The house at 3333 Cambridge was constructed in 1952. Its low pitched roof, unadorned brick walls, and vertical windows (which on the front elevation are mostly grouped, reducing their vertical proportions) offers a slight resemblance to 1930s International-style houses. Other mid-century features include the attached garage (complete with a cupola and weathervane) and ornamental iron work which was installed on the front, side and rear of the house. A semi-enclosed circular space was also designed for the southwest/rear corner of the house and is seen on the 1952 building plans. The circular form, divided into 15 sections, includes one recessed section (due to the adjacent window) with a door and transom. The current design and materials within the remaining 14 sections are (from the ground up): a lower wood panel, a vinyl double-hung window, and a transom. The sections are joined by structural posts. The roof is flat and decorative ironwork, matching that on the house, runs the perimeter of the roof. The porch shows signs of deterioration due to intrusion of water, with delaminating wood panels evident around the bottom of the porch.

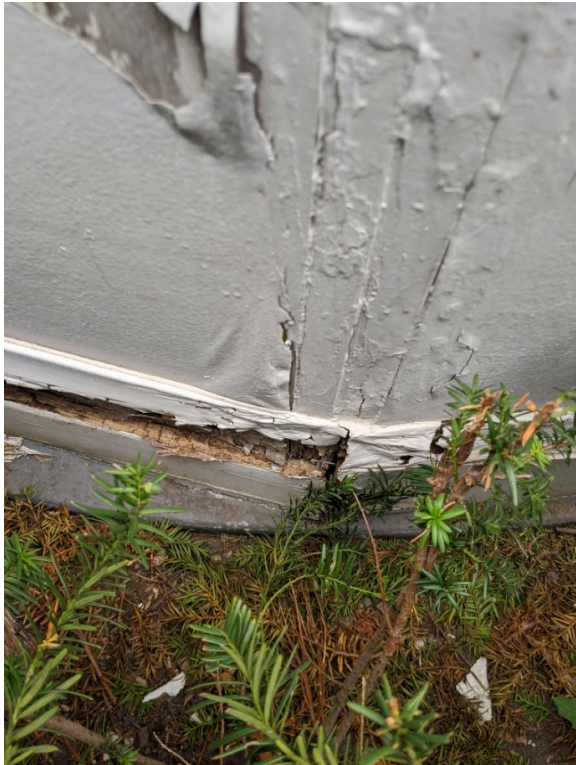
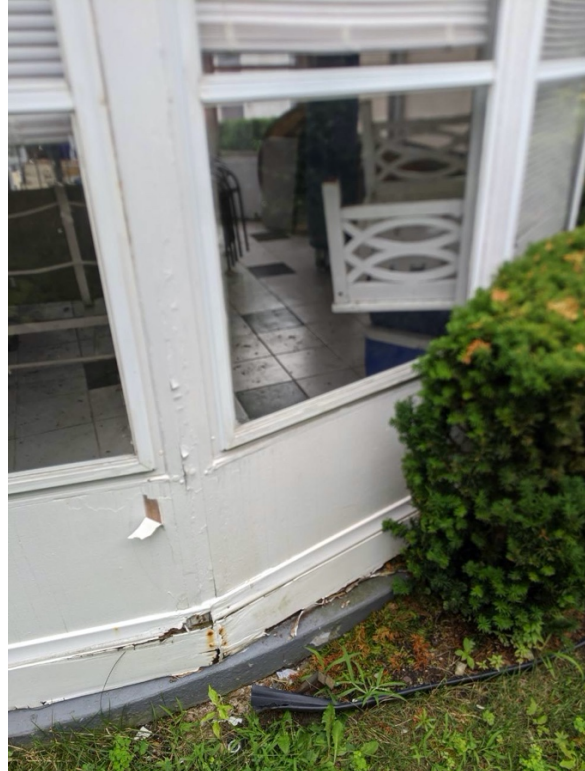
This house has an existing sun porch room that is attached to the back, NW corner. The condition is extensive rot and deterioration. The vinyl windows, painted plywood paneling, common pine trim, aluminum K style gutters, multiple outlets, and linoleum flooring were retrofitted during a previous remodel. The design and installation of these elements allows water to infiltrate from the behind the gutters, around the windows, through the paneling joints, and actually traps any water that gets in at the bottom.

The homeowners wish to restore this structure to its original intention as a screened porch. As so many remodeling projects turn out, this room doesn't function as an interior space and is an eye sore.

The original framework is made up of slab to ceiling posts, dotting the perimeter. The rotten ones will be replaced and the vertical spaces between them will be subdivided into small, then larger framed screens. The lowest sections will be cedar framed paneling.

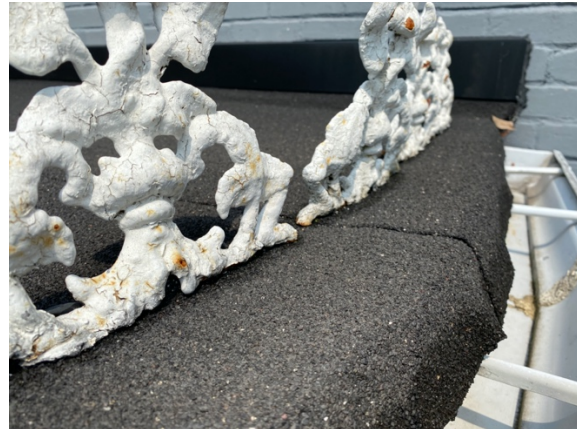
The ornamental iron work is a motif seen around the house and was installed around the roof perimeter. The roof was redone recently, and they remounted these pieces. They were mounted with surface screws, then sealed with roofing silicone. Some of the water damage below may have been tied to these and the previous failing roof. If water is present when we open things up, we can remove these, and better address their attachment points with proper sealing. They will be placed exactly where we found them.
