STAFF REPORT 12-9-2020 MEETING

APPLICATION NUMBER: 20-6981

ADDRESS: 489 HENRY (AKA BERWIN APARTMENTS)

SCOPE: REHABILITATE APARTMENT BUILDING

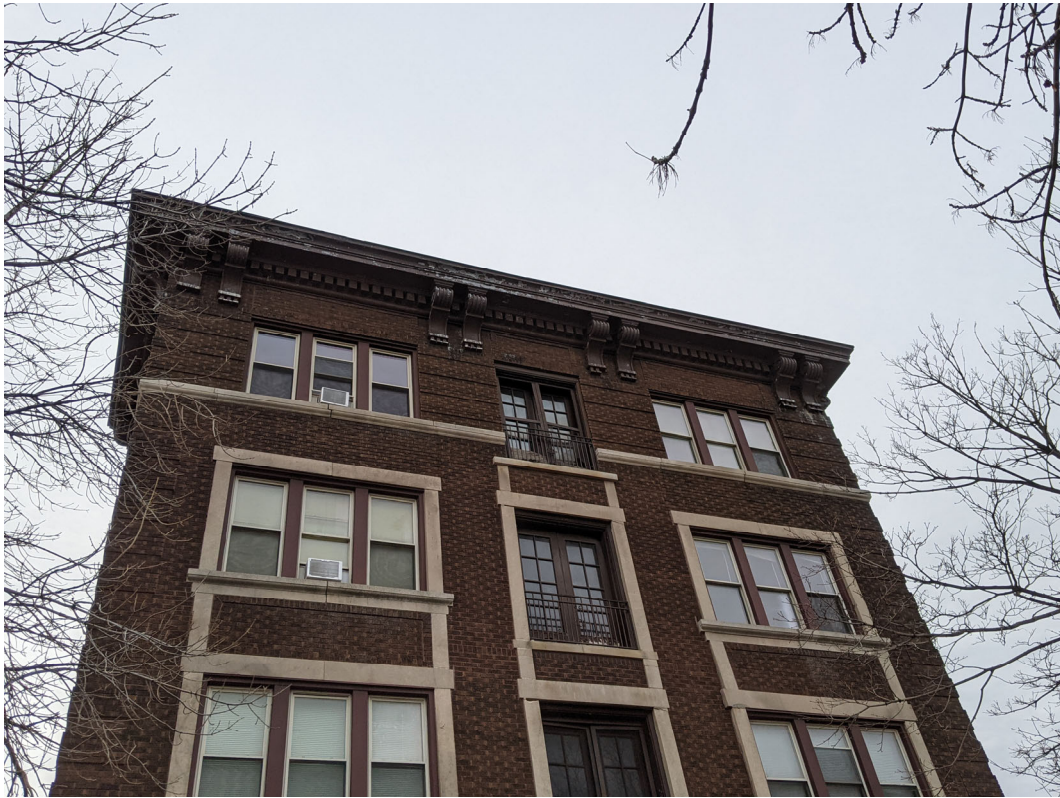
Per the architect, and as confirmed by HDC staff to the extent feasible from the public right-of-way, the brick and stone areas of the building are in fair to good condition, with some locations of step cracking, mortar loss, puncture holes, and some efflorescence below stone sills. The stone shows some discoloration and cracking. The two exterior basement doors on the north (primary) façade do not match in style or material. The western basement access door is metal, with a small diamond-shaped light. There is a glazed transom that has been boarded over. The eastern basement access door is wood with four rectangular lights at the top of the door and a chute built into the door structure.

Detail view showing conditions at the Henry (primary) facade. Staff photo, November 24, 2020.

- ***Inspected for damage***
- ***Brown paint to be removed*** [process not provided]
- ***Masonry cleaned with a light duty detergent and low pressure water rinse***
- ***Brick and stone will be repointed, and loose or displaced units will be reset***
- ***Repointed mortar will match the color, texture, compressive strength, joint width, and joint profile of the existing historic mortar***
- ***Damaged brick and stone will be repaired as necessary***
- ***Any units too badly deteriorated to repair will be replaced, with salvaged brick to be reused where replacements are needed before new units are used***
- ***If new units are necessary, they will be selected to match the existing in size, profile, color, and finish***
- ***The stone surround at the main entry will be cleaned to remove all paint and return to bare stone*** [process not provided]

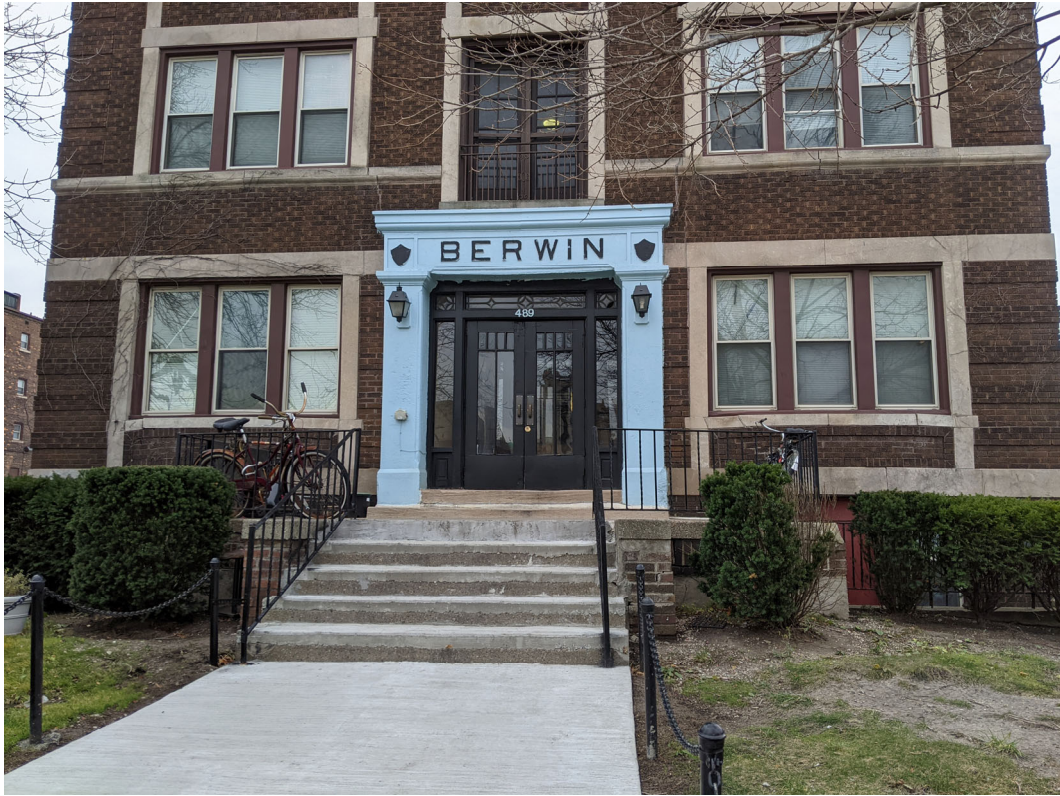
The Berwin is one of two occupied buildings in the Cass-Henry Historic District, the other being the its near twin Bretton Hall (439 Henry) at the eastern end of the block. Curiously, both occupied buildings feature stonework around the entranceway that is inappropriately painted light blue; a condition noted disapprovingly in the district's Elements of Design (#9, *Relationship of colors*). The lettering, and a circular detail flanking it, have also been painted black. The transom windows feature leaded glass with an ornamental design. Such delicate ornamentation may have initially extended to the sidelights below, but they are now fitted with plain glass set in what appears to be their original wood frames. The wood doors appear original and of historic-age. Puzzlingly, the doors have a complex, modernistic divided light (muntin) configuration (which might be termed "4 small over 2 tall") that matches the balconette doors on the second through fifth floors of *Bretton Hall* several lots to the east, but *not its own* balconette doors, which are more traditionally divided into eight (8) divided lights of the same size. The cast stone surround of the entry features pilasters topped with a simple classical entablature. Sconces are installed on the pilasters; staff has not yet confirmed whether these units are of historic age, but likely not. There is a water meter relay unit insensitively mounted on the left pilaster.

Detail view showing main entrance at Henry, note "BERWIN" name above. Staff photo, November 24, 2020.

- The building’s designation report, excerpted above, does take note of the building’s name “Berwin” as a character-defining feature remaining at the building’s entrance. This feature should be preserved. The application suggests that future signage “will be reinstated in the same location.”

- No approvable process has been proposed for the removal of the brown paint over the brick, or the blue/black paint over the stonework. A process or specification ensuring the preservation of the historic masonry should be submitted for staff review.

- The ultimate design for building signage should ensure retention and display of the stone-carved “BERWIN” name as a contributing element to the historic character of the building. Staff suggests that, if desired, it would be appropriate to place modestly-scaled additional signage in the landscape in front of the building subject to the Commission’s own sign guidelines and staff review.

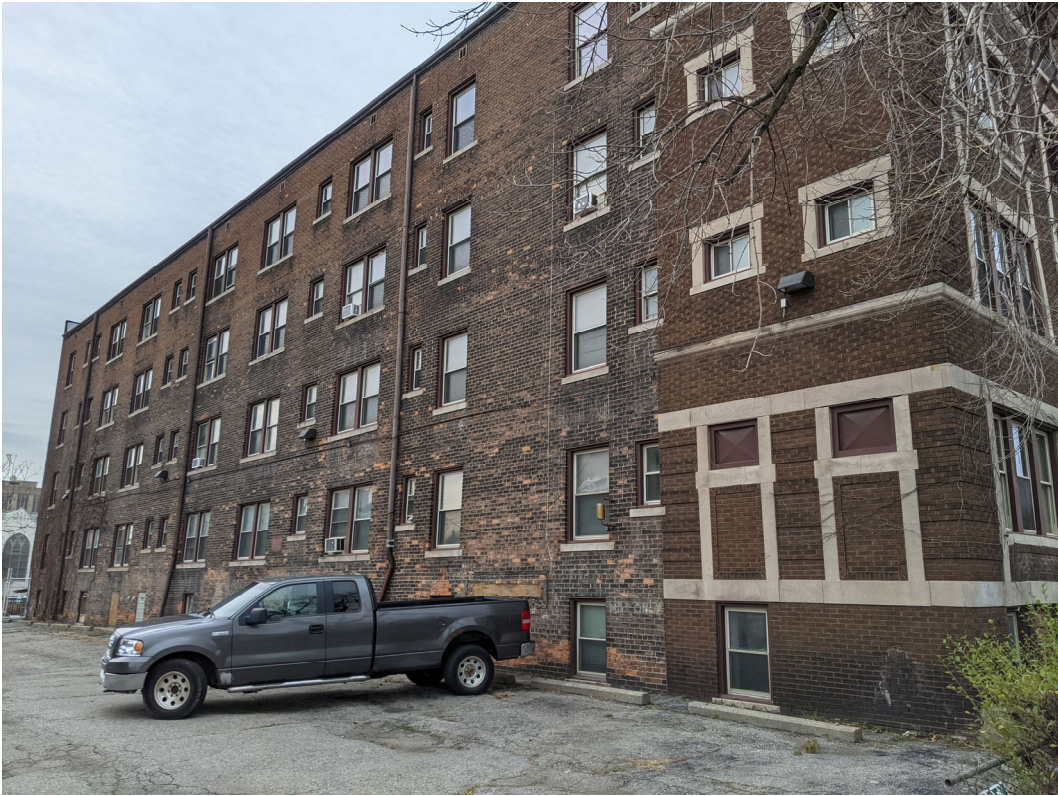
View of East elevation, adjacent to parking lot at 481 Henry. Staff photo, November 24, 2020.

- ***ADA lift and new entrance door will be installed on the east façade of the building, convenient to the adjacent parking lot***

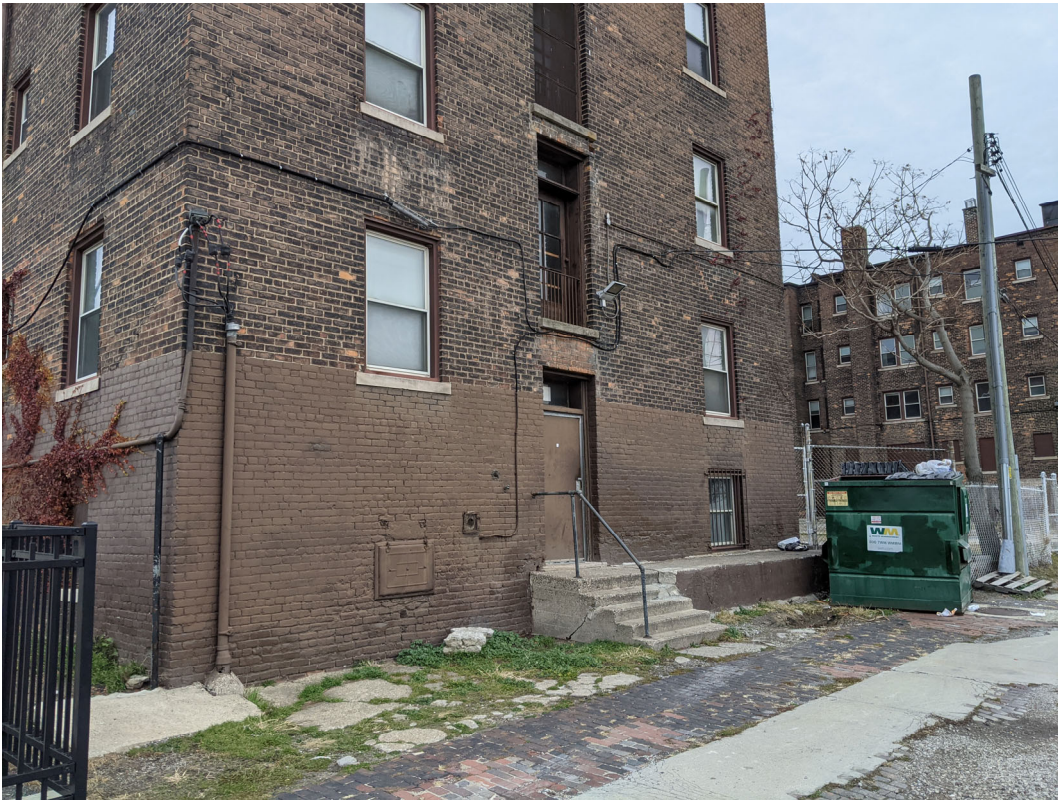
The brown face brick (and cornice) extends around to the side elevations and continues for about one bay (somewhat less than Bretton Hall), then transitions to common brick with architectural detail reduced to stone sills. The rear elevation has modest historical and architectural character of a more utilitarian nature, with furniture loading openings at each rear stair landing, and a projecting steel beam (hoist) above, aligned with the center hall; at least two historic-age multi-light wood doors are extant in the openings. The brick is common and has been painted brown up to about six feet high, presumably to obscure or discourage graffiti. There is a short flight of (non-historic) concrete steps to the rear door, joined to a small loading platform adjacent to a dumpster.

View of rear (south) elevation at alley. Staff photo, November 24, 2020.

- ***At the rear elevation, the ground floor steel door and the furniture loading doors will be inspected for damage and repaired as necessary. The metal guardrails at the furniture loading doors will be replaced with a new metal guardrail system.***

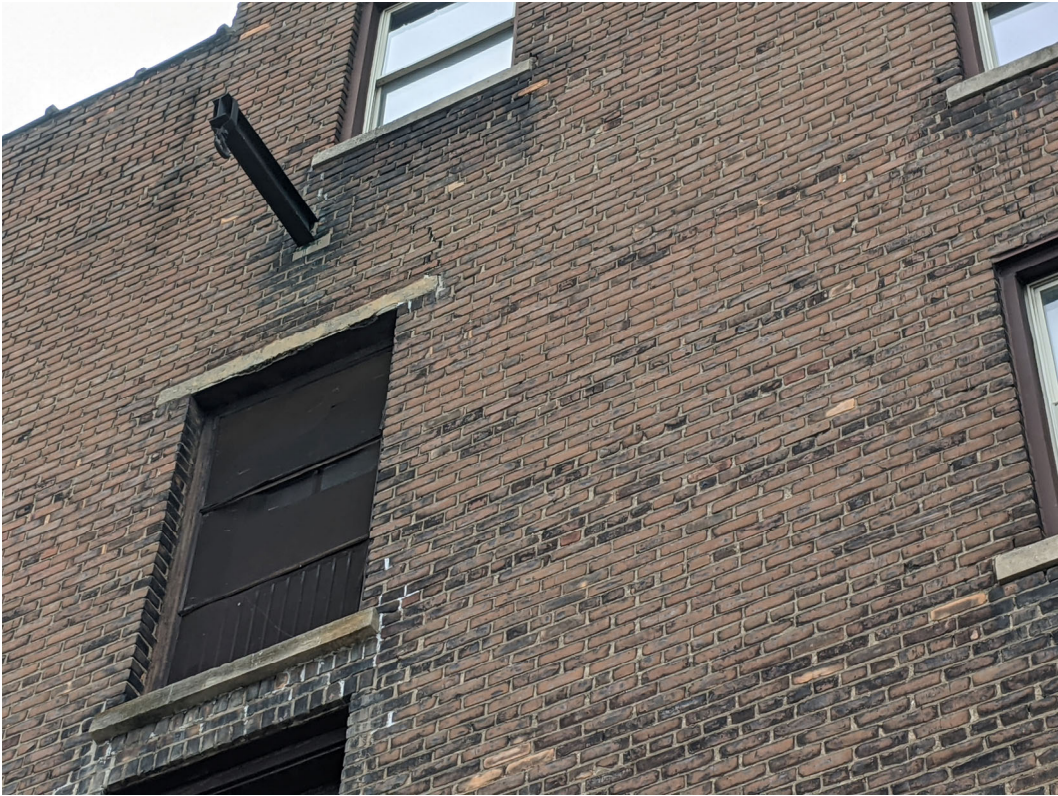
Detail view of brick and furniture hoist beam at top of rear elevation. Staff photo, December 7, 2020.
