STAFF REPORT 12-9-2020 MEETING

APPLICATION NUMBER: 20-6982

ADDRESS: 459 HENRY (AKA CLARIDGE APARTMENTS)

SCOPE: REHABILITATE APARTMENT BUILDING

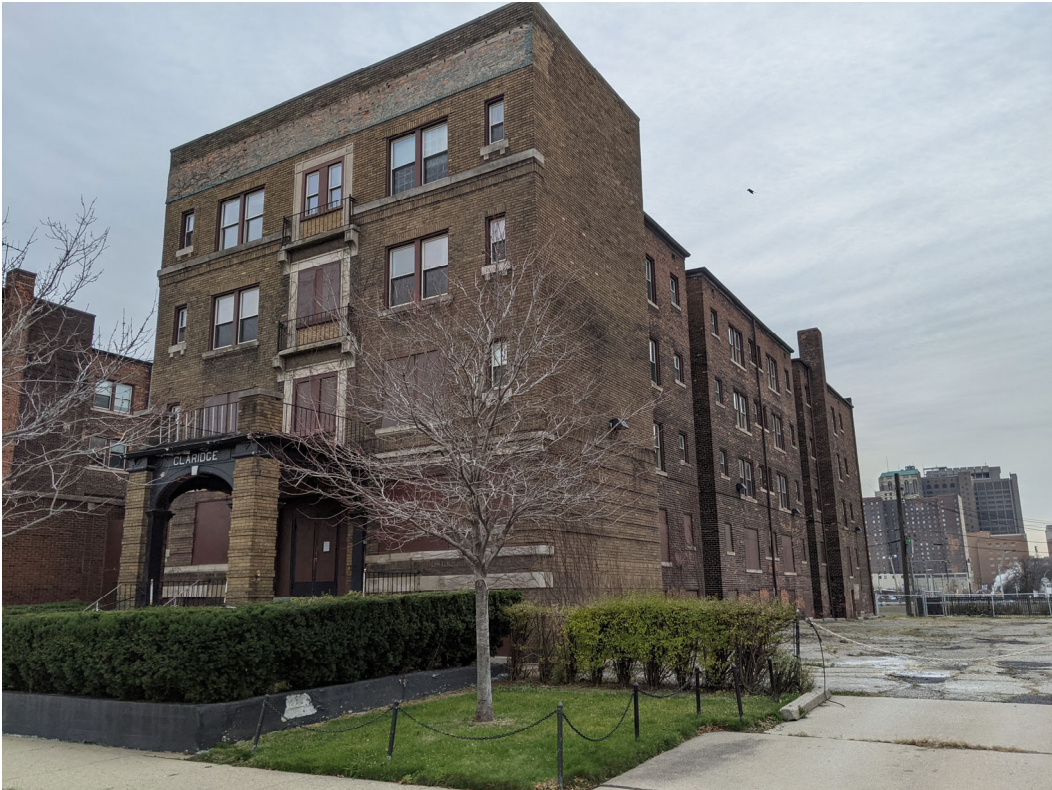
View of the Claridge Apartments, view to the southeast. Staff photo, November 24, 2020.

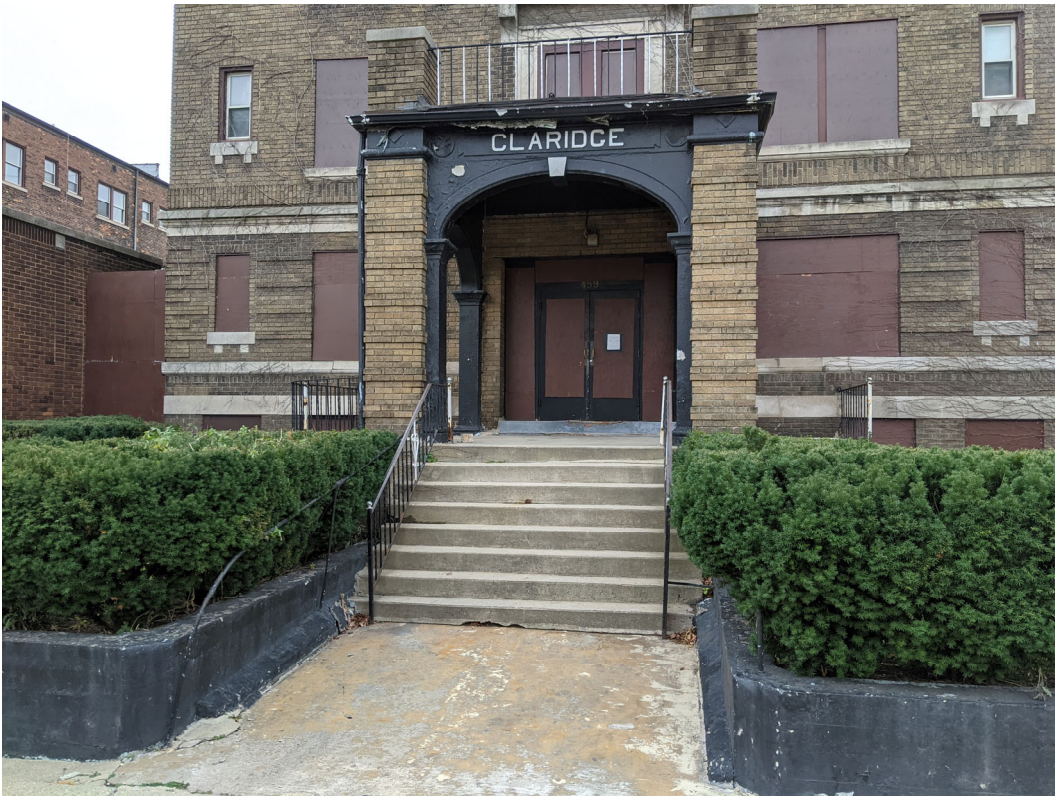
The Claridge Apartments is vacant, yet retains substantial integrity and is considered to be a contributing resource to the historic district. The cast stone elements at the arched entry porch have been inappropriately painted black, though the name "CLARIDGE" inscribed above in the stone architrave remains clear and visible. Its central entrance, underneath the arched entry, features what appear to be historic age, wooden double entry doors, which are currently boarded. The sidelight and transom windows are boarded, so staff could not determine status of any windows underneath. Per the applicant, the transom is leaded glass with an arts and crafts design. There is a single non-historic light fixture affixed to the brick above the entry.

View showing main entrance at Henry, note "CLARIDGE" name above. Staff photo, November 24, 2020.

- The ultimate design for building signage should ensure retention and display of the stone-carved “CLARIDGE” name as a contributing element to the historic character of the building. Staff suggests that, if desired, it would be appropriate to place modestly-scaled additional signage in the landscape in front of the building subject to the Commission’s own sign guidelines and staff review.

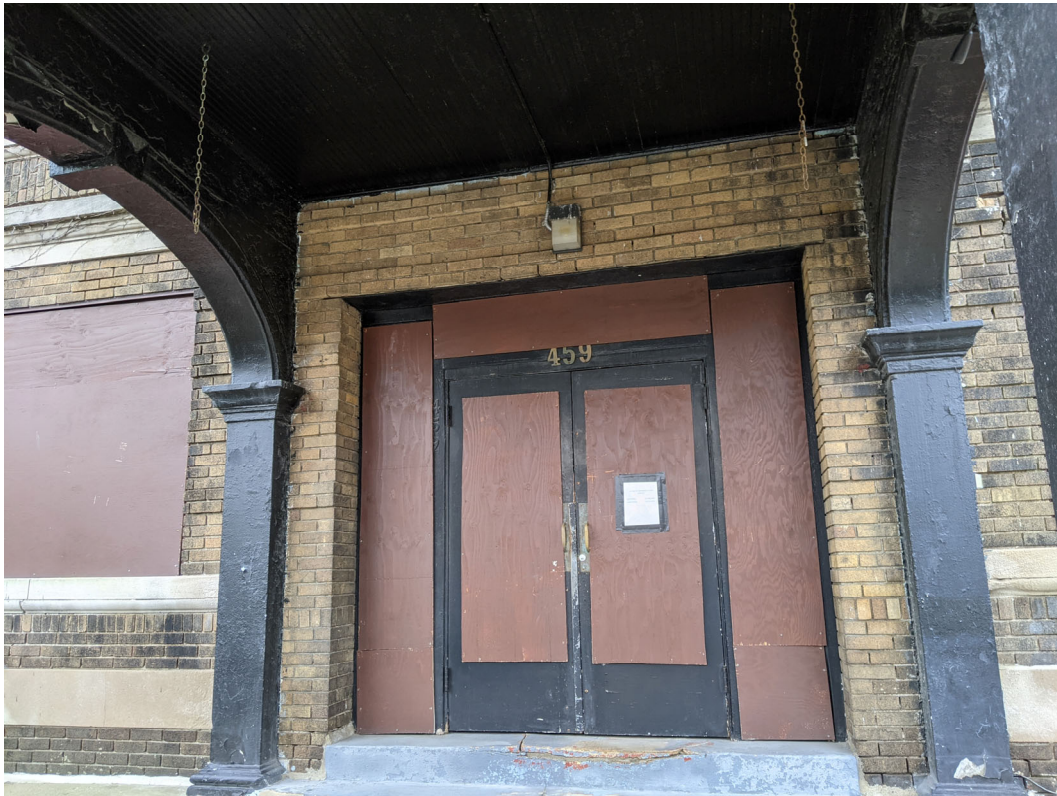
Detail view of entry doors and stone detailing of porch. Staff photo, November 24, 2020.

- *Main entrance doors will be inspected for damage and repaired as necessary with new hardware to match existing*
- *Basement doors will be inspected for damage and repaired as necessary with new hardware or replaced with compatible doors*

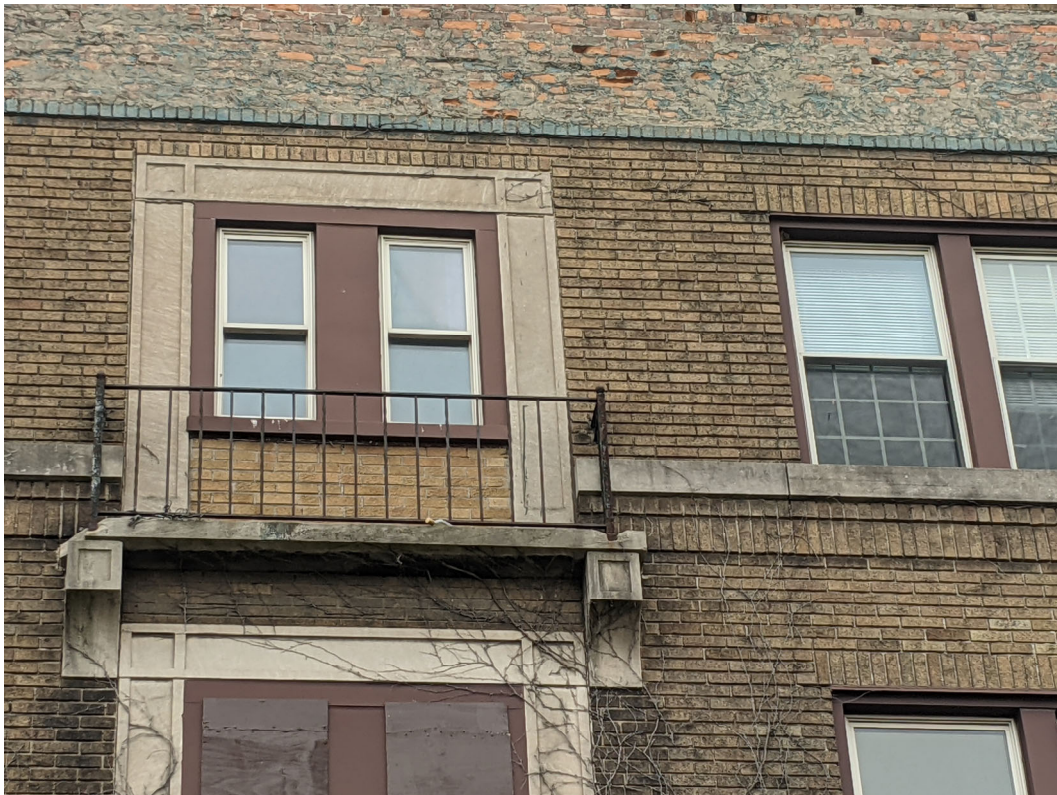
The balconette door locations at the levels above (center bay) have been altered with inappropriate windows, non-historic infill brick, or boarded. At the uppermost location, two double-hung windows of non-historic age poorly sized for the opening are incorporated in a partially bricked closure.

A light-colored brick band exists at the top of the north façade where a cornice once existed.

Detail view of altered balconette openings and cornice area above. Staff photo, December 7, 2020.

- *A new fiberglass or GFRC cornice will be fabricated using the existing cornices at 439 and 489 Henry as design intent. Cornice color to match historic color found at reference locations (TBD).*

- *At the center bay balconettes, the anachronistic windows will be removed, along with the infill brick knee wall. Openings will be replaced with wood double doors, using the balconette doors at 439 Henry (Bretton Hall) as design intent. Aluminum storm doors will also be added in front of the double doors. The storm doors will be compatible with the historic nature of the building without appearing falsely historic.*

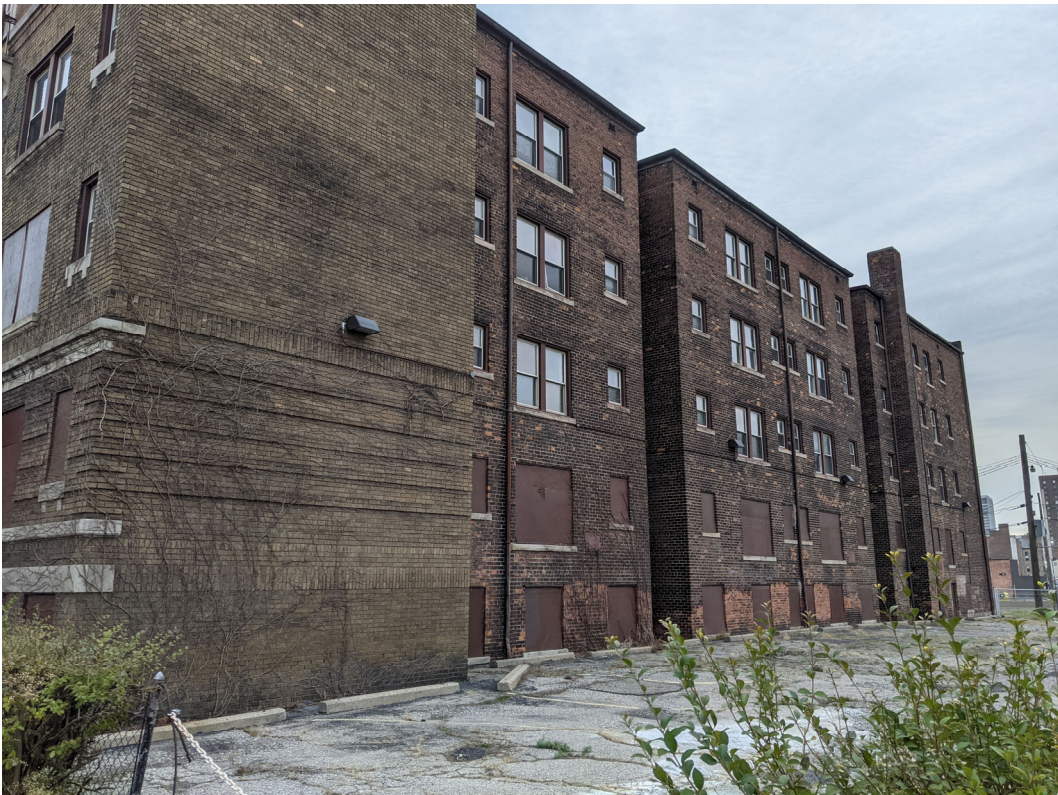
The yellow-brown face brick extends around to the side elevations and continues for about one bay (somewhat less than Bretton Hall), then transitions to common brick with architectural detail reduced to stone sills. There are no windows in the west-facing "wrap", and only a few in the east-facing portion. Architectural interest is sustained through a number of protruding brick courses which form a striated design in the brickwork, picking up a similar motif in the building's brick porch piers. The remainder of the side elevations are punctuated with large numbers of window openings in a semi-regular manner.

View of west elevation, adjacent to parking lot at 467-569 Henry. Staff photo, November 24, 2020.

- *ADA lift and new entrance door will be installed on the west façade of the building convenient to the adjacent parking lot*

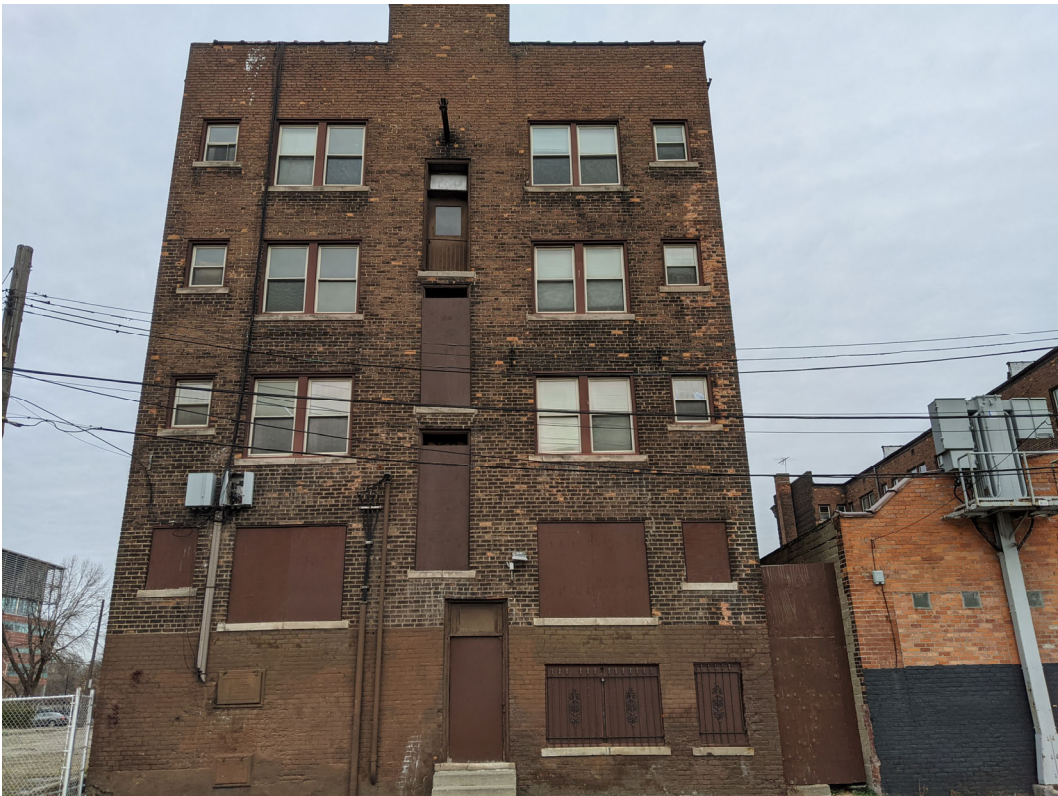
The rear elevation is of a more utilitarian nature, with furniture loading openings at each rear stair landing, and a projecting steel beam (hoist) above, aligned with the center hall; most of the door openings are boarded, but a single visible door does potentially appear to be of historic age. The brick is common and has been painted brown up to about six feet high, presumably to obscure or discourage graffiti. There is a short flight of (non-historic) concrete steps to the rear door.

South (alley) elevation. Staff photo, November 24, 2020.

- *At the rear elevation, the ground floor steel door and the furniture loading doors will be inspected for damage and repaired as necessary with new hardware or replaced with compatible doors.*
