STAFF REPORT 12-9-2020 MEETING

APPLICATION NUMBER: 20-6983

ADDRESS: 447 HENRY (AKA WILLIAM B. RALSTON GARAGE)

SCOPE: REHABILITATE COMMERCIAL STOREFRONT/GARAGE BUILDING

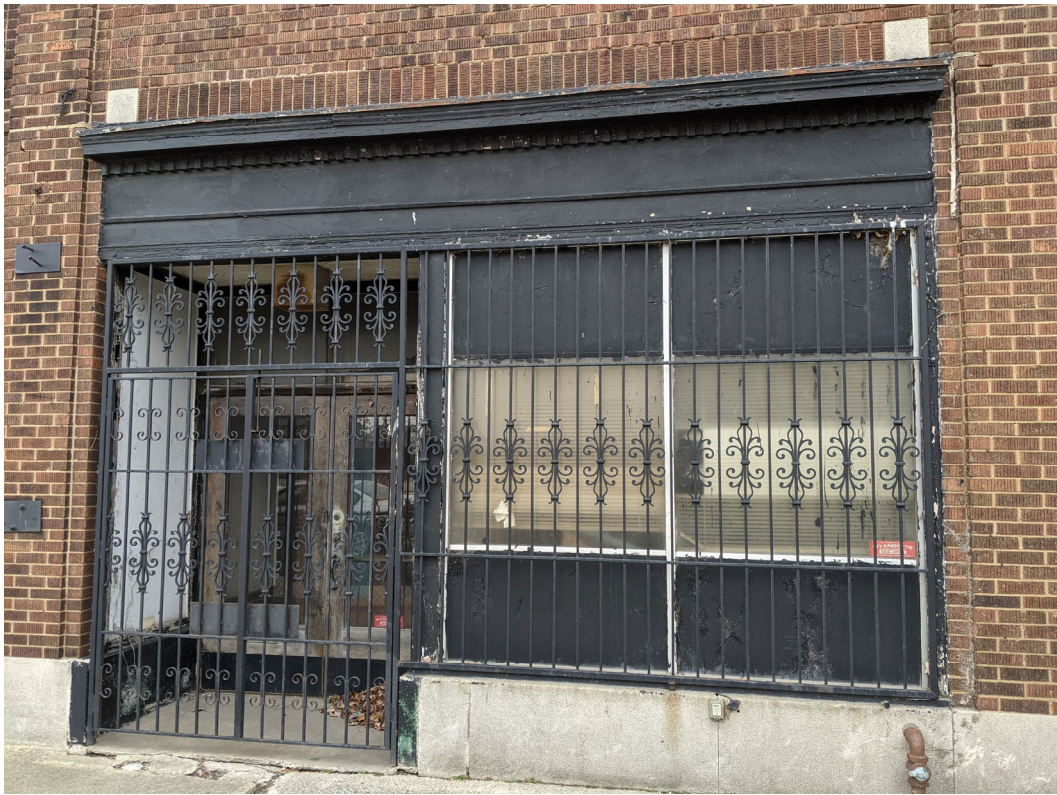
Detail view showing conditions at the westernmost storefront. Staff photo, November 24, 2020.

- In addition to the potential removal of the westernmost storefront's sign band and entablature/cornice, the historic-age store doors will be removed, the recess will be altered, and some areas of stone base removed. Excepting the alterations to the "sign band" transom zone discussed above, staff finds that these changes to the doors, glass, and base are generally appropriate alterations reasonably consistent with the building's reuse. The stone base should be preserved and repaired in areas where its removal is not necessary.

- The design be modified to prioritize the retention of historic materials across all three bays as revealed by further field investigation, to include the denticulated entablature at the westernmost bay, and that staff be given authority to review/approve a revision to the storefront design.

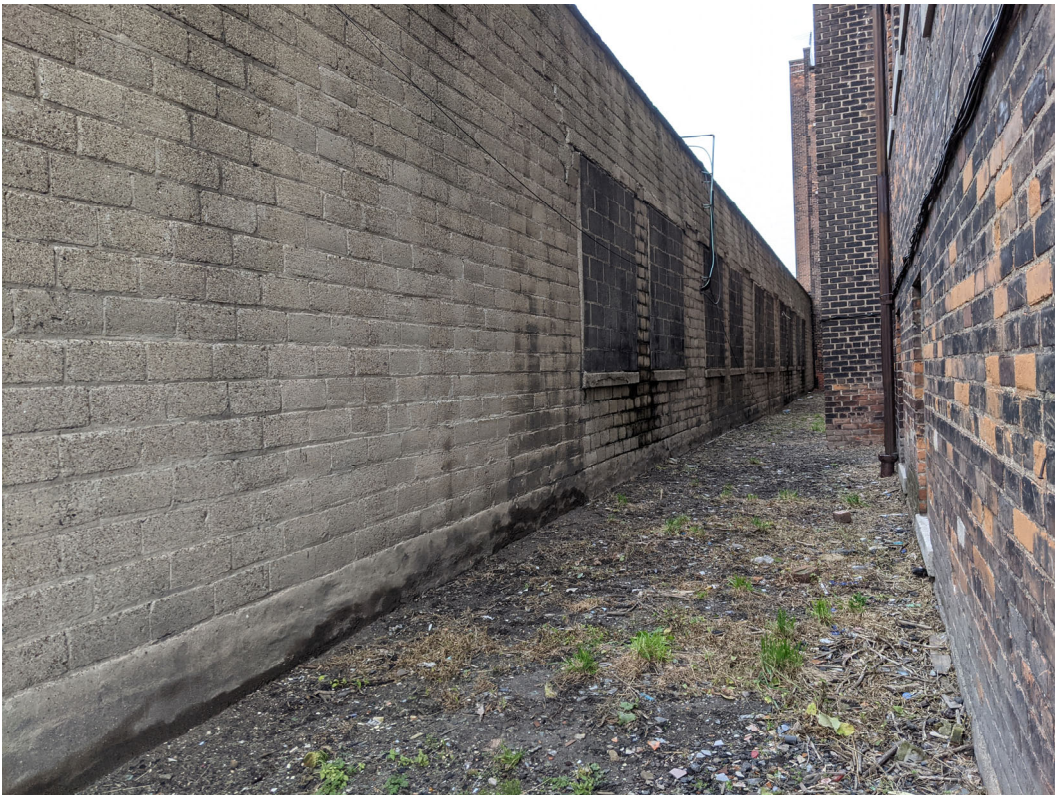
View of the concrete block east elevation, immediately adjacent to Bretton Hall. Note the large, blocked-in window openings. Staff photo, November 24, 2020.

- The windows within the openings at the utilitarian west and east elevations, given the building's original occupancy and architectural cues at the rear were likely originally industrial steel sash composed of multiple small vertically-oriented wireglass lights divided by steel muntins. An appropriate new window design for these locations, given that there are apparently no originals remaining in the blocked openings, would be a similar reproduction "industrial" or "shop" design rendered in modern materials, instead of the larger rectangular muntin-free openings proposed. Such designs are commonly available and used in many of Detroit's industrial/commercial buildings in utilitarian settings. Staff finds the introduction of additional doorways to be appropriate.

- The design be modified to choose a different window type/configuration for the openings at the east and west elevations consistent with an industrial steel window style appropriate to the utilitarian historic context, subject to staff approval

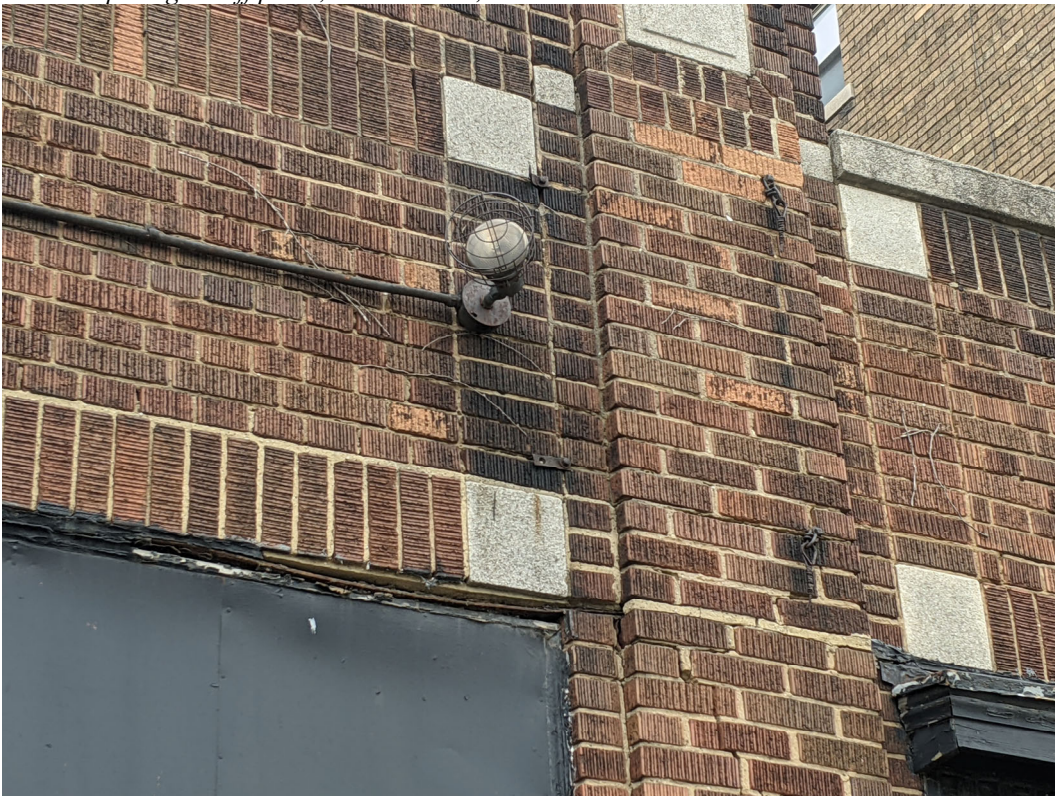
Per the architect, and as confirmed by HDC staff to the extent feasible from the public right-of-way, the brick and stone areas of the building are in fair to good condition, with some locations of cracking, mortar loss, puncture holes and some staining on the stone base. Of the four original stone globe finials atop the brick piers, two are in largely deteriorated condition (or missing). The balance of the stone accents are in good condition. There is no signage at present. The building has a membrane roof in fair to poor condition.

Detail view of brick/stonework and existing light fixtures at front facade. Staff photo, November 24, 2020.

- ***Inspected for damage***
- ***Black paint to be removed*** [process not provided]
- ***Masonry cleaned with a light duty detergent and low pressure water rinse***
- ***Brick and stone will be repointed, and loose or displaced units will be reset***
- ***Repointed mortar will match the color, texture, compressive strength, joint width, and joint profile of the existing historic mortar***
- ***Damaged brick and stone will be repaired as necessary***
- ***Any units too badly deteriorated to repair will be replaced, with salvaged brick to be reused where replacements are needed before new units are used***
- ***If new units are necessary, they will be selected to match the existing in size, profile, color, and finish***

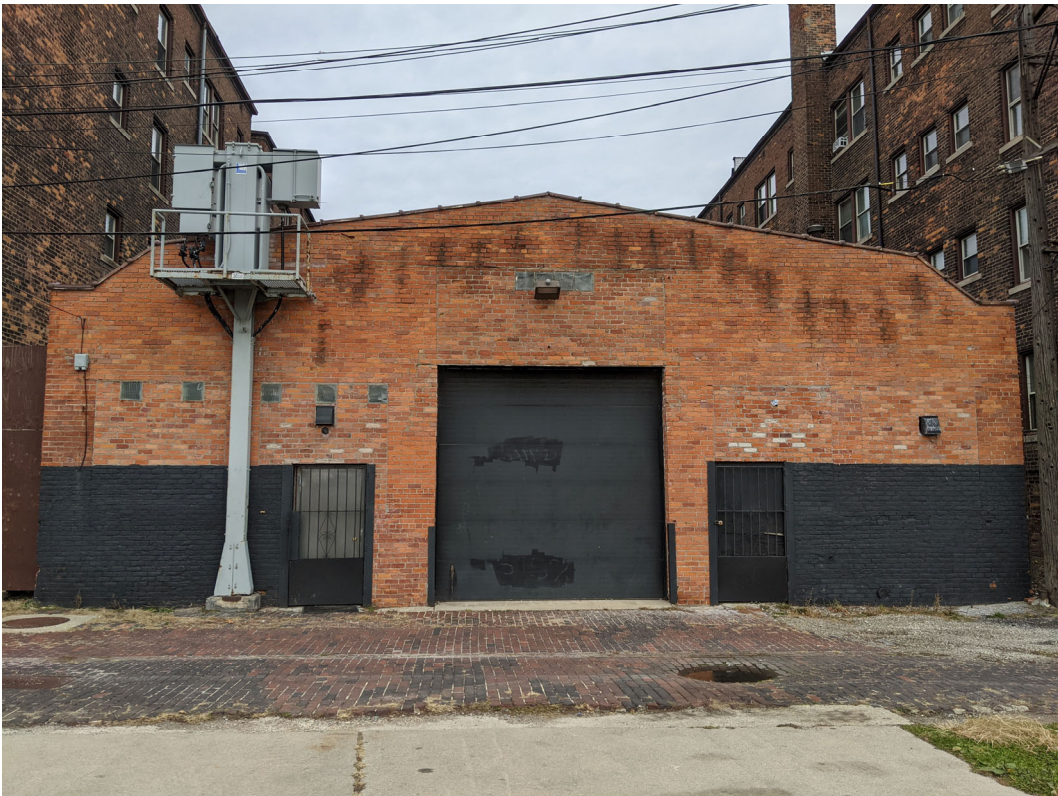
South (rear) elevation at alley. Staff photo, November 24, 2020.

- ***At the rear (public alley) elevation, the central metal coiling door will be replaced with a new insulated overhead door to match the existing in size and appearance.*** [material not provided]
Pedestrian doors will be replaced with solid hollow metal doors and frames.
