STAFF REPORT 12-9-2020 MEETING

APPLICATION NUMBER: 20-6984

ADDRESS: 439 HENRY (AKA BRETTON HALL APARTMENTS)

SCOPE: REHABILITATE APARTMENT BUILDING

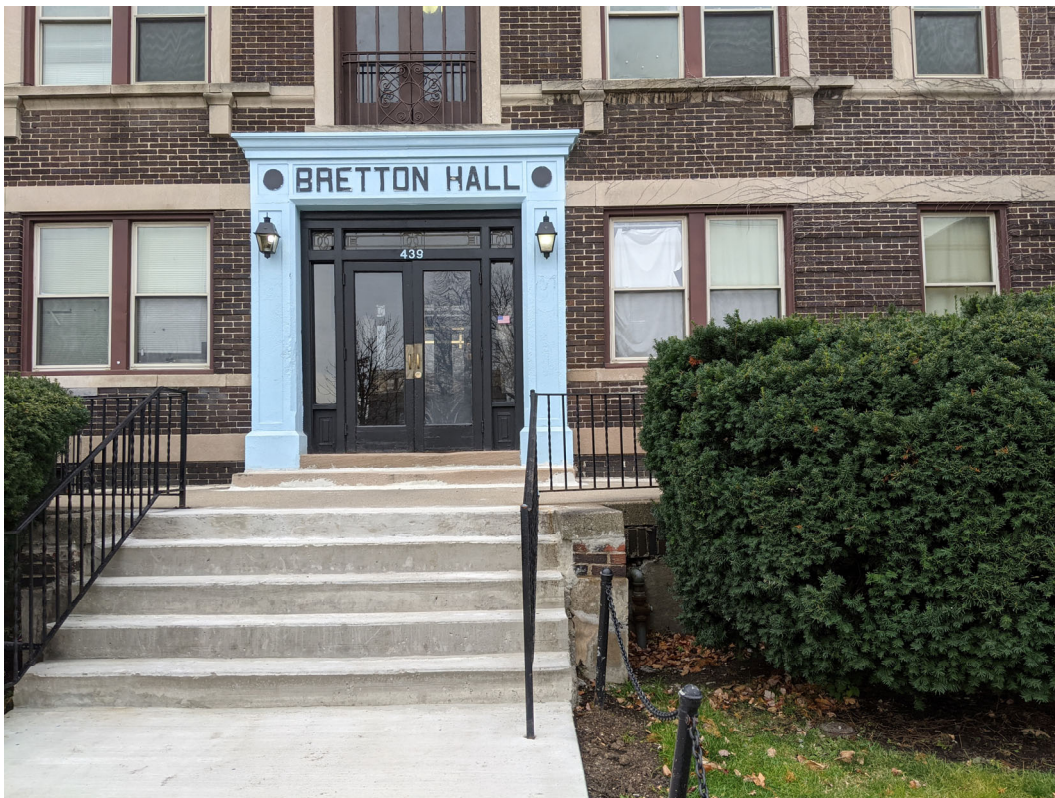
Bretton Hall is one of two occupied buildings in the Cass-Henry Historic District, the other being its near twin sister building, the Berwin (489 Henry), at the western end of the block. Curiously, both occupied buildings feature stonework around the entranceway that is inappropriately painted light blue; a condition noted disapprovingly in the district's Elements of Design (#9, *Relationship of colors*). The lettering, and a circular detail flanking it, have also been painted black. The transom windows feature leaded glass with an Arts and Crafts design. Such delicate ornamentation may have initially extended to sidelights below, but they are now fitted with plain glass set in what appears to be their original wood frames. The entry doors appear original and are currently fitted with a single pane of glass, though evidence at the Berwin (489 Henry, refer to the staff report) suggest that these doors may have originally had a divided light configuration matching the balconette doors in the stories above. The cast stone surround of the entry features pilasters topped with a simple classical entablature. Sconces are installed on the pilasters; staff has not yet confirmed whether these units are of historic age, but likely not.

Detail view showing main entrance on Henry, note "BRETTON HALL" name above. Staff photo, November 24, 2020.

- Staff does question the proposed replacement of the historic age building’s entry doors, since they are relatively rare character-defining features (especially with respect to the missing doors on other buildings in the district), and not described as being beyond repair or even in deteriorated condition.

- Per discussion above, staff recommends that the historic entry doors be preserved, repaired as necessary, and returned to service
- No approvable process has been proposed for the removal of the brown paint over the brick, or the blue/black paint over the stonework. A process or specification ensuring the preservation of the historic masonry should be submitted for staff review.

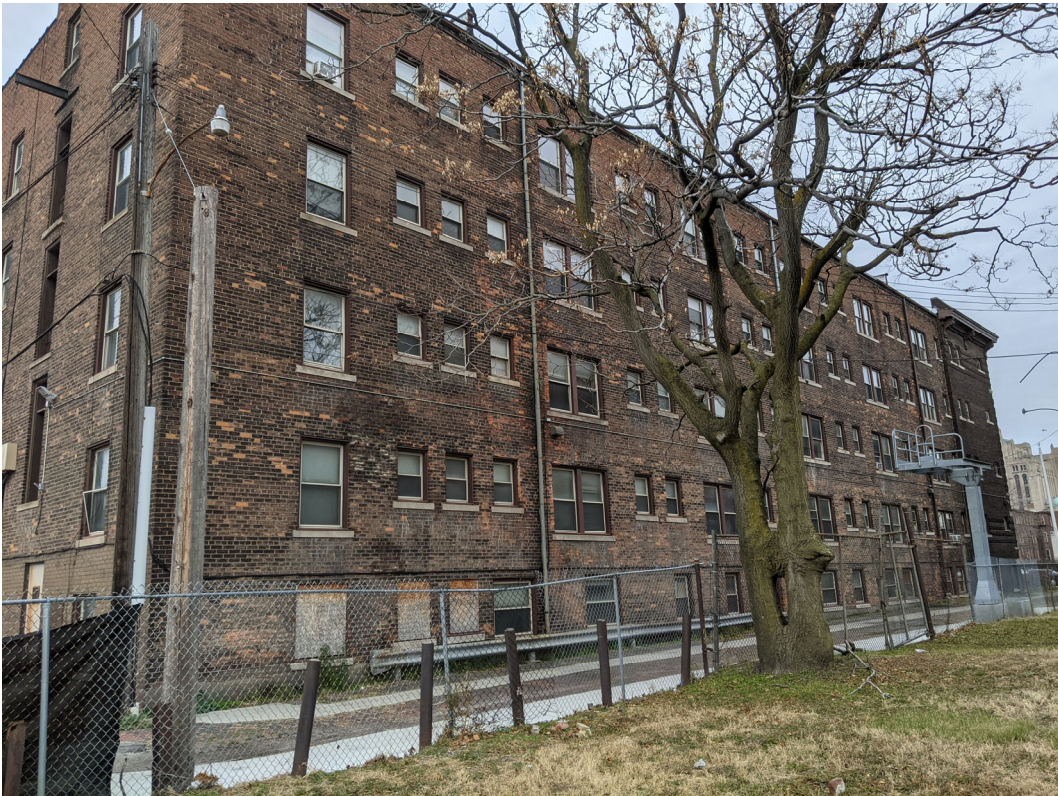
The brown face brick (and cornice) extends around to the east elevation and continues for about two bays, then transitions to common brick with architectural detail reduced to stone sills. The west elevation treatment is similar, although at the transition to common brick the elevation steps back approximately ten feet, allowing for an "alley" like space between this building and the garage building (447 Henry). The rear elevation has modest historical and architectural character of a more utilitarian nature, with furniture loading openings at each rear stair landing, and a projecting steel beam (hoist) above, aligned with the center hall; at least two historic-age multi-light wood doors are extant in the openings at the 2nd and 3rd story. The brick is common and has been painted brown up to about six feet high, presumably to obscure or discourage graffiti.

East elevation at alley. Staff photo, November 24, 2020.

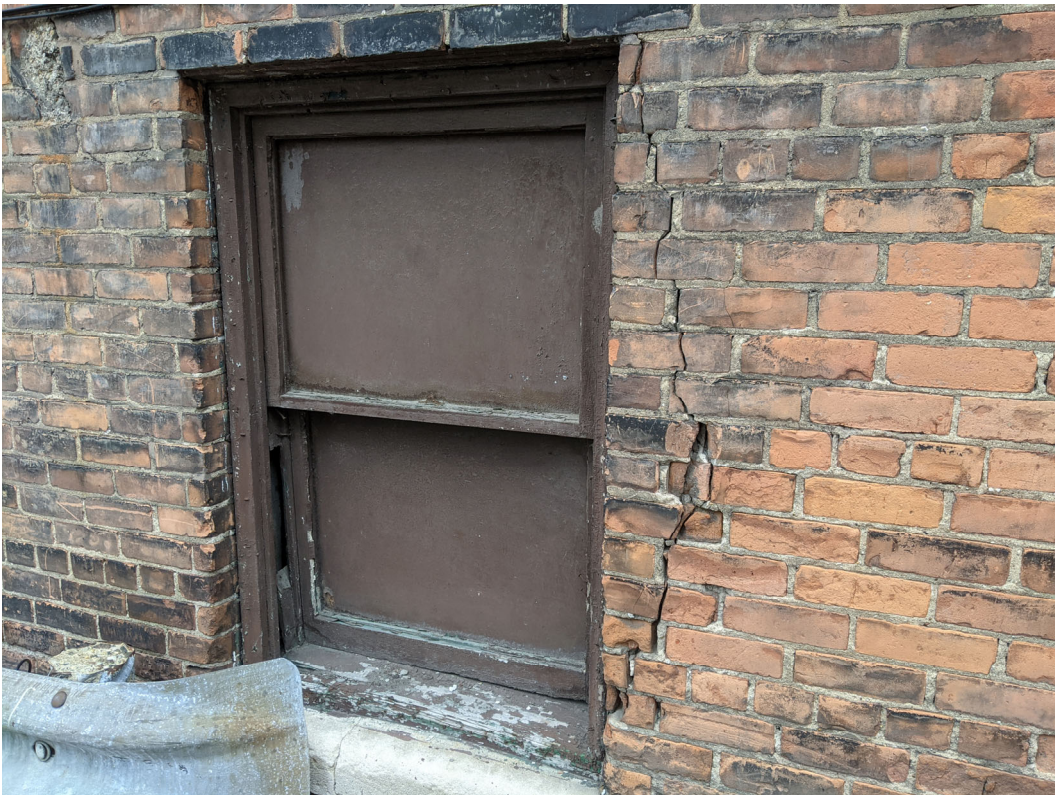
A single remaining wood window at the basement level, east elevation. Staff photo, December 7, 2020.

- The applicant proposes new historic replica, aluminum-clad wood windows throughout to replace the existing vinyl units. Staff finds the proposed product to be appropriate, and that a 1/1 configuration would also be appropriate in all instances. There is one remaining original wood window in fairly deteriorated condition at the basement level, along the alley, which staff does not consider a character-defining feature supporting the historic integrity of the building.
