STAFF REPORT 12-9-2020 MEETING

APPLICATION NUMBER: 20-6985

ADDRESS: 427 HENRY (AKA THE HENRY, HENRY APARTMENTS, HENRY FLATS)

SCOPE: REHABILITATE APARTMENT BUILDING

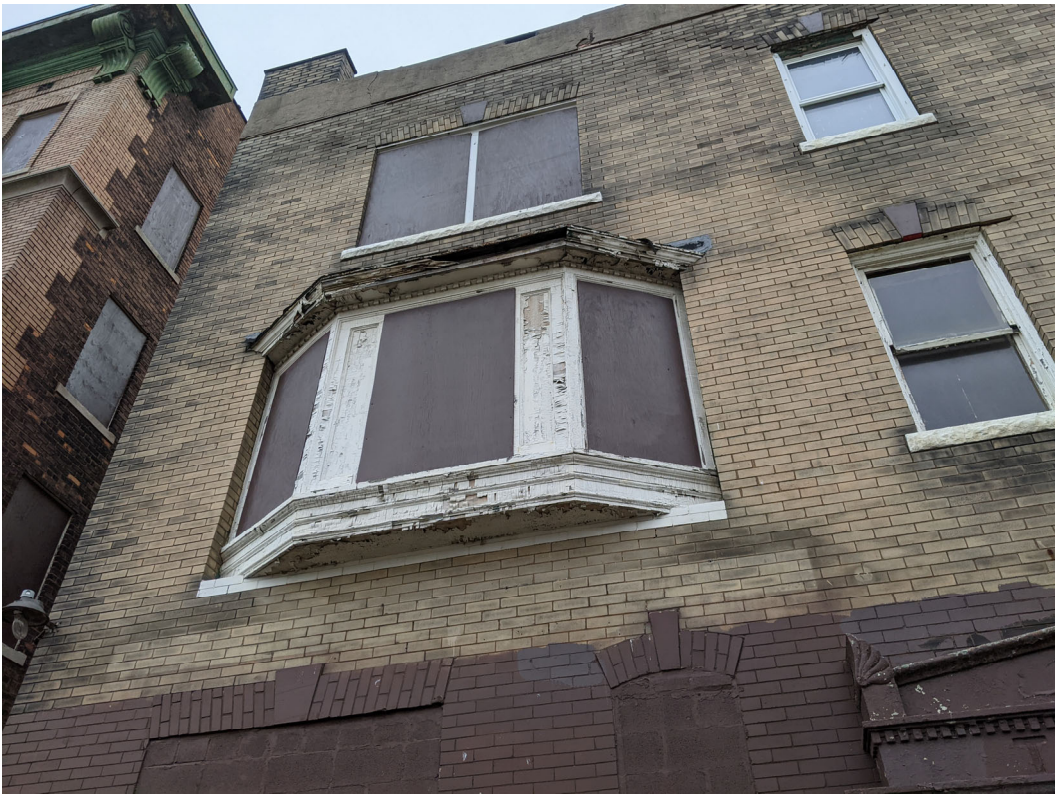
Detail view showing conditions at the Henry (primary) facade. The center (2nd story) window is original. Staff photo, November 24, 2020.

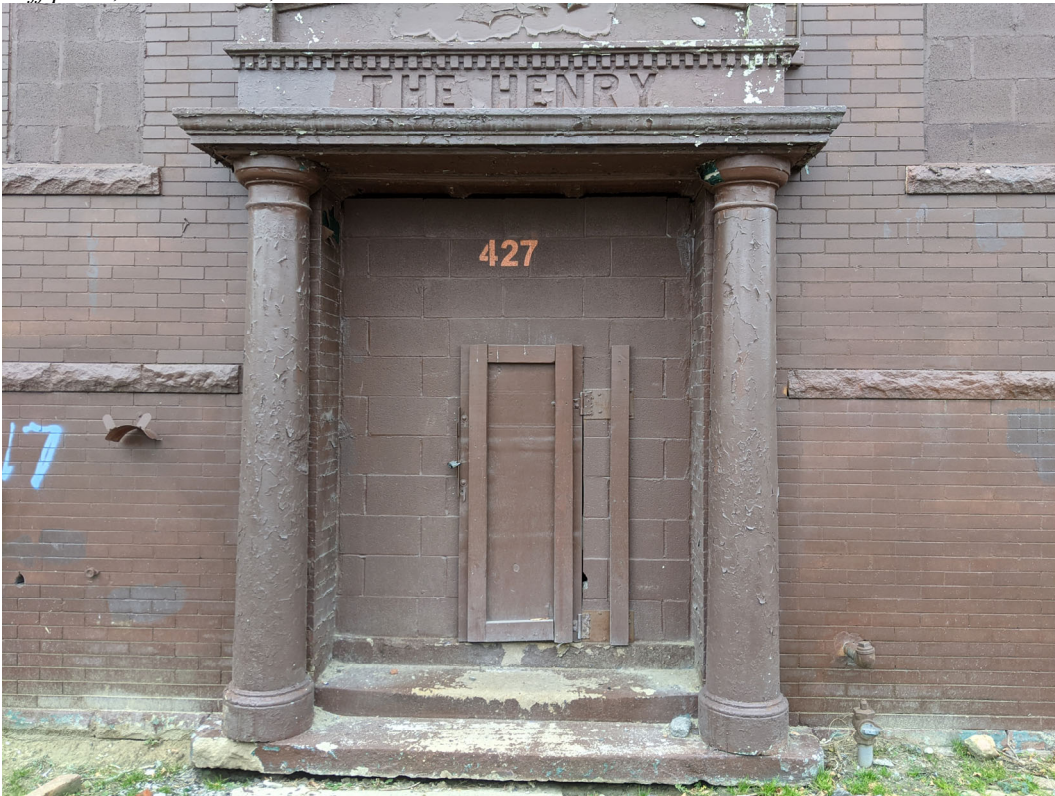
Detail view showing main entrance at Henry, note "THE HENRY" name above. Staff photo, November 24, 2020.

- The building’s original entrance door(s) is no longer extant. Staff finds that the proposed replacement design is historically appropriate. The building’s designation report, excerpted above, does take note of the building’s name “The Henry” as a character-defining feature remaining at the building’s entrance. This feature should be preserved.

- The historic name of the building, set in stone above the entryway, be preserved and remain visible.

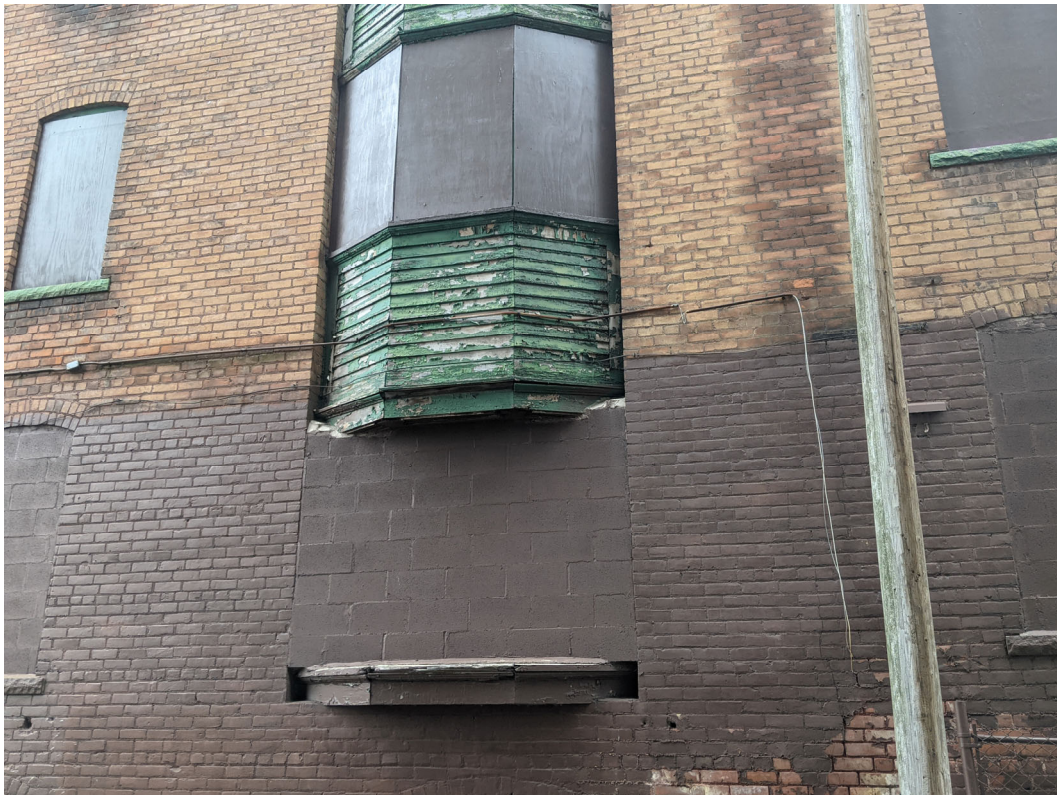
Detail view of west-facing bay at alley elevation. Note unusual clapboard detailing, and missing first story windows. Staff photo, December 7, 2020

- *At the west (alley) elevation, the bay window structure will be reclad with new wood (and first floor reconstructed) with the existing sightlines and applied wood trim maintained or rebuilt if too deteriorated. 6/1 windows will be installed at the bays*

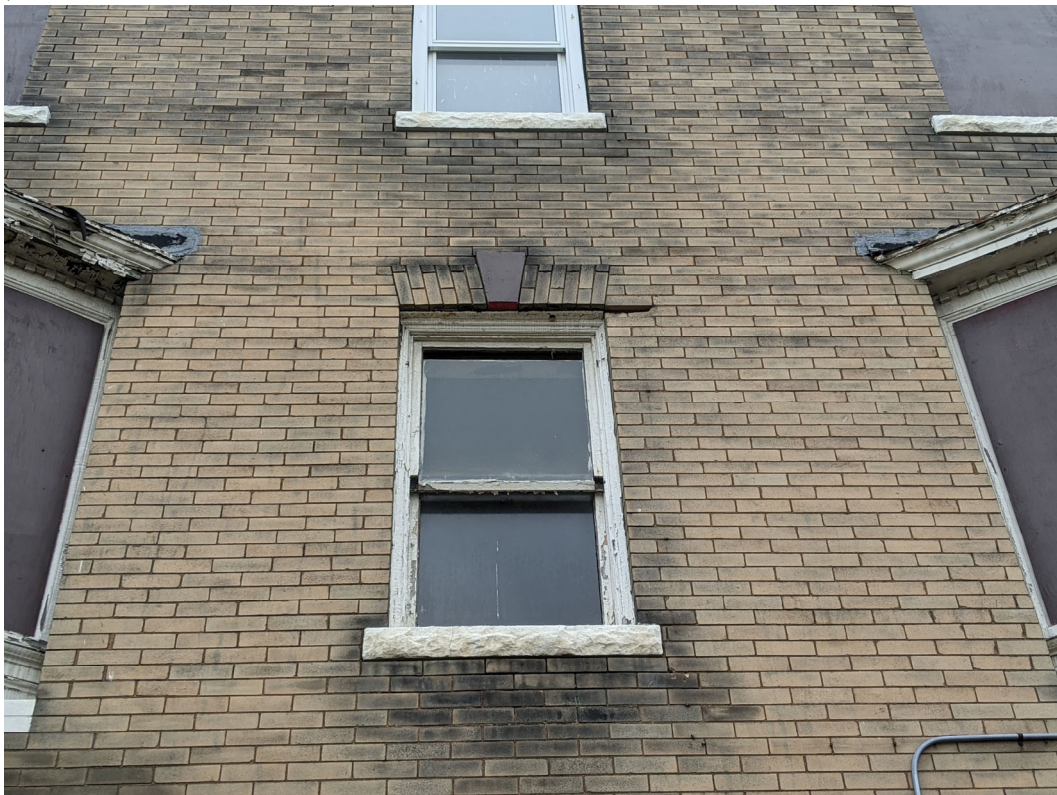
Detail view of an original wood window at the front elevation. Staff photo, December 7, 2020.

- For the reasons stated above under “Observations,” staff is not eager to recommend replacement of the remaining historic wood windows absent proof of being beyond repair. The existence of “last remaining” character-defining elements has always merited special attention in the practice of historic preservation; indeed, the existence of this particular historic district is itself an example of such good practice. The remaining wood windows at the Henry Street facade, if restored, would contribute to the historic character of the rehabilitated building and should be retained. Given that this façade has a relatively small number of windows (18 total), and each of those windows has a comparatively larger effect on the character of the whole (similar to a smaller residential property), the replacement windows for this primary façade (only 10 would be required, by staff’s count, to join the 8 existing), should be specified as wood to match existing. The aluminum-clad replacement windows as proposed would be appropriate for the other, secondary elevations. Staff does not find that the Standards or Guidelines would prize aesthetic or technical uniformity over preservation of historic fabric.

- The windows on the front (primary) façade to be a mix of the restored original wood windows with the remainder to be new windows in the design configurations proposed but executed solely in wood; except as staff approves replacement of historic windows based on receipt of documented deterioration beyond repair (condition subject to receipt of further clarifying information from applicant concerning original windows)
