STAFF REPORT: FEBURARY 10, 2021 MEETING

APPLICATION NUMBER: 21-7053

ADDRESS: 1948 CHICAGO BLVD.

SCOPE OF WORK: CONSTRUCT NEW ADDITION AT REAR, WINDOW REPLACEMENT, VARIOUS EXTERIOR MODIFICATIONS AND GENERAL MAINTENANCE

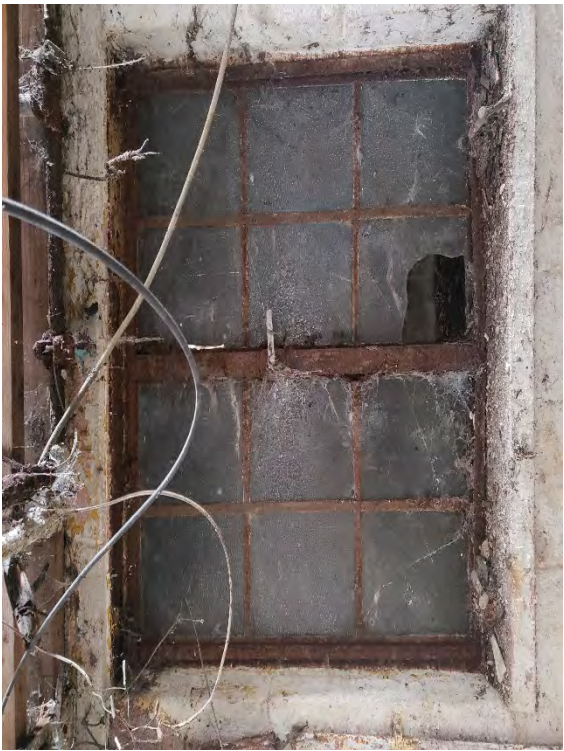
- The applicant provided staff with photo documentation of an original window from the house, that is found in a window well. These window frame dimensions measure 2-1/8" and the muntins measure 3/4".

Figure 1. The only remaining window
(Applicant photo)

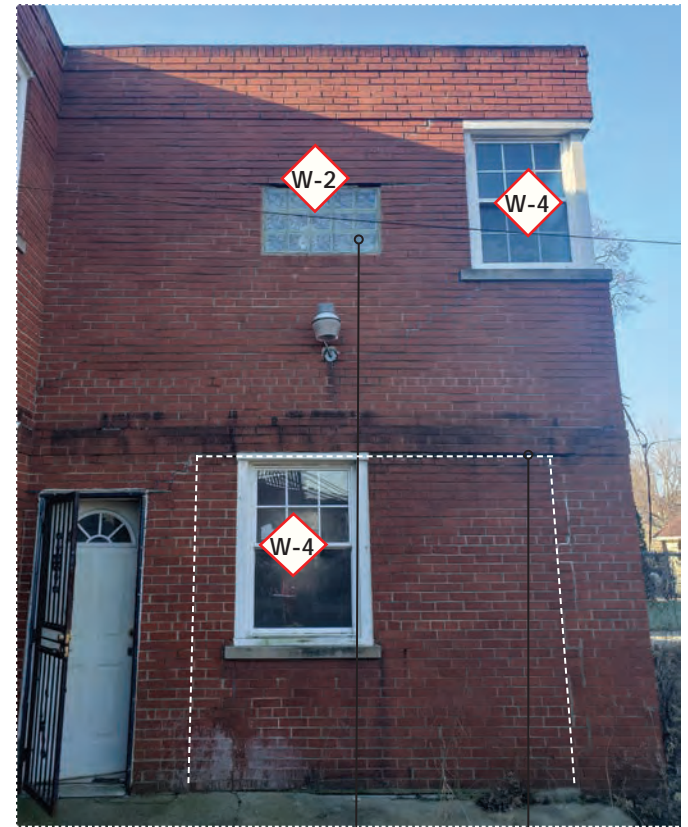
Fig. 1 | East Facade (Former Garage)

Original home had one car garage.

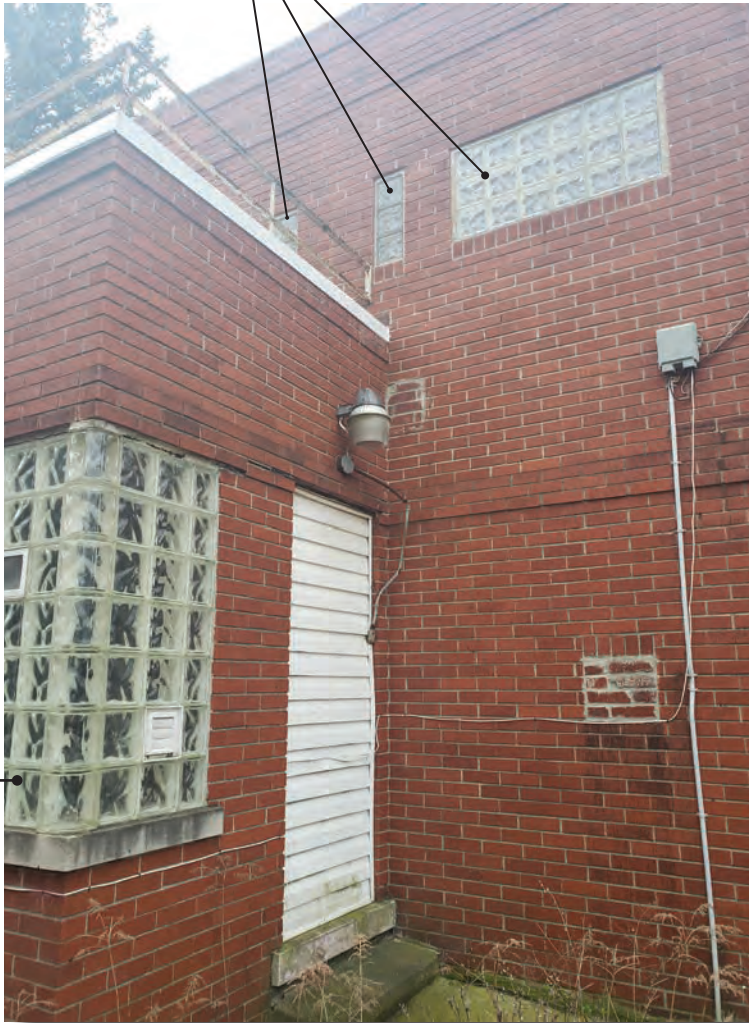
Fig. 2 | Looking SW at East Facade (Former Rear Entry)

Glass Block is not original to home according to historic photos

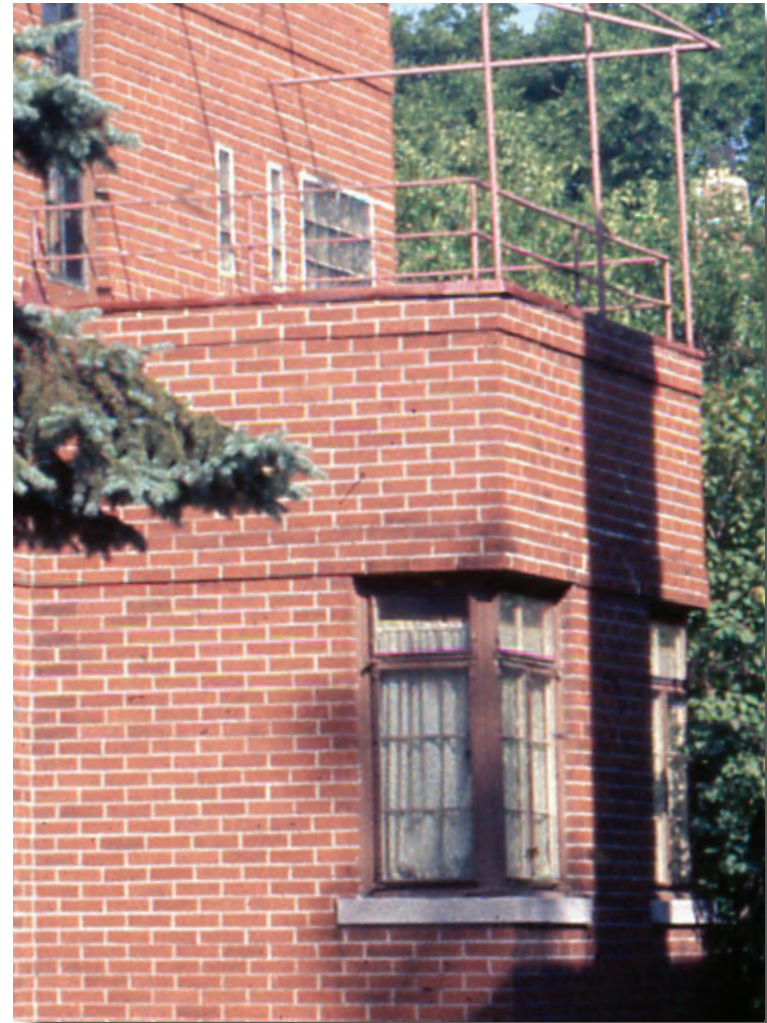
Fig. 3 | Historic 1974 Boston Edison photo references existing glass block windows on 2nd Floor with metal railing and fabric canopy structure.

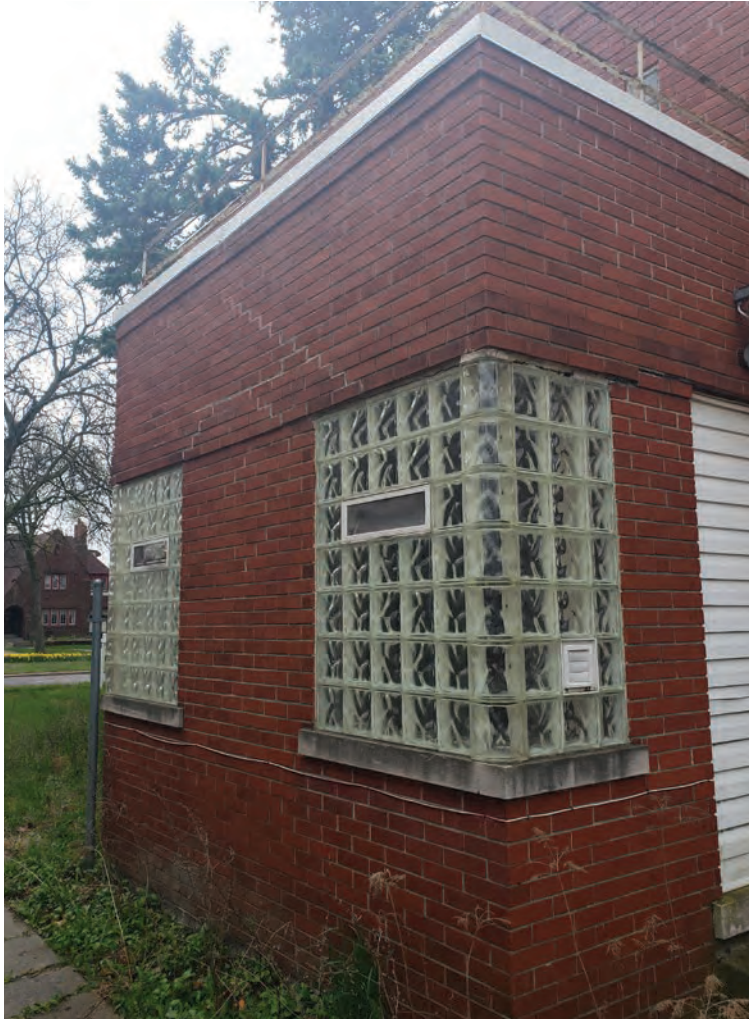
Fig. 3A | Today, the windows have been replaced with glass block. See window type (W-3) for more informaton

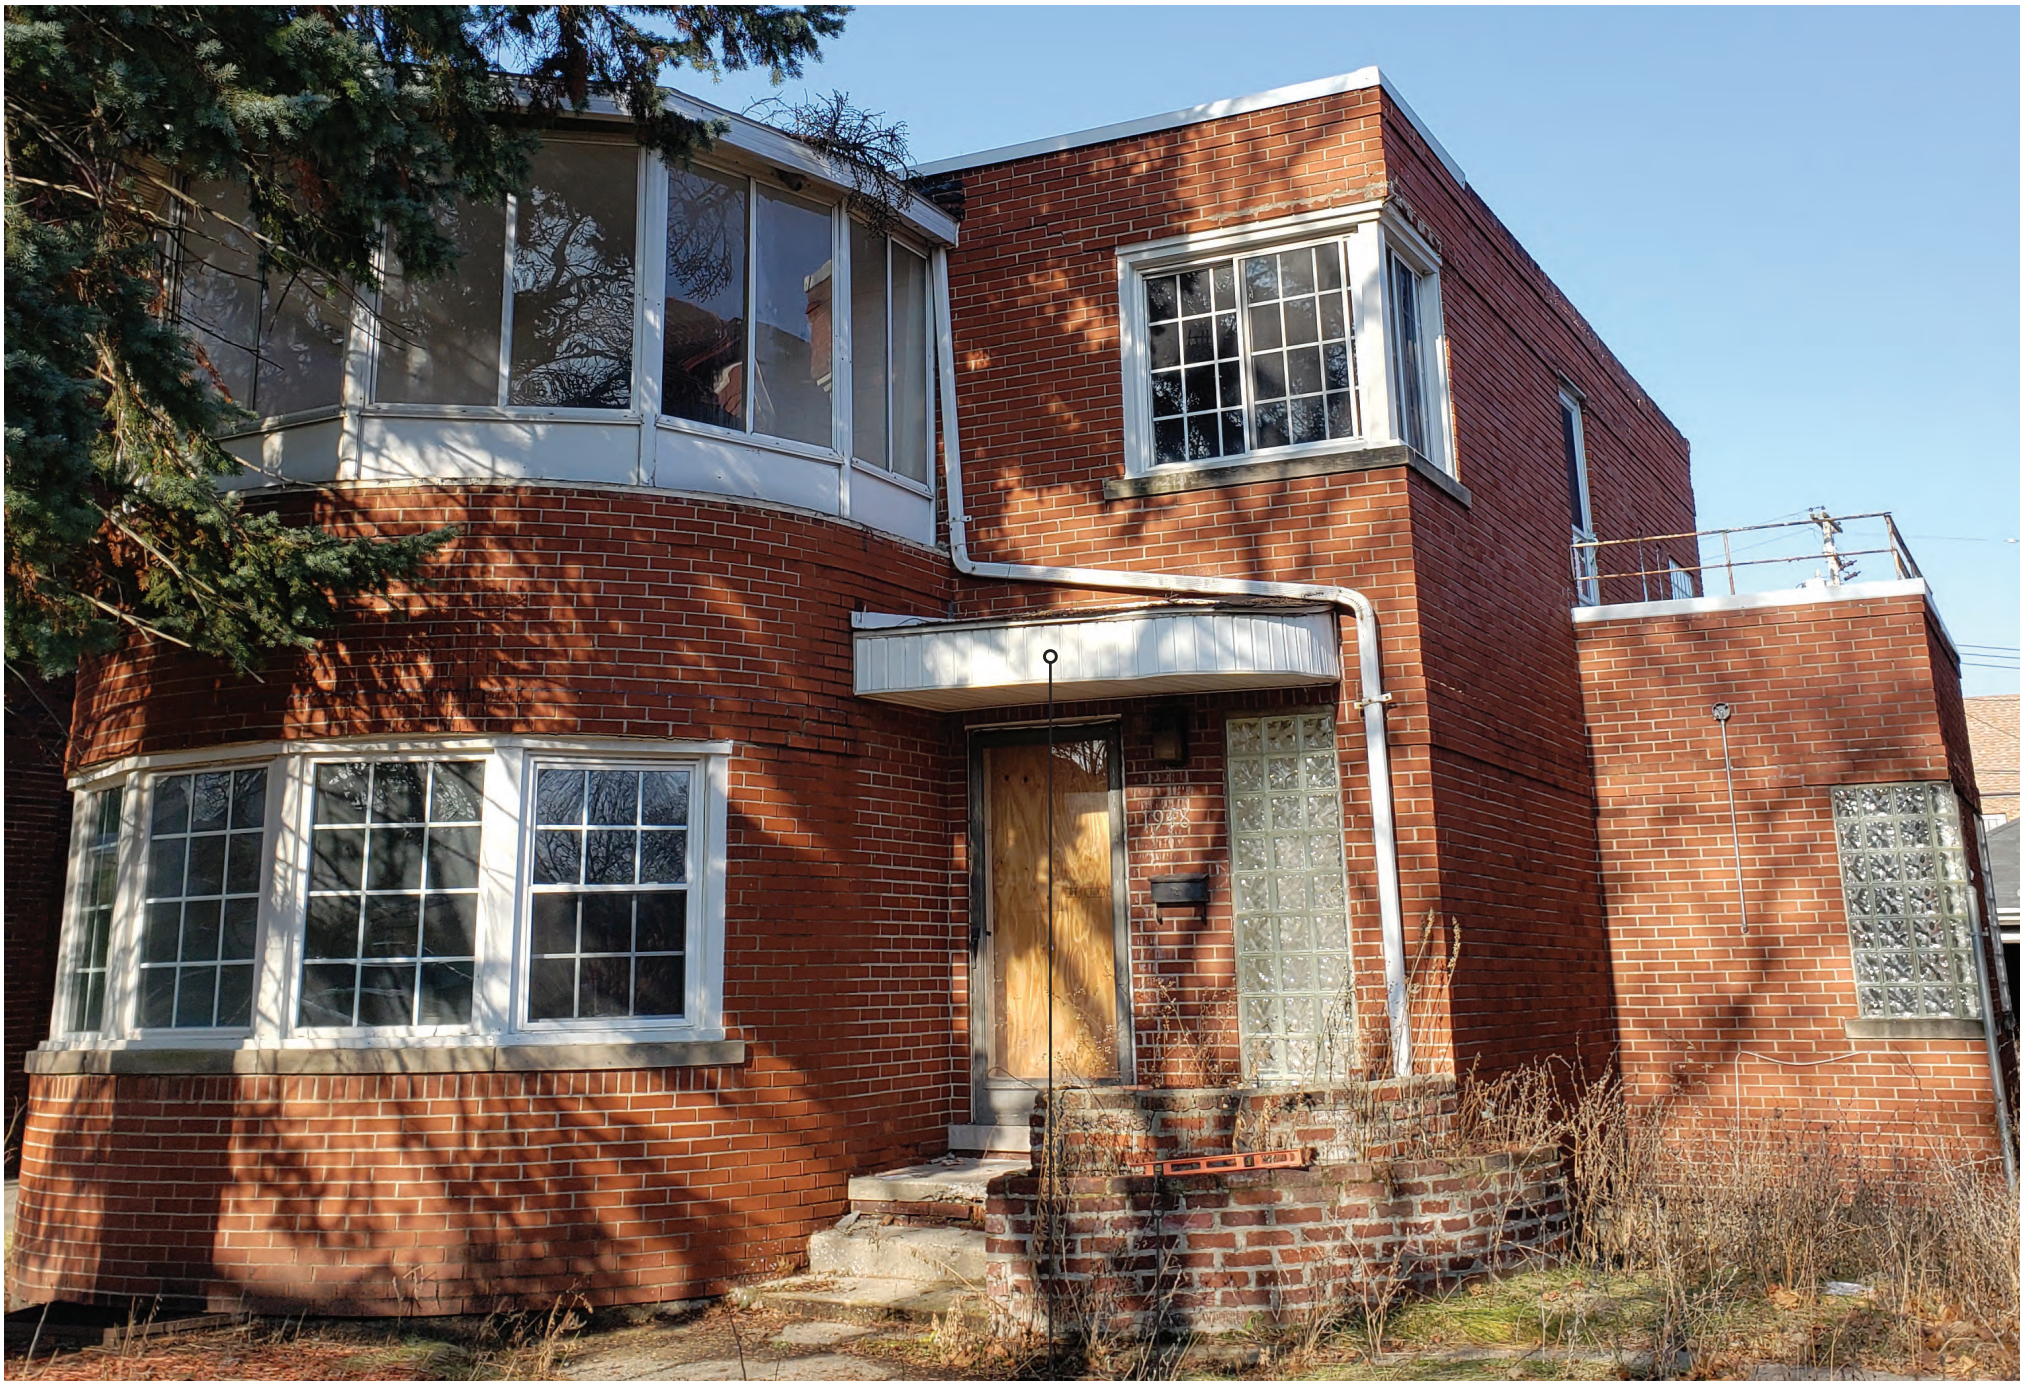
- 5 Existing vinyl windows sit below desk height. We propose to add 3-courses of matching brick to align with top of existing stone sills.
- 6 Existing planter foundation has deteriorated and will need to be replaced. Existing planter bricks are not original to home. Repair includes new footing, restacking w/ matching brick, and stone cap.
- 7 Porthole Window front door would have been original to the home. We propose to reintroduce this chic door style back to home
- 8 This glass block is original to this home. We propose to replace dated glass block with new glass block and mortar

Fig. 6 / South Facade (Street View). See 1974 and 1980 Historic Photos

Repair existing entry awning w/ metal composite

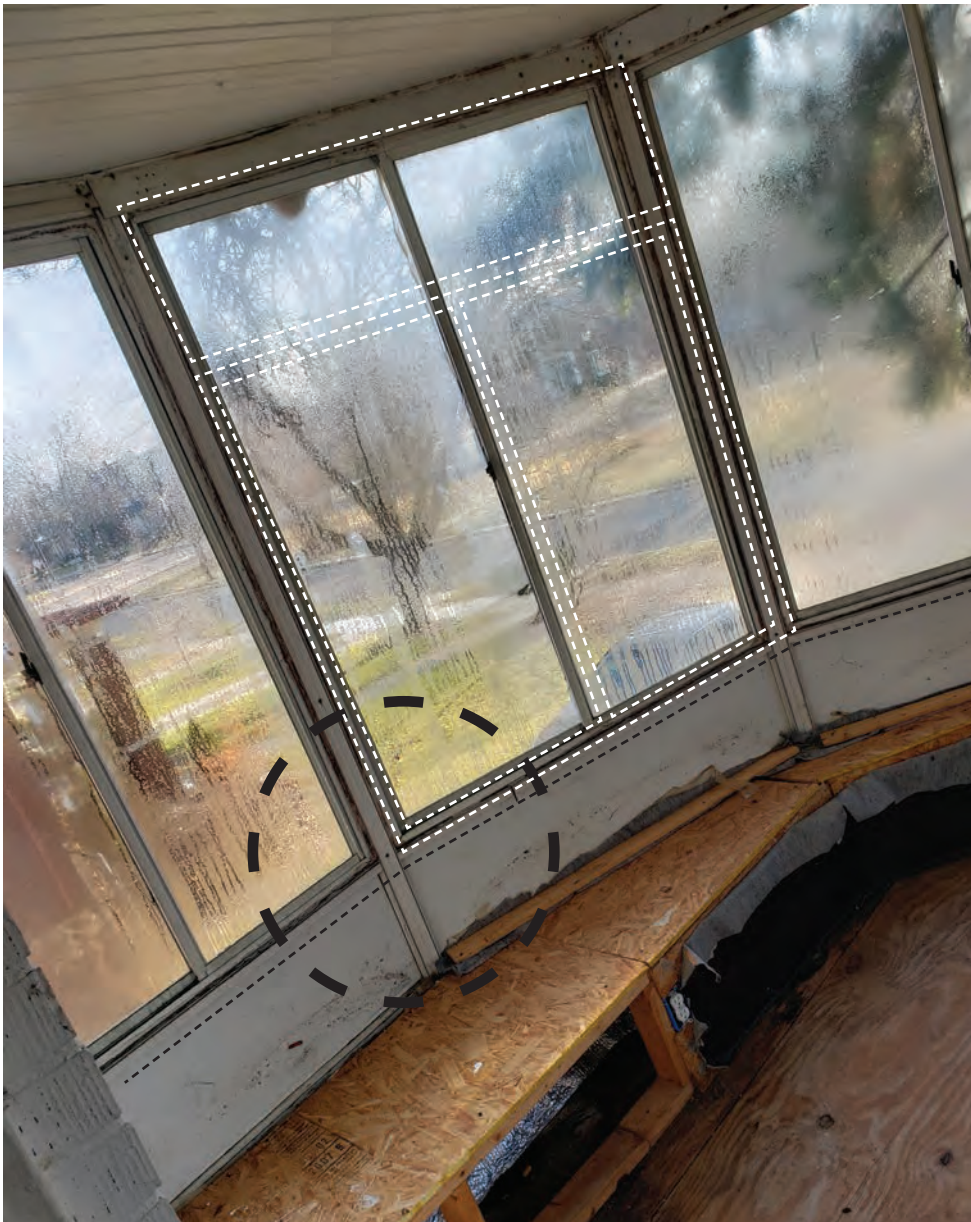
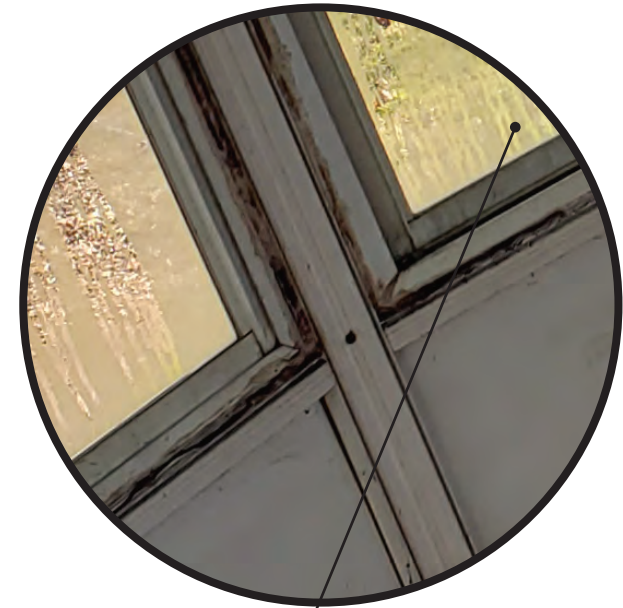
SOUTH FACADE - 1ST & SECOND FLOOR

Existing Conditions:

- Single Pane Glazing
- Installed between 1958-1974
- Existing seals have deteriorated. Plastic frames have become brittle.
- Existing interior space is non insulated. Existing glazing system life cycle has expired.

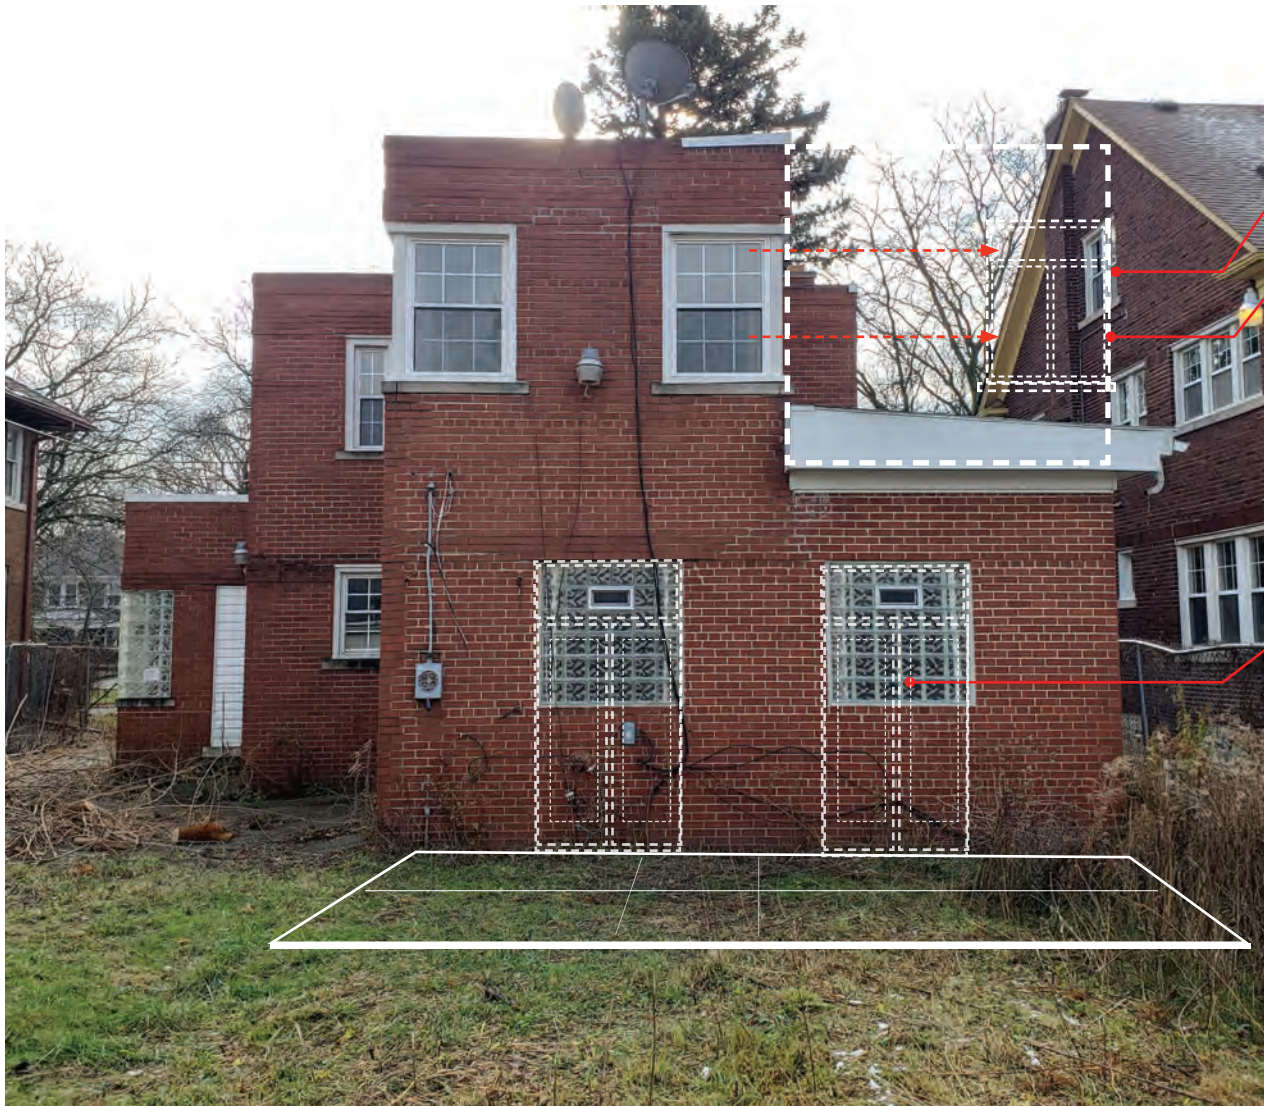
NORTH ELEVATION - REAR ELEVATION

Remove deteriorated "corner"
style vinyl windows and replace
with similar casements.

Add 175 sqft brick addition.
Match brick, mortar, and tooling
to existing brick of home.
