STAFF REPORT 02-10-2021 MEETING

APPLICATION NUMBER: 21-7068

ADDRESS: 1451 BROOKLYN

SCOPE: DEMOLISH STAIR ENCLOSURE, REPLACE WINDOWS, REHAB BUILDING

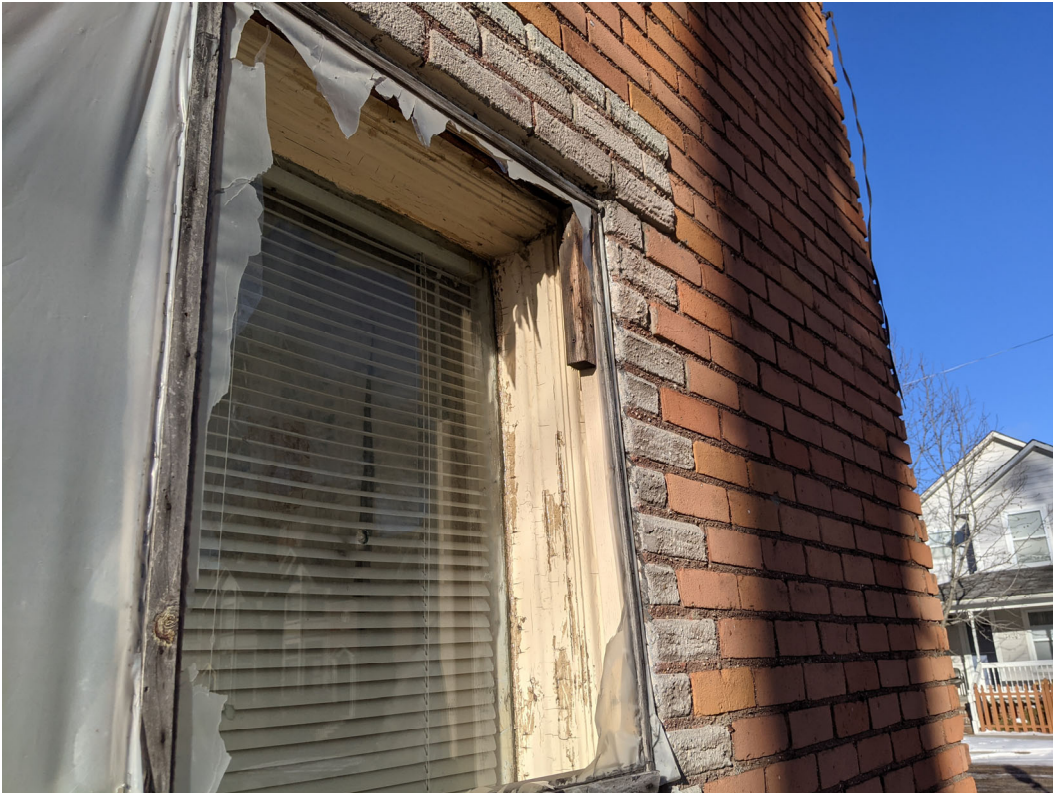
- Staff was unable to field confirm that the shop windows once enclosed mulled double-hung sash as recreated on the submitted drawings. The existing conditions are a casing in fair condition with a metal-clad sill.

Detail view of shop window frame at first story along Brooklyn Street. Staff photo, February 3, 2021.

- The existing historic and distinctive wood windows at the primary facades along Brooklyn and Labrosse Streets, including eight (8) 1-over-1 double-hung windows and the two (2) large fixed, undivided light "shop" windows, *but excluding the three (3) wood casement pairs at the former porch along Labrosse for reasons of technical infeasibility*, are to be retained, reglazed, and repaired, with new sash elements permitted as required. A paint color for these windows appropriate to the style of the building is approvable by staff; and,
- Replacement wood double-hung windows permitted on secondary elevations and at the former Labrosse porch shall be Andersen A Series; and,
- The six (6) new wood double-hung windows at the former Labrosse porch should be painted to match the retained historic windows in the primary facades.

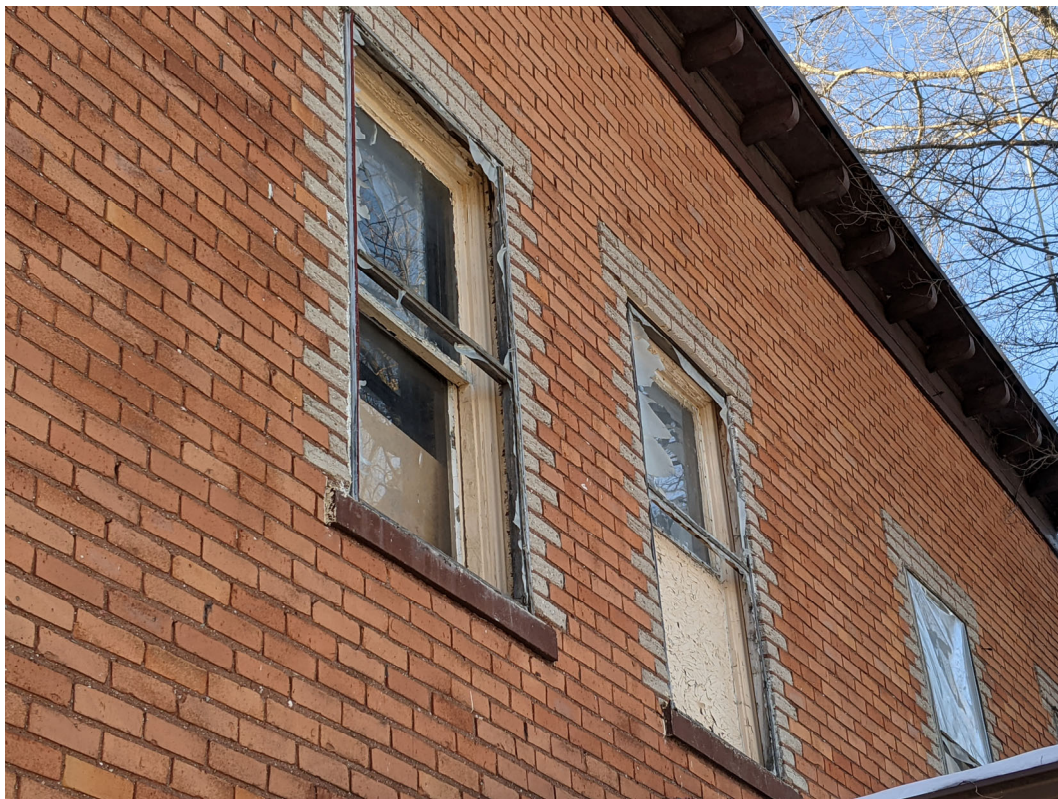
- Staff was unable to confirm the applicant's characterization of the double-hung windows as beyond repair. It is staff opinion that the windows are distinctive character-defining features; they exhibit a robust articulation and depth not easily reproduced in a modern replacement window. It appears that parts of existing sash and other sub-elements of the windows could be repaired and renewed without losing the entire window.

Detail view of windows at second floor. Though there are many areas requiring paint and repair, with certain elements missing and/or requiring replacement, the work would not be technically challenging. Staff photo, February 3, 2021.

- However, it is staff’s opinion that the existing wood windows on the two primary facades along Brooklyn and Labrosse (with the exception of the poorly installed wood casements at the former porch) should be retained and repaired. The repair of the 1/1 double-hung windows would require replacement of some sub-elements (stops, sill, sash, etc.), but staff recommends that such a repair would be reasonable and economically and technically feasible under the Standards. These highly visible wood windows are important to the historic character of this small, residential scale building, but are also important to the historic character of the surrounding environment, given that several of the adjacent nineteenth-century homes continue to feature character-defining wood windows of a similar type as are on this partially residential structure. The windows at the secondary elevation are less important for the building’s character, and have greater integrity issues. The surviving fixed, undivided light wood shop windows at the first story are now rarely seen in Detroit, and are in surprisingly intact condition, including metal-clad sills. Staff finds them to be particularly important in establishing and preserving the historic character of this modest building.
